Second Five-Year Review Report

Smeltertown Superfund Site Operable Units 1 and 2

Chaffee County,
Colorado

September 2010

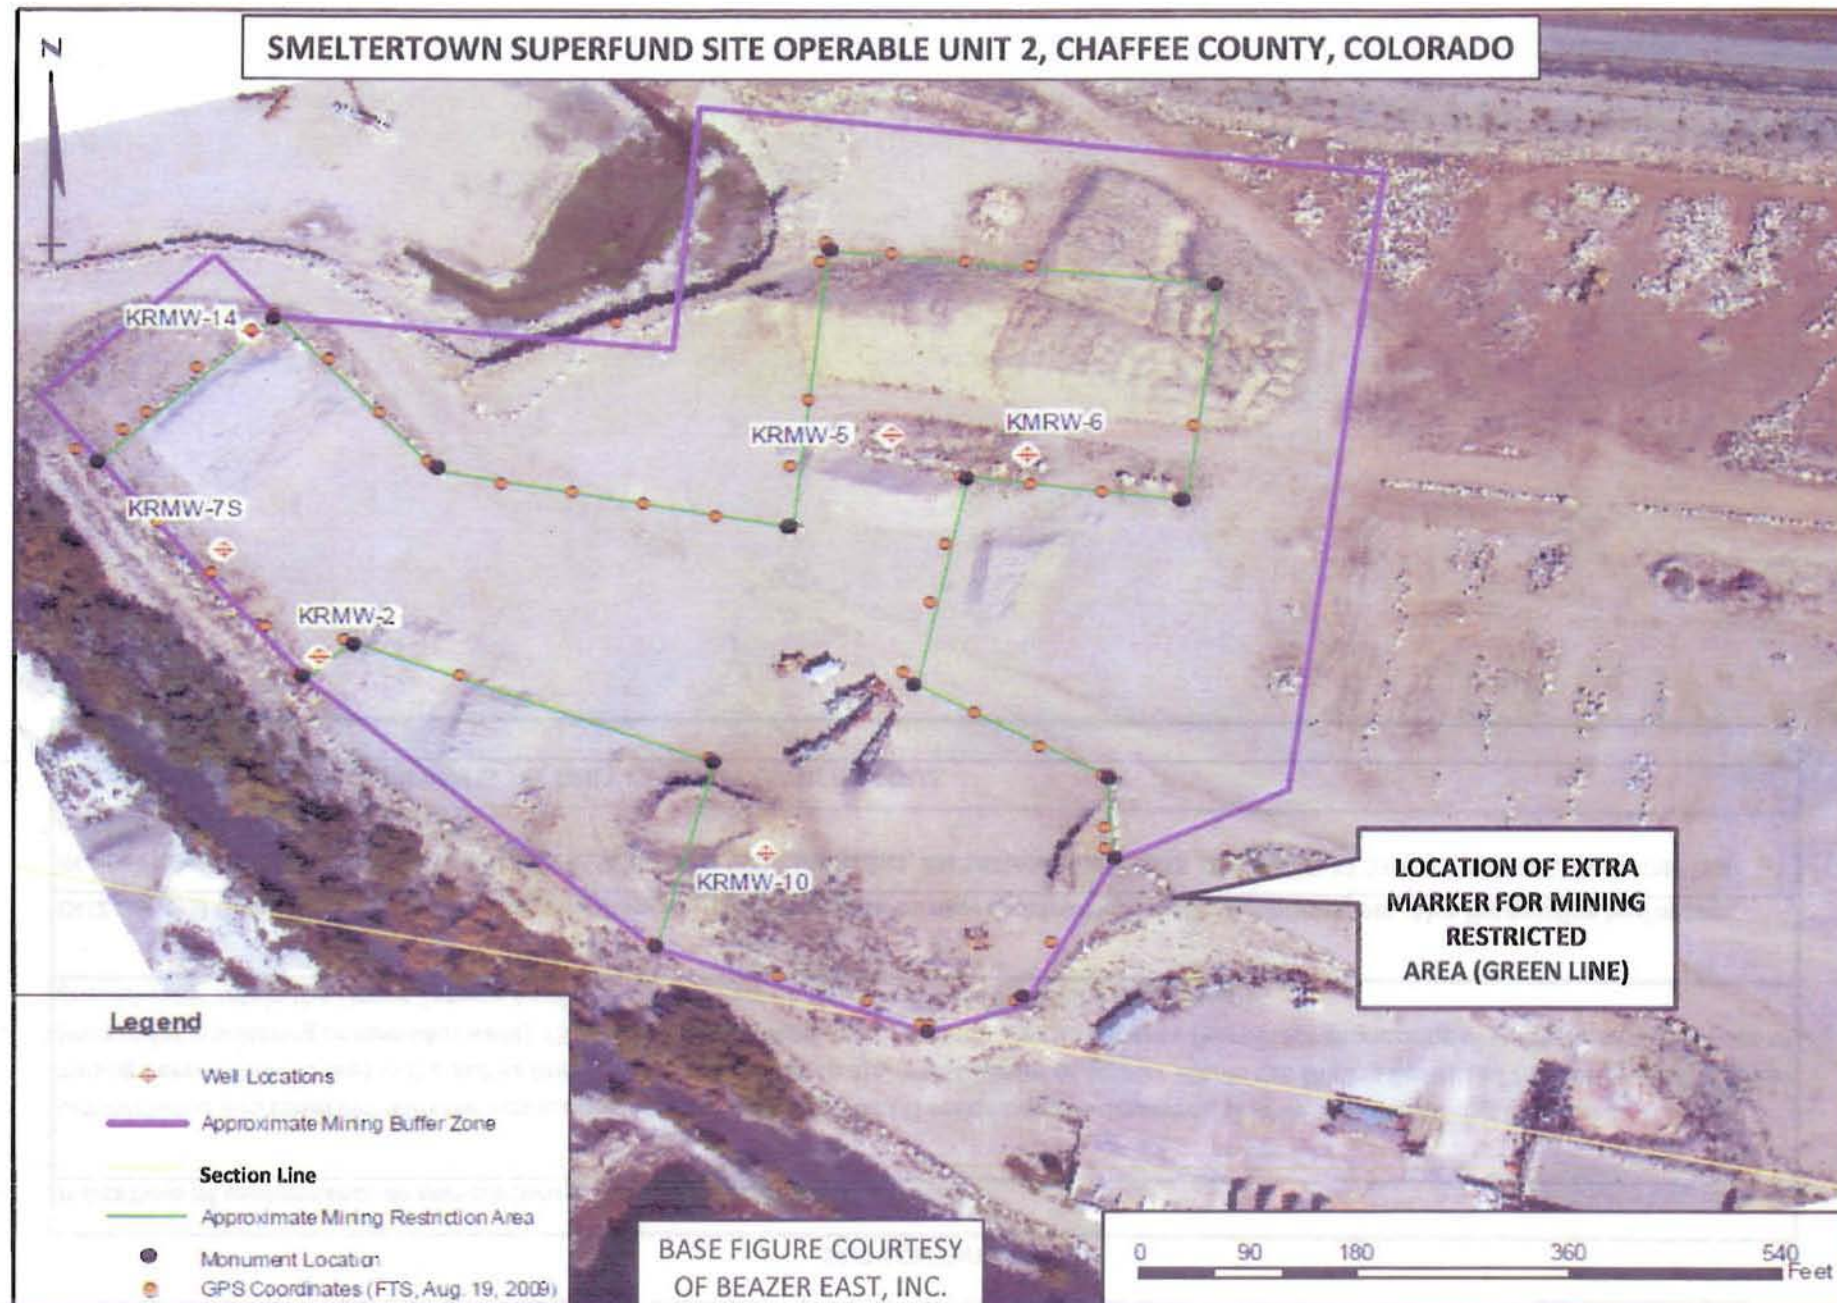
SMELTERTOWN SUPERFUND SITE OPERABLE UNIT 2, CHAFFEE COUNTY, COLORADO

IN ADDITION TO THE REQUIRED 17 MINING RESTRICTION AREA MARKERS, AN 18TH MARKER WAS OBSERVED AT THE LOCATION SHOWN ON THE ATTACHED AERIAL PHOTO.

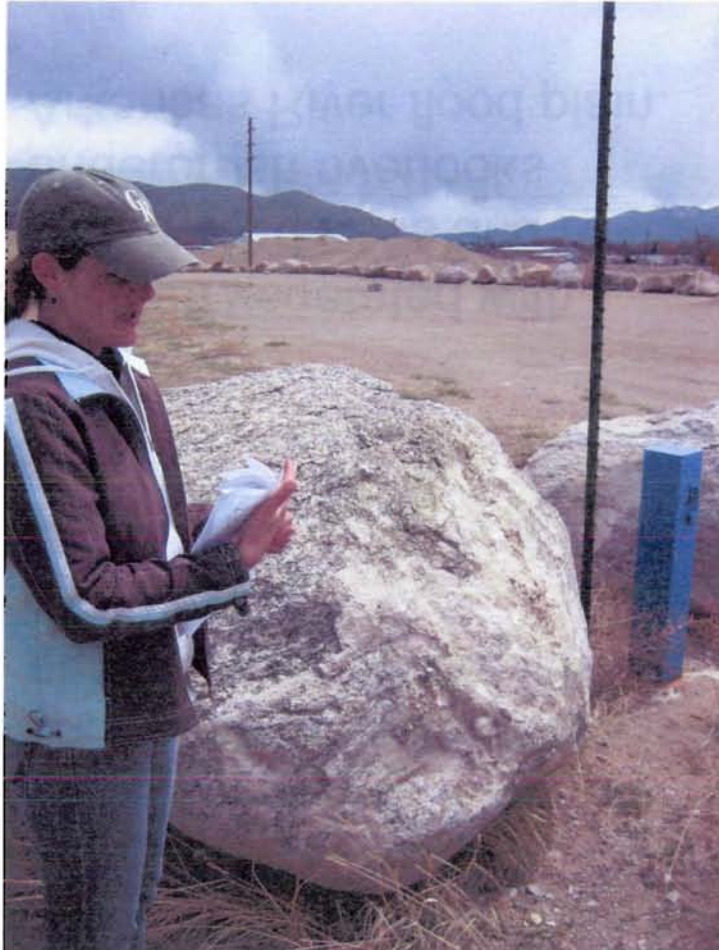
- Site visit coordinated with the inspection of the site's 17 monitoring wells.
- Monitoring wells are well marked and protected from damage by the heavy earth moving machinery.

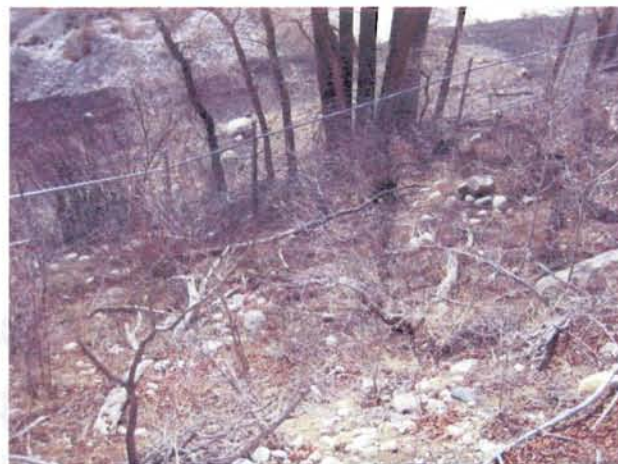
The fence around Spring No. 5 had been constructed and the gate was locked and in satisfactory condition. No flow of water or DNAPL, and no creosote odor were observed within the fenced area during the field inspection.

Fenced off seep area, restricts public from possible DNAPL exposure.

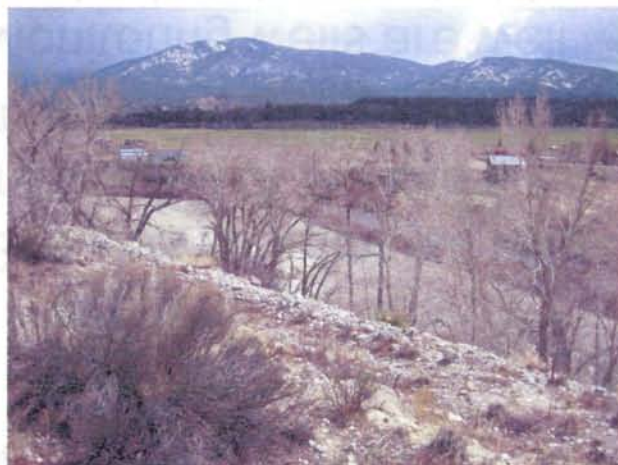
Steep bluff vegetated with cottonwood trees and underbrush overlooks Arkansas River flood plain.

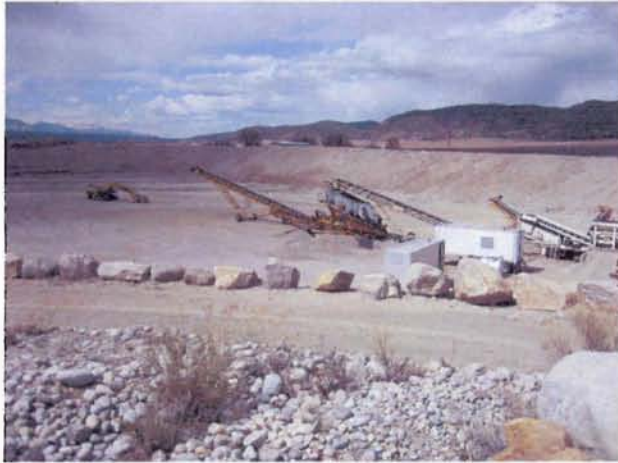
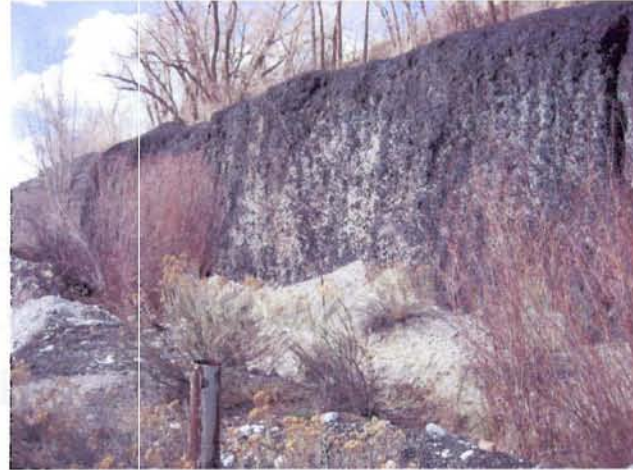
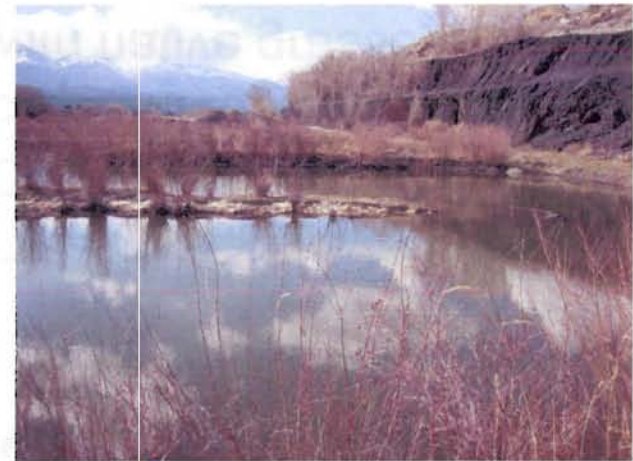
- Top left: Gravel operation near OU2
- Top right: Slag deposits along the Arkansas River
- Bottom right: Ponds adjacent to the Arkansas

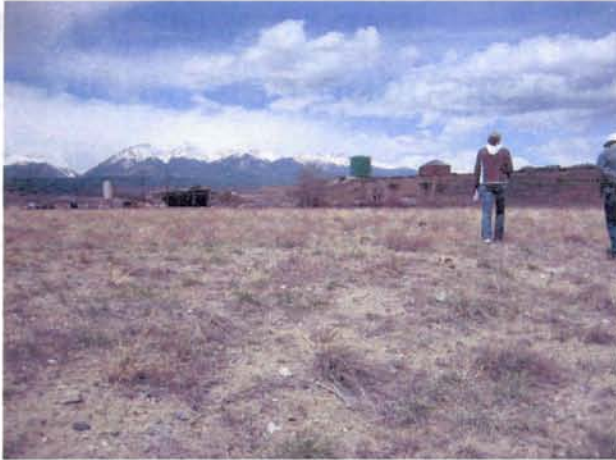
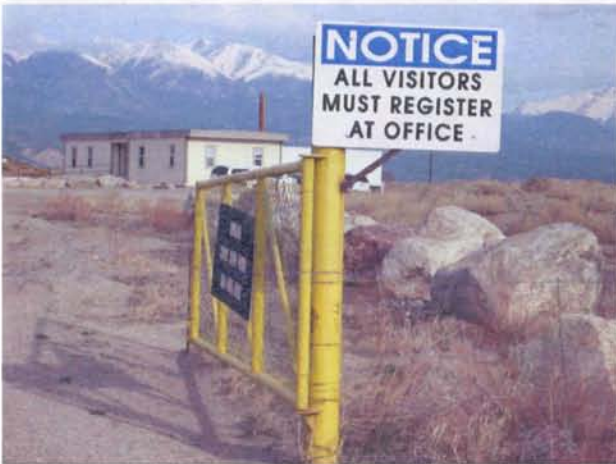
1. The cover system associated with the WCA remains in satisfactory condition and therefore prevents human exposure to consolidated wastes. Vegetative cover density is similar to nearby offsite non-irrigated properties. No erosion, animal burrows or differential settling were noted during the inspection.
2. The Butala and Teck LLC property perimeter fences are in satisfactory condition, and serve to control access to the WCA.
3. Institutional controls prohibiting residential use and restricting drilling, excavation, or re-contouring of the cap has been implemented, and compliance with the controls was confirmed during the site visit on April 20-21, 2010.
4. Groundwater monitoring has been conducted at the required frequency, for the required chemicals.

- The Consolidation Area at OU1 has been capped with clay and top soil and vegetated with native grasses.
- The Superfund site has restricted access and is gated and fenced.
