**City of Temecula  
Municipal Separate Storm Sewer System (MS4)  
Inspection Report**

**City of Temecula - Municipal Separate Storm Sewer System (MS4)**  
**(Order No. R9-2004-001)**  
**Photograph Log**  
Inspected by: Scott Coulson (PG Environmental, LLC)

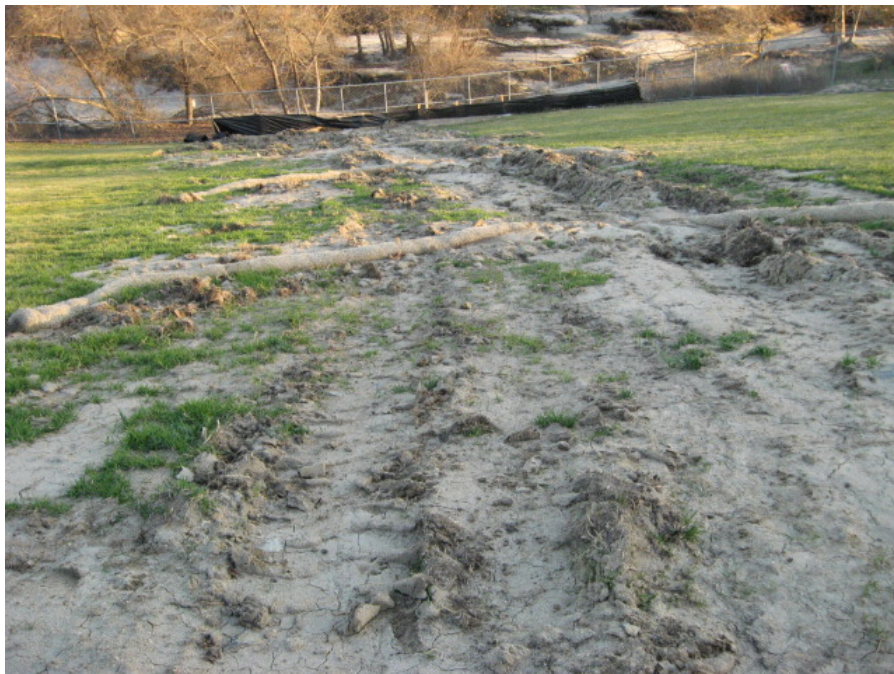
designated minimum BMPs at each construction site within its jurisdiction year round.” It was observed during the inspection that adequate BMPs were not implemented to prevent the discharge of sediment from the disturbed slope area at the northern perimeter of the site (see attached Photograph 1). Adequate BMPs were not implemented to dissipate flow velocity on the slope and the surface of the slope was not stabilized. Slope erosion was observed, including rill and gulley formation at the base of the slope (see attached Photograph 2). Furthermore, evidence of a previous failure event was observed, including a section of silt fence at the base of the slope that had been undercut (see attached Photograph 3) and erosion beyond the silt fence BMP (see attached Photograph 4). As a result, there was a discharge of sediment from the disturbed slope area leading offsite toward Empire Creek. BMPs must be adequately installed, inspected, and maintained to prevent the discharge of sediment from the disturbed slope area leading offsite toward Empire Creek. Moreover, the City must ensure erosion prevention, slope stabilization, and maintenance of all source control and treatment control BMPs at the YMCA project site.

Photograph 1: View of the disturbed slope area at the northern perimeter of the YMCA site

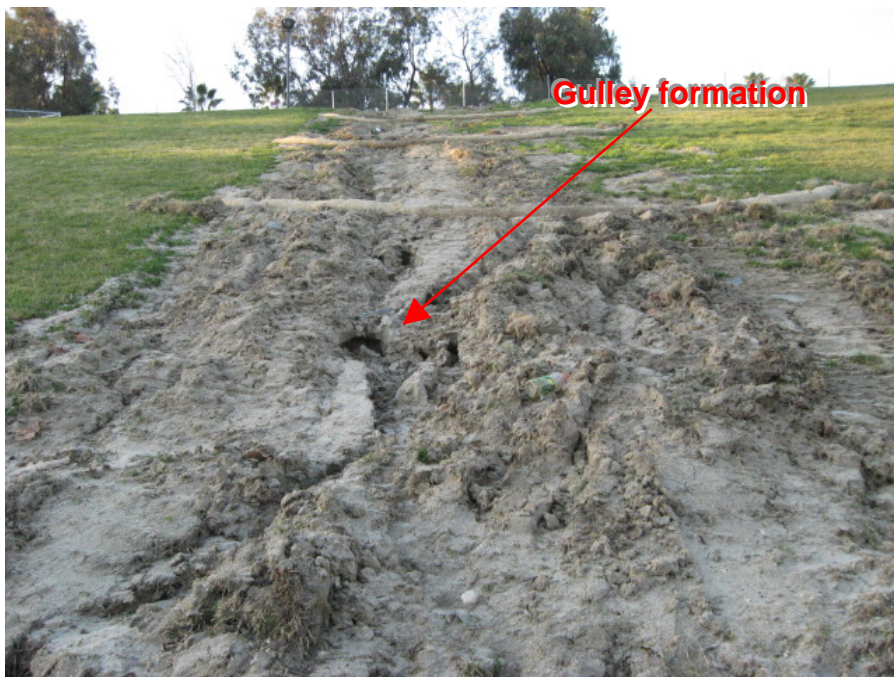
Photograph 2: Slope erosion was observed, including rill and gulley formation at the base of the slope

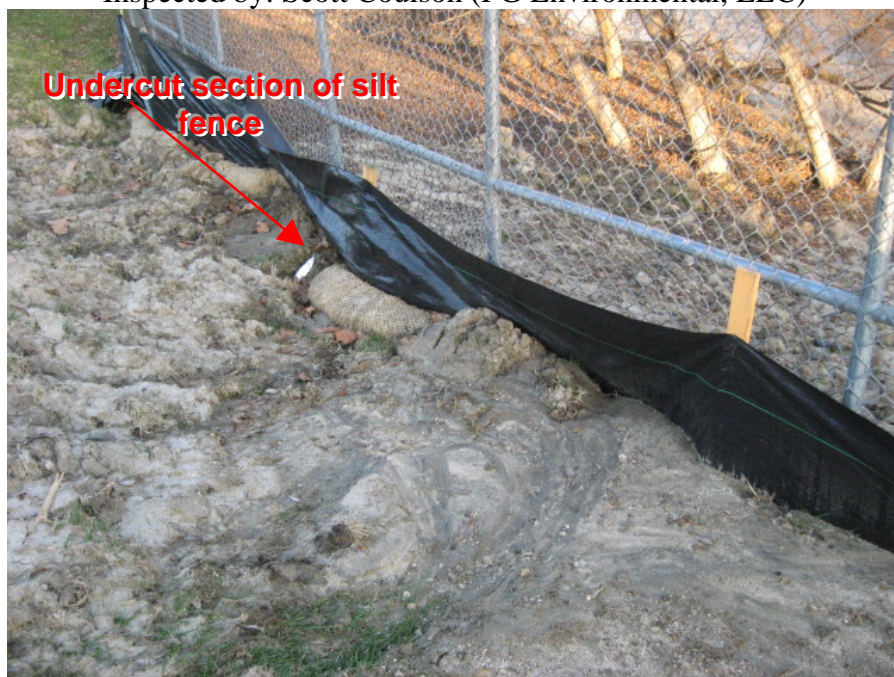
Photograph 3: A section of silt fence at the base of the slope had been undercut by a previous flow event

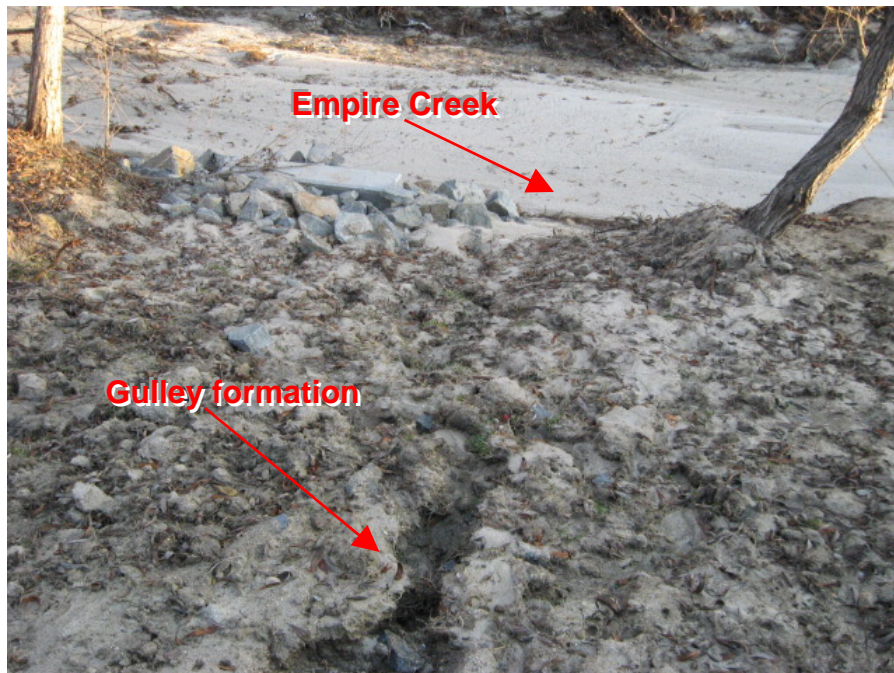
Photograph 4: Erosion beyond the undercut section of silt fence BMP shown in Photograph 3

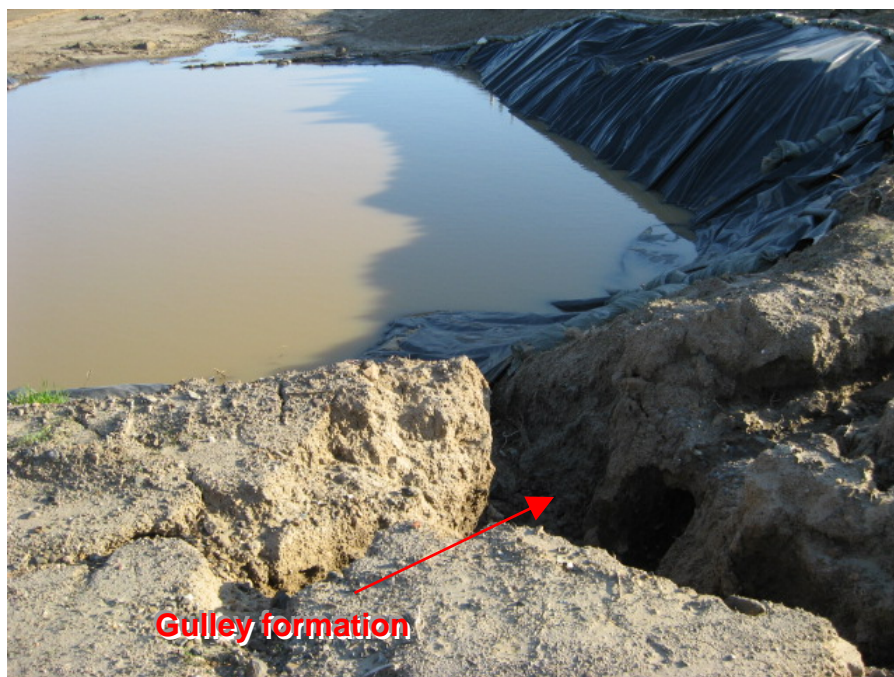
Photograph 5: Sediment laden water in the structural control and gulley erosion present at the inlet area

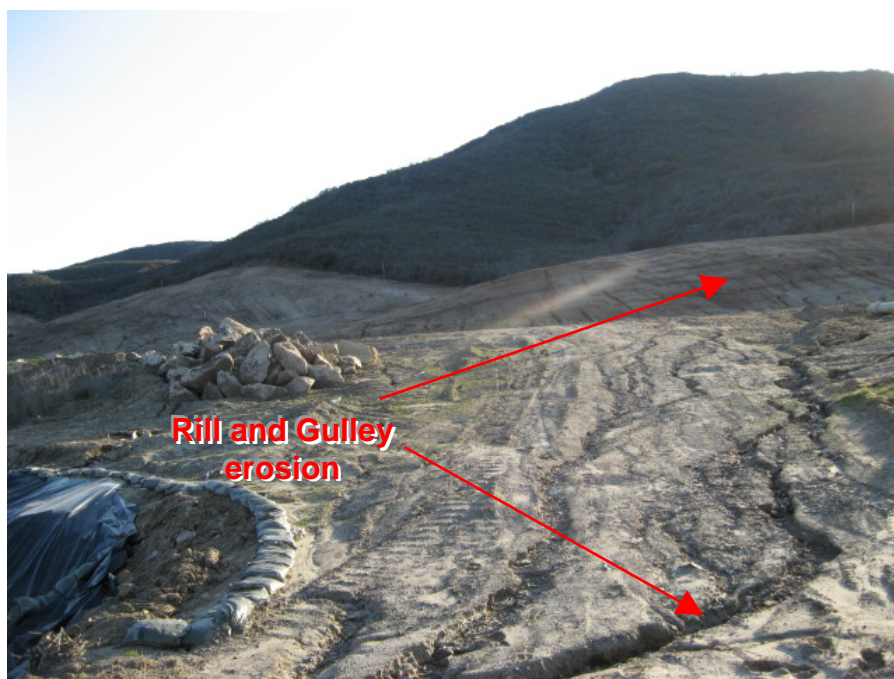
Photograph 6: Rill and gulley formations on the disturbed slope leading to the sediment trap BMP

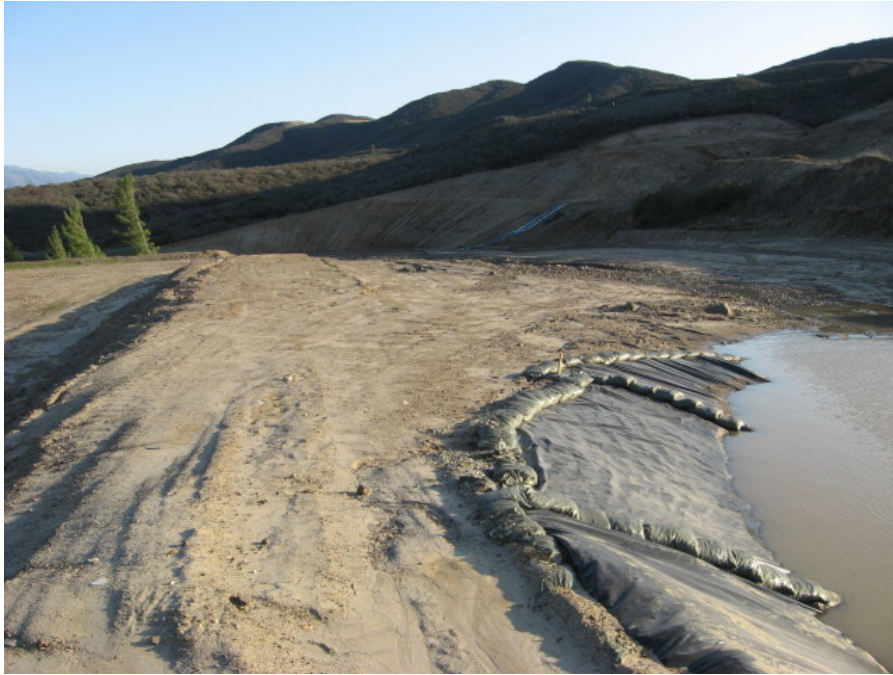
Photograph 7: A large area of exposed soil was observed down-gradient of the sediment trap BMP

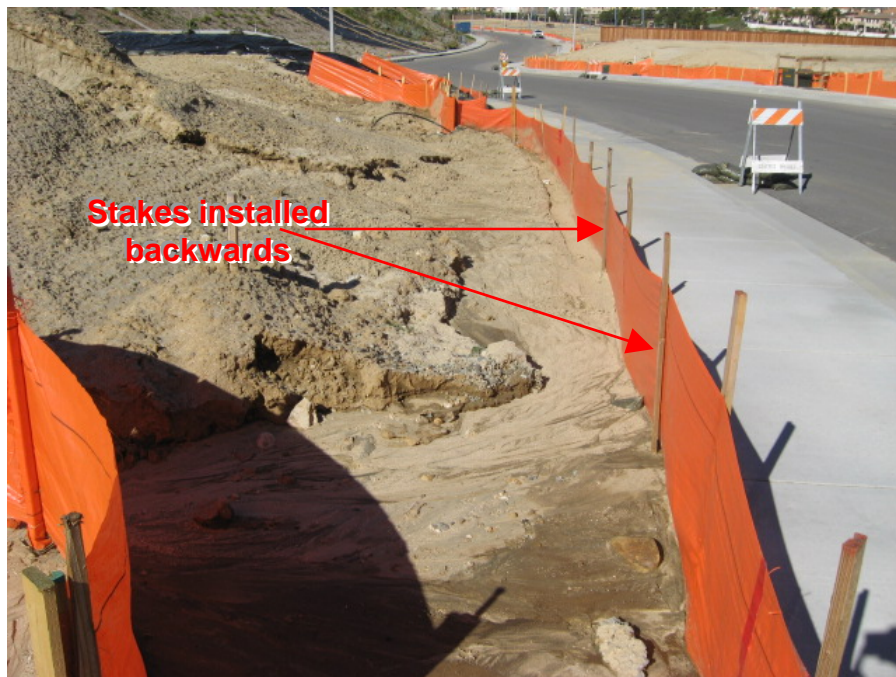
Photograph 8: The silt fence was not installed on the contour and stakes were incorrectly positioned on the up-gradient side of the silt fence

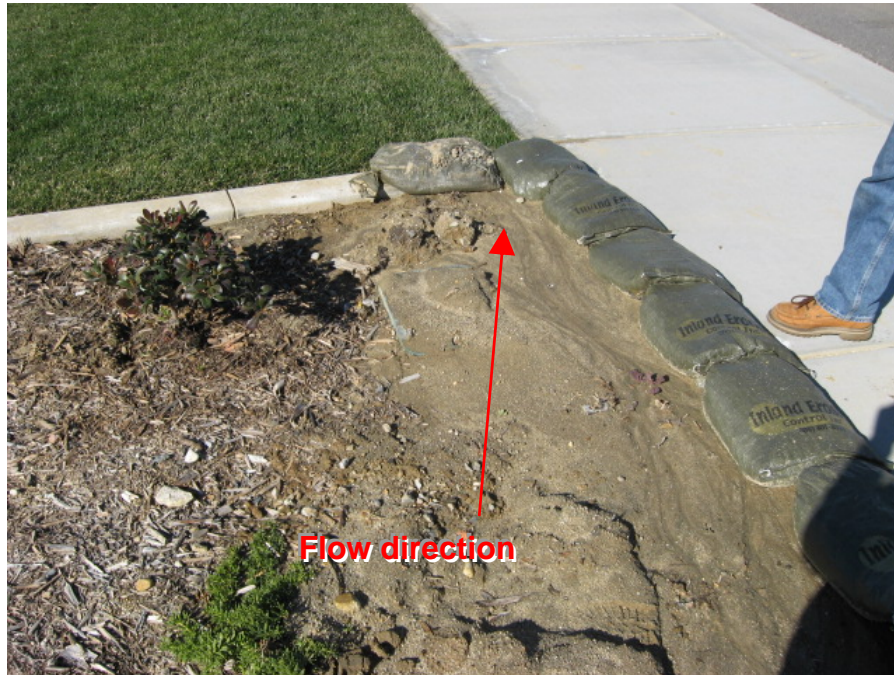
Photograph 9: Sediment accumulated in the down-gradient landscaping

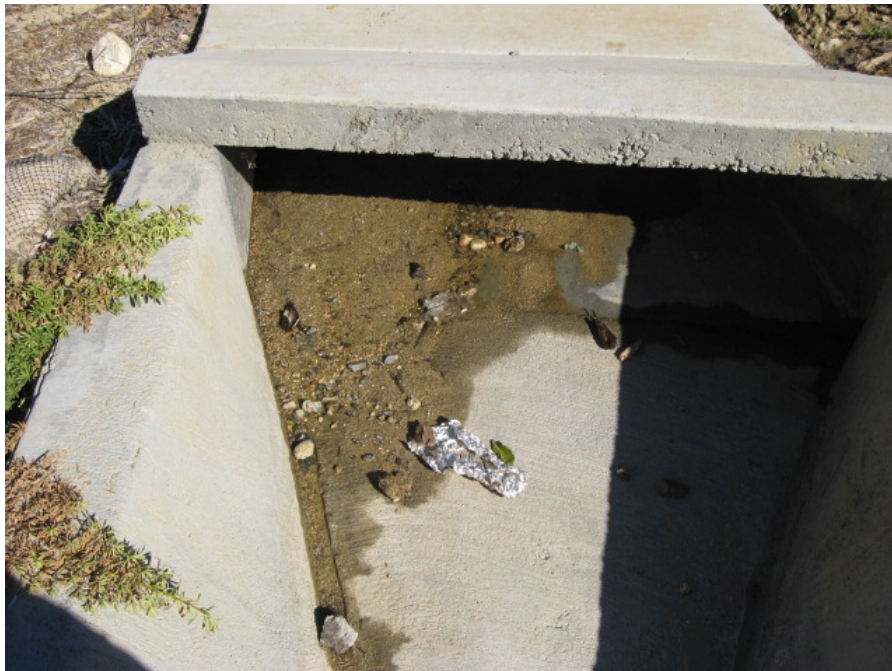
Photograph 10: Sediment accumulated in the drainage conveyance located down-gradient of Photographs 8 and 9

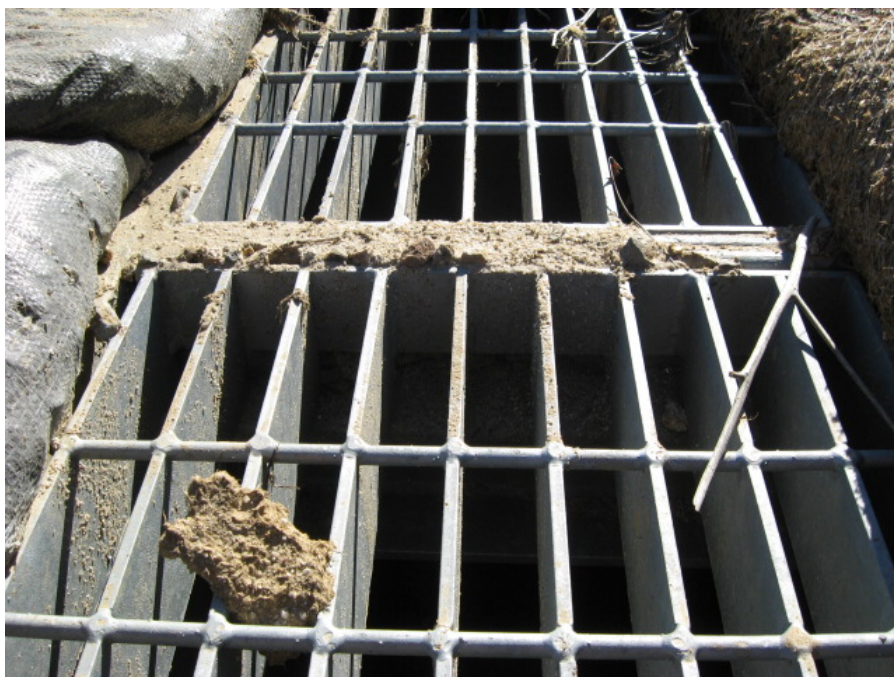
Photograph 11: Evidence of a previous failure event was observed, including sediment that had been discharged to a down-gradient storm drain inlet

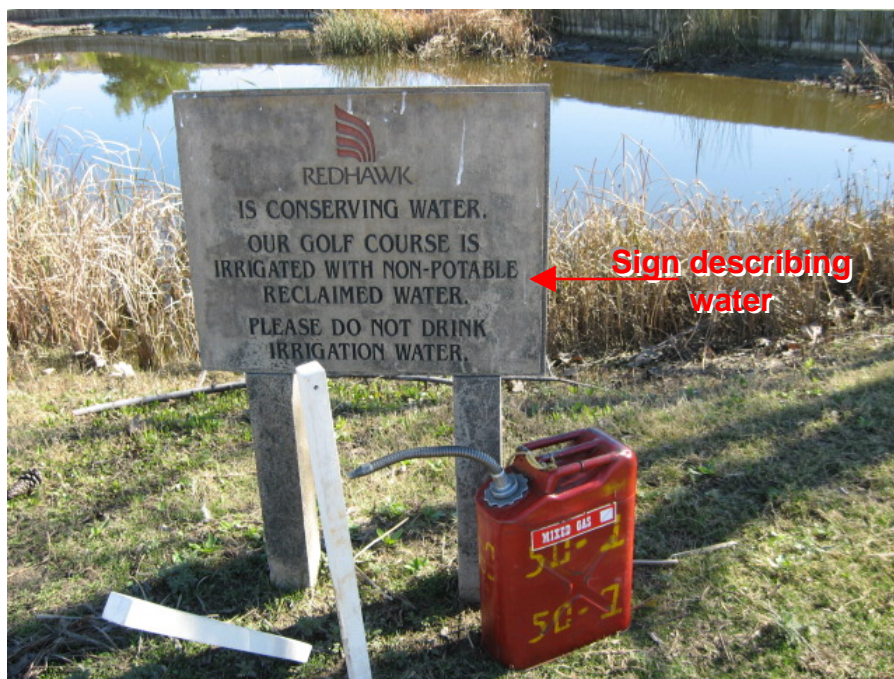
Photograph 12: The water drained from the golf course irrigation pond was from a non-potable reclaimed water source

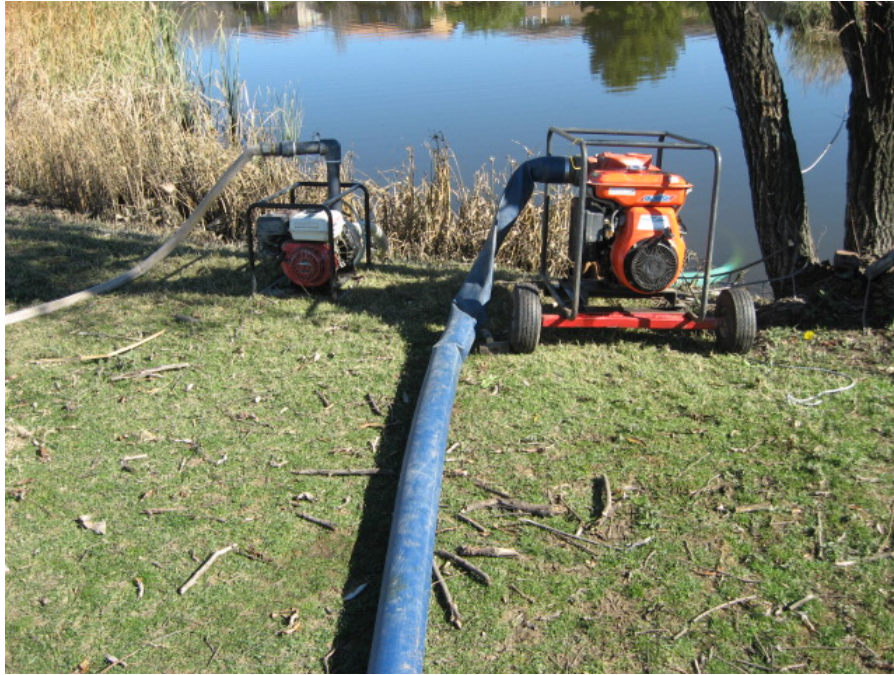
Photograph 13: Actively operating pumps used to drain the golf course pond

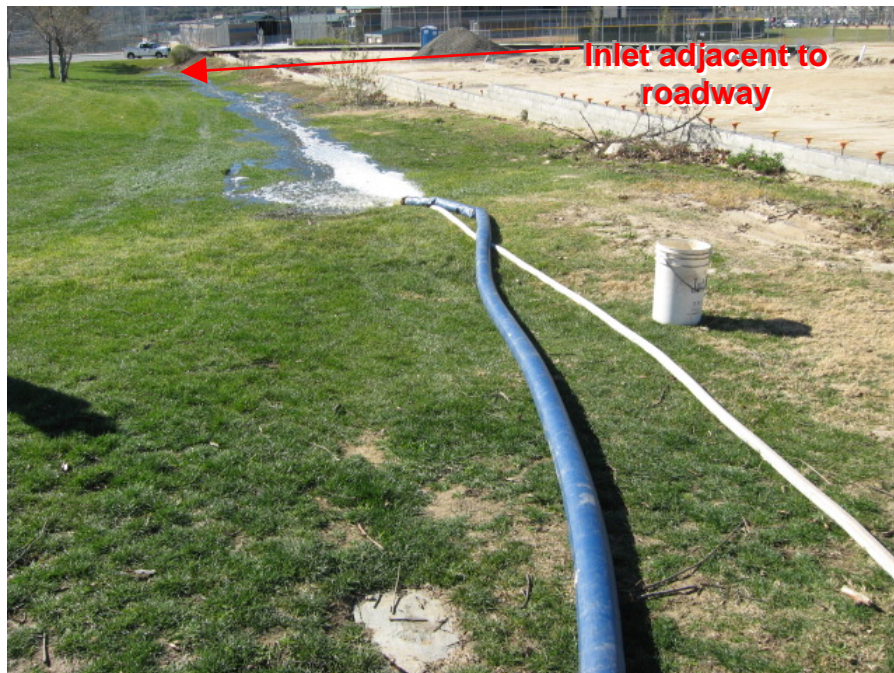
Photograph 14: Non-potable reclaimed water was pumped to a grass drainage swale and subsequent storm drain inlet leading to the Pechanga Parkway Drainage Channel

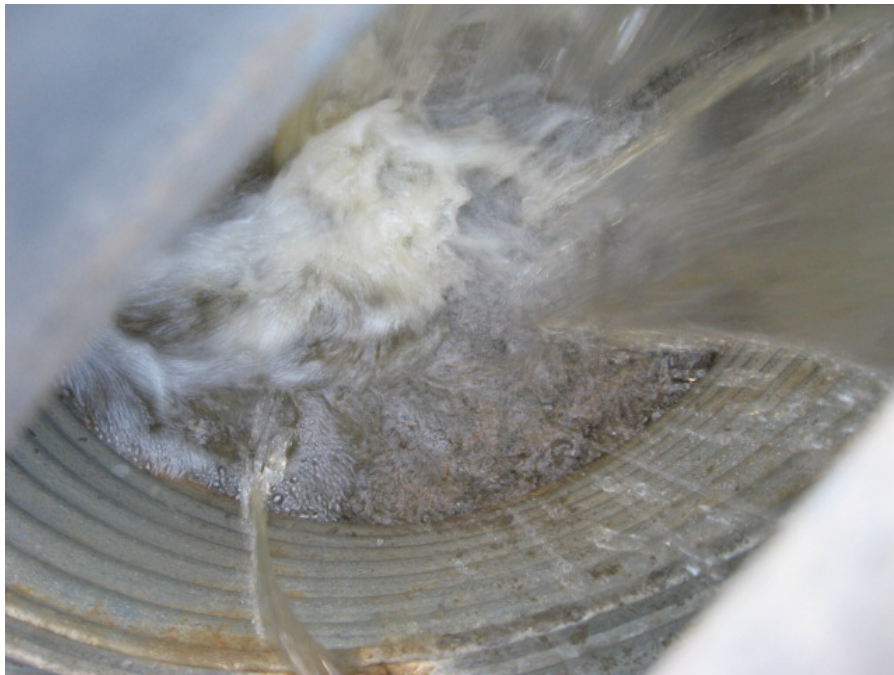
10. Regional Water Board Order No. R9-2004-001, Requirement B.1, requires the City to “effectively prohibit all types of non-storm water discharges into its MS4 unless such discharges are either authorized by a separate NPDES permit; or are authorized in accordance with Requirements B.2 and B.3 [of the Order].” It was observed during the inspection that pond draining activities were actively causing an unauthorized non-storm water discharge to a drainage inlet located southwest of the pond. The water drained from the golf course irrigation pond was from a non-potable reclaimed water source (see attached Photograph 12), and potentially contained high levels of nutrients, pesticides, and other pollutants. Actively operating pumps (see attached Photograph 13) were discharging the reclaimed water across a grass drainage swale (see attached Photograph 14) to a storm drain inlet leading to the Pechanga Parkway Drainage Channel. As provided by Mr. Ben Neill (Water Resource Control Engineer, Regional Water Board), this discharge was not authorized by a separate NPDES permit. As a result, there was an illicit non-storm water discharge to the storm drain

and subsequent Pechanga Parkway Drainage Channel (see attached Photographs 15 and 16). The Temecula Municipal Code, Chapter 8.28, Section 200, Prohibited discharges, does not clearly prohibit this type of non-storm water discharge into the City's MS4 (see attached Exhibit 3). In addition, a fuel can filled with gasoline was stored outdoors where it could be exposed to storm water contact (see attached Photograph 12). The City must effectively prohibit all types of illicit non-storm water discharges into its MS4. Furthermore, the City's Illicit Discharge Detection and Elimination Program must be designed to emphasize frequent, geographically widespread inspections, monitoring, and follow-up investigations to detect illicit discharges such as the non-storm water discharge described above.

Photograph 16: View inside storm drain inlet leading to the Pechanga Parkway Drainage Channel
