Appendix A
Storm Water Management Plan: Comments from NDEP and Co-Permittee Response

Storm Water Management Plan: Comments from NDEP and Co-Permittee Response

Appendix B
Clark County

Appendix B.1
Documentation of Findings

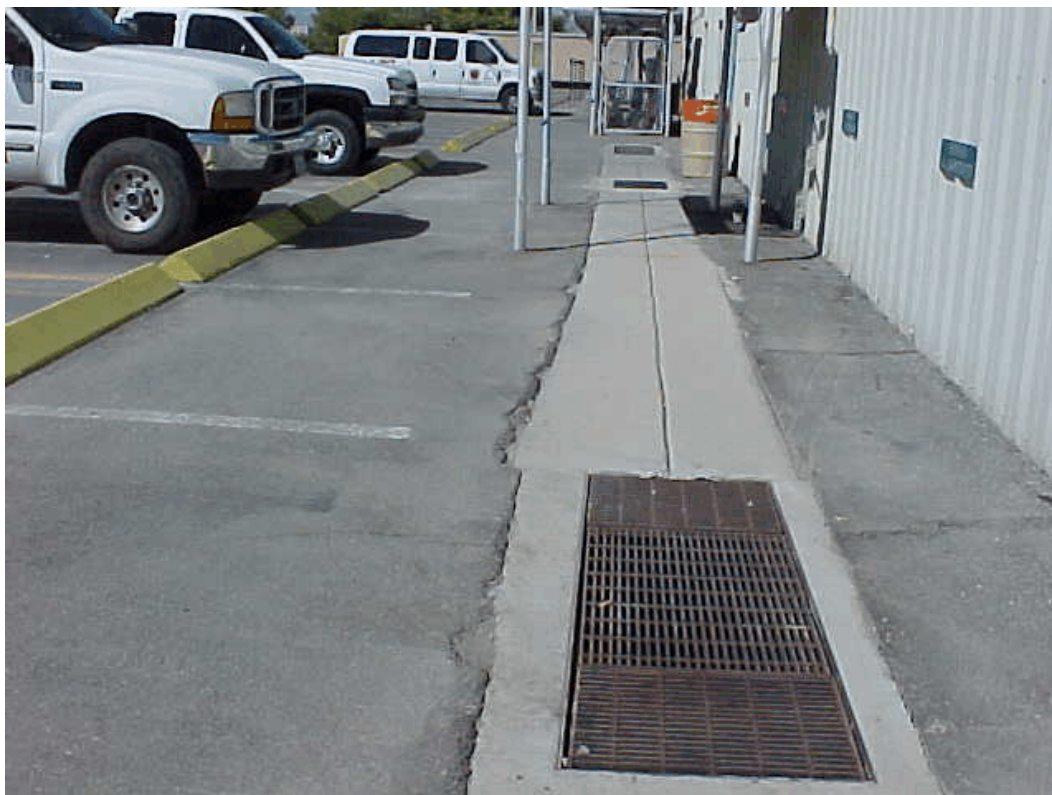
Photo 1. Fleet (primary) facility: Unprotected storm water inlets at north edge of parking area.

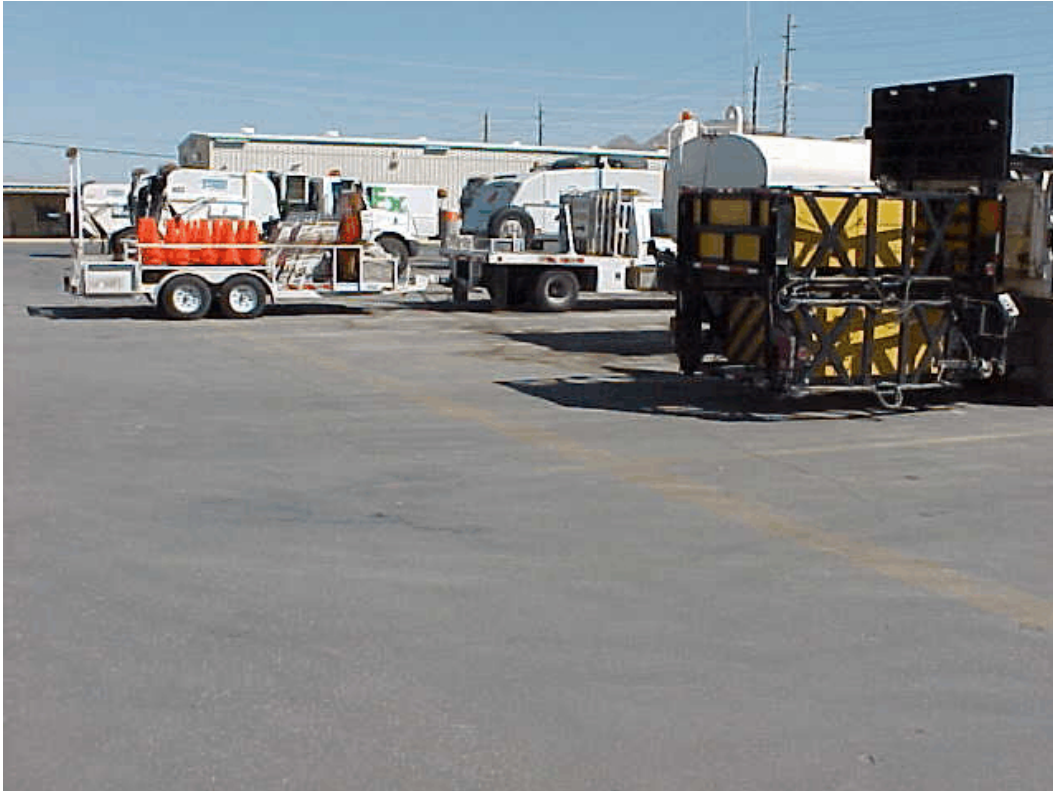
8. The Fleet facility had numerous locations with pavement staining due to petroleum product spills/leakage from parked vehicles.
9. The Vector Control facility had cut open 55-gallon drums of biological larvicide and spilled residue to the pavement.

Photo 7. Fleet (primary) facility: Truck parking area with spills/leakage staining on pavement.

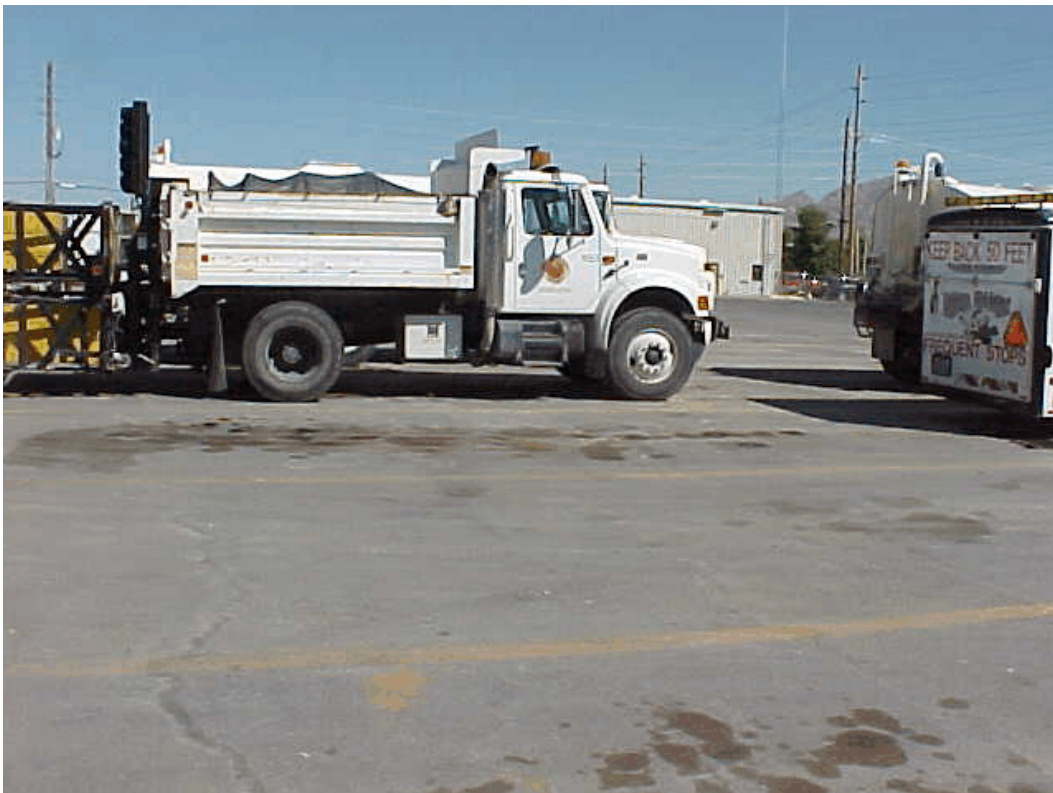
Photo 8. Fleet (primary) facility: Truck parking area with spills/leakage staining on pavement.

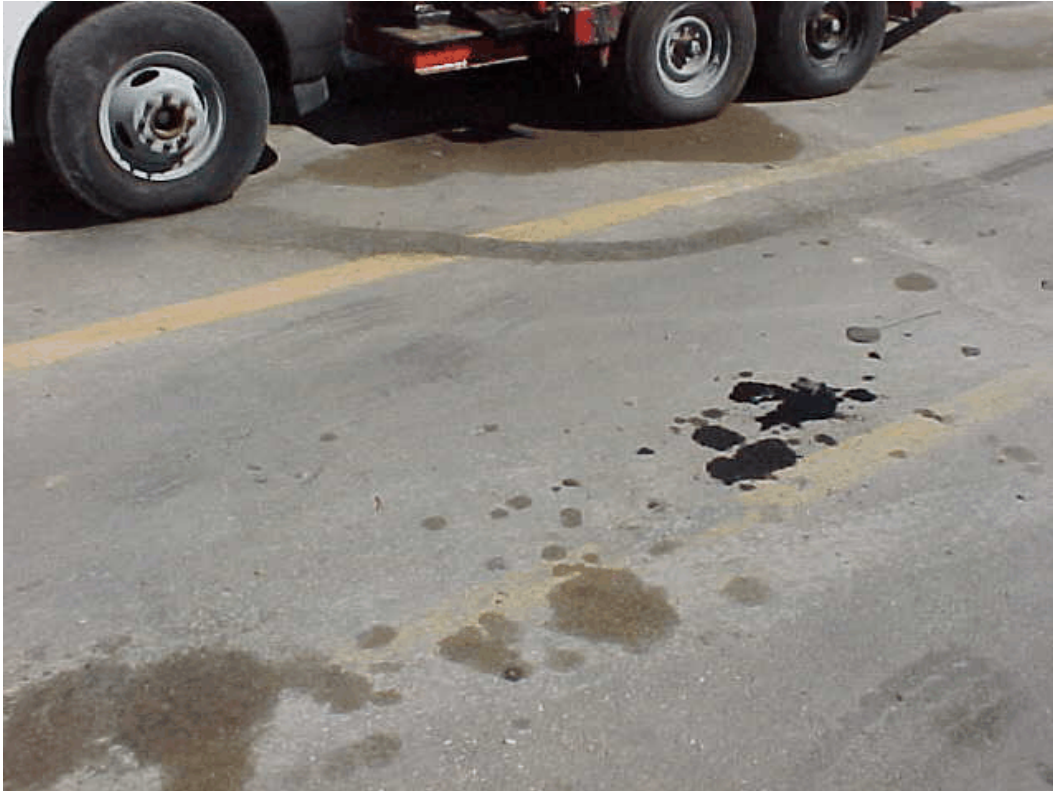
Photo 9. Fleet (primary) facility: Truck parking area with spills/leakage staining on pavement.

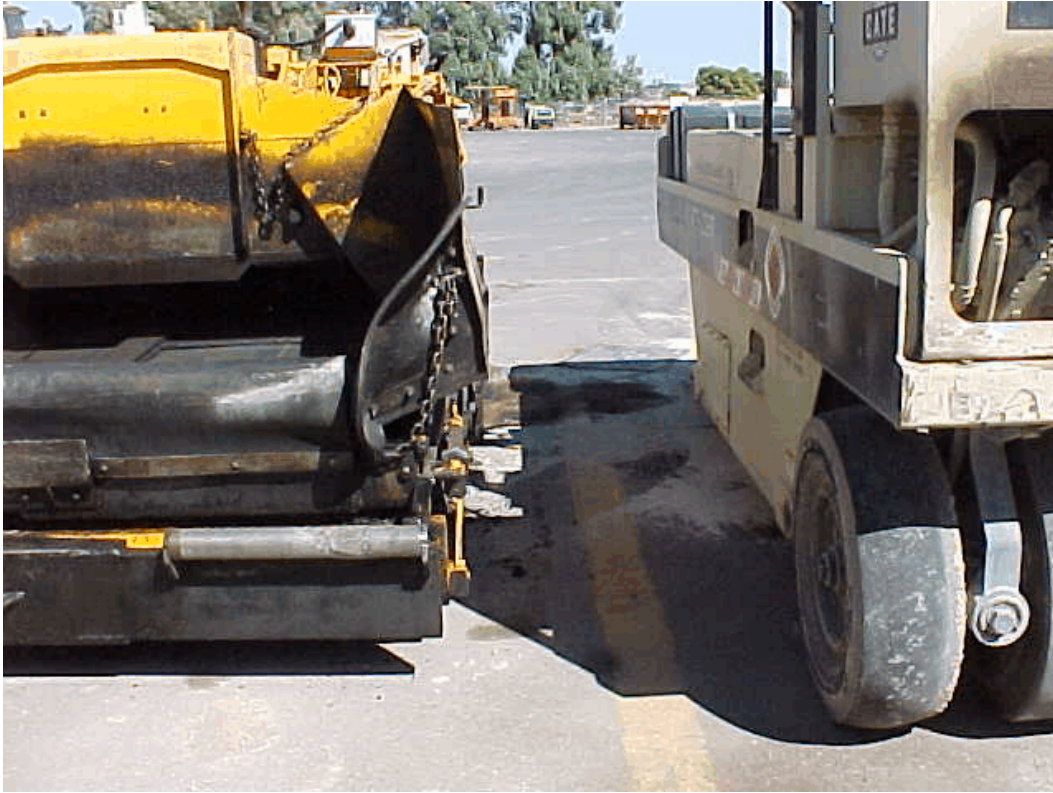
5. The secondary Fleet facility parking lot petroleum product pavement staining was upslope from offsite locations at the southern property boundary. The petroleum product would be carried in storm water runoff from the pavement.
6. The spilled residue biological larvicide was in a uncontained, uncovered area of pavement at the Vector Control facility. Storm water runoff would potentially carry the larvicide off site.
7. The Traffic facility had chemical containers that were uncontained and exposed to rain and rupture from vehicle accident. Storm water would carry any spillage that might occur.

Photo 11. Fleet (secondary) facility: Truck and paving equipment parking area with spills/leakage staining on pavement.

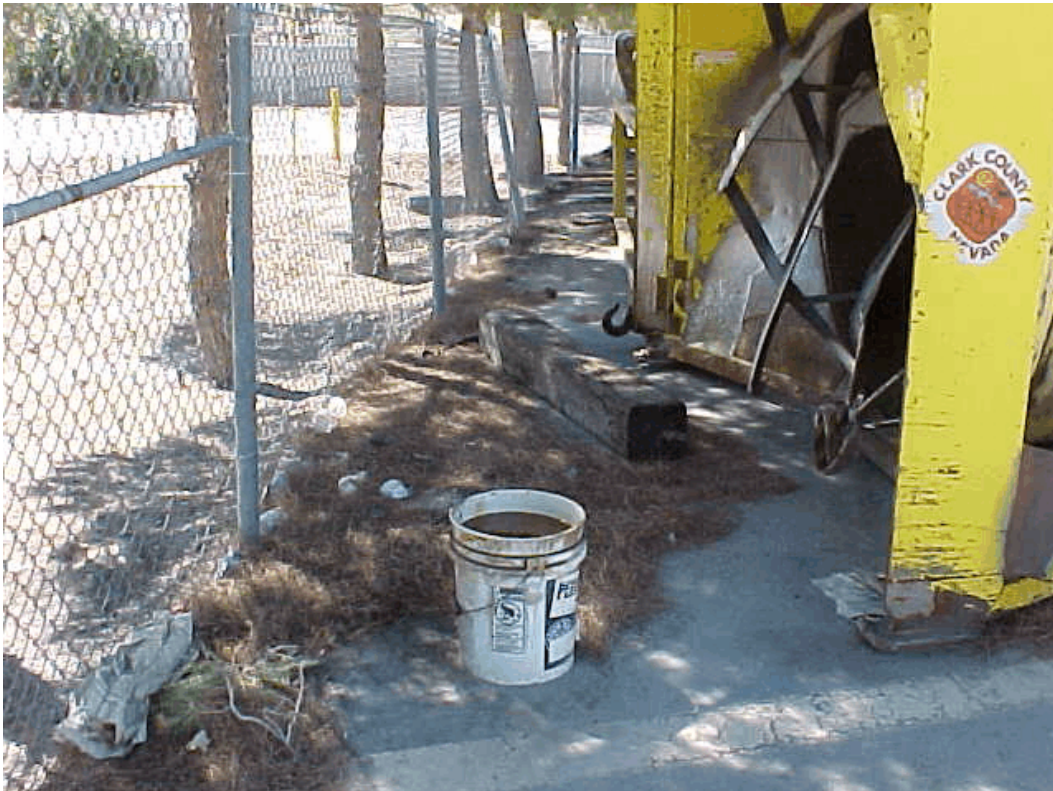
Photo 12. Fleet (secondary) facility: Open 5-gallon pail of oily water in truck and paving equipment parking area.

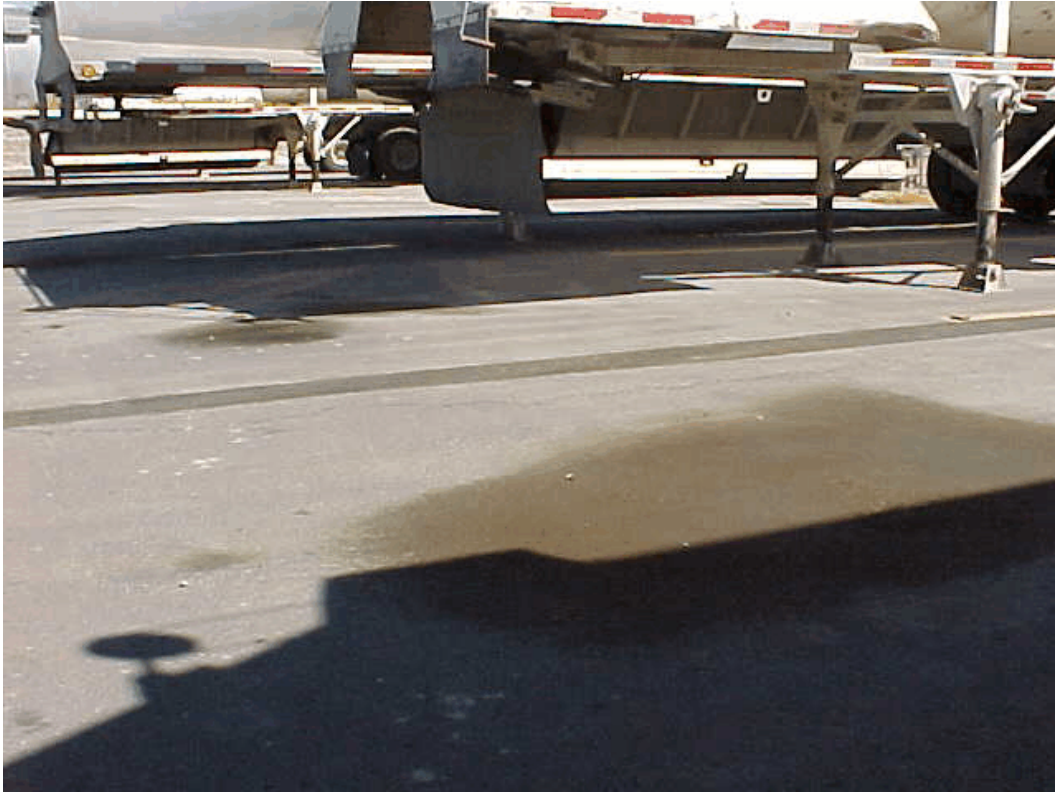
Photo 13. Fleet (secondary) facility: Truck and paving equipment parking area with spills/leakage staining on pavement.

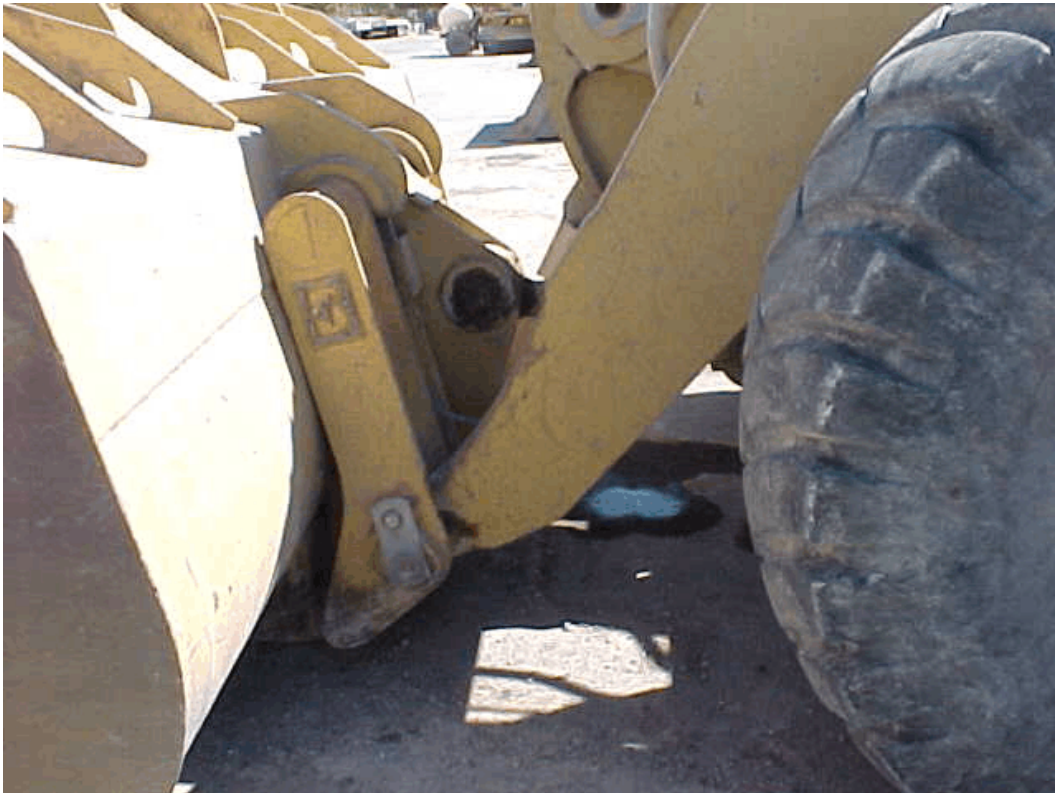
Photo 14. Fleet (secondary) facility: Front loader with an active leak.

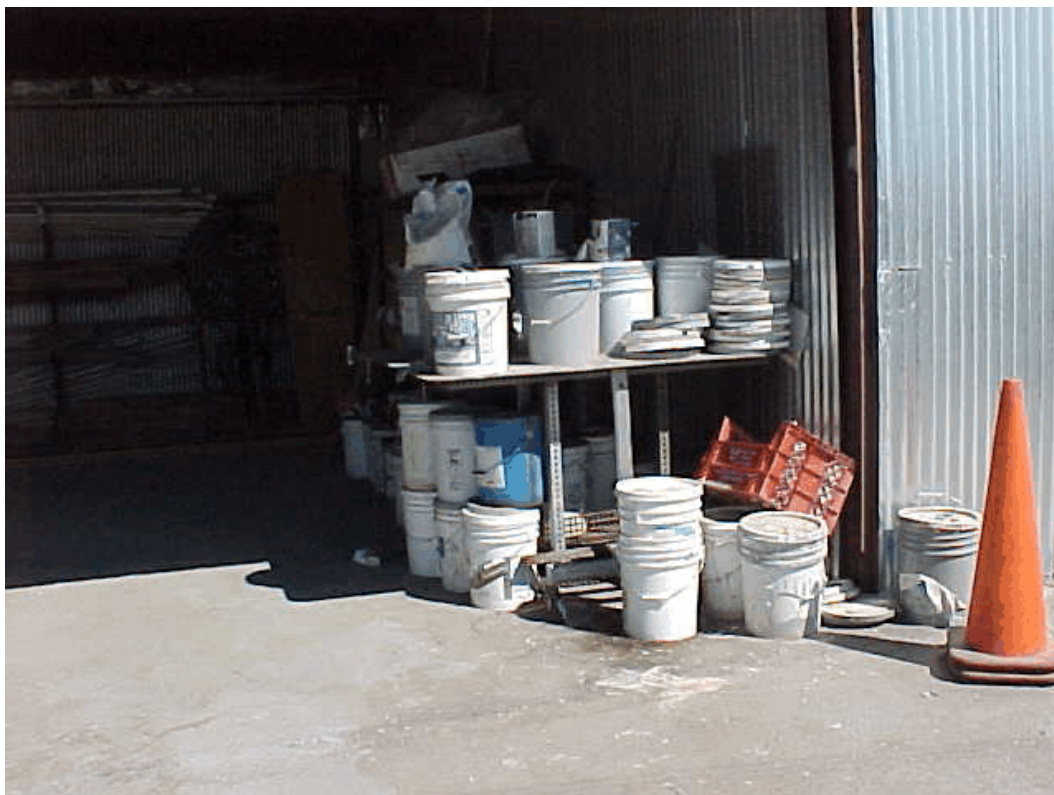
Photo 15. Fleet (secondary) facility: Full and partially full 5-gallon pails of stucco and form oil.

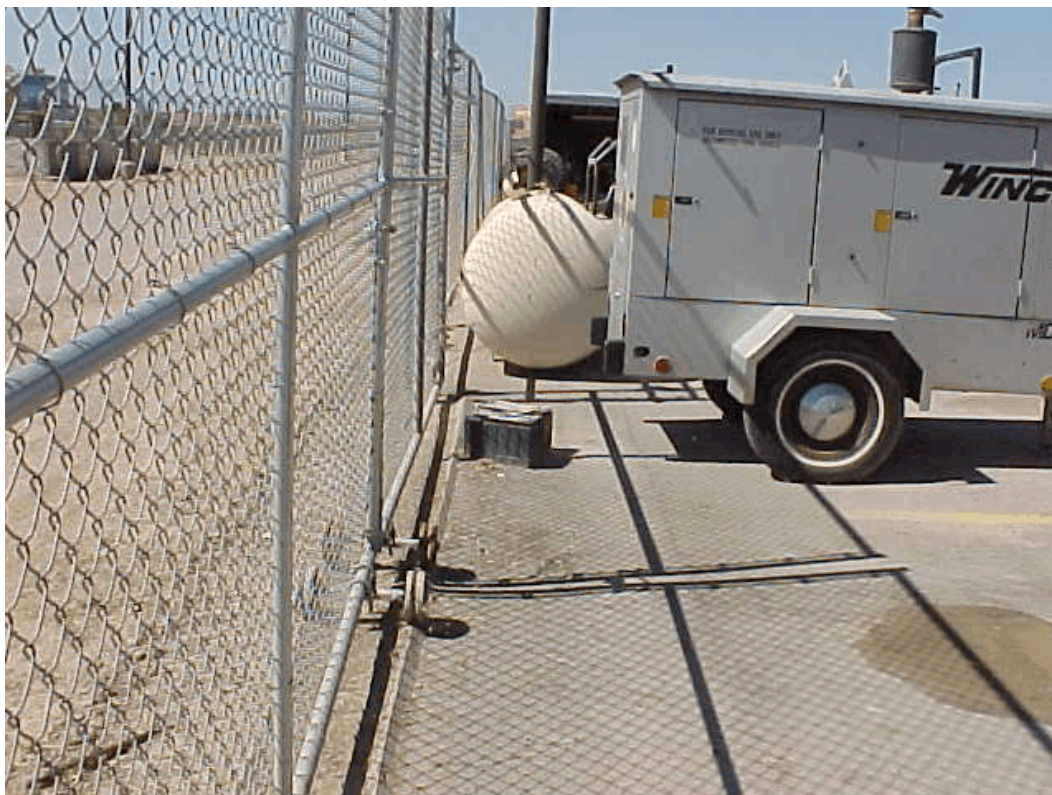
1. Exposed and uncontained used batteries at the Automotive Repair facility had the potential to lose acid to storm water runoff.
2. The spillage at the Fuel Point area was under the canopy, but had the potential to be tracked out of the canopy area and be carried to the adjacent street by storm water.

Photo 1. Two used exposed and uncontained batteries located outside the Automotive Repair facility.

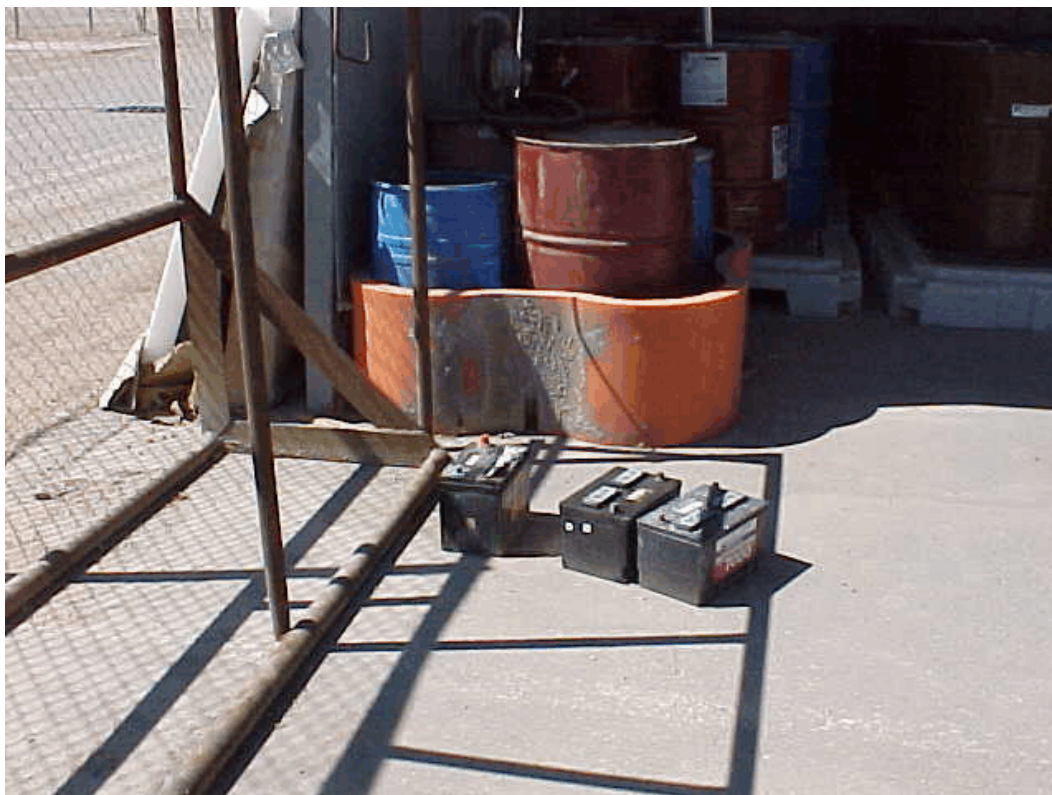
Photo 2. Three used exposed and uncontained batteries located outside the Automotive Repair facility.

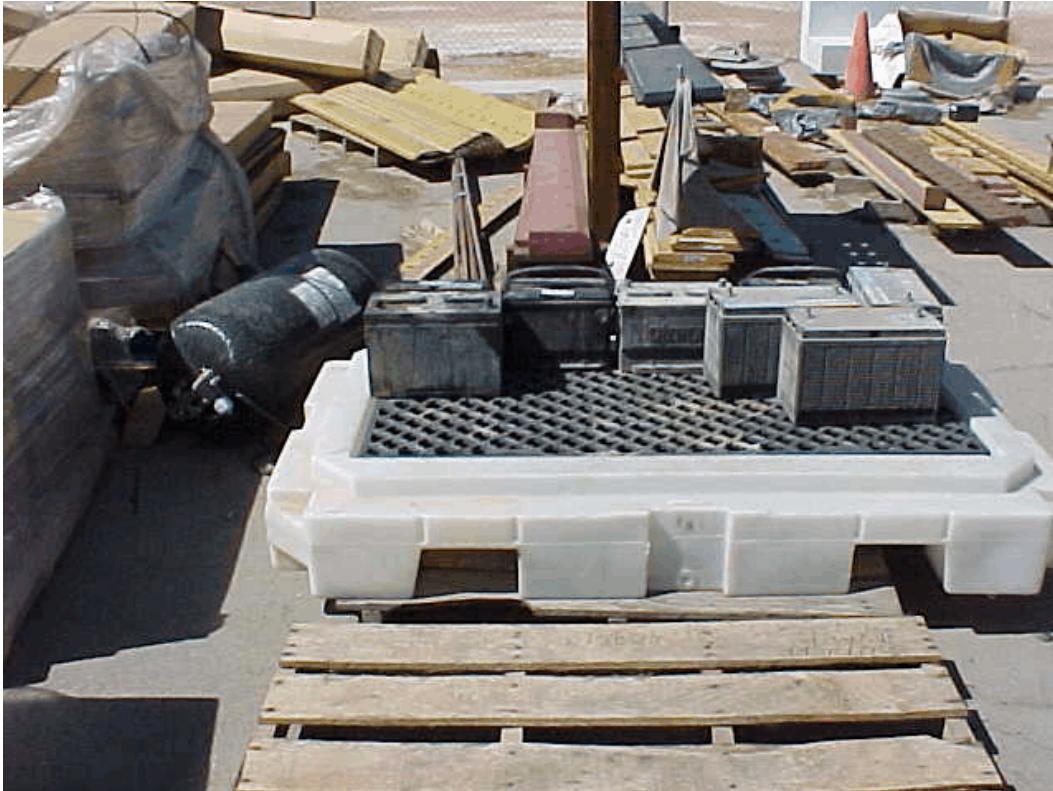
Photo 3. Exposed, but contained used batteries located outside the Automotive Repair facility.

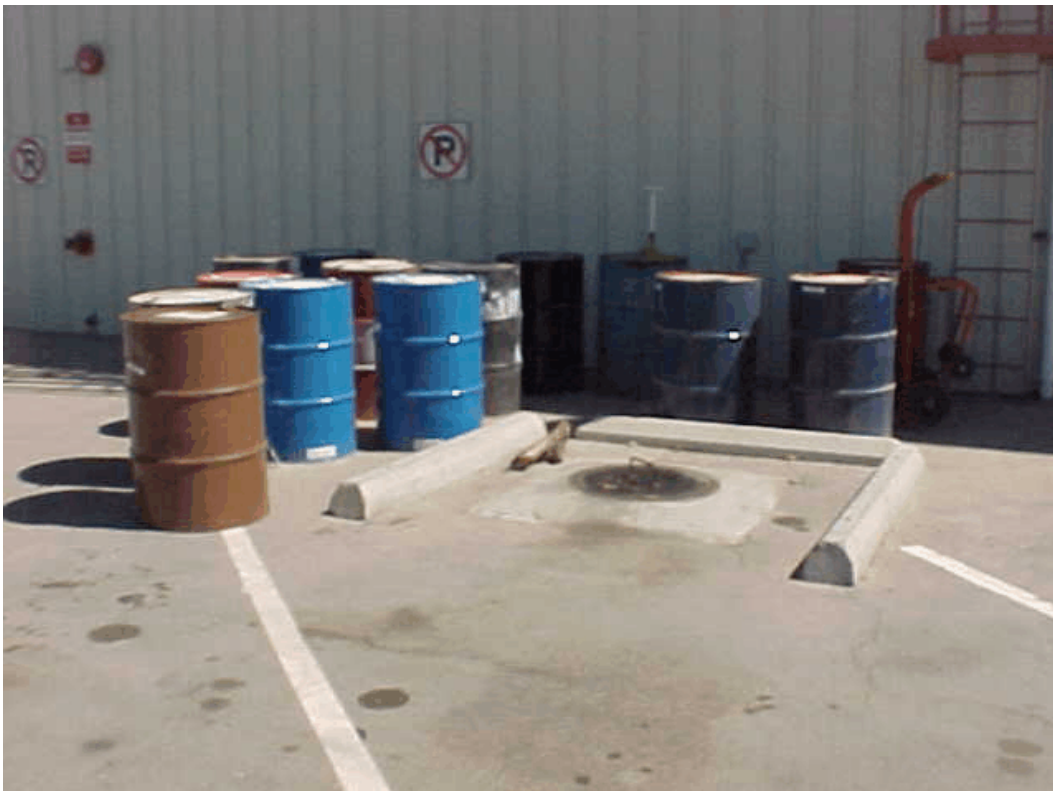
Photo 4. Waste oil pit and multiple 55-gallon drums that are full, partially full, and empty at the Automotive Repair facility.

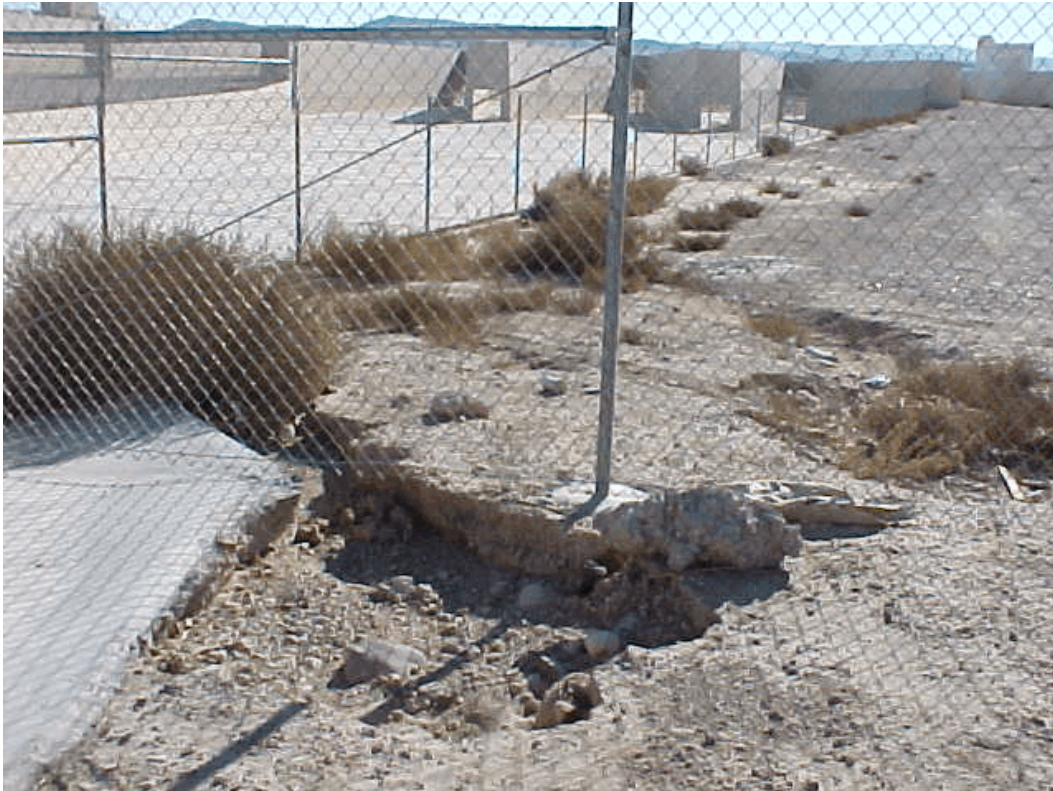
1. Erosion into the detention basin was observed at several locations. Some erosion channels in the west wall of the detention basin were at least four feet deep and six feet wide. Mr. Suckow stated that the erosion in the west wall had occurred several months ago.
2. Utility work was ongoing outside the east fence of the detention basin. The heavy equipment was parked inside a locked gate to the detention basin area. Mr. Suckow was unaware of the ongoing work.
3. An approximately 36-inch pipe for storm water discharge to the detention basin had recently been installed at the northwest corner of the detention basin. The pipe appeared to have been installed by the developer of an adjacent subdivision. Mr. Suckow was unaware of the installation.

1. Clark County is not actively repairing erosion into the detention basin and has not implemented Best Management Practices (BMPs) such as stabilization and/or riprap of the basin walls. Loose soils eroded into the basin will potentially be carried by storm water to the Duck Creek Channel when a rain event occurs.

Photo 1. Erosion to the detention basin at the northeast corner.

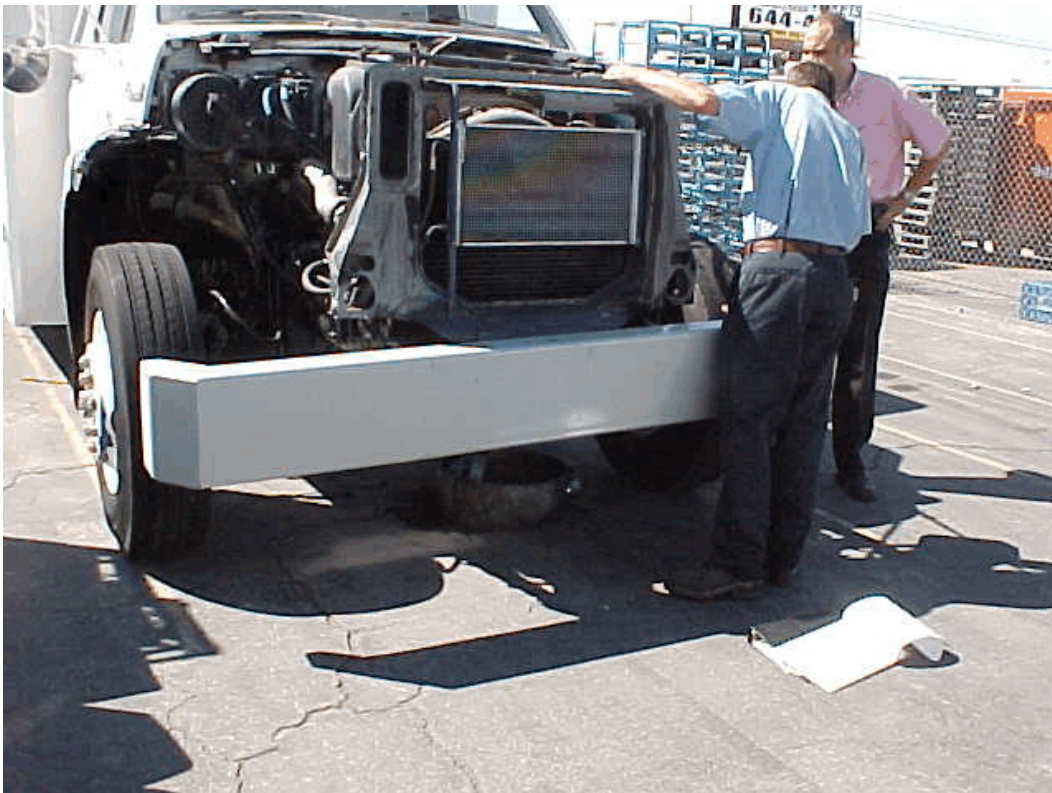
7. He directed the removal of the salvage drum materials within 30 days.
8. He inspected a truck stored outside that was under repair and directed the truck engine area be covered with a tarp to avoid contamination of storm water.

Photo 6. Mr. Palsgrove inspecting a truck that was being repaired. A drip pan was being used under the engine.

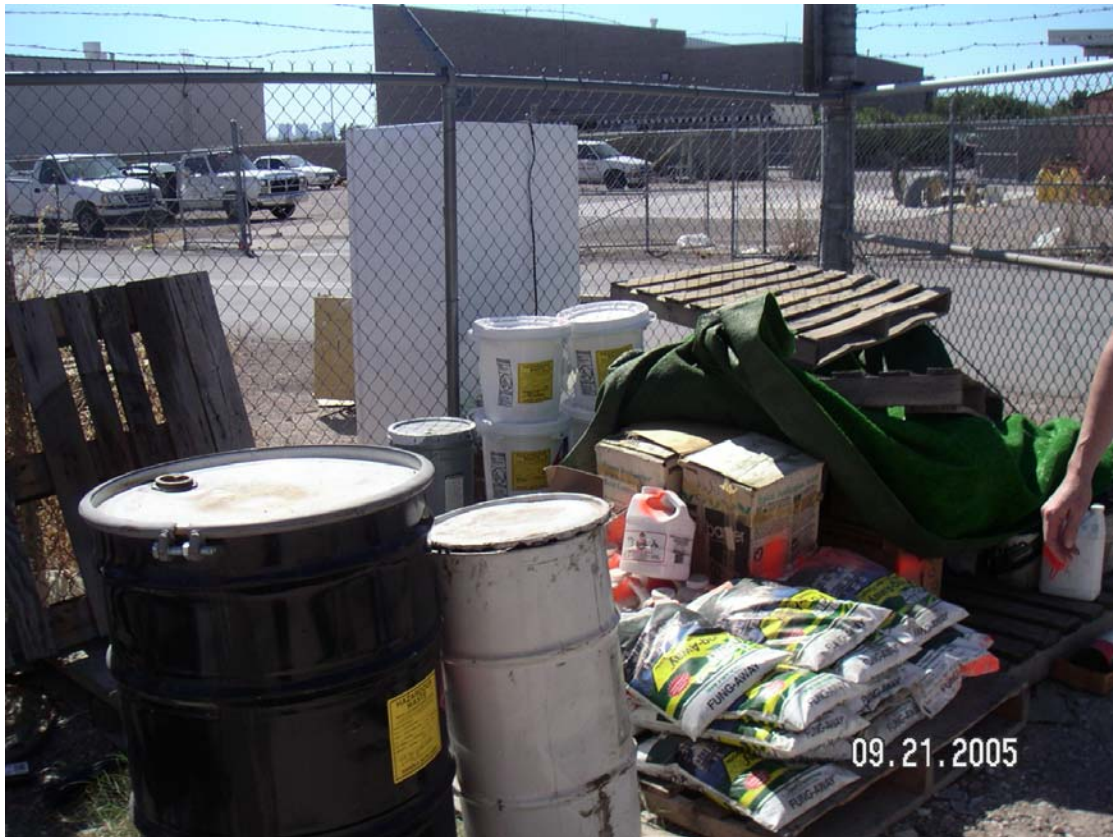
Photo 3. Waste materials abandoned by Parks Department.

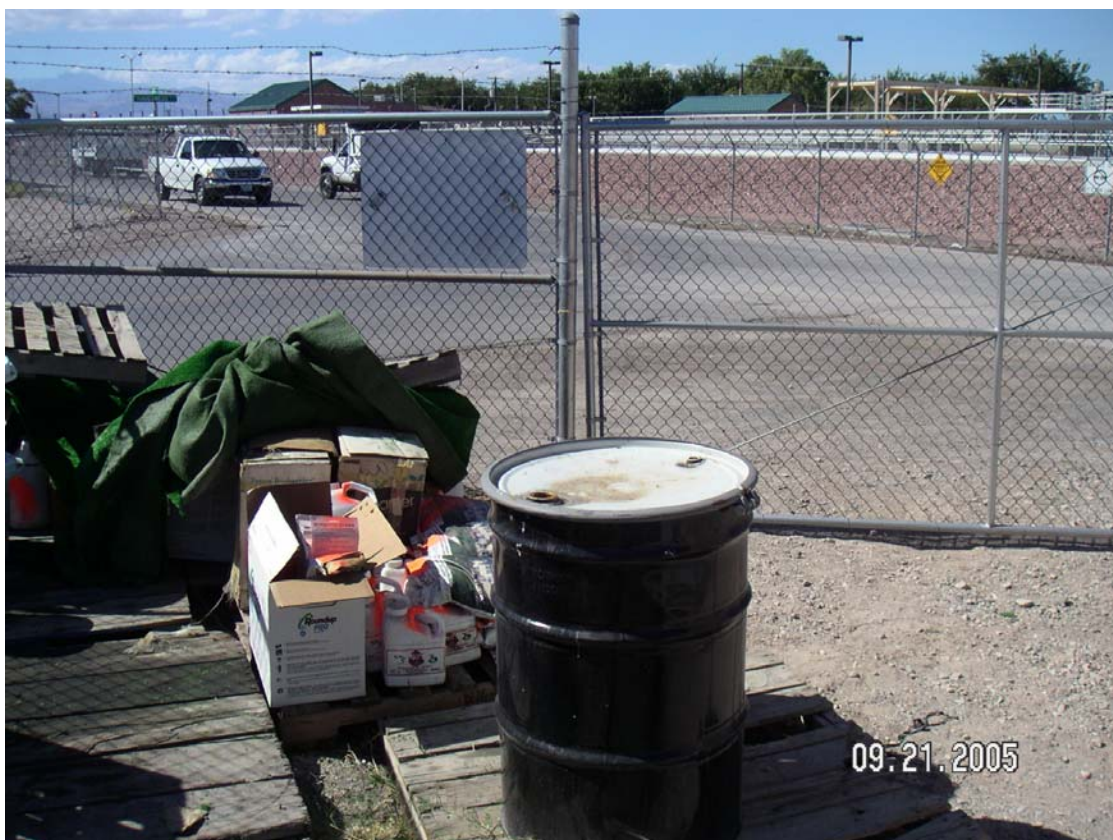
Photo 4. Waste materials abandoned by Parks Department.

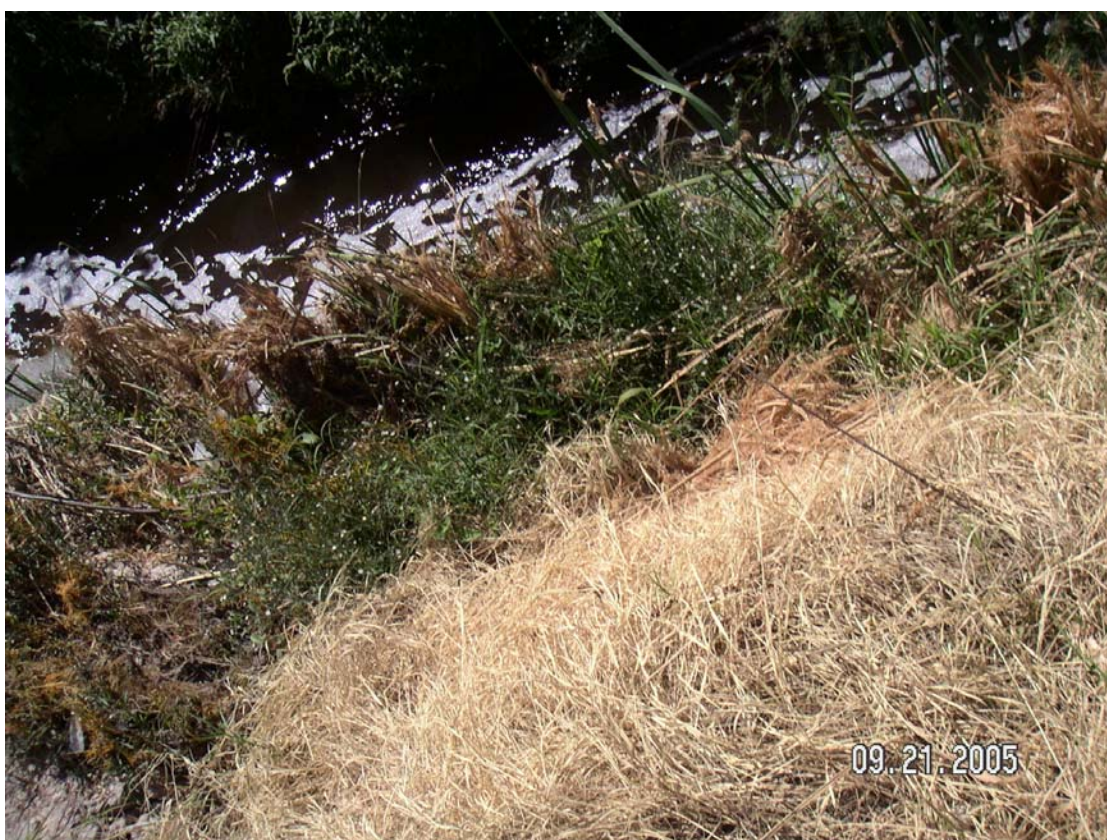
Photo 4. Las Vegas Wash - Appearance is brown with suds.

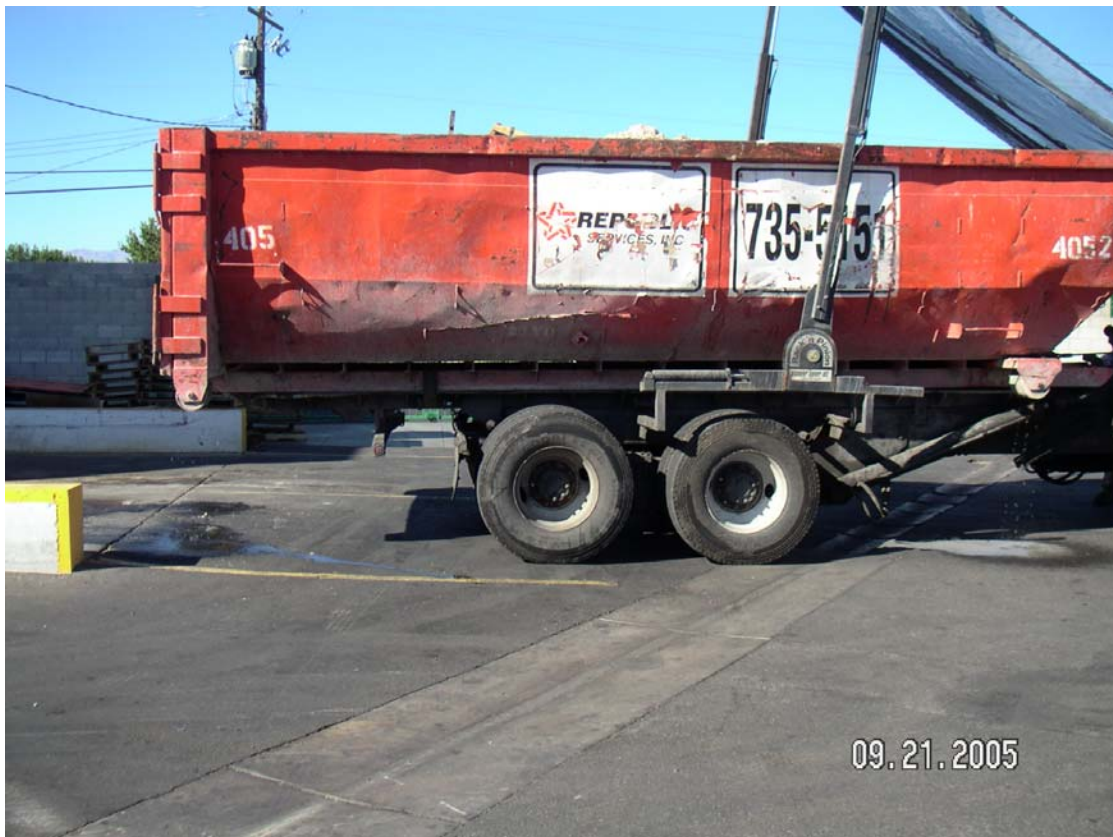
Photo 1. Roll-off container is leaking.

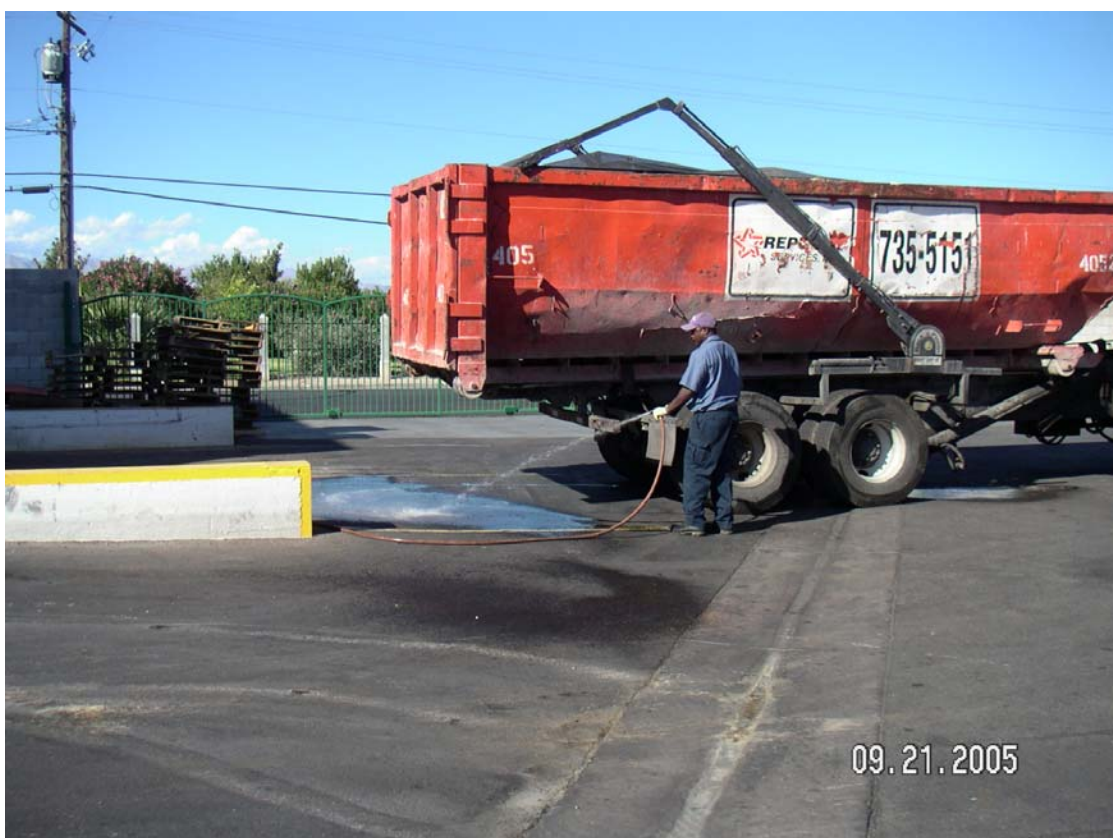
Photo 2. Roll-off container is leaking.

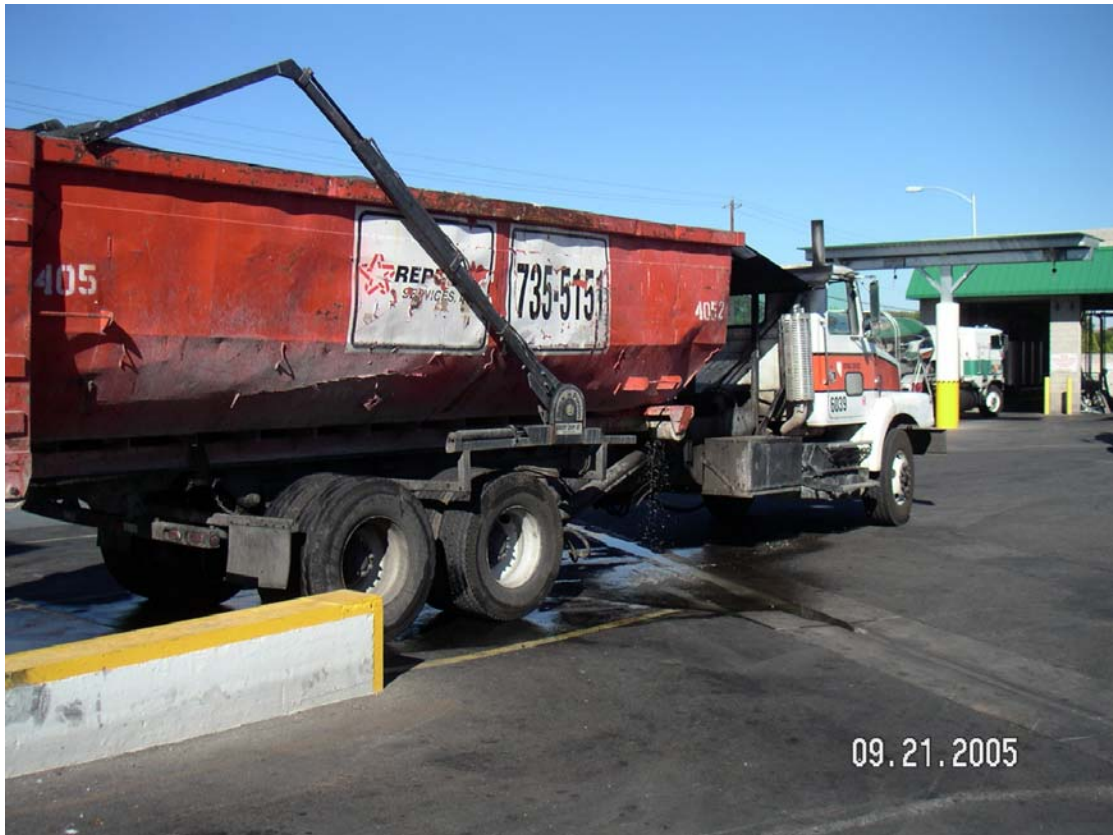
Photo 3. Roll-off container is leaking.

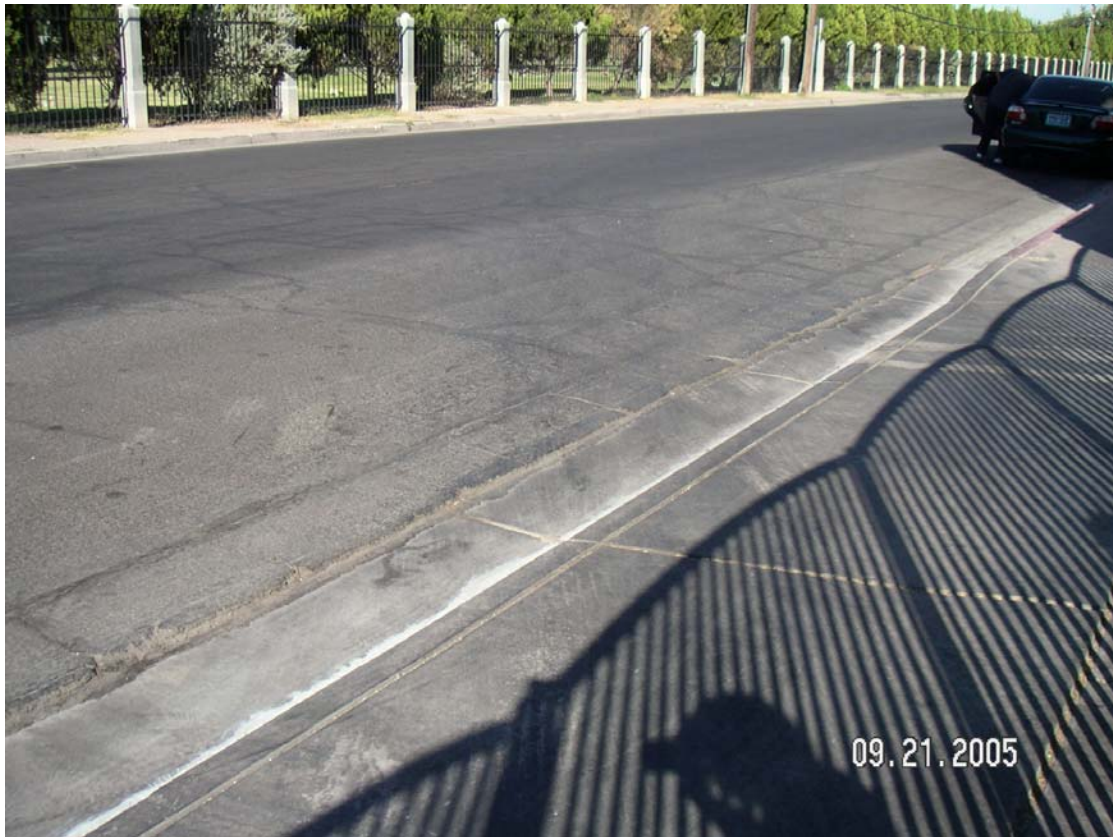
Photo 7. Dried milk solids in street gutter outside facility.

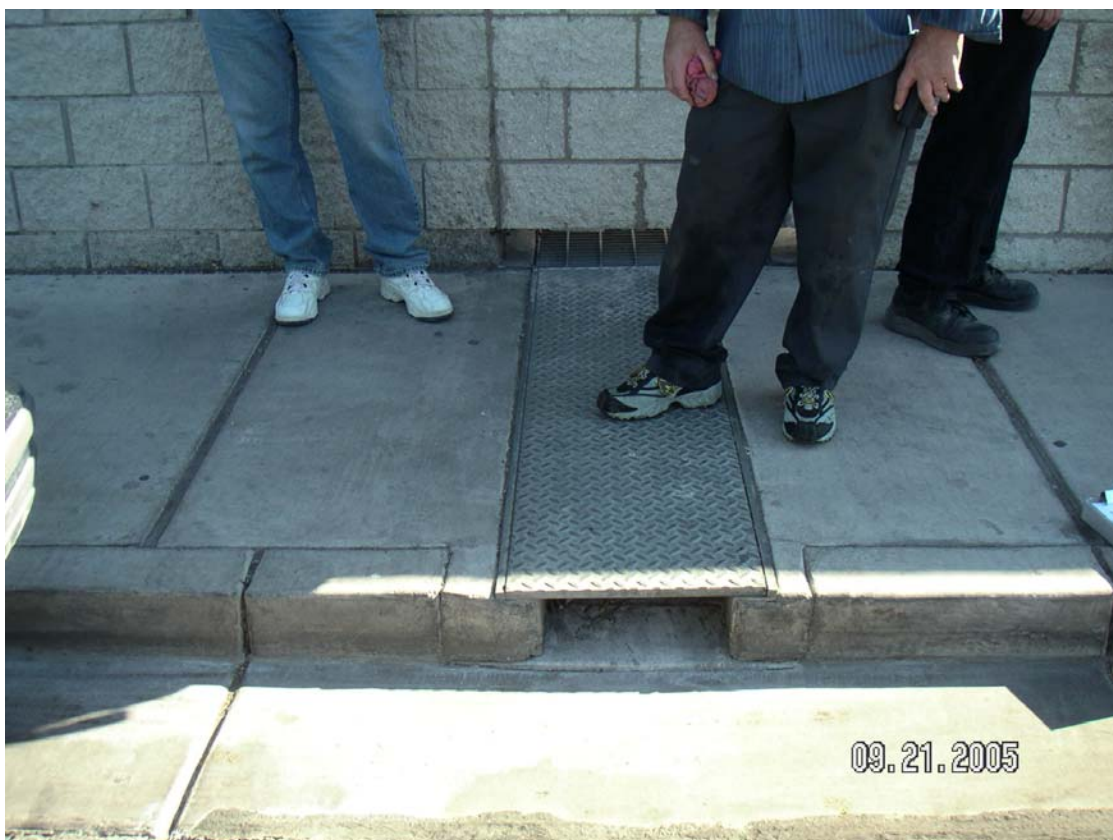
Photo 8. Dried milk solids entered street gutter from facility drain.

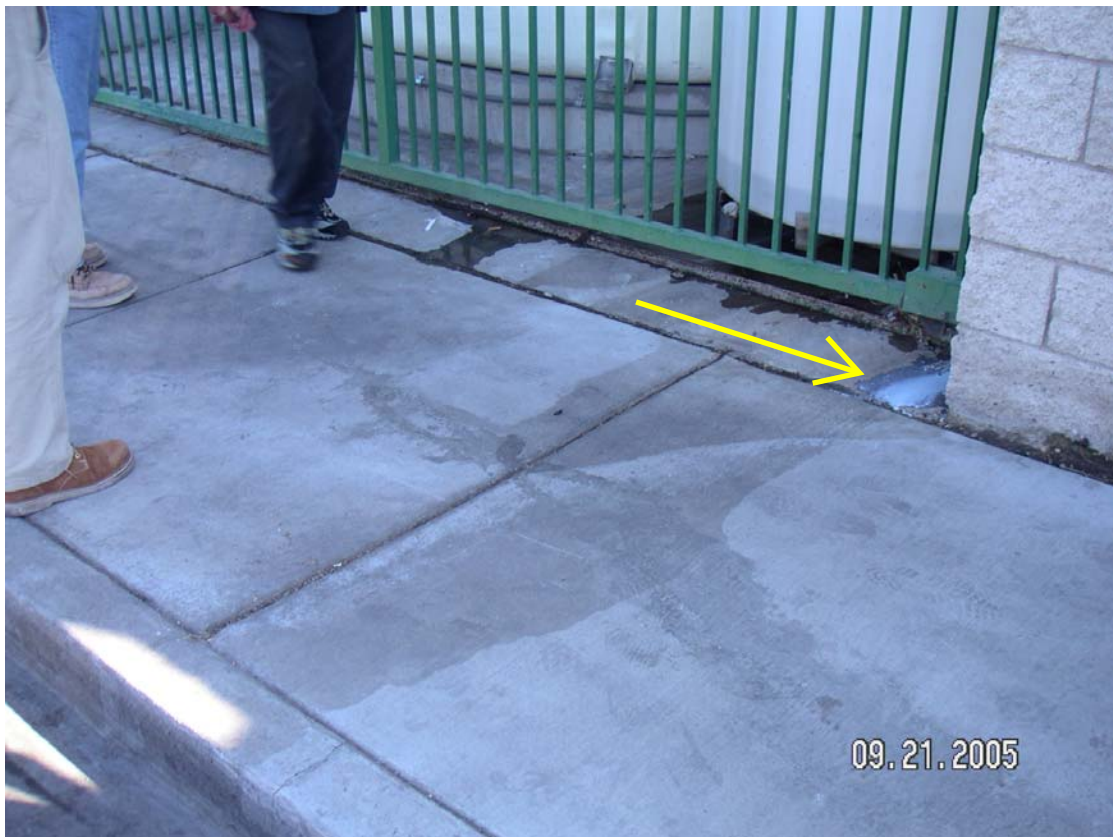
Photo 9. Discharge to street from leaking tank.

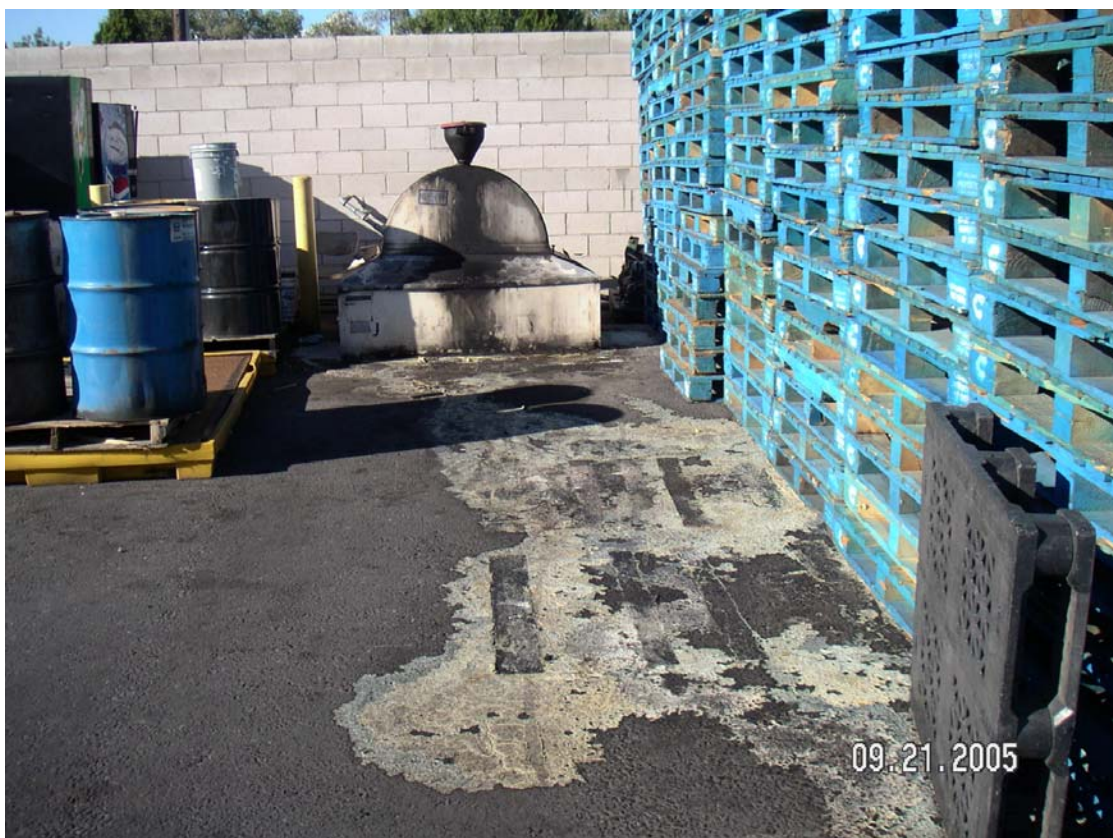
Photo 10. Dried milk solids on asphalt inside facility.
