Appendix A
Storm Water Management Plan: Comments from NDEP and Co-Permittee Response

Storm Water Management Plan: Comments from NDEP and Co-Permittee Response

Appendix B
Clark County

Appendix B.1
Documentation of Findings

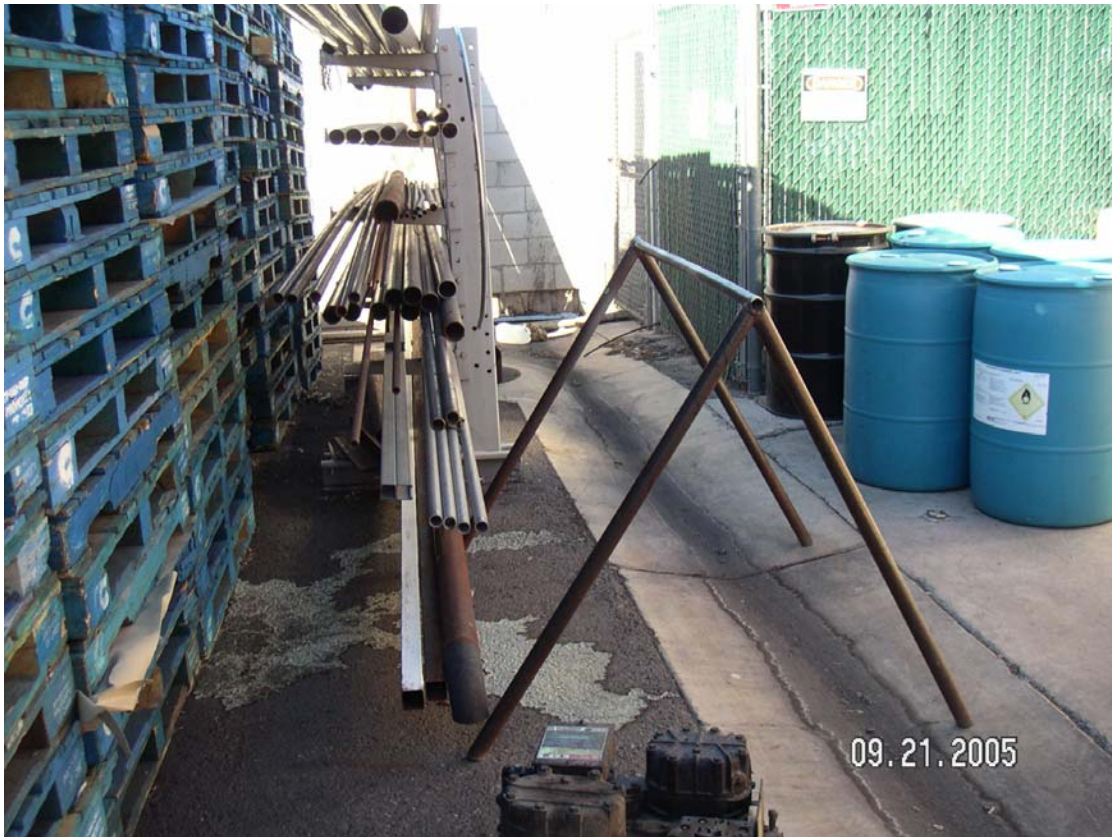
Photo 11. Dried milk solids spilled next to drain to street seen in Photo 8.

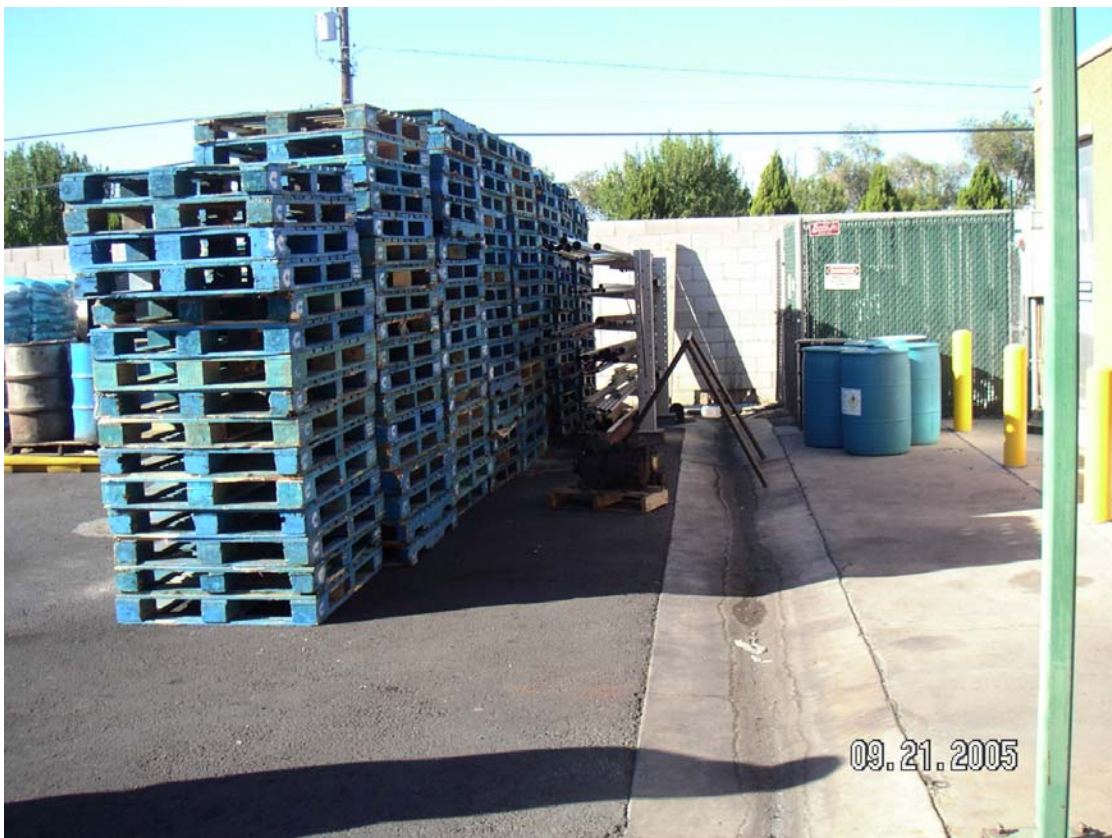
Photo 12. Dried milk solids spilled next to drain to street seen in Photo 8.

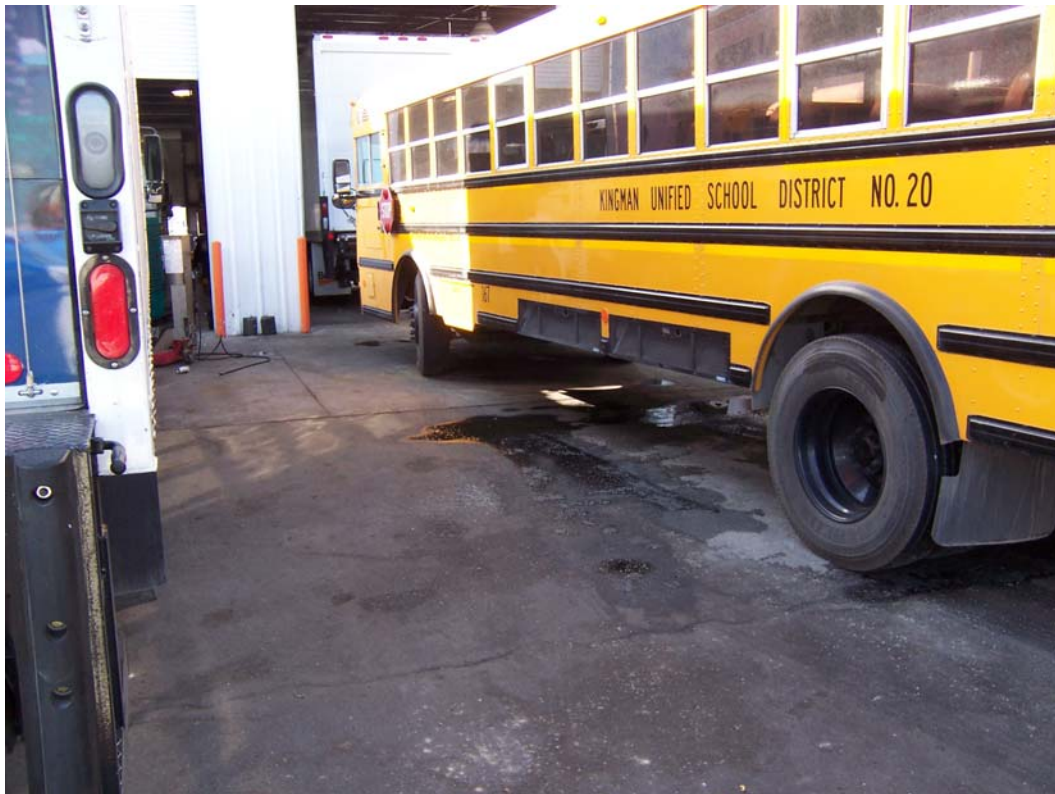
Photo 3. Apparent leakage under bus being maintained outside of shop area.

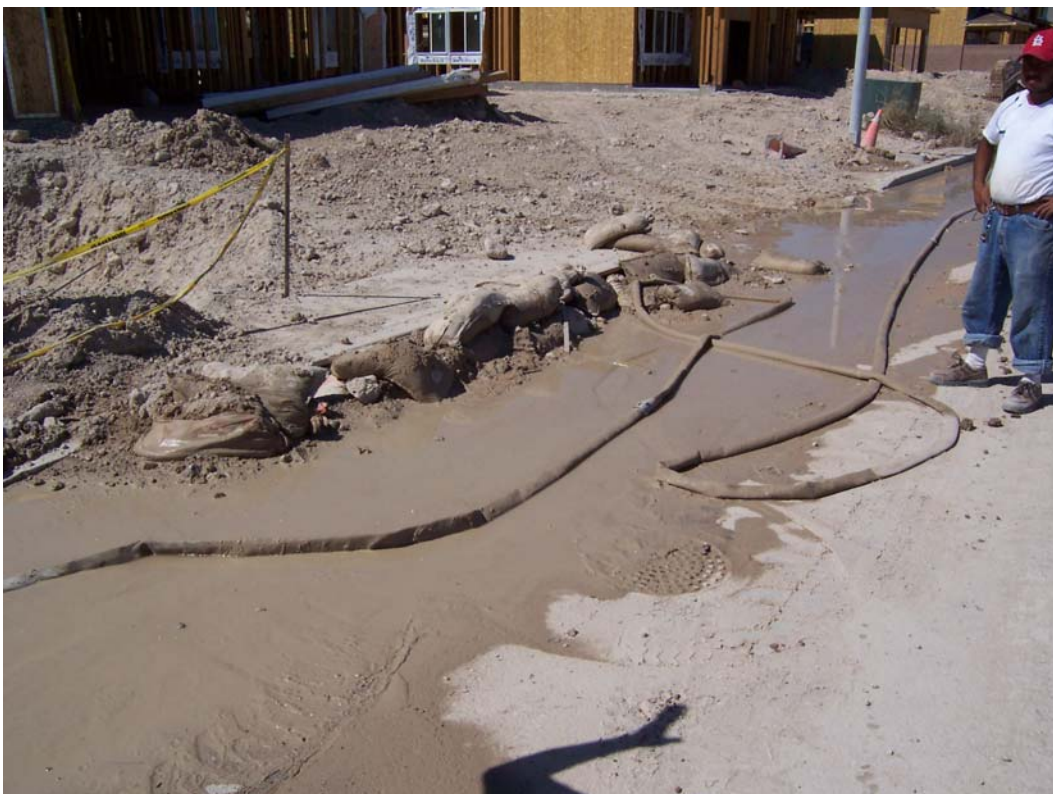
Photo 2. Storm inlet at the site. Sediment is also entering the storm sewer through the pick hole in the manhole in front of the inlet. Hose in the photo is the fire hose the site had been using to clean the street. Note poor condition of sand bags used for inlet protection and dirt extending past curb line.

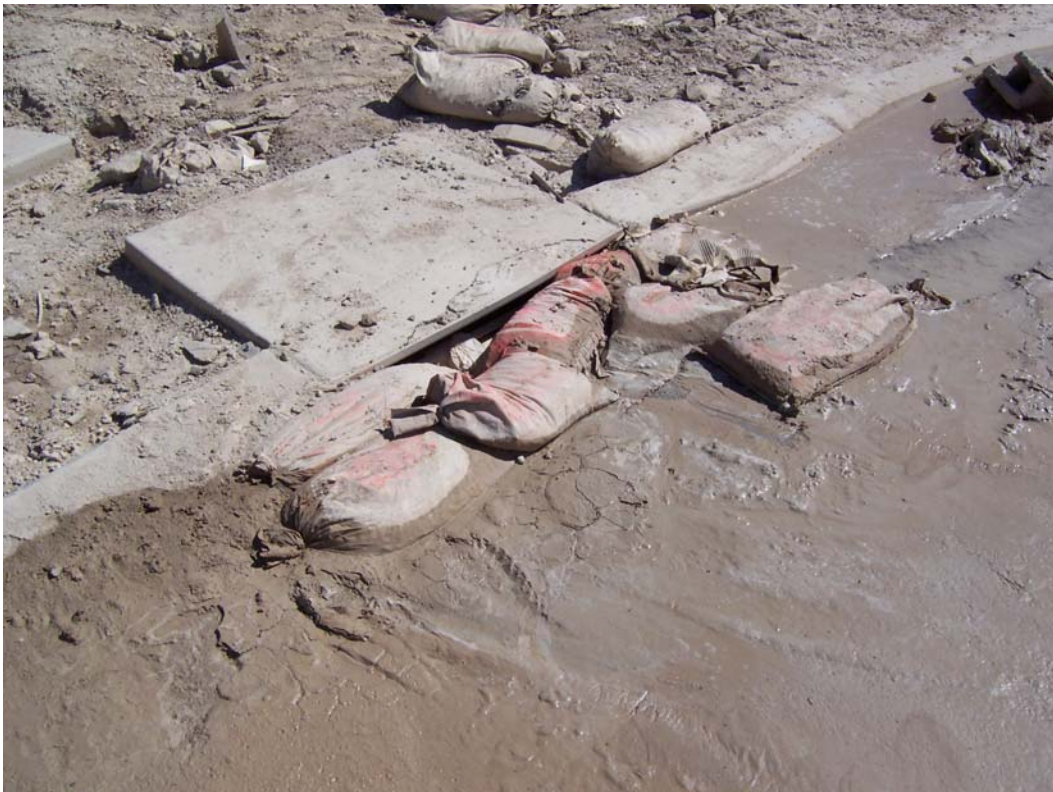
Photo 3. Different storm inlet at the site. Separation between sand bag at the right and curb allows sediment to enter the inlet.

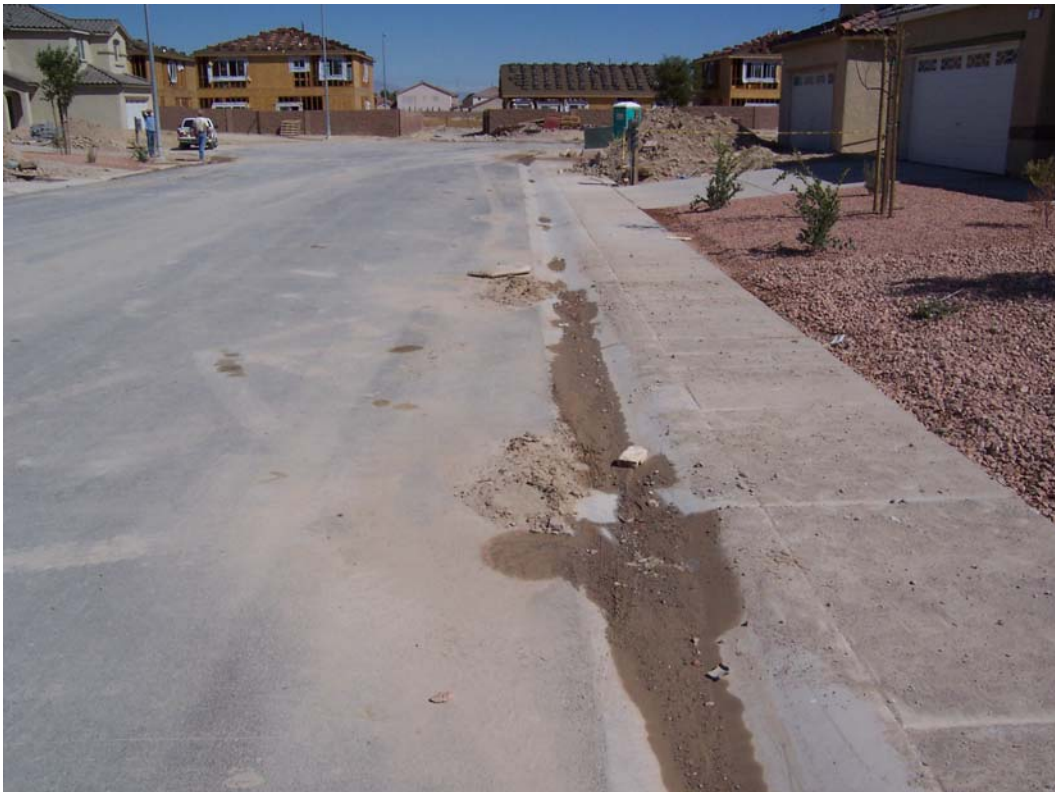
Photo 5. Sediment in the street. Moisture indicates street was washed earlier in the day. Note sand bag, center rear of photo, pulled back from the curb.

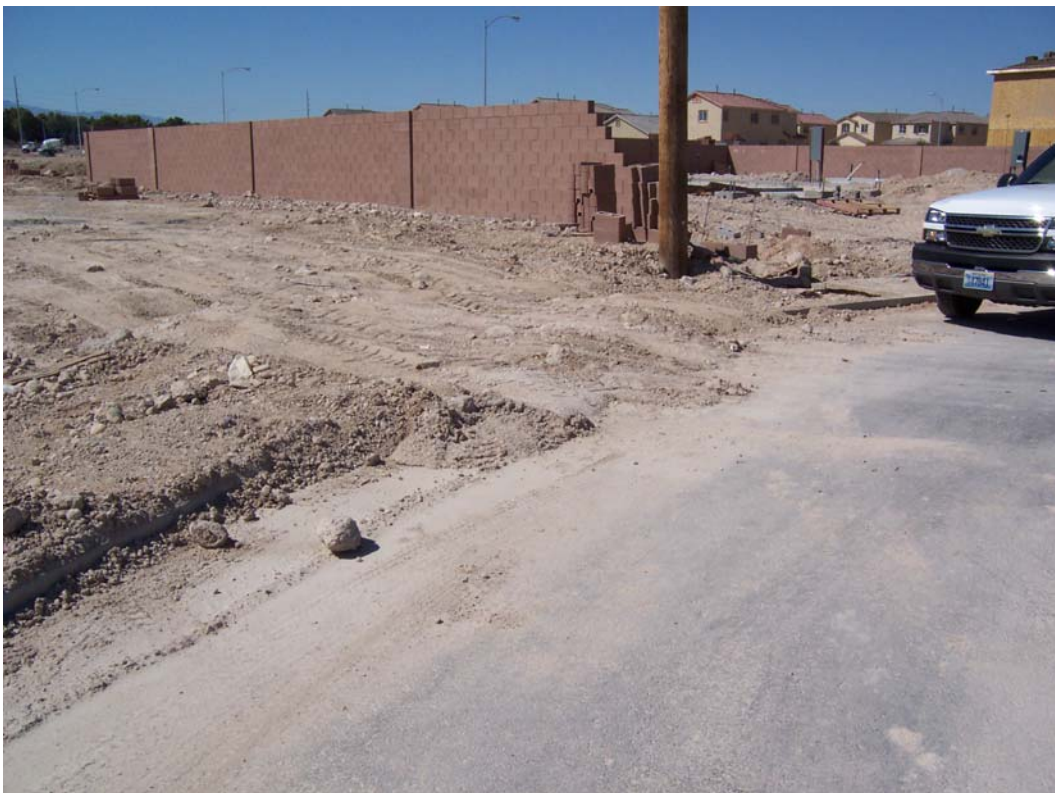
Photo 6. Absence of trackout controls at a site entrance. Note dirt extended past curb line into the street.

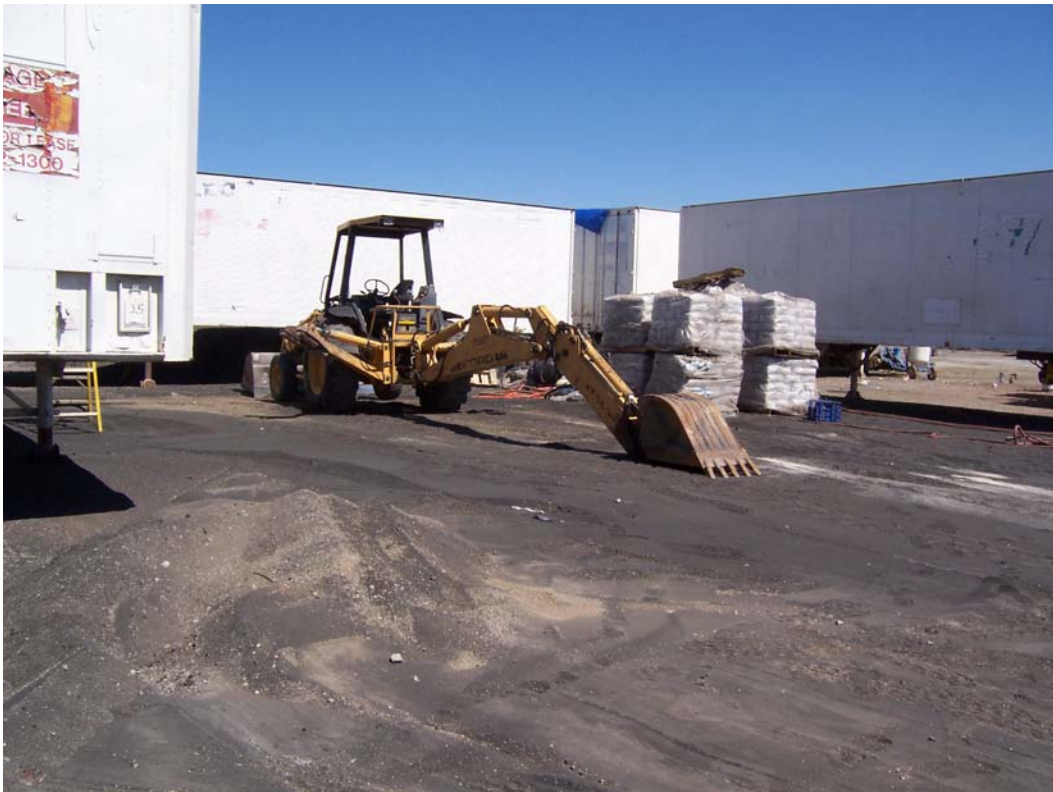
Photo 1. Open air sand blasting activity at the site. Dark material around the backhoe being sand blasted is spent sand blast grit. White bags on pallets at photo right are additional unused grit. No containment was provided around the area.

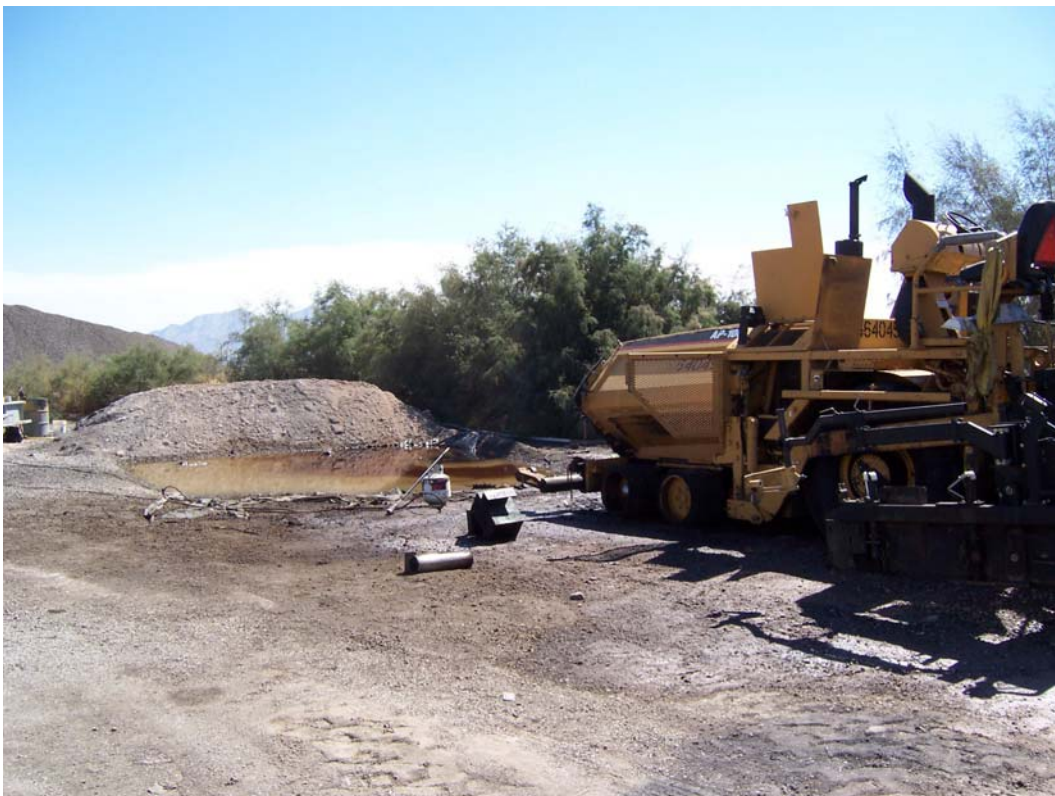
5. A pit had been dug at the site to receive wash water from an equipment cleaning operation that had been set up. The pit contained contaminated, oily water from the cleaning operation. Although a plastic liner had been placed in the pit, the area where equipment was being cleaned was not lined. The soil in this area was heavily stained with oil.

Photo 4. Paving machine being cleaned with wash water discharged to the pit shown in Photo 3. Note oil stains on the ground in front of and around the machine.

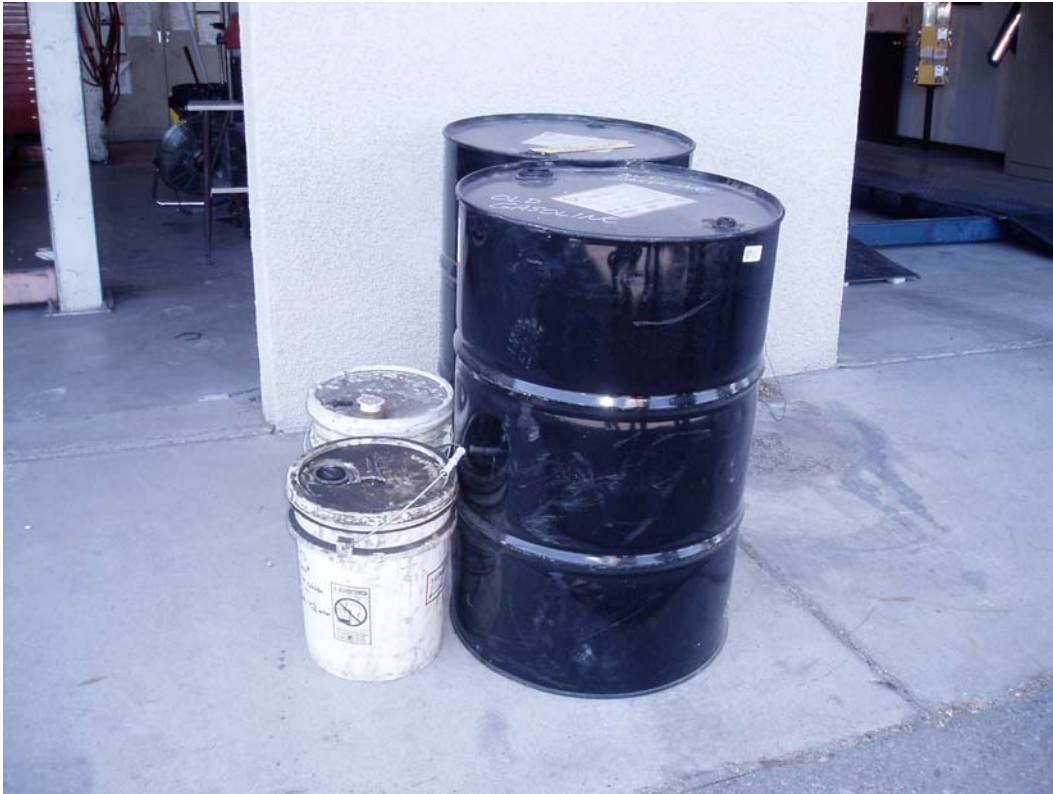
1. Self-inspections of the municipal facilities are not occurring.
2. Containers of used oil were observed outside without secondary containment.
3. The site was clean and well-maintained.

Photo 1. Two 55-gallon drums of used gasoline and two smaller buckets located outside the garage and without secondary containment.

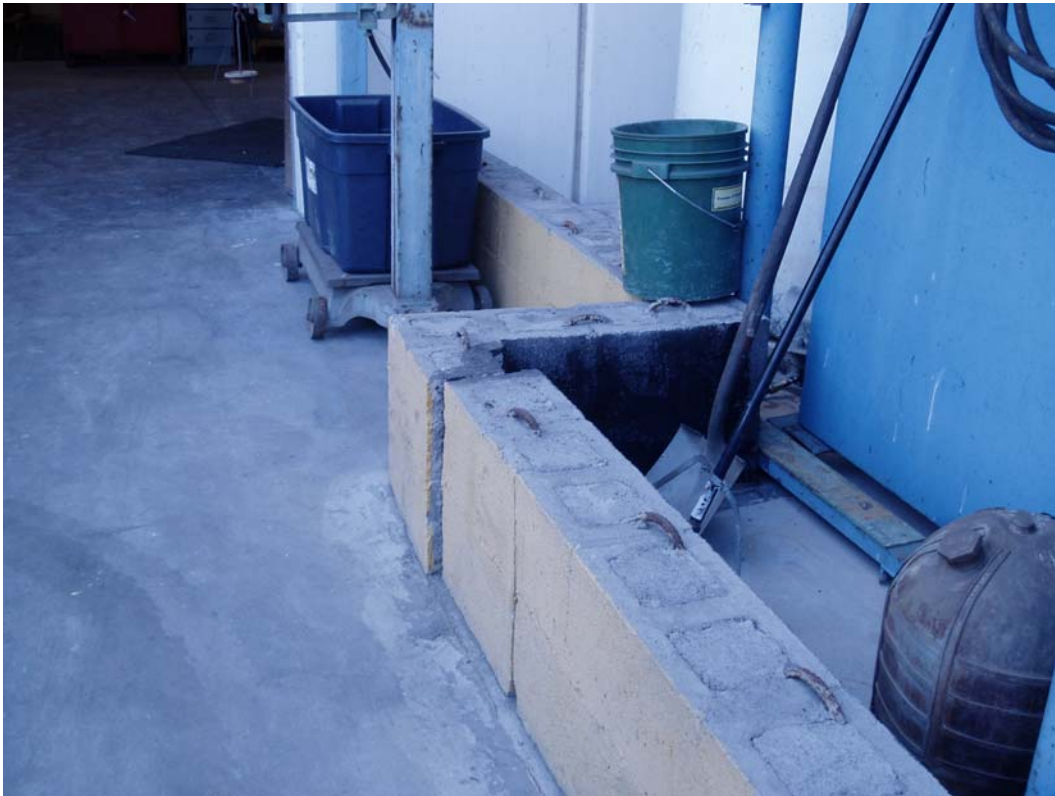
Photo 1. Crack in secondary containment.

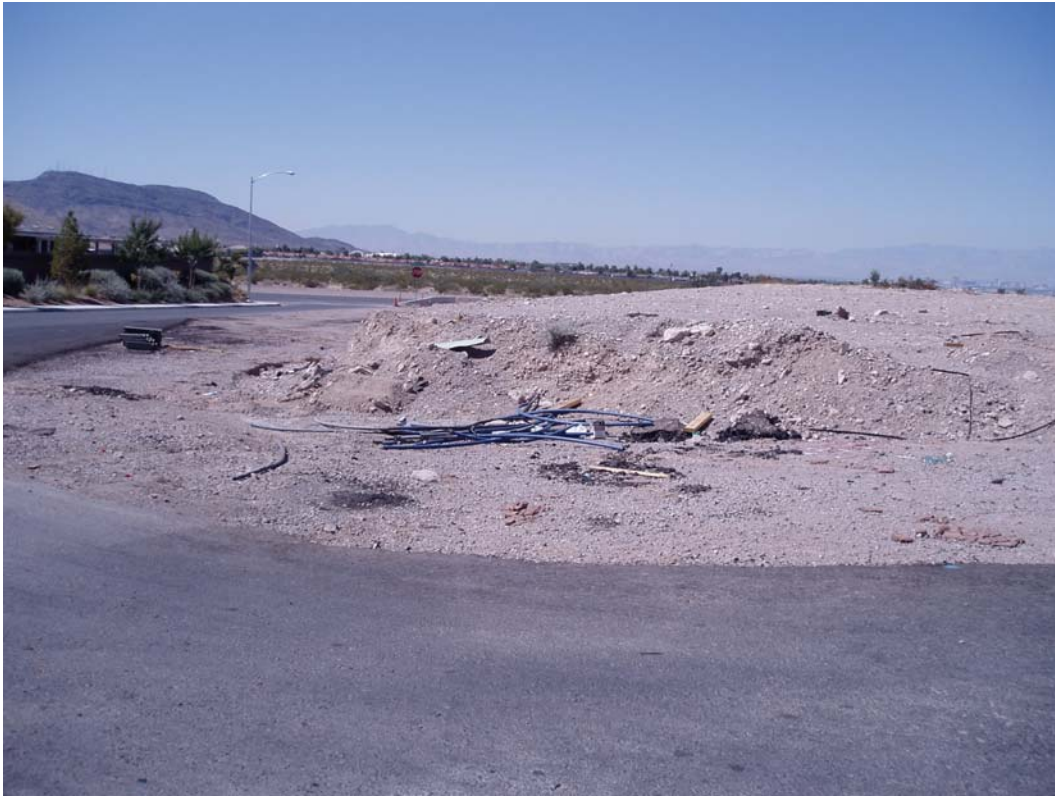
Photo 1. Debris at construction site entrance.
