# Millers Creek Watershed Improvement Plan

## **Excerpt Showing an Example of Hydrology Documentation**

**April 2004**

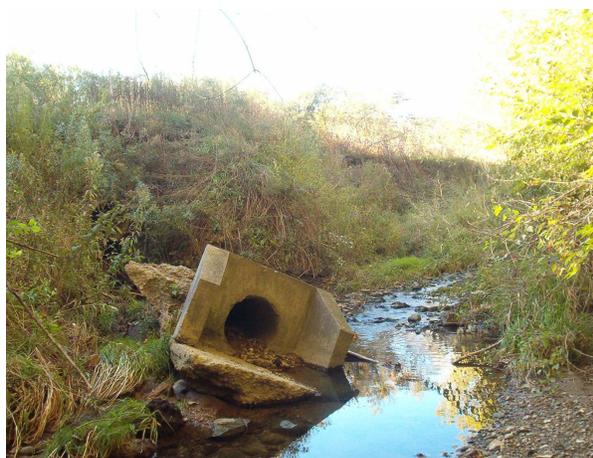
The high bed slope combined with extensive Directly Connected Impervious Area (DCIA) has led to some extreme downcutting. The downcutting has disconnected some of the stream from its floodplain. Some of the Hubbard reach above the 84-inch curved culvert, and most of the reach from the baffle box at the end of the 84-inch culvert down to Glazier, is incised. These conditions have led to undercut storm sewer outlets, failed outlets, failing retaining walls and extreme bank erosion (See **Figure 5.7**).

**Figure 5.7 Fallen end section in Glazier Reach**
