From: Keith Gagnon, LSRP Consulting <kgagnon@lsrpconsulting.com>
Sent: Wednesday, November 02, 2016 5:06 PM
To: Haklar, James
Subject: Former Alcoa Building 12, Edgewater, NJ - Estimated De Minimus Volume of Soil

Former ALCOA Facility – Building 12

(NJDEP #97-6-10-0037-28)

700 River Road

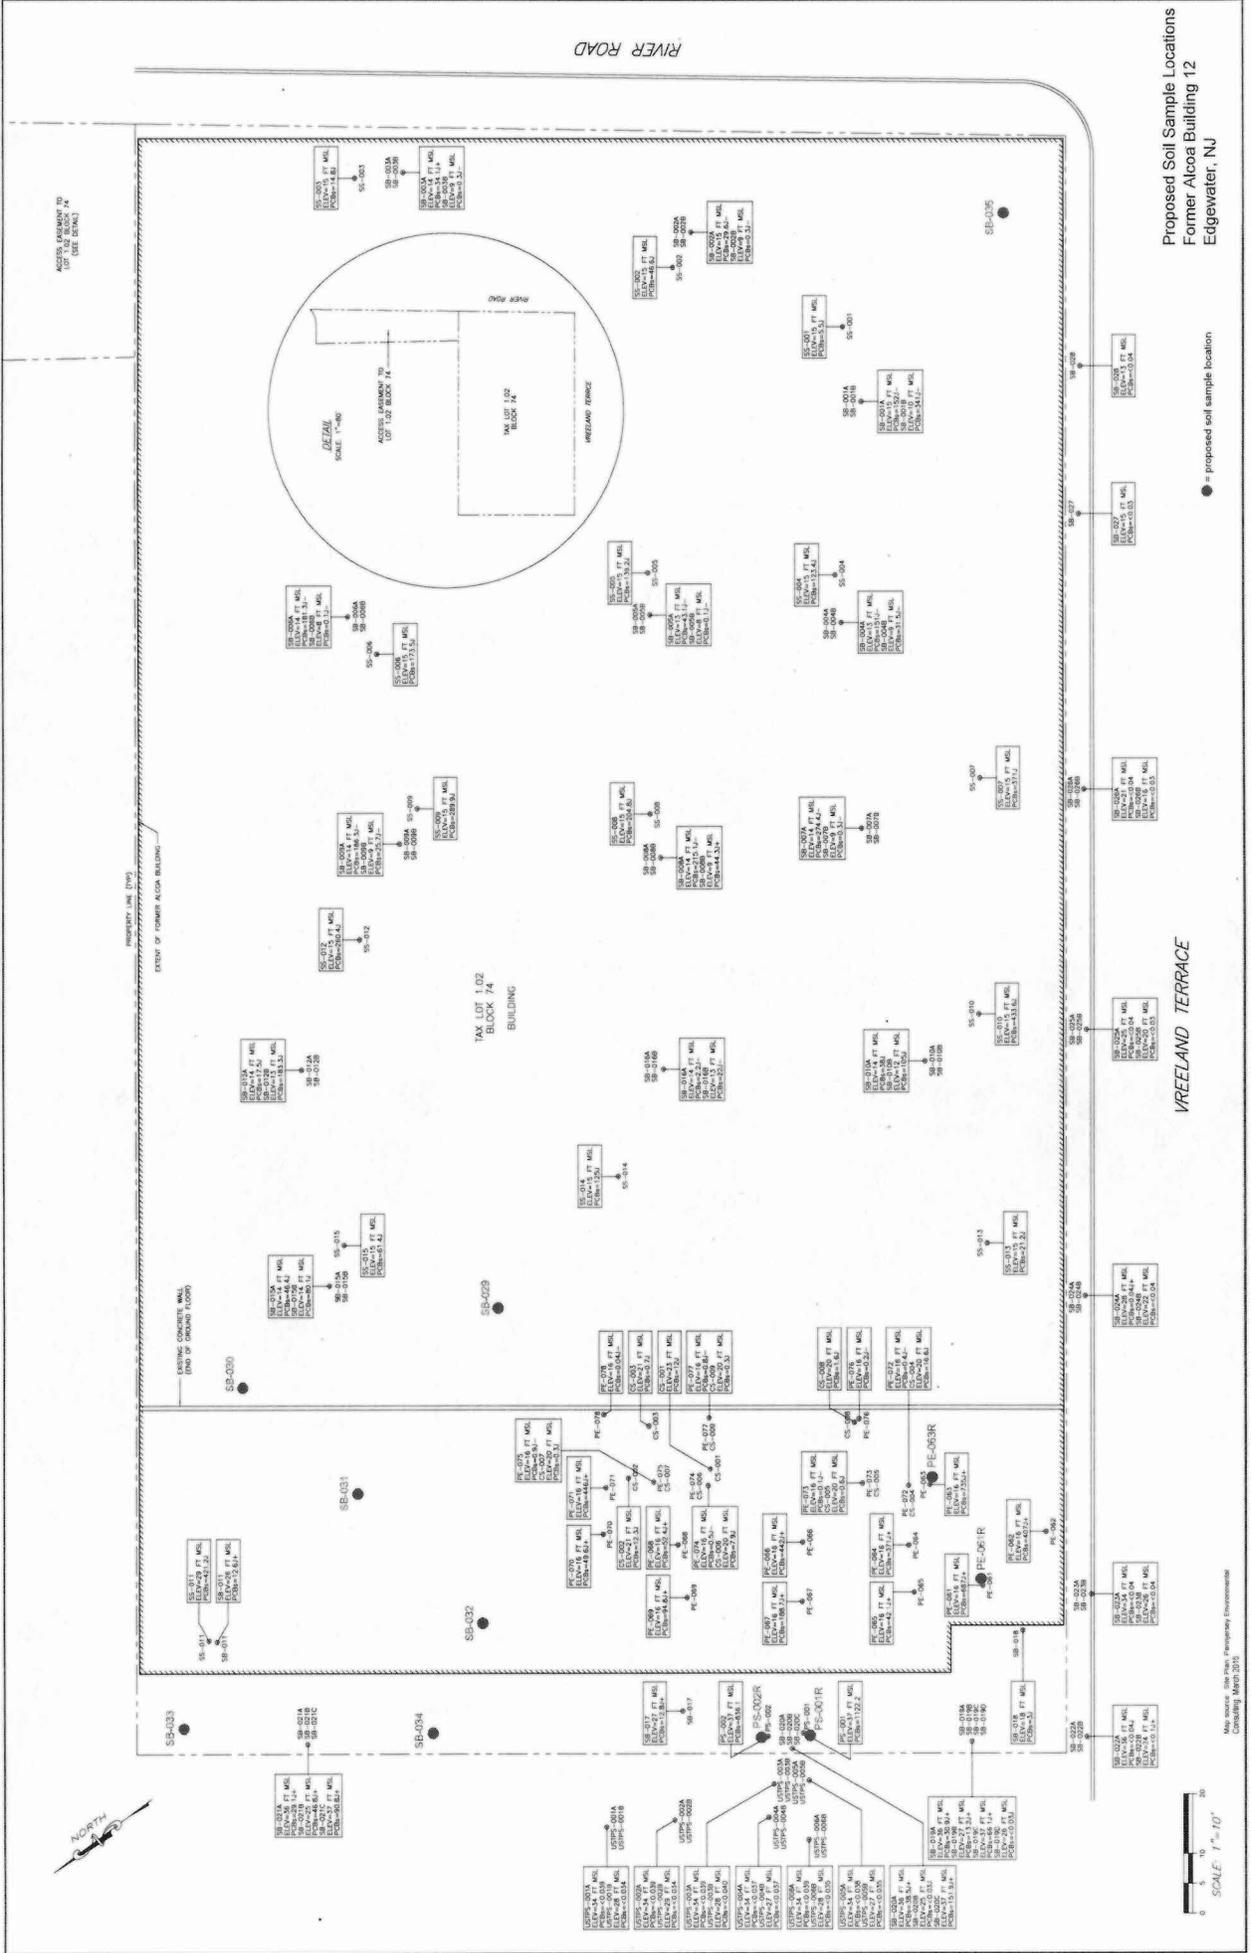
PROPOSED SOIL SAMPLE LOCATIONS

Each of seven borings will extend to a depth of 2 feet and the soils will be visually screened for evidence of staining and PCB contamination. At least one soil sample will be collected from each boring from the interval suspected of being contaminated; if no evidence of contamination is observed, the sample will be collected from the initial 6-inch interval of soil below the previously installed gravel layer. This plan is consistent with the sampling performed during the site-wide soil characterization activities, where the initial characterization samples were collected within the upper 1 foot of soil.

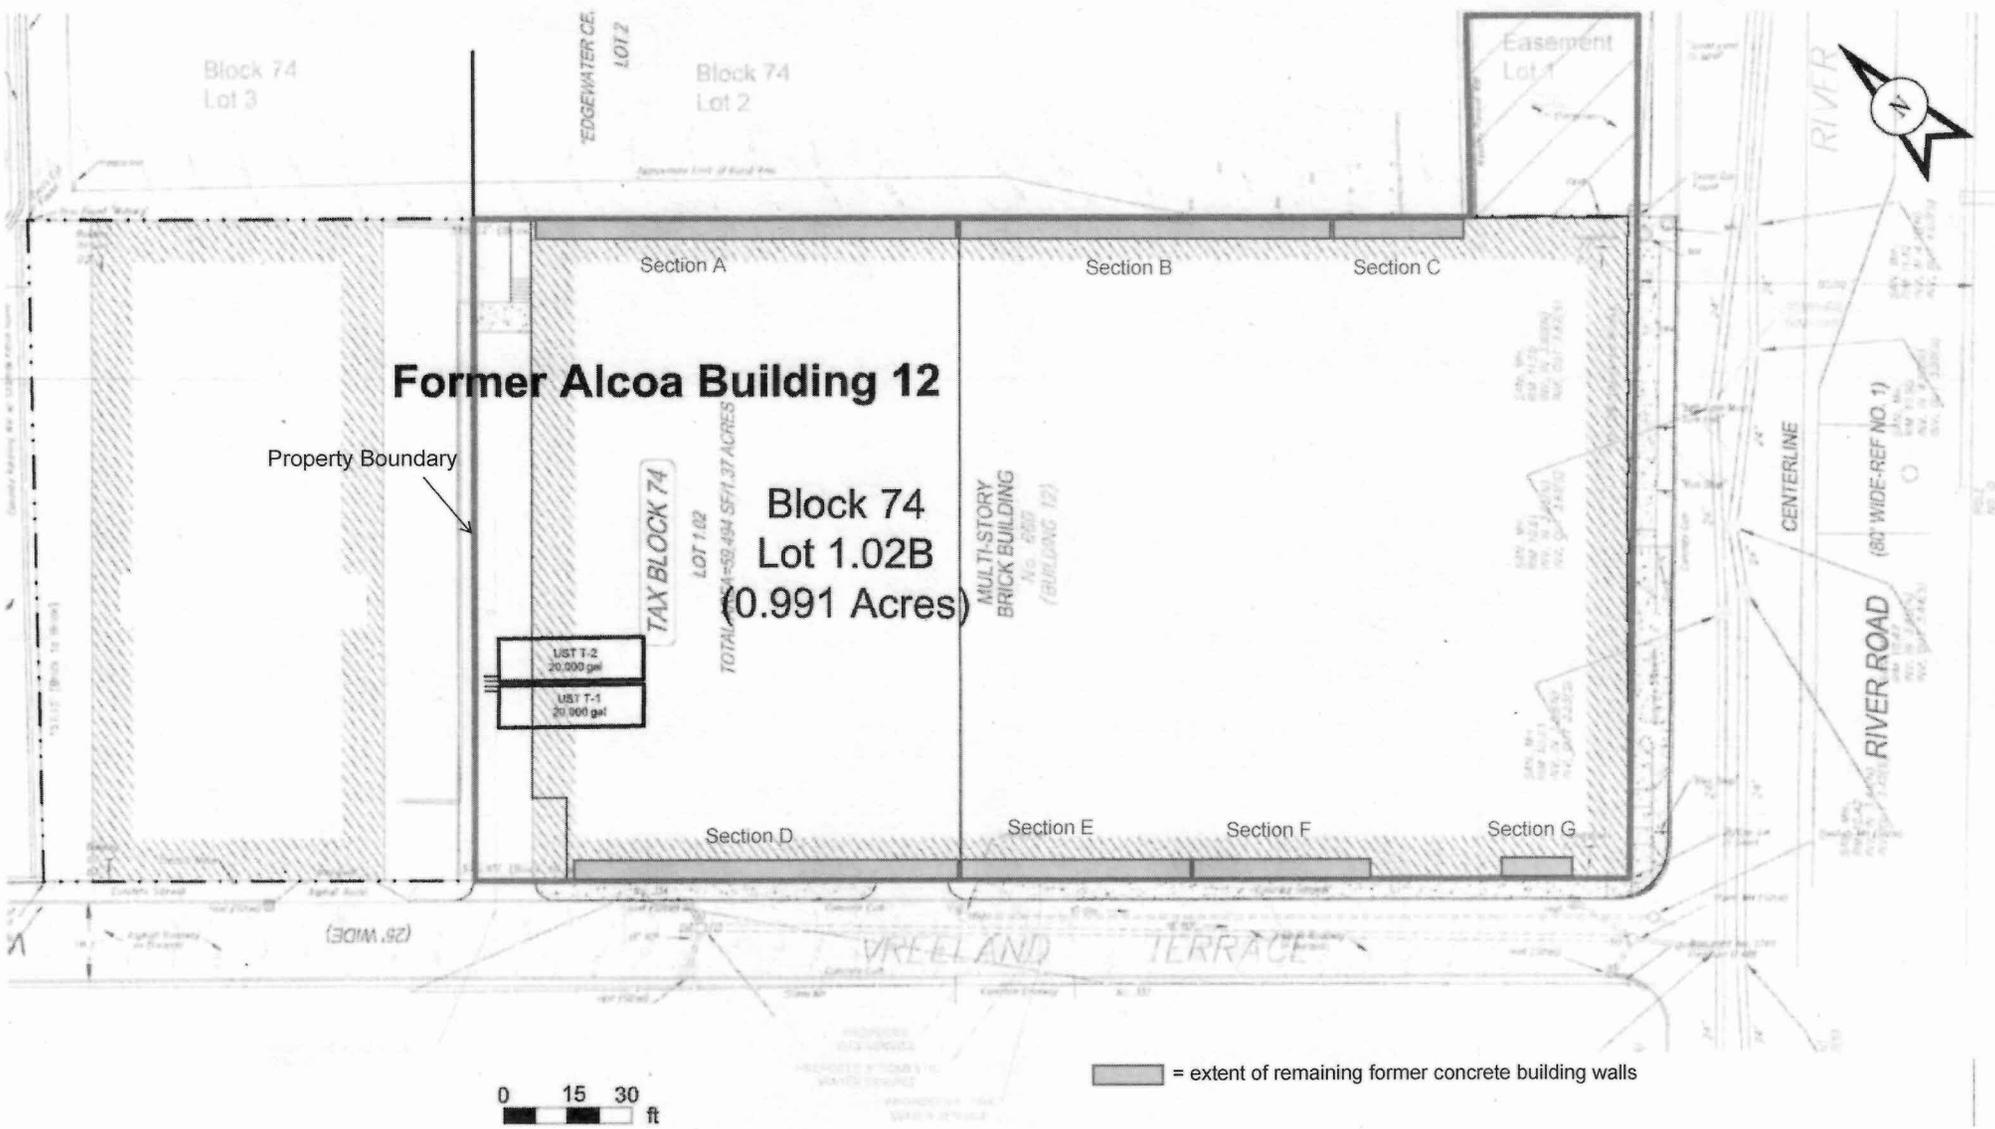
LOCATION OF REMAINING FORMER CONCRETE BUILDING WALLS

Prior to sealing, 21 samples from the concrete walls were collected and analyzed for PCBs via concrete cores from 10 locations biased to areas of visible staining or discoloration. The PCB concentrations ranged from 0.037 to 1.0 ppm, with an average concentration of 0.56 ppm.

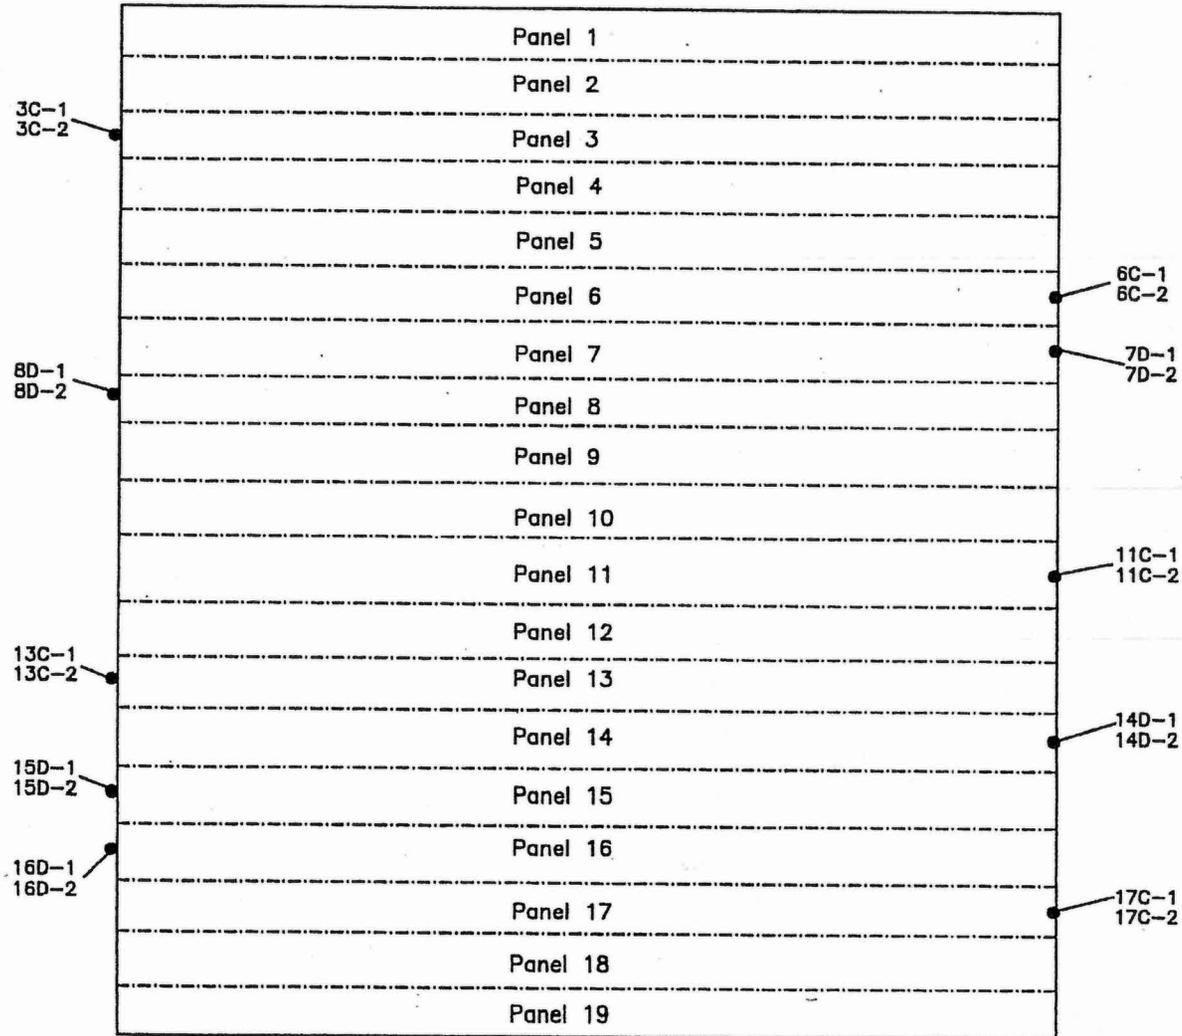
The sampling results are presented in Table 2 and Figure 3. They indicate that all of the cores collected from suspected areas without contamination had PCB concentrations below the 0.49 ppm criteria, both in the surficial and 2-inch depth samples. As for the areas that were suspected as being contaminated, three of the five surficial samples had PCB concentrations slightly in excess of the 0.49 ppm criteria. Only one of these samples exhibited contamination in the 2-inch depth section. This last sample was the most visibly stained.

C = Sample locations where the floor did not contain staining
