NONPOINT SOURCE SUCCESS STORY

Ski Resort Improves Stormwater Management and Restores Two Streams in Jay Branch Watershed

EPA 841-F-19-001SS
December 2019

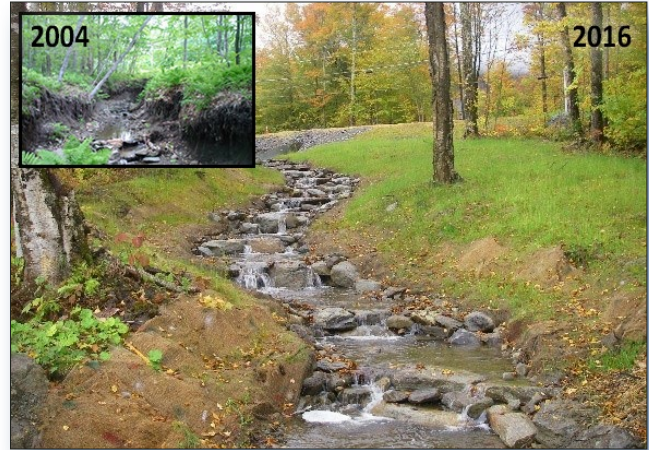
Figure 2. Tributary 9 headwater stream channel, before and after restoration.

JPR eliminated a segment of road next to one of Tributary 9's headwater streams and enhanced the vegetated stream buffer. In addition, nearly 800 feet of another headwater stream draining to Tributary 9 that had undersized culverts and gully erosion was restored, with two culverts replaced and upsized and the banks revegetated (Figure 2). Not only does the restored reach minimize the volume of sediment delivered to downstream reaches, the addition of native shrubs and trees along the restored streambanks provide shade, which lowers water temperatures and improves water quality.
