South Florida Ecosystem Assessment: Everglades Water Management, Soil Loss, Eutrophication and Habitat

Monitoring for Adaptive Management: Implications for Ecosystem Restoration

SOUTH FLORIDA ECOSYSTEM ASSESSMENT

**Everglades Water Management,
Soil Loss, Eutrophication and Habitat**

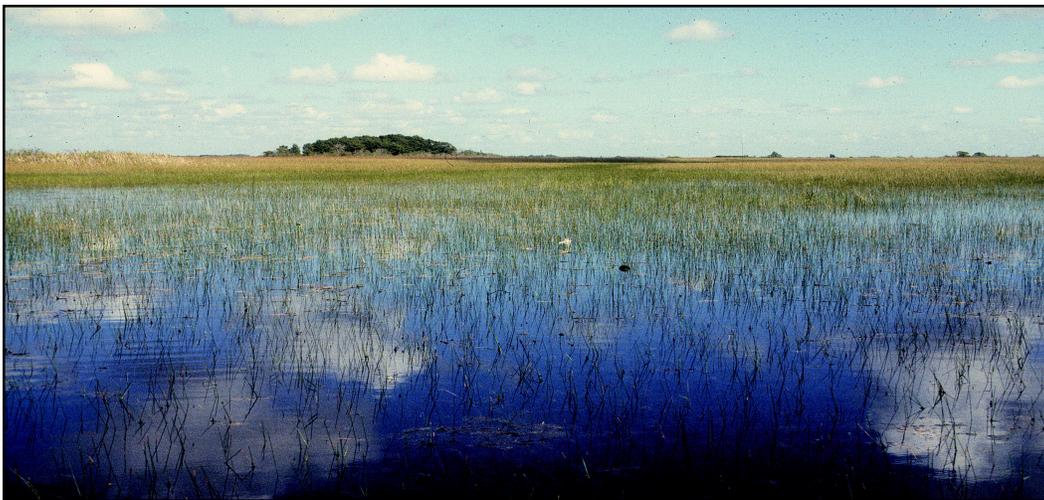
FIGURE 1. Numerous environmental issues threaten the Everglades “River of Grass,” such as water management, soil loss, water quality degradation, and habitat alteration.

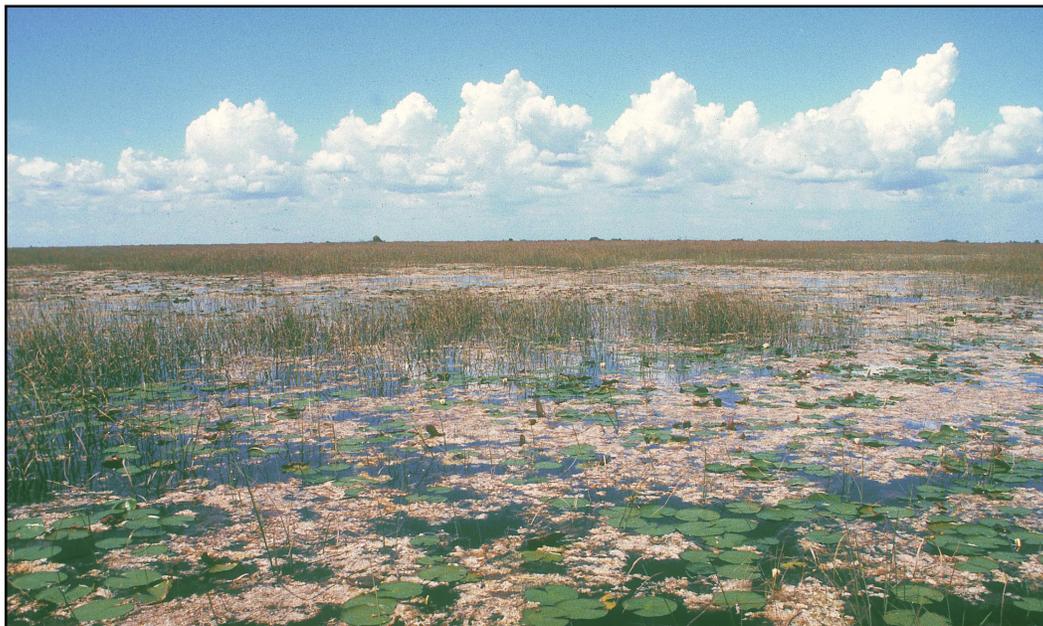
FIGURE 2. The Everglades wet prairie - sawgrass marsh mosaic.

Well-developed attached or floating periphyton mats are a defining characteristic of Everglades habitats, particularly wet prairies and deeper slough areas (Figures 2, 17, 45 and 46). These biologic communities serve multiple functions such as providing oxygen to the water column for fish, removing calcium carbonate from the water and depositing it as soil, removing phosphorus from the water to very low levels, and serving as a food web base⁽²¹⁾. These periphyton communities are sensitive to very slight increases in nutrient concentration, with increases in phosphorus condition causing mat disappearance or changes to the periphyton assemblage, including species composition and biomass. Consequently, periphyton are a sensitive indicator of marsh ecosystem status.

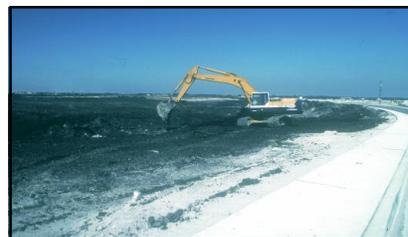
FIGURE 5. Urban expansion into drained Everglades wetlands within west Broward County, 1995. Note the black peat soil.

Today, 50% of the historic Everglades wetland has been drained. The Everglades ecosystem has been altered by extensive agricultural and urban development (Figures 4 to 8). South Florida's human population of about six million continues to increase and encroach on the ecosystem's land and compete for its water. This human population is projected to increase to 15 million within a few decades⁽¹⁾ (Figure 4).

A variety of soil types are found in the Everglades. Soils to the west in Big Cypress Swamp are primarily sandy, while the wetland soils of the central Everglades are primarily organic peat (see Figures 5 and 16). Peat soils are formed by decaying plant matter. Another major soil type found within Everglades wetlands is a calcitic mud (marl), commonly found in the shallower peripheral marshes of the Everglades subjected to shorter periods of surface water inundation (Figure 30). Marl is found in association with thick algal mats, called periphyton, which are able to precipitate calcium carbonate from the water column⁽¹⁶⁾.

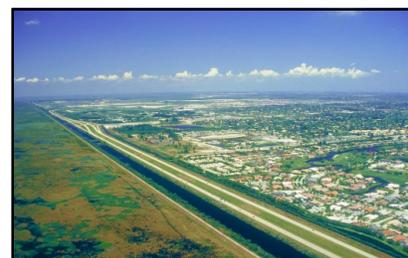
FIGURE 6. Urban expansion into Everglades wetlands in western Broward County, 1995.

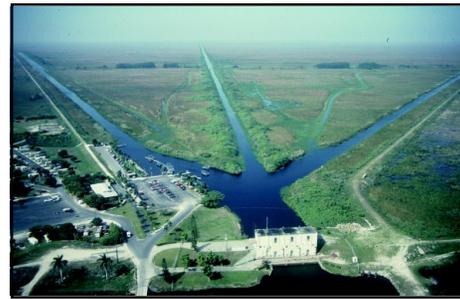
FIGURE 11. An extensive system of canals, levees, and water control structures has modified Everglades water conditions and provides a conduit for pollutant transport. This pump station discharges untreated stormwater from an urban basin into the Everglades.

have been irreversibly drained. The water storage and water quality filtration functions that these wetlands provided is gone. The canal system quickly drains water from developed areas and the wetlands that remain. On average, a billion gallons of fresh water are discharged to the coast each year. Discharges to the Everglades are frequently too much or too little, and are often at the wrong time (Figure 10). Some areas are too wet while other areas are too dry. Overland sheetflow is interrupted by levees and canals that crisscross the Everglades and can provide a conduit for pollutant transport from urban and agricultural areas (Figure 11). Nutrient enrichment has become a threat to the Everglades.

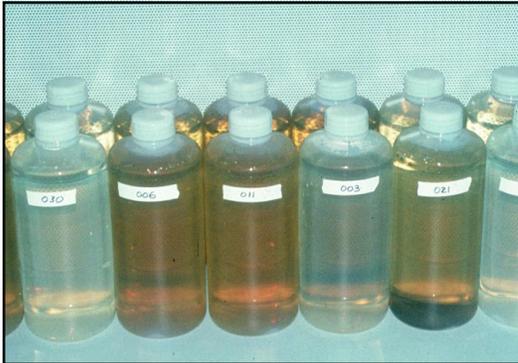
FIGURE 15. Water samples were collected at each site and analyzed for nutrients, mercury, and other constituents.

The media sampled at each site include surface water (Figure 15), canal sediment, marsh soil (Figure 16), algae (Figure 17), and prey fish (Figure 18). The study sampled three physiographic regions: Everglades ridge and slough; marl prairie/rocky glades; and Big Cypress Swamp.

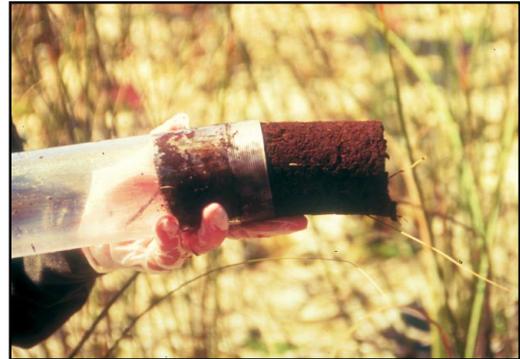
FIGURE 16. A typical peat soil core collected from an Everglades wet prairie.

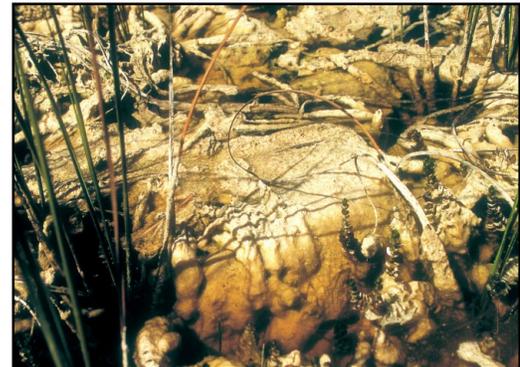
FIGURE 17. Well-defined periphyton mats are a defining characteristic of the Everglades ridge and slough complex.

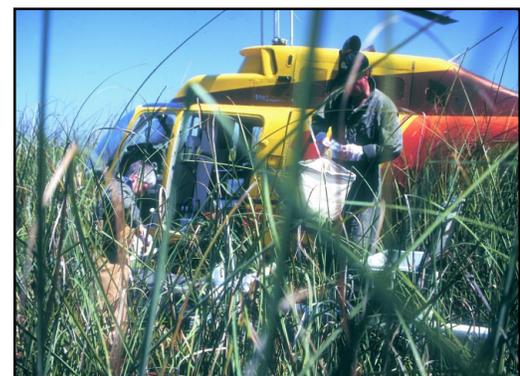
FIGURE 18. Sampling prey fish in a sawgrass marsh.

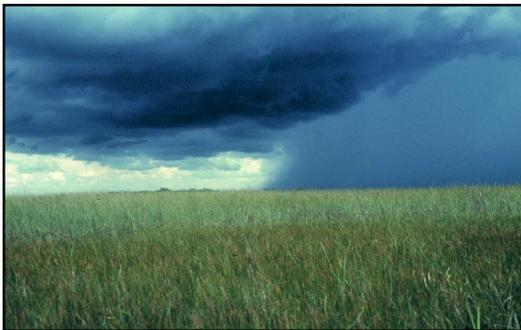
FIGURE 19. A typical intense rain event in the slough-wet prairie complex during the summer wet season.

Rainfall is highly seasonal, with about 80% falling during the May to October wet season (Figures 19 and 20). Rainfall during the 1993-1996 sampling period was above average. Discharge through public water pumping stations is also highly seasonal. For example, at S-8, a pumping station that provides flood control for part

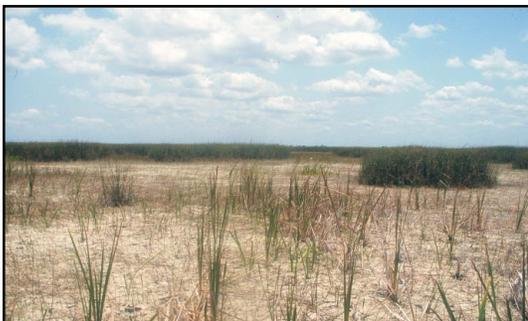
FIGURE 21. The slough-wet prairie complex during the dry season.

Marsh water depths vary greatly with time and location (Figures 21, 23 to 25). Water depths are deepest immediately upstream of levees that impede the natural flow of water, such as the southern portions of Arthur R. Marshall Loxahatchee National Wildlife Refuge (the Refuge) and Water Conservation Areas 2 and 3A (Figure 23). Although all of these long hydroperiod areas remained wet during the study period, the unnaturally deep water depth of over five feet was observed within Water Conservation Area 3 where the L-67 levee prevents sheetflow to the south.

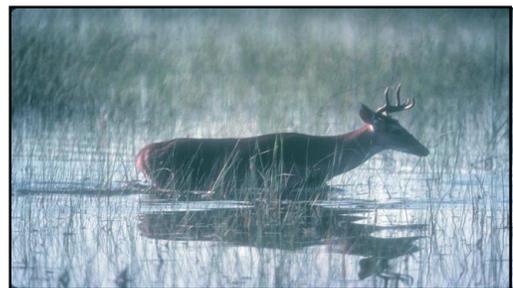
FIGURE 25. The slough-wet prairie complex during the wet season in Everglades National Park.

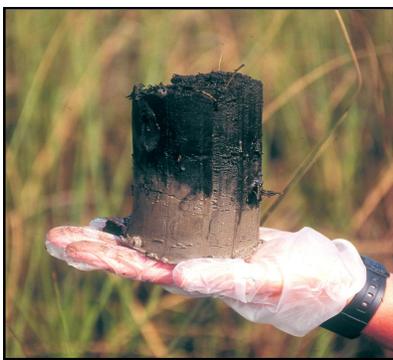
FIGURE 30. An Everglades soil core with peat overlaying marl.

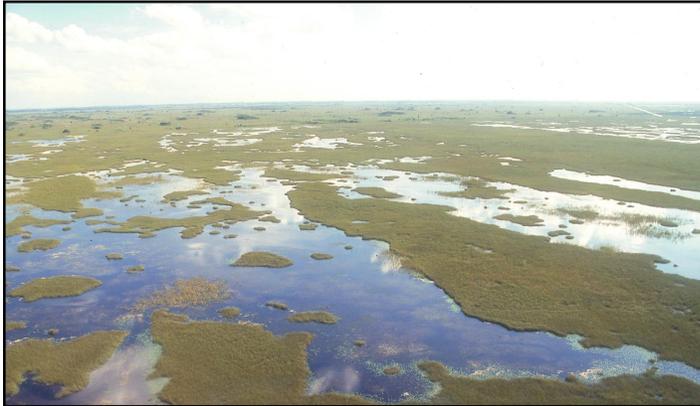
FIGURE 41. Aerial view of the Everglades showing the mosaic of sawgrass marsh and wet prairie plant communities.

Wet prairie and sawgrass marsh are the two dominant plant communities in the Everglades. Sawgrass was dominant at 47% of the 479 sampling sites and the wet prairie-slough complex was dominant at 44% of the sites (Figures 41 to 43). Wet prairie tends to dominate in the Refuge, and in wetter portions of WCA3. Sawgrass tends to dominate north of Alligator Alley and in Water Conservation Area 2, while the Park contains a mix of the two communities. Cattail presence along with soil phosphorus is shown in Figure 43. Cattail was present at 10% of the sampling sites.

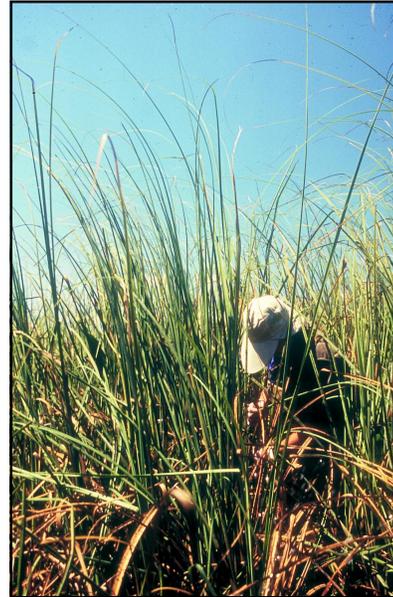
FIGURE 42. Sawgrass marsh with high plant density.

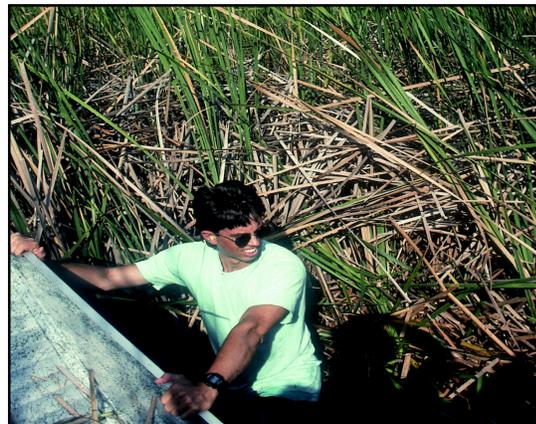
FIGURE 44. Everglades eutrophication promotes cattail expansion.

Cattail was prevalent in the northern portions of Water Conservation Areas 3A and 2A, and sites that were generally in close proximity to canals. There tends to be a strong association between cattail presence and soil phosphorus or proximity to canals. As soil phosphorus increases, there is a greater likelihood that cattail will be present⁽²³⁾.

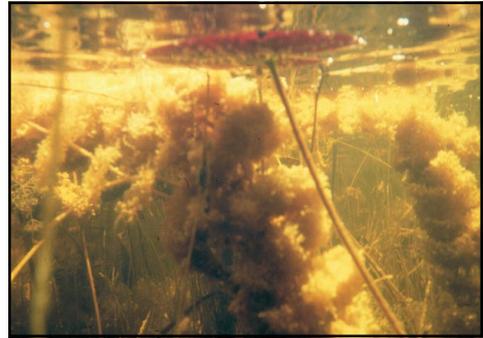
FIGURE 45. Underwater view of a wet prairie in southern Water Conservation Area 3 with periphyton attached to macrophytes.
