#### CC Plume - USGS PowerPoint Presentation

# Let's backup a bit: The Dilemma of the Capital City Plume (post 1993)

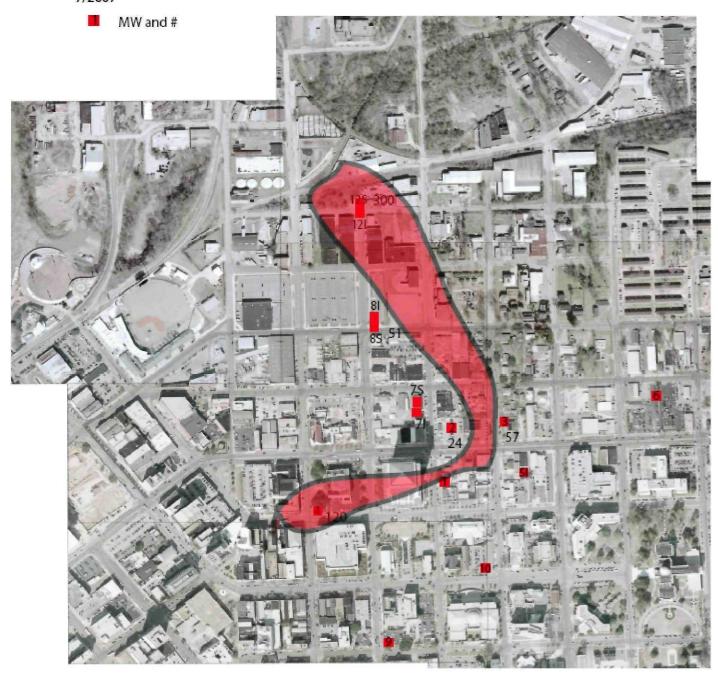
PCE, Groundwater Results, ug/L 7/2007

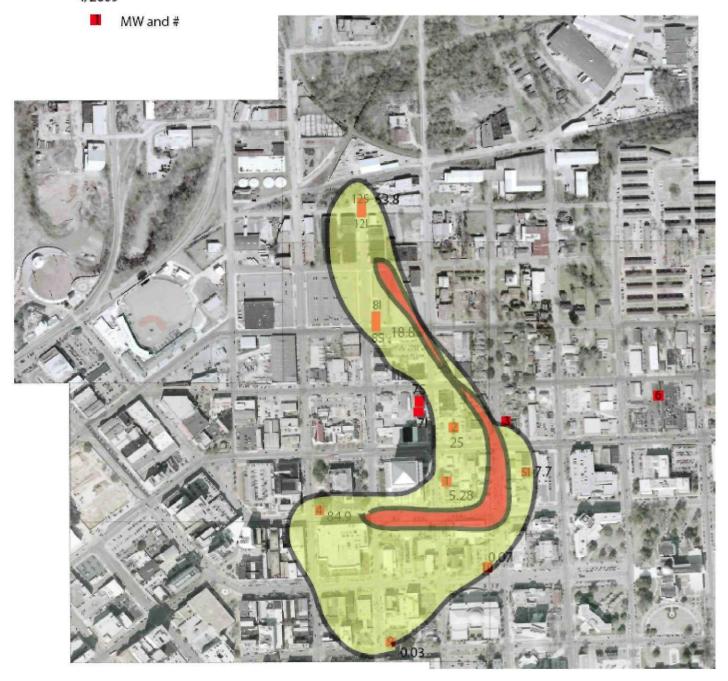
PCE, Groundwater Results, ug/L 4/2009

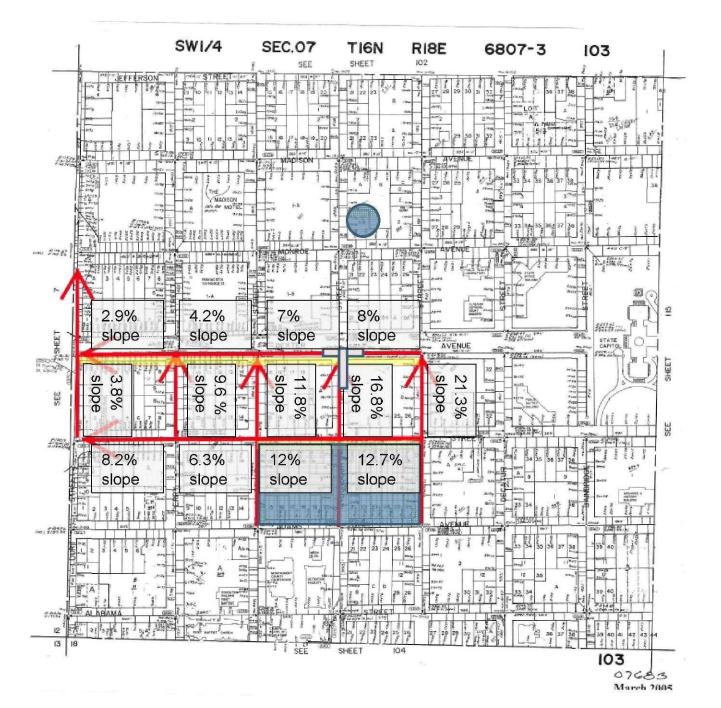
How PCE, TCE, and chloroform got into the groundwater Beneath the RSA chiller plant
