**Subject: Dickson County Landfill Reassessment Report (Revision 4)**  
**Dickson, Dickson County, Tennessee**  
**Contract No. 68-W-00-120 (START)**  
**TDD No. 4T-01-11-A-004**

DICKSON COUNTY LANDFILL REASSESSMENT REPORT

Revision 4

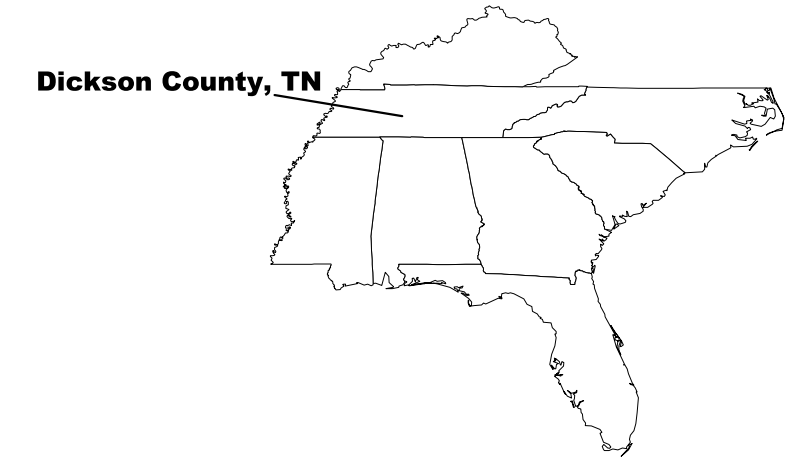
U.S. ENVIRONMENTAL PROTECTION AGENCY  
**DICKSON COUNTY LANDFILL REASSESSMENT REPORT**  
 DICKSON, DICKSON COUNTY, TENNESSEE  
 U.S. EPA ID No. TND981467673  
 EPA Contract No. 68-W-00-120  
 TDD No. 4T-01-11-A-004  
  **FIGURE 3- INDUSTRIAL/COMMERCIAL FACILITY LOCATION MAP**  
 TETRA TECH EM Inc.

TtEMI then reviewed TDEC files for the identified facilities to gather information on potential contaminant sources, groundwater investigations, and groundwater corrective actions. Additional facilities were researched based on discussions with the TDEC. Files reviewed included DSWM files at the Central Office, DWS files at the NEAC and Central Office, and DSF files in the NEAC. Given the voluminous files to review, only those portions of the files that discussed contaminant sources, regulatory actions, waste generation and disposal, and significant raw material usage were copied. A summary of regulatory files reviewed for each facility is provided in Appendix C. Copies of files obtained through TtEMI's regulatory file review are provided in Attachment L. Selected industrial facilities identified through TtEMI's database review are shown on Figure 3.

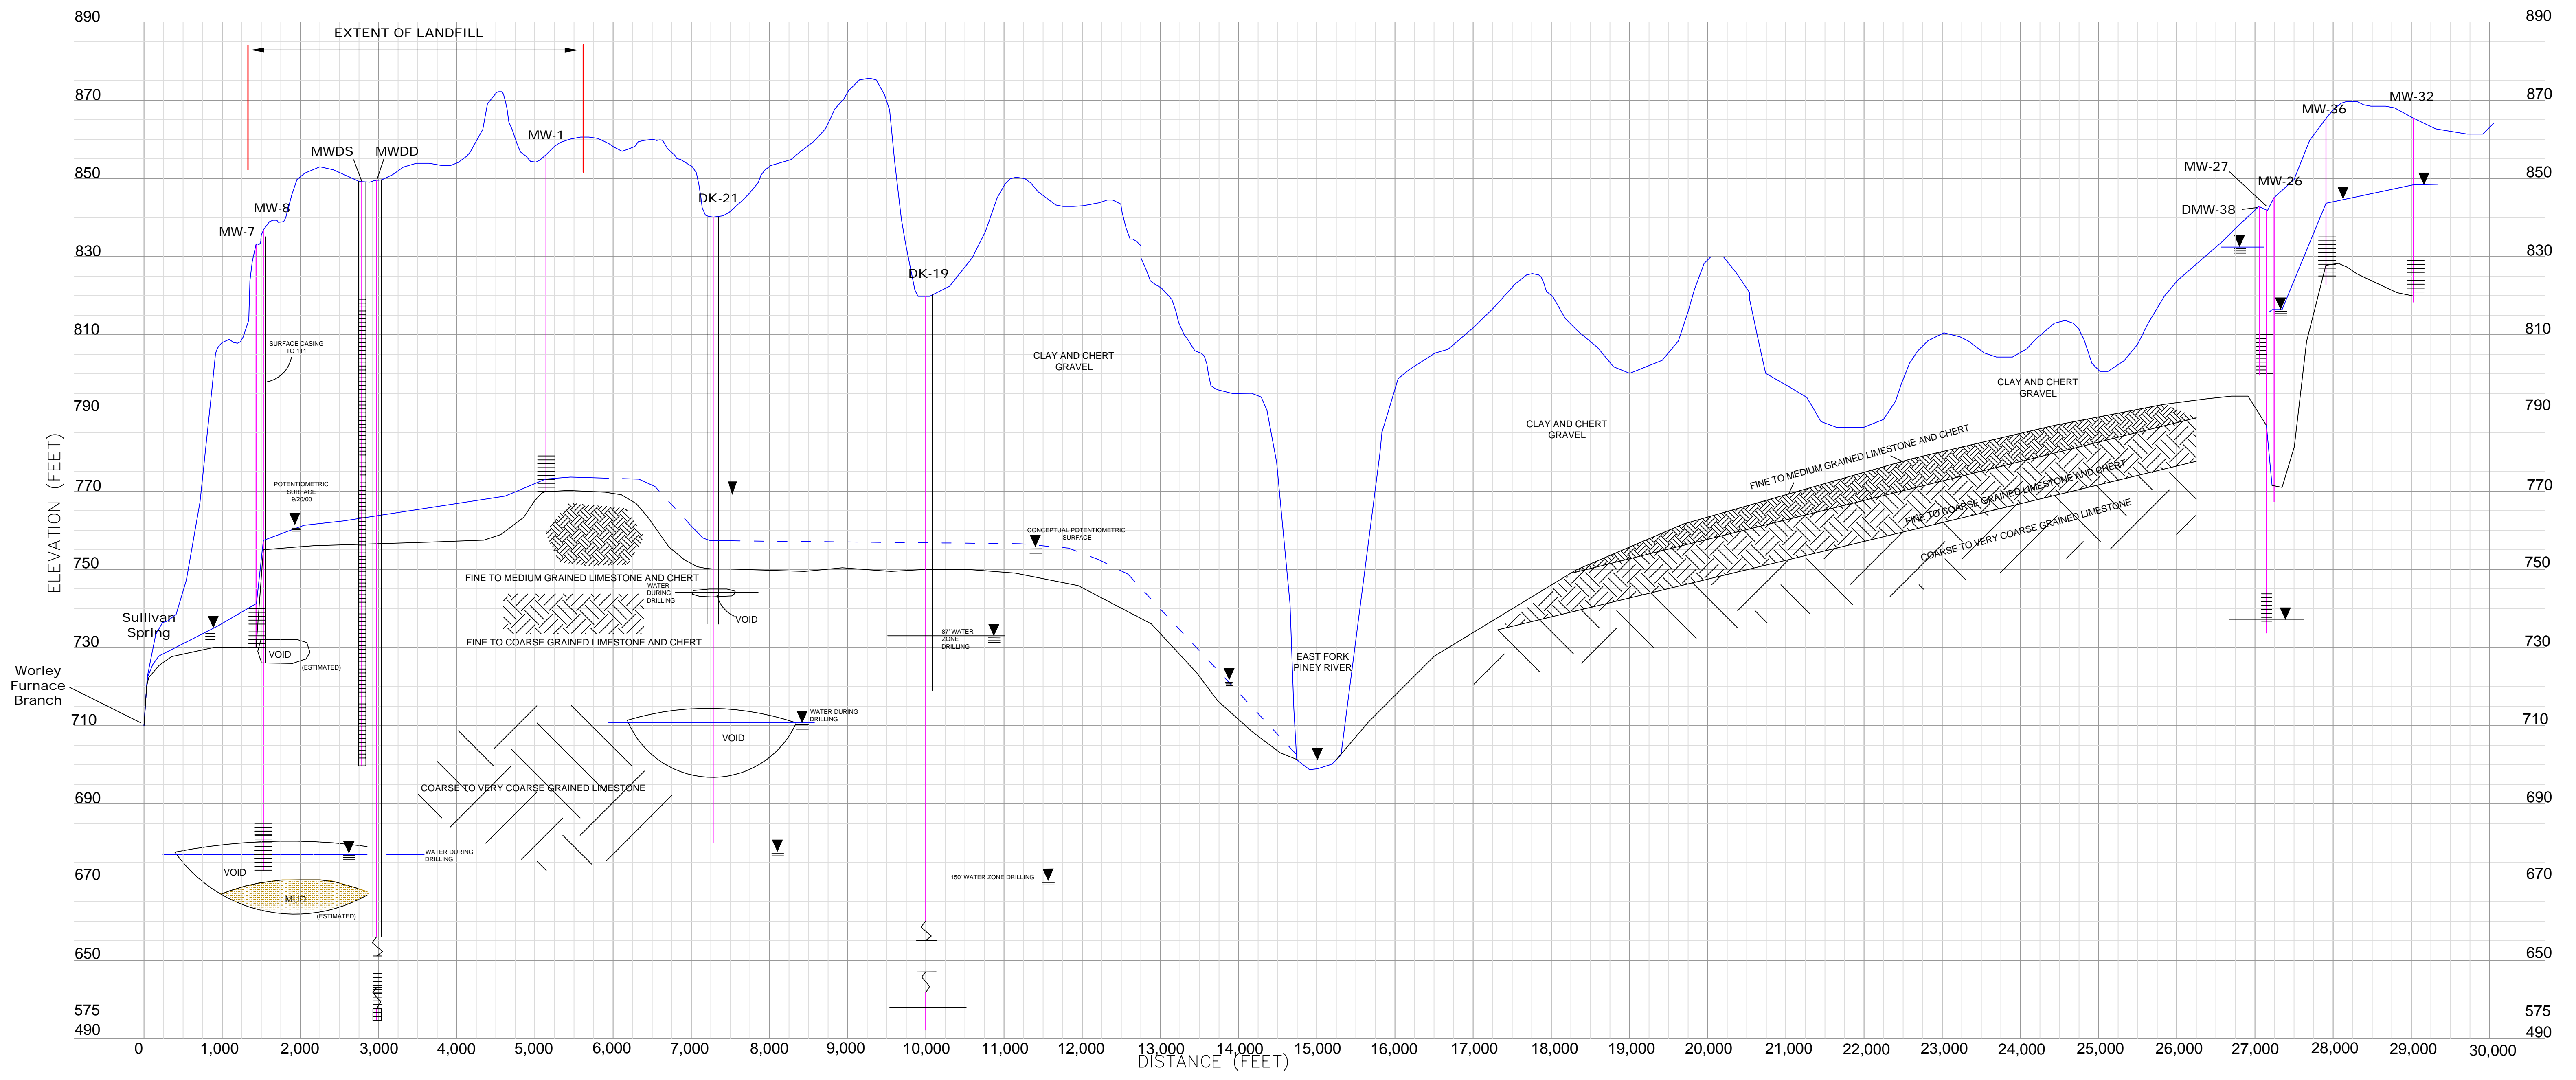
B-B'

LEGEND			
— (Pink line)	WELL DEPTHS	- - - (Dashed line)	ROCK TYPE BOUNDARY
▼ (Black triangle)	POTENTIOMETRIC SURFACE	▨ (Cross-hatch)	FINE TO MEDIUM-GRAINED LIMESTONE AND CHERT
— (Solid line)	TOP OF BEDROCK	▨ (Diagonal lines)	FINE TO COARSE-GRAINED LIMESTONE AND CHERT
(Vertical lines)	WELL SCREEN	▨ (Diagonal lines)	COARSE TO VERY COARSE-GRAINED LIMESTONE
(Vertical lines)	CASING	□ (Square)	DK USGS WELL
— (Dotted line)	MSL MEAN SEA LEVEL	□ (Square)	DK-21 WATER SUPPLY WELL
' (Apostrophe)	FEET		
" (Quotation mark)	INCHES		
— (Red line)	LANDFILL BOUNDARY		
MW	MONITORING WELL

Reference: Construction, Lithologic, and Water-Level Data for Wells Near the Dickson county Landfill, Dickson County, Tennessee, 1995, Prepared by the U.S. Geological Survey 1996.
