FIGURE 4-10 TOP OF BEDROCK GROUNDWATER PLUME (TEMPORARY WELLS and PERMANENT WELLS)
 TCE CONTAMINATION, OCTOBER/NOVEMBER 1996
 REMEDIAL INVESTIGATION REPORT
 NORTH BELMONT PCE SUPERFUND SITE
 NORTH BELMONT, GASTON COUNTY, NC
 SESD PROJECT No. 96S-058, JUNE 1997

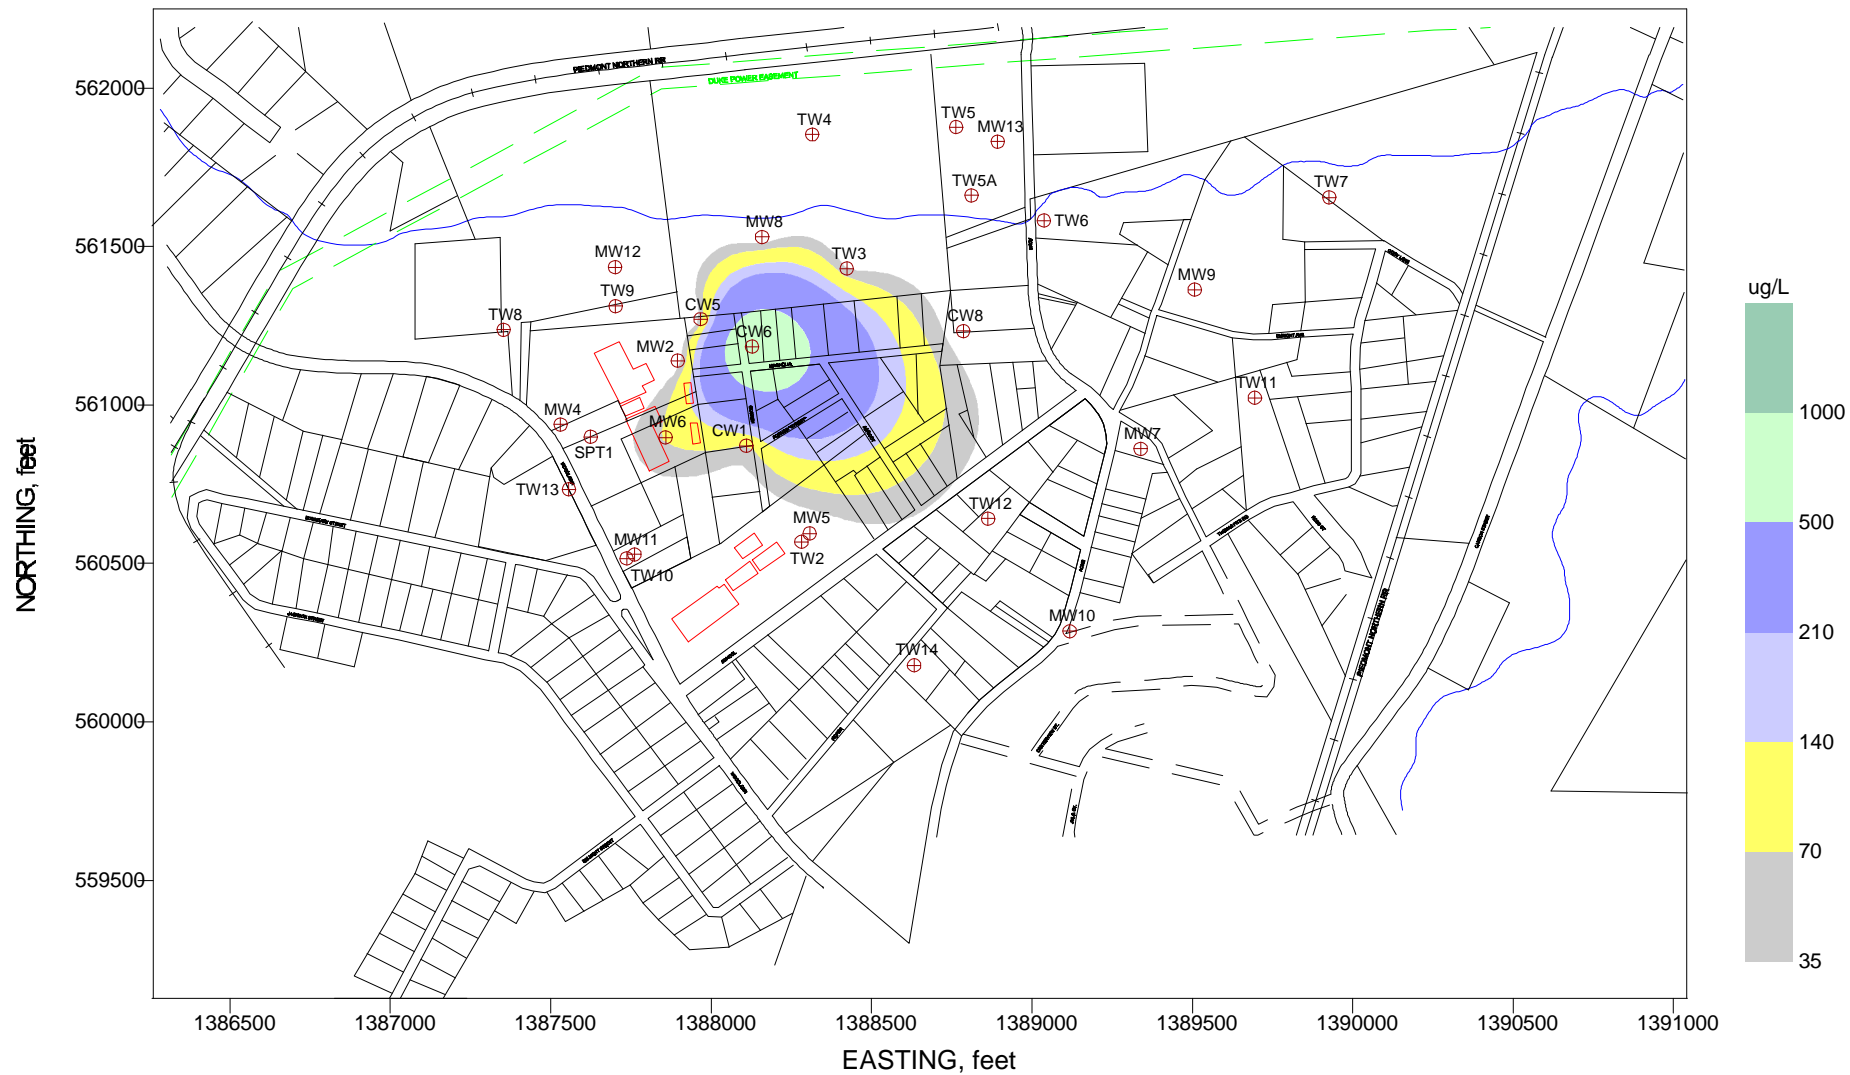
FIGURE 4-11 TOP OF BEDROCK GROUNDWATER PLUME (TEMPORARY WELLS and PERMANENT WELLS)
 CIS-1,2 DCE CONTAMINATION, OCTOBER/NOVEMBER 1996
 REMEDIAL INVESTIGATION REPORT
 NORTH BELMONT PCE SUPERFUND SITE
 NORTH BELMONT, GASTON COUNTY, NC
 SESD PROJECT No. 96S-058, JUNE 1997

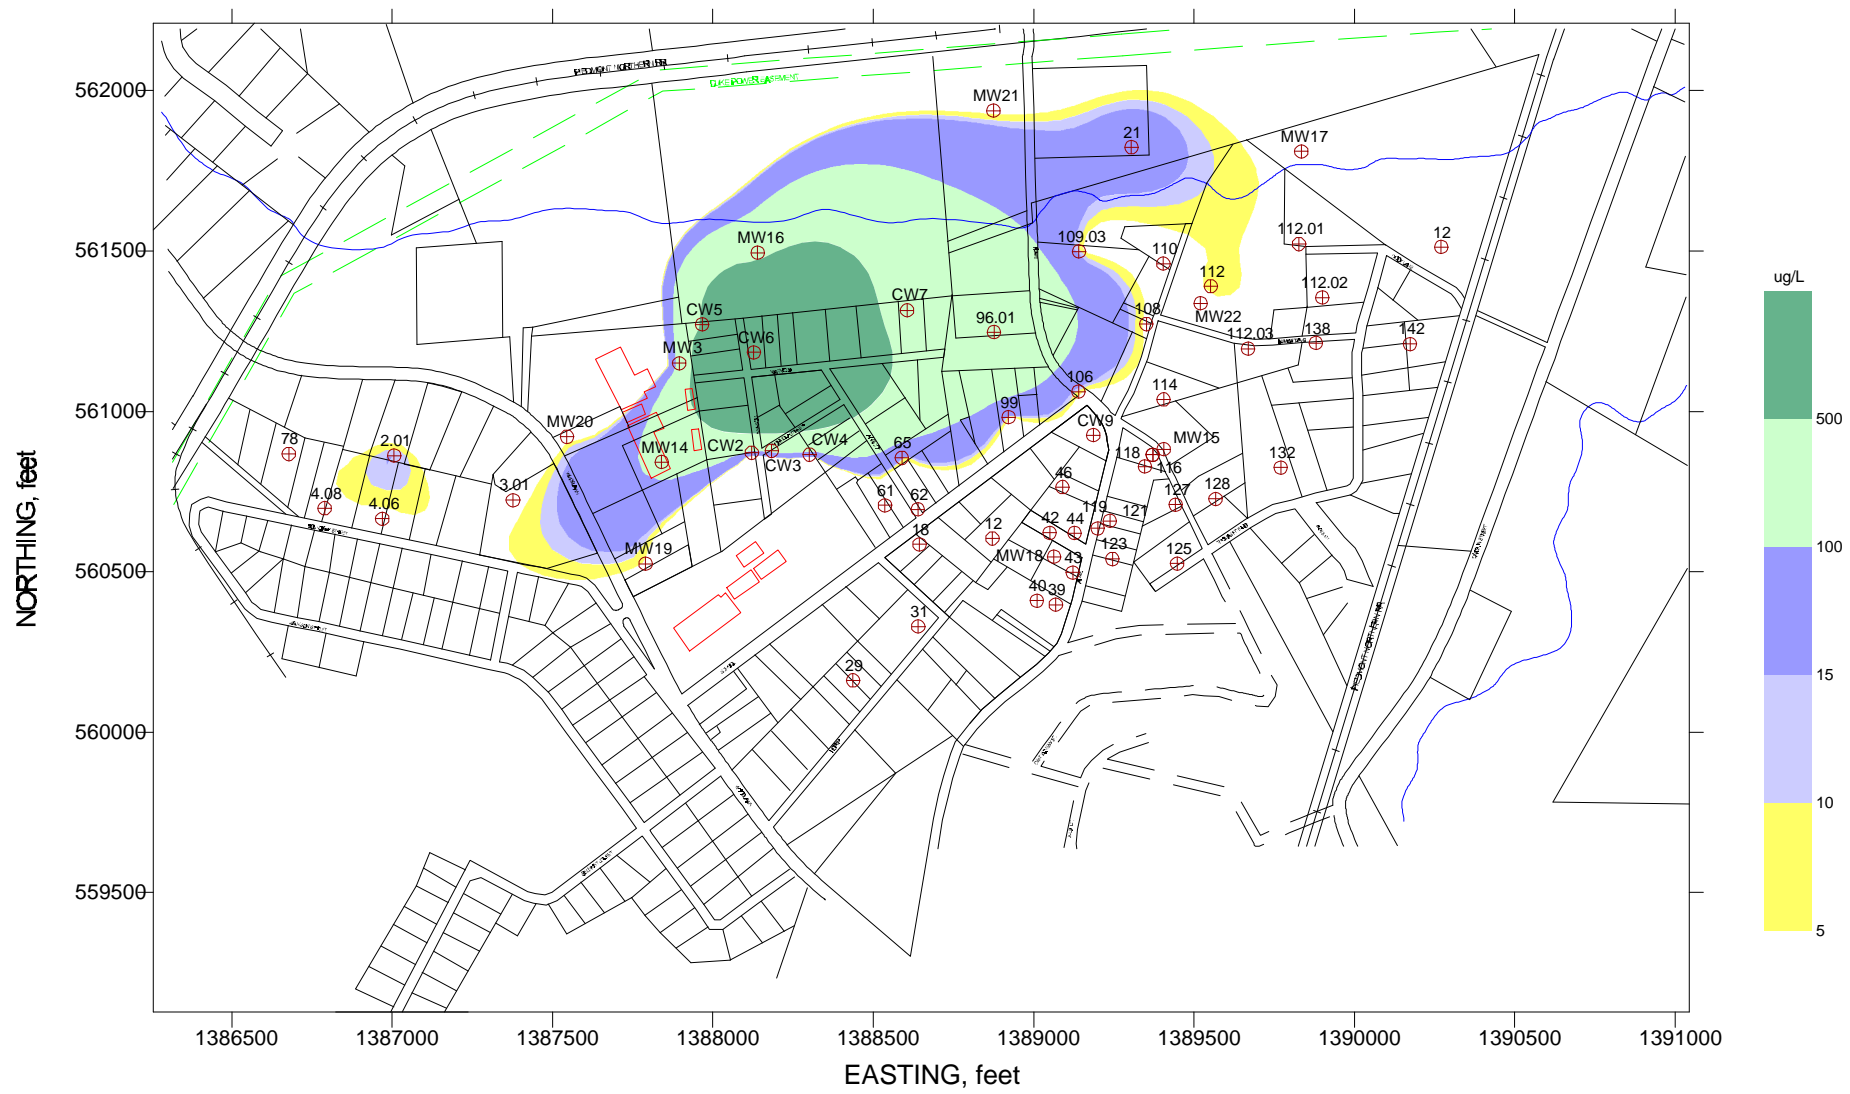
FIGURE 4-12 BEDROCK GROUNDWATER PLUME (BEDROCK MW and POTABLE WELLS) NOT TO SCALE
 PCE CONTAMINATION, OCTOBER/NOVEMBER 1996
 REMEDIAL INVESTIGATION REPORT
 NORTH BELMONT PCE SUPERFUND SITE
 NORTH BELMONT, GASTON COUNTY, NC
 SESD PROJECT No. 96S-058, JUNE 1997

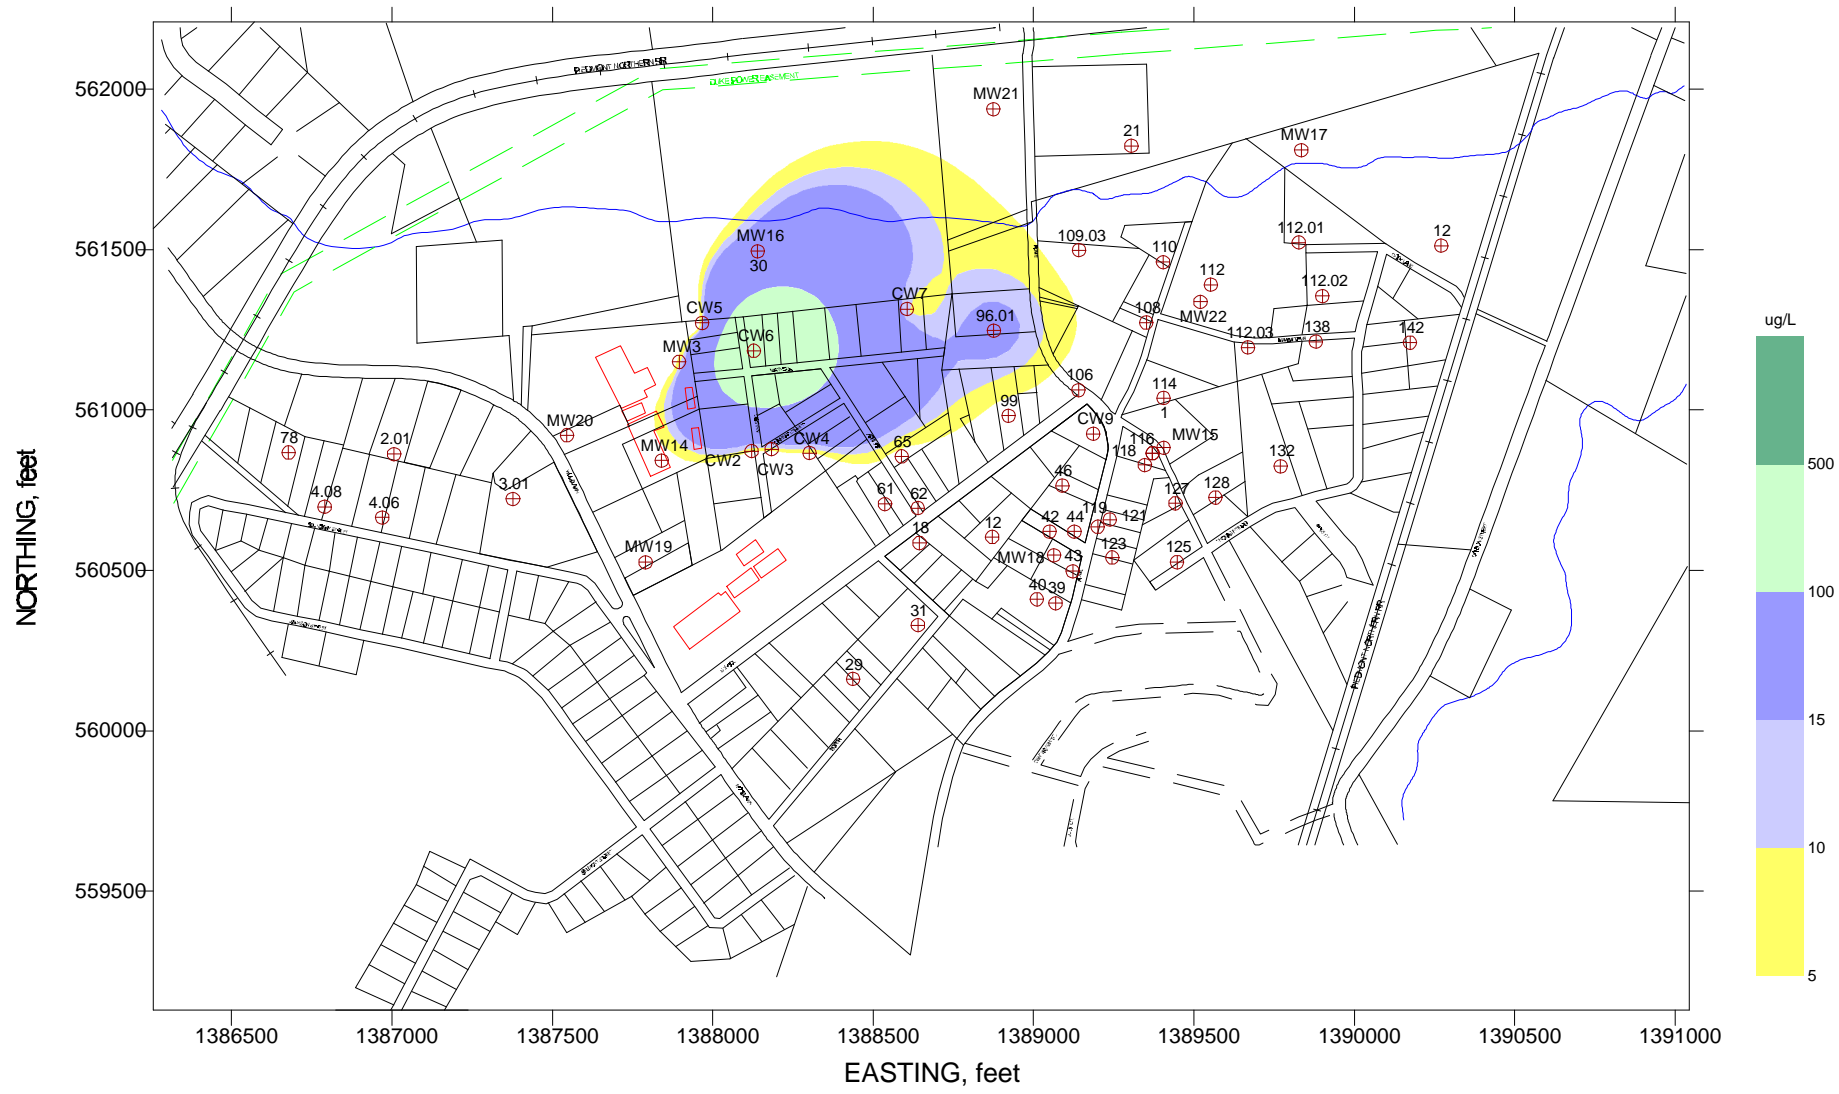
FIGURE 4-13 BEDROCK GROUNDWATER PLUME (BEDROCK MW and POTABLE WELLS) TCE CONTAMINATION, OCTOBER/NOVEMBER 1996
 REMEDIAL INVESTIGATION REPORT
 NORTH BELMONT PCE SUPERFUND SITE
 NORTH BELMONT, GASTON COUNTY, NC
 SESD PROJECT No. 96S-058, JUNE 1997
