Removal and Restoration of In-stream Sediment Ponds: Part 2 – A Case Study

**Appalachian Stream Mitigation
Workshop**

**Prepared by: Lance M. DeBord
D. R. Allen & Associates, P.C.**

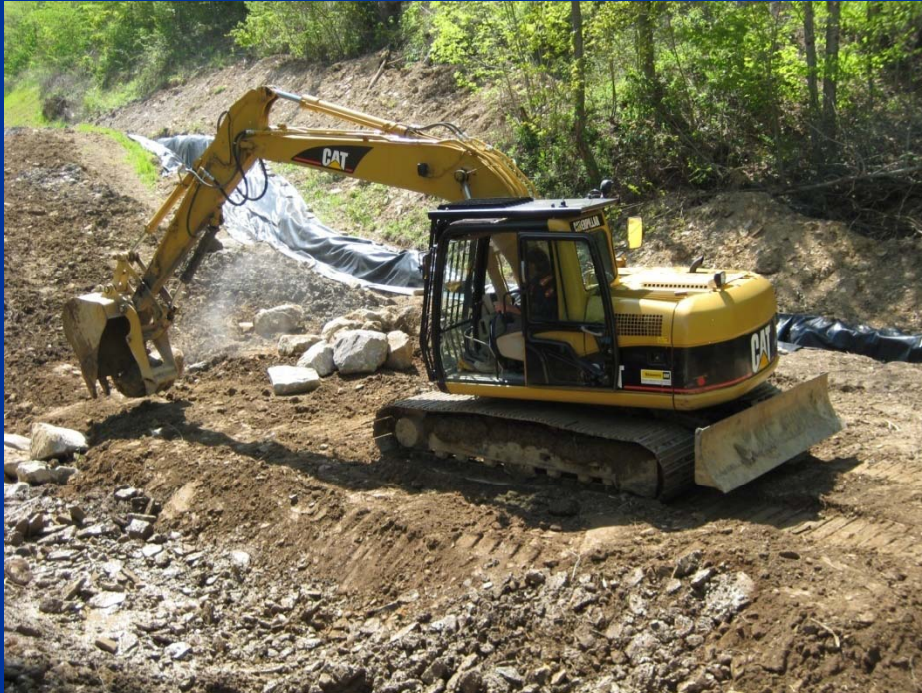
Divert Water

- Temporary diversion
- Pump around

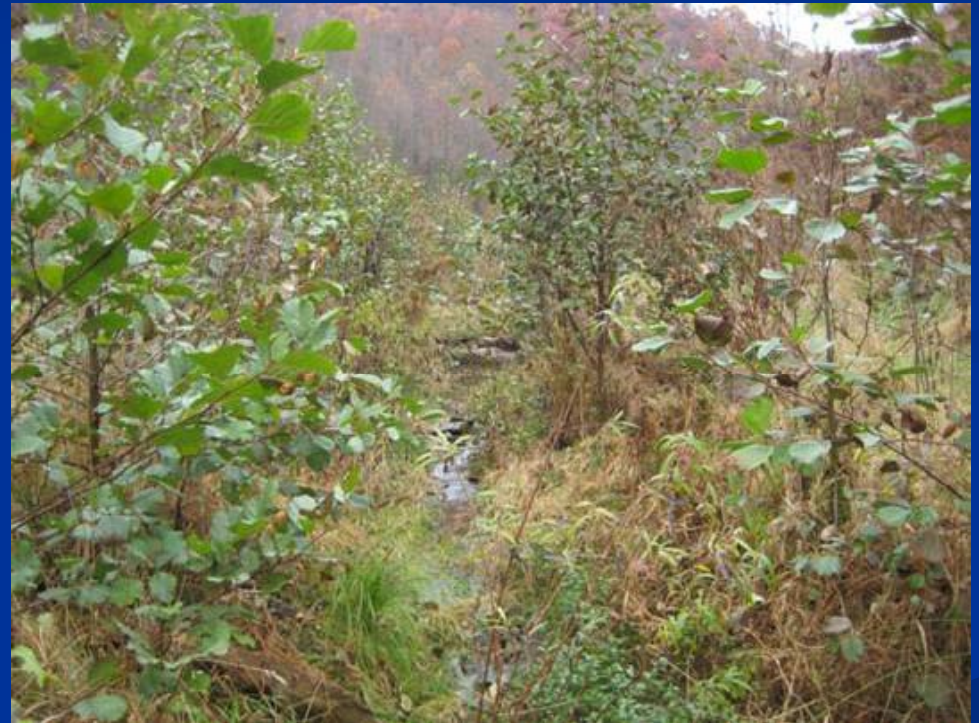
Chaney Creek

- 1.6 sq. mi. drainage area
- Stream Type B3, B3c, B3a
- Slopes 1% - 6%
- Width/Depth Ratio 10 – 13
- Sinuosity 1.2 – 1.3
- Bankfull Width 13.3 – 15.2
- Max Pool Depth 3.0 – 3.5
- Pool Length 14.7 – 25.9
- Max Riffle Depth 1.4 – 1.7
- Pool Spacing 26.6 – 53.2

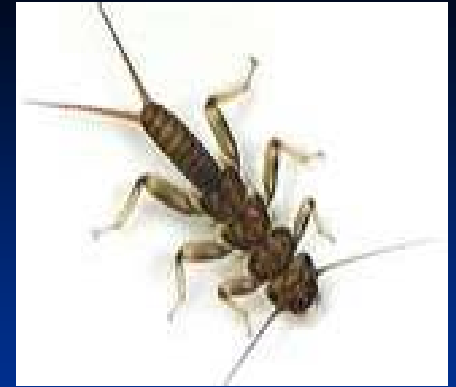
Monitoring Results

Chaney Creek						
Year	MBI	Cond.	Habitat	Fish (#species)	Trees/ acre	EKSAP
2007	0.54	622	169	156 (5)	700	0.52
2008	0.59	500	181	89 (6)	-	0.56
2009	0.66	455	183	171 (6)	-	0.62
2010	0.70	464	185	125 (5)	1230	0.63
