# **Lake Attitash Assessment Report**

## **May 29, 2014**

Hilary Snook  
USEPA Region I Laboratory  
Chelmsford, MA

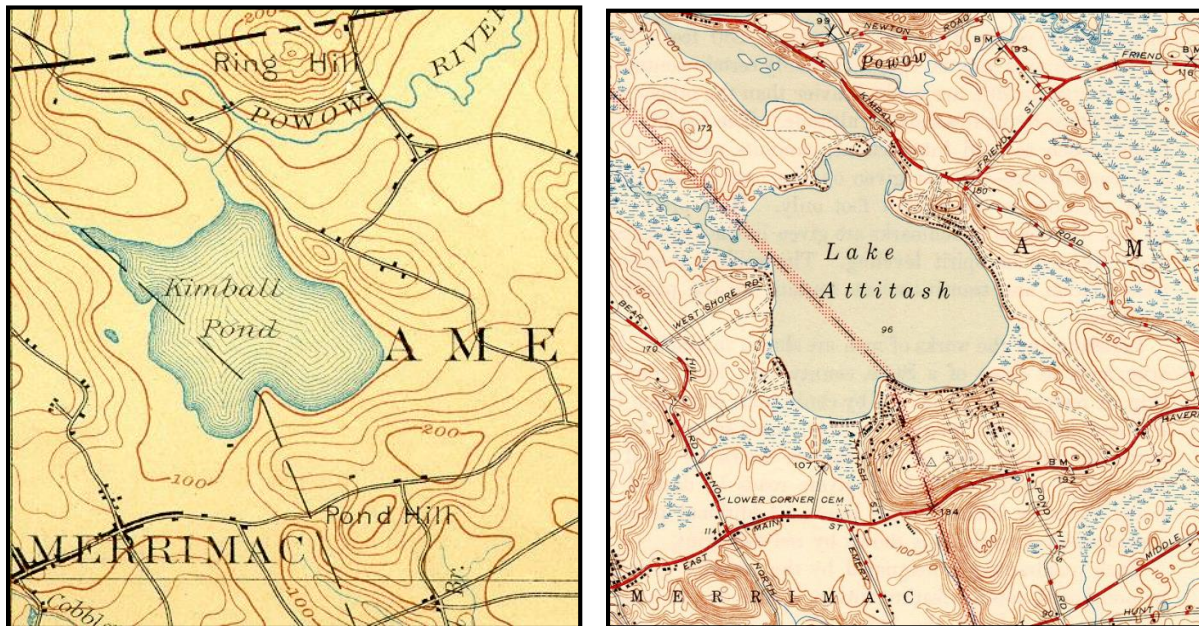
**Figure 1-1: 1894 and 1944 topographic maps showing the density of dwellings around the lake. A report from 1912 stated that the lake was already densely populated with summer homes by that time. The name of the lake was changed prior to 1900.**

Lake Attitash has undergone a transformation typical for most urban lakes (figure 1-1).

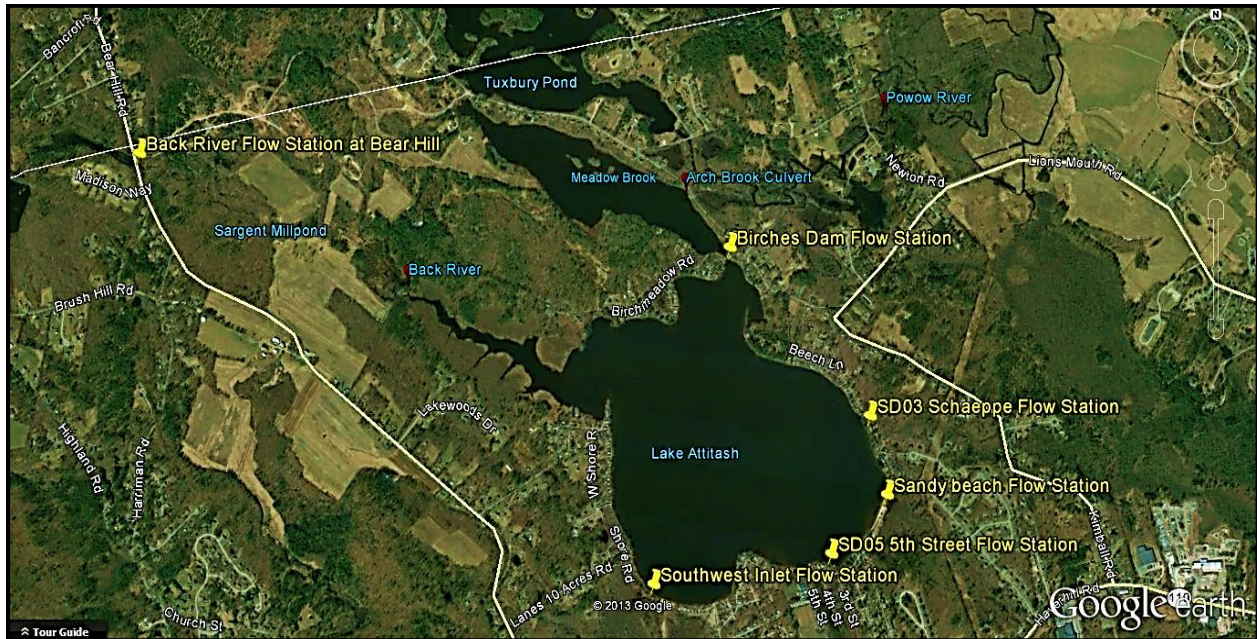
**Figure 2-1: Major Inflows & Outlet to Lake Attitash**

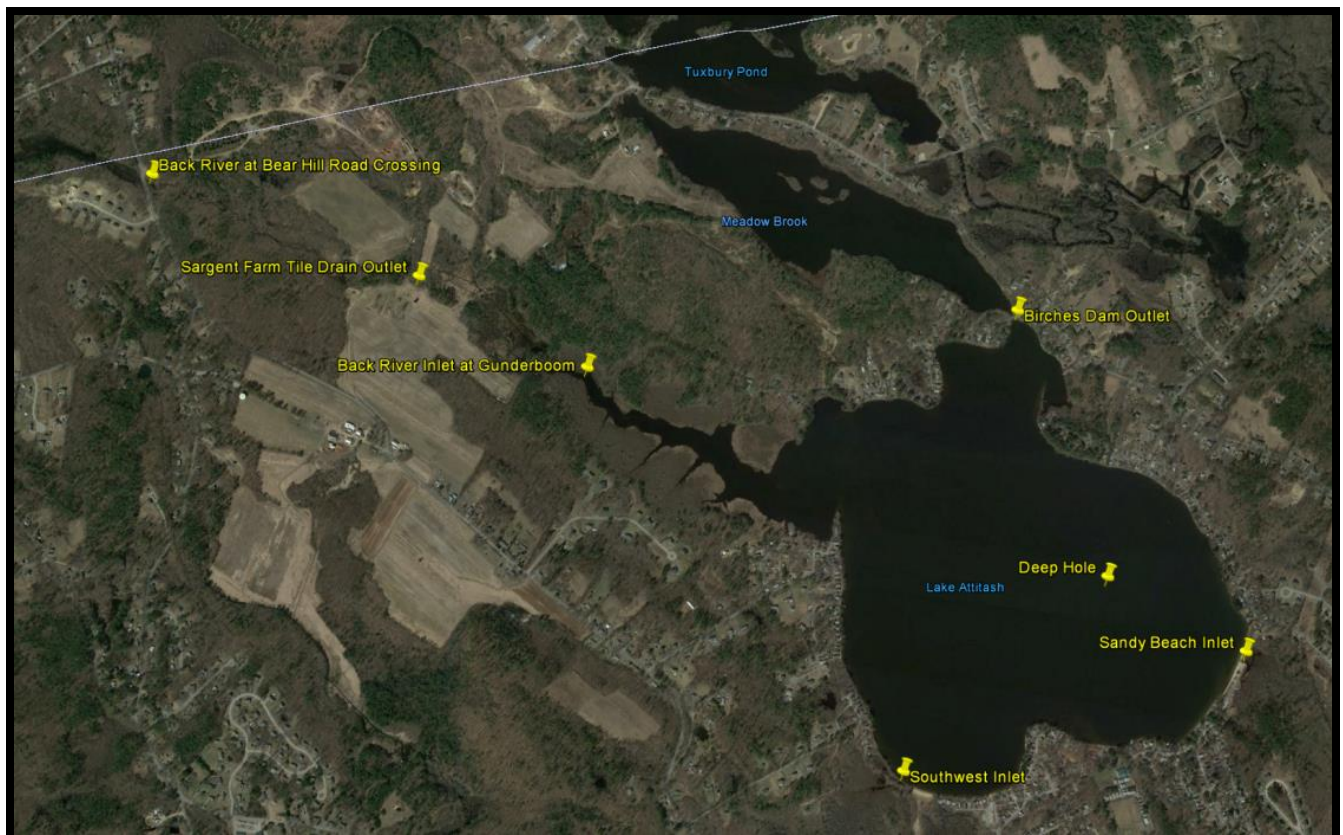
**Figure 3-1: 2011 Dry weather sampling locations without stormwater outfalls.**

Dry weather samples were collected throughout 2011 from all of the primary inflow locations, the deep hole area, and at the Birches Dam outflow (Figure 3-1). Sampling events took place every other week, starting through the ice in late February at the deep hole and continuing through December. Samples collected at the deep hole surface utilized a tube sampler that integrated the top two meters of surface water. Deep hole samples collected at the bottom utilized a Kemmerer sampler that collected discrete samples one half meter off the bottom. Samples collected from the other site locations were “grab” samples, taken just below the water surface in new lab certified pre-cleaned bottles. Samples collected in March and April were limited to the Back River Bear Hill Road crossing, the Southwest Inlet, the Birches Dam outlet, and any storm drains that were discharging at the time. Other areas such as the deep hole and Back River near the Gunderboom filtration barrier were not collected in March and April due to inaccessibility from unsafe lake ice conditions. Samples were collected twice monthly throughout the remainder of the year to the extent possible. All samples were collected utilizing standardized EPA field protocols and an approved Sampling and Analysis Plan (SAP), and transported on ice to the USEPA Regional Laboratory for analysis.

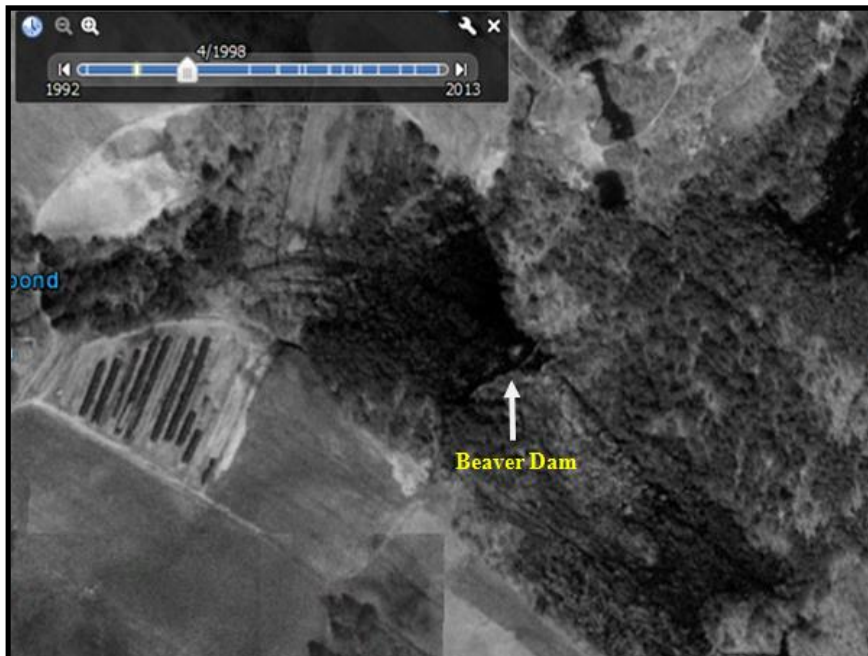
**Figure 3-4: Large beaver dam below Sargent Farm in 1998**

three times higher than TP concentrations that would be found in raw sewage effluent (15,000 ug/L). These 1998 TP concentrations are almost too high to be believable, with the exception of possibly one explanation that may lend credence to these values. In 1998 long standing beaver dams were located throughout the Back River, with an exceptionally large one spanning over 250 feet across the downstream area of the Sargent's farm agricultural fields and the

Back River lower wetland area (Figure 3-4). January through March of that year the watershed received above average precipitation. April gave us about an inch below the monthly average and May about one inch above the monthly average, nothing too out of the ordinary. June however, dropped 10.51 inches of precipitation on the watershed, almost seven inches more than the average precipitation for that month. This quantity of rainfall would have completely flooded the wetlands behind the beaver dams and possibly flooded out lower lying fields and contributed to significant runoff volumes. It was around this time frame that the Back River beaver dams were thought to have been torn out. Draining the flooded fields would make sense, and could possibly account for much of the anomalously high phosphorus concentrations

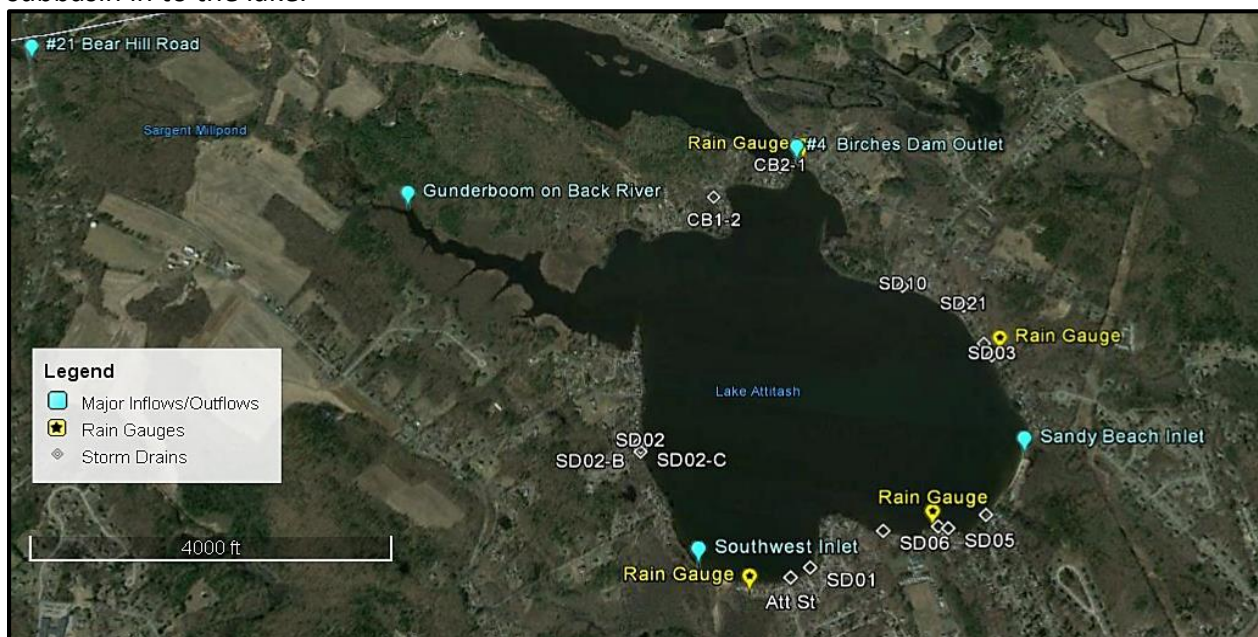
Figure 4-2: Lake Attitash wet weather survey sampling locations.

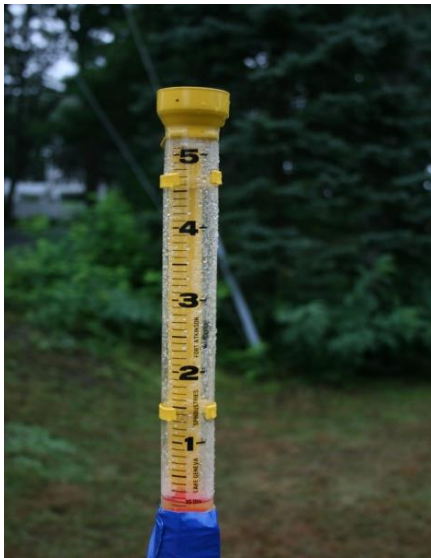
**Figure 4-2:** Typical rain gauge used for the wet weather survey.

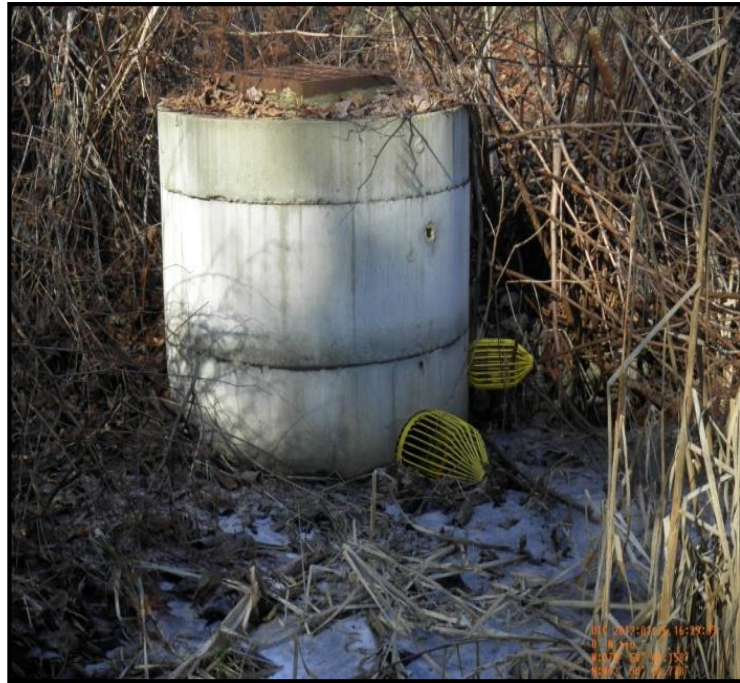
**Figure 4-6: Sediment and debris filled in to level of yellow invert cages, short circuiting the detention BMP**

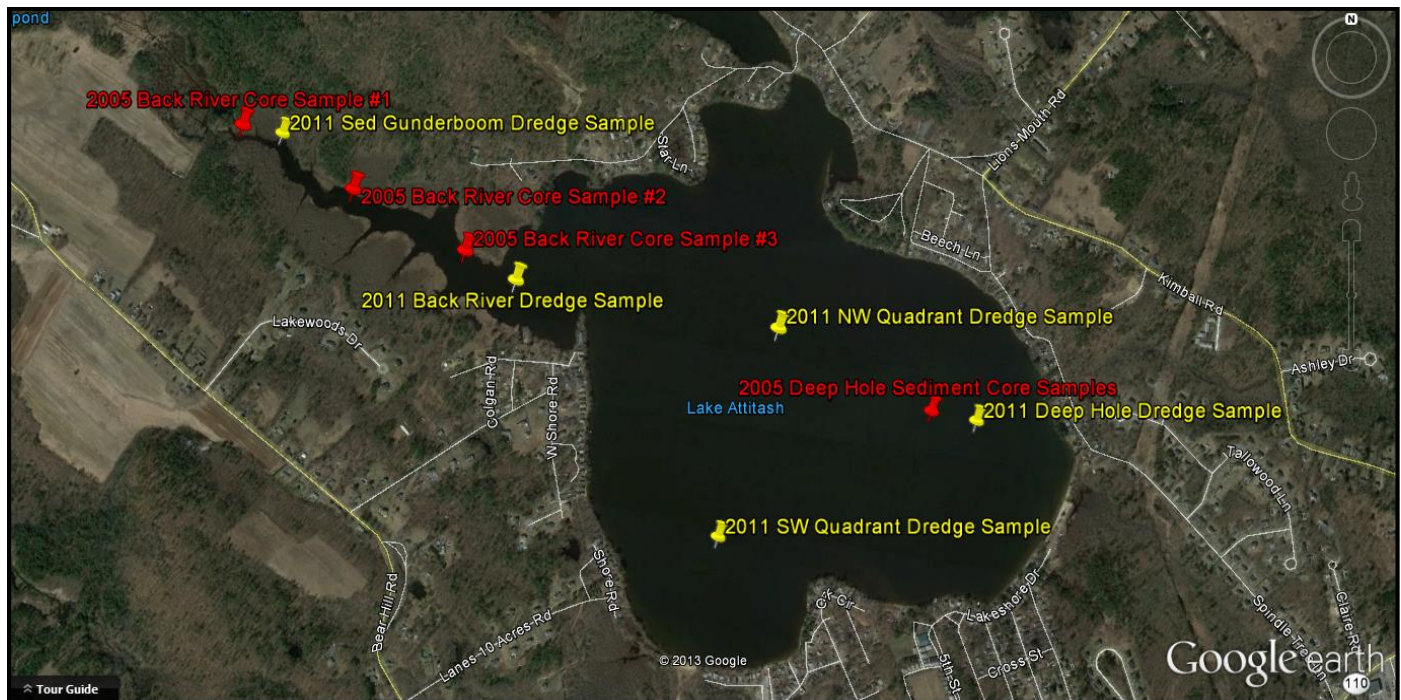
**Figure 5-1: Locations of sediment core and dredge sample collections.**

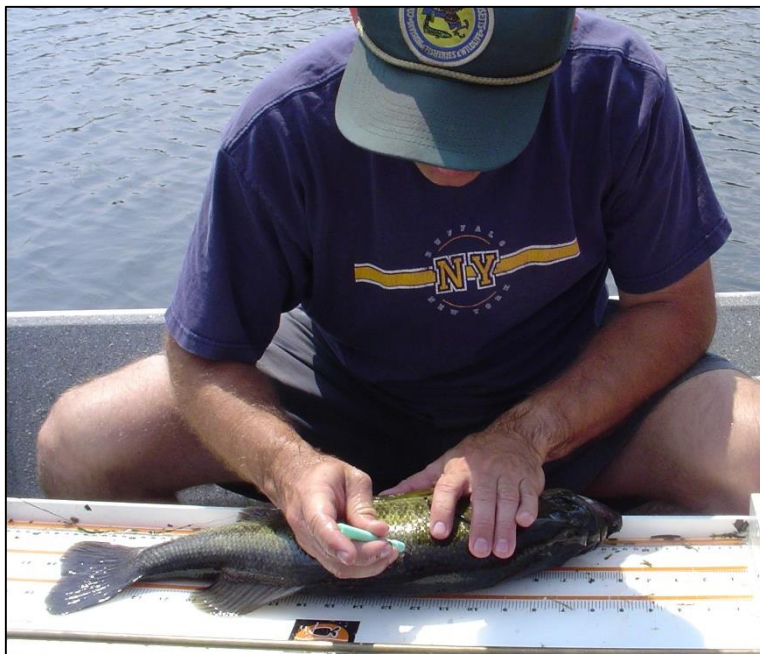
**Figure 6-1: Extracting a tissue sample from a Lake Attitash Largemouth Bass**

In 2005, the USEPA was piloting non-lethal methods in the region for testing mercury concentrations in fish muscle tissue through the use of biopsy plugs. Small tissue samples could be taken from fish easily without inducing mortality, and the fish could be returned to the water

body. This has proven to be an effective approach without having to sacrifice popular and prized game fish for the sake of minute volumes of fish tissue necessary for mercury analysis (Figure 6-1).

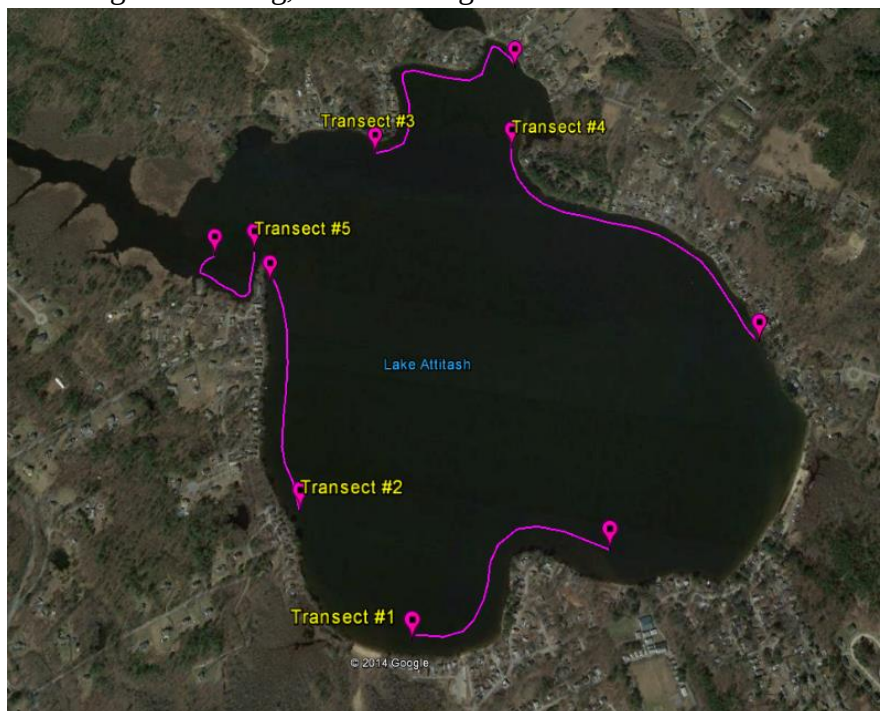
Figure 6-3: May 2009 Electrofishing Transect Locations

Since this trophic cascade condition was initially somewhat suspect as one cause of problems in Lake Attitash, the EPA undertook a cursory fisheries assessment of the lake. The objective was not to initiate a fish population survey of the lake or an in depth trophic level assessment, either of which is a significant and time consuming undertaking, but more to get an idea of the relative abundance of fish species in the water body and a cursory idea of the size and distribution of top level predators and forage fish species. A heavily weighted forage species population coexisting with a depauperate predator population could potentially be indicative of an imbalanced trophic system. Night time electrofishing efforts took place in late May of 2009 and consisted of five transects of approximately fifteen minutes of actual shock time, each spaced at a relatively uniform distance from the shore in water approximately three to eight feet in depth. It should be noted that electrofishing approaches for fish capture are somewhat selective.

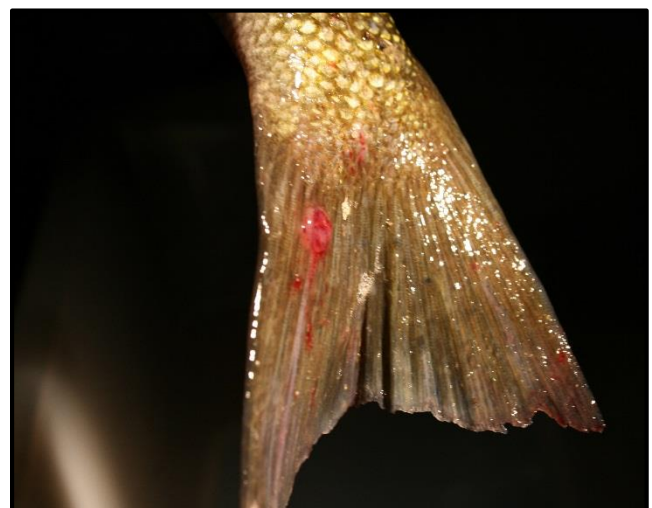
**Figure 6-5: Ulcerations, eroded and split fins on Lake Attitash Eastern Chain Pickerel**

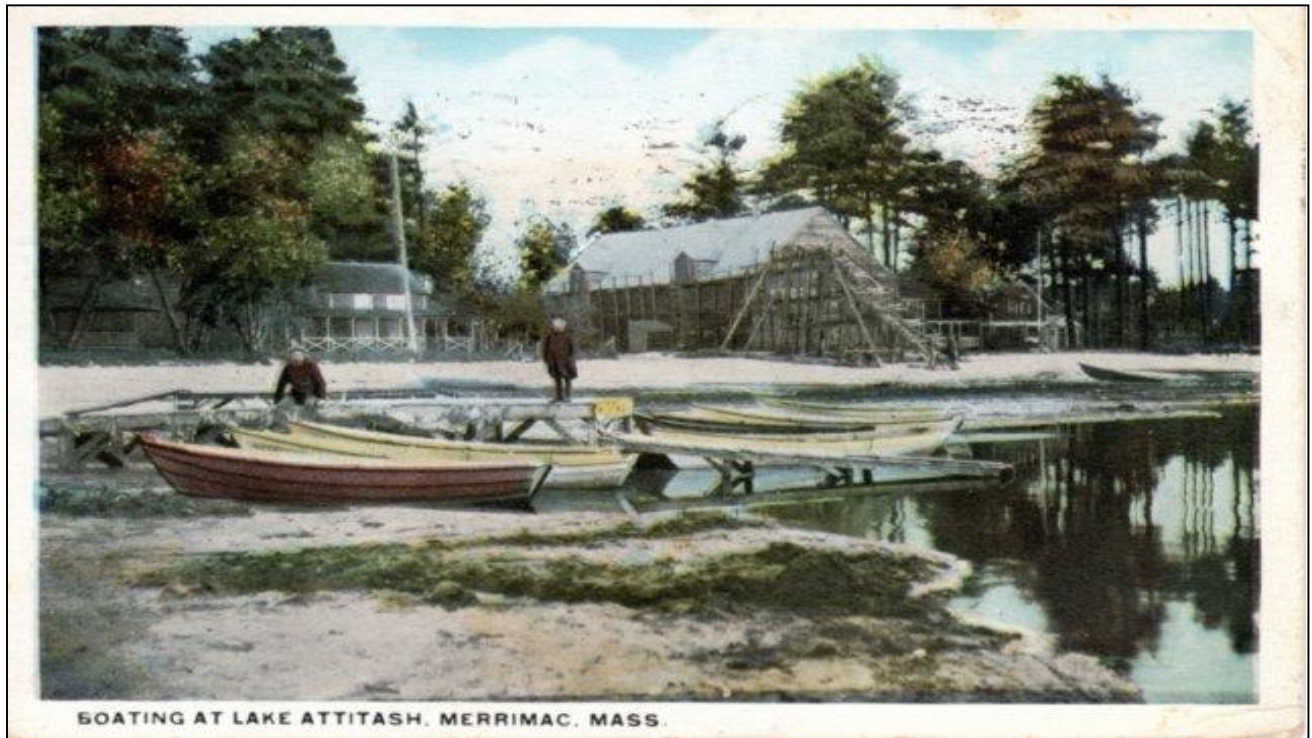
**Figure 7-4:** Historic postcard (Circa 1929) showing ice house at present boat landing site and revealing the significant lake drawdown and presence of decaying aquatic vegetation on the shoreline; plants were not able to gain a foothold in nearshore areas due to hydromanipulations.

From around the 1920s up until the late 1960s to early 1970s, manipulation of lake water levels took place several times a summer, with levels fluctuating at times by more than three feet. In the late 1950s the lake water level was controlled from Tuxbury Pond, rather than the Birches Dam. This degree of hydro manipulation was captured in many old postcards and photographs of the lake (Figures 7-3 and Figure 7-4). In 1966, water flowage rights were sold by the Massachusetts Electric Company to the Town of Amesbury. Water levels did not appear to be closely regulated for the next couple years by the town, and in general were kept relatively low according to comments in the Notini report and from Amesbury newspaper clippings from the day. There does appear to be one exception however; a December 1959 newspaper article reports that a year round resident at the time (Shute) complained to the Amesbury town selectman that since the time that the town took over jurisdiction of the water rights, the water was kept at “a very high level year round.” Because of the elevated water table, any significant rain resulted in a flooded dry well and failure of the septic system. What the exact elevation was at that point is unknown, but up until this point at least, based on the historical anecdotal information, it would make sense that plants were limited to the center of the lake because
