## **FIELD ACTIVITIES REPORT Mine Entry**

**RED AND BONITA MINE SITE  
Silverton, San Juan County, Colorado**

**TDD No. 1008-01**

**December 14, 2012**

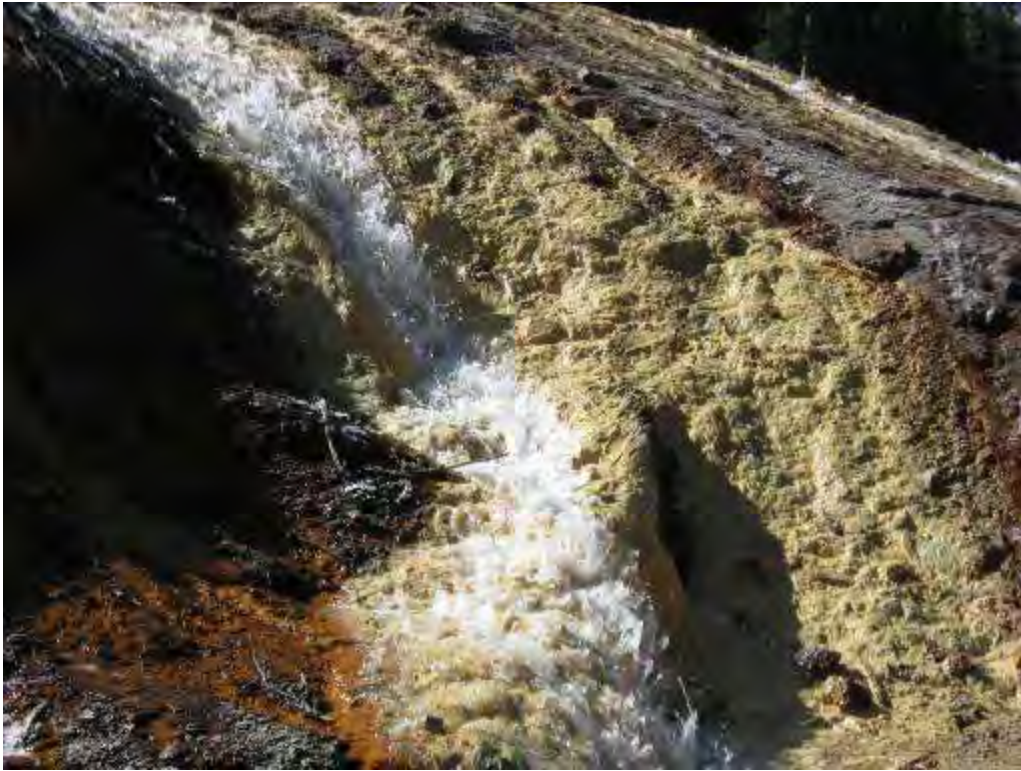
**PHOTO 1**

5-31-12. Yellow-orange and red colored iron precipitate on dump face, flowing mine drainage.

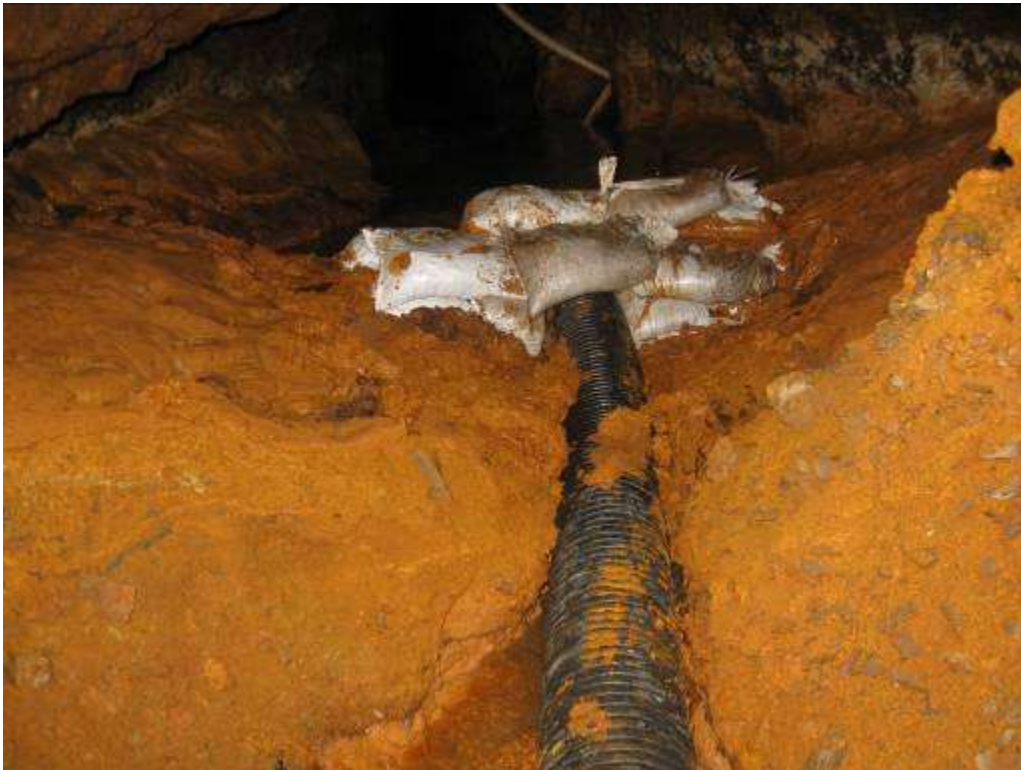
**PHOTO 4**

6-5-12. Temporary dam inside portal in attempt to control mine drainage. Yellowbooby accumulation in foreground.

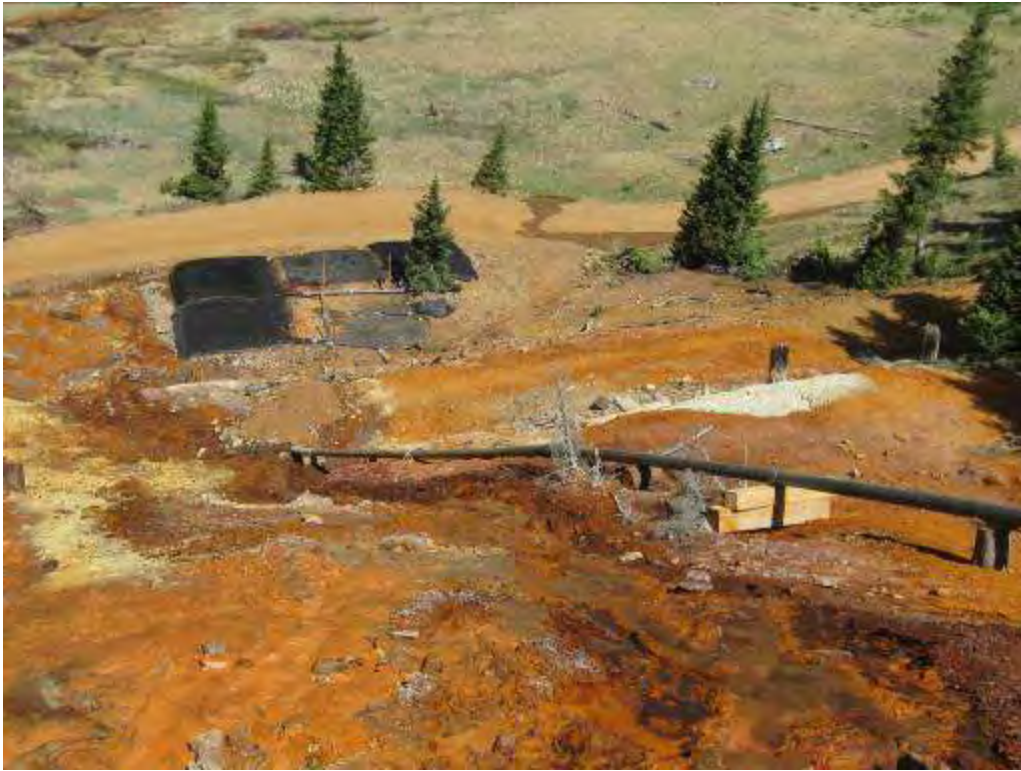
**PHOTO 5**

6-6-12. View from top of mine dump toward manifolded filter bags.

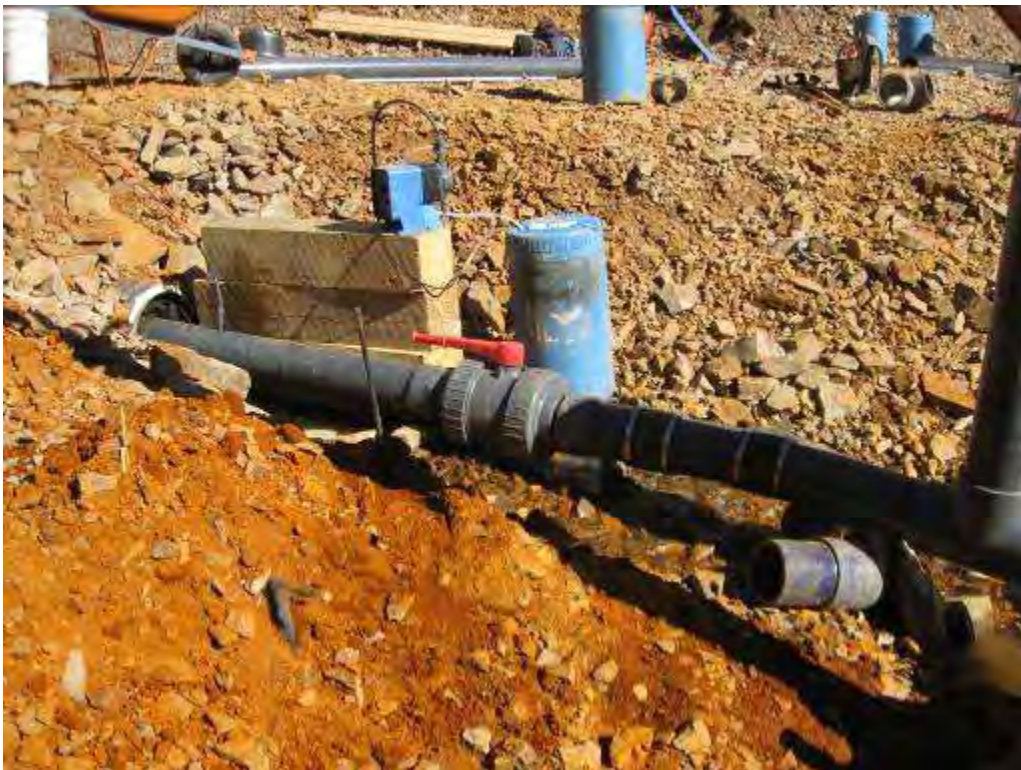
**PHOTO 6**

6-6-12. Aluminum sulfate flocculant added to pipe transmitting drainage to filter bags.

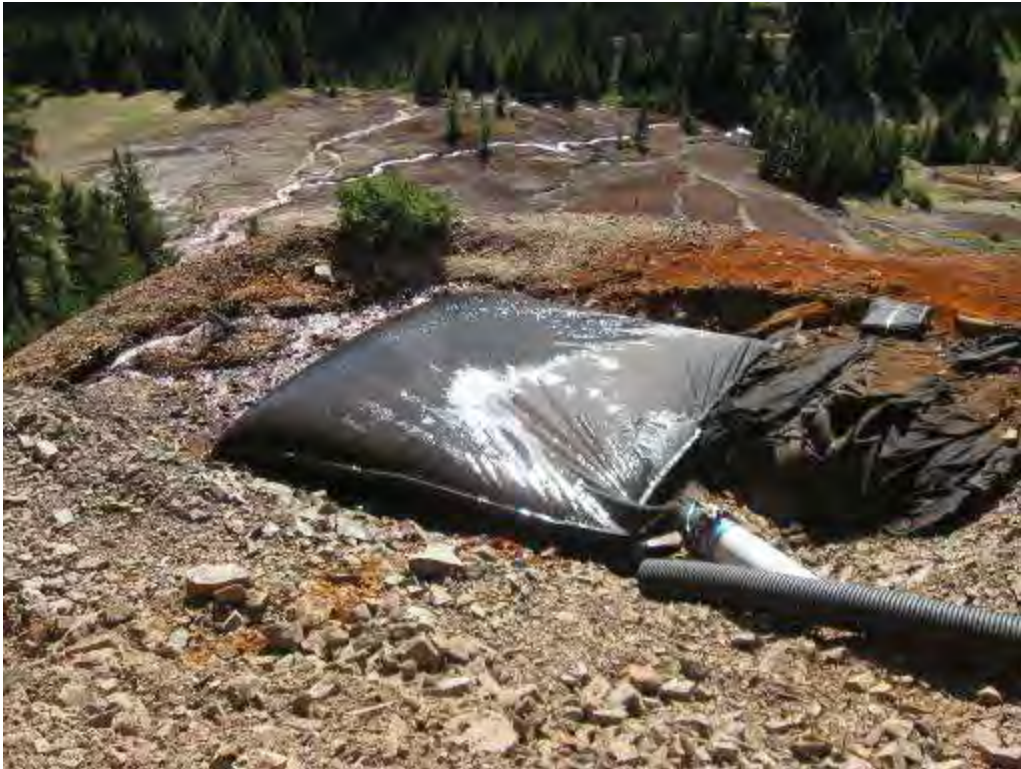
**PHOTO 7**

6-6-12. Filter bag located on top of dump near portal. Intermittently used. Draining to ditch on south side of mine dump.

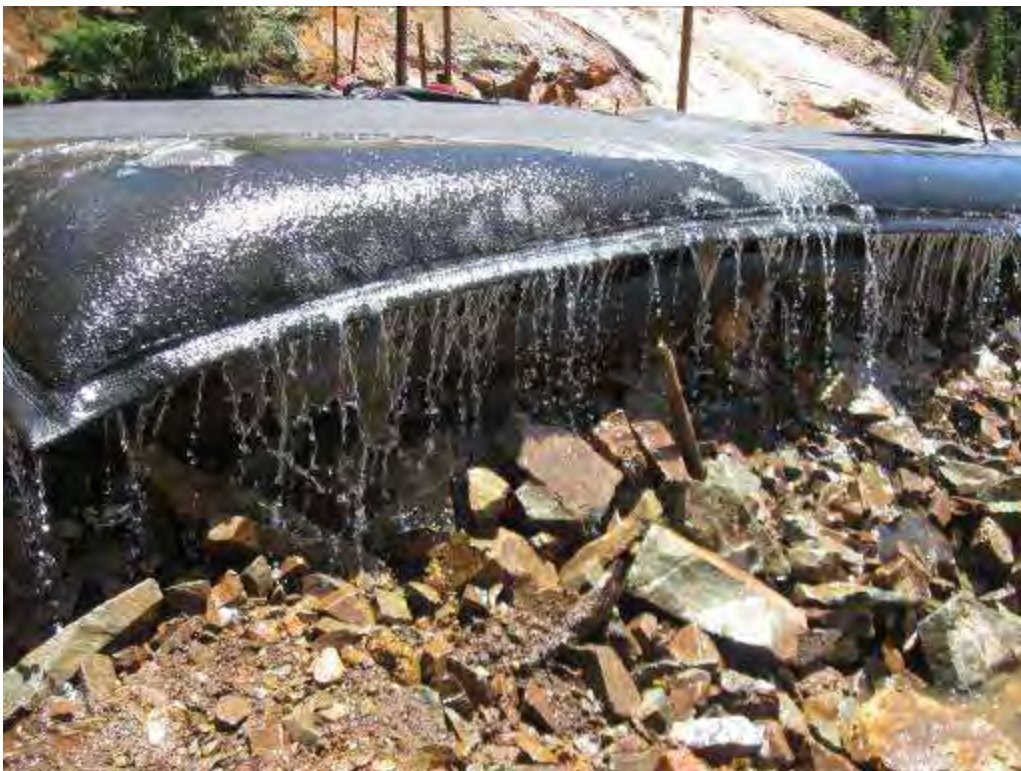
**PHOTO 8**

6-6-12. Filter bag at base of mine dump. Note visibly clear release water.

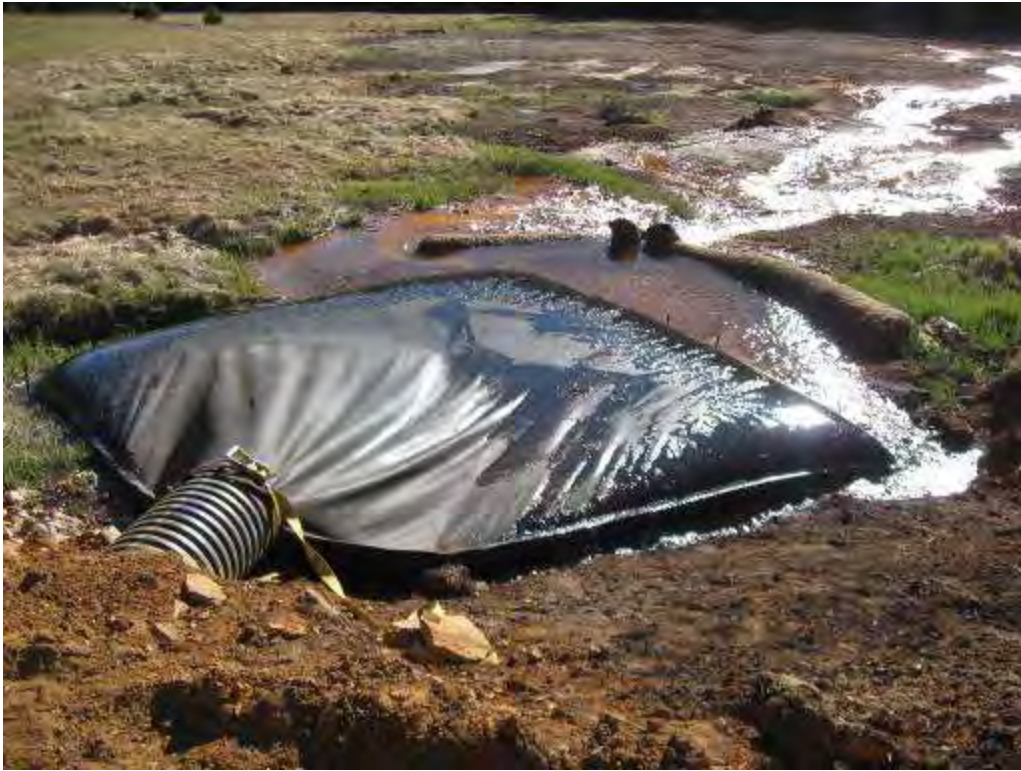
**PHOTO 9**

5-31-12. Secondary filter bag placed on ditch culvert pipe on CR53 below mine.

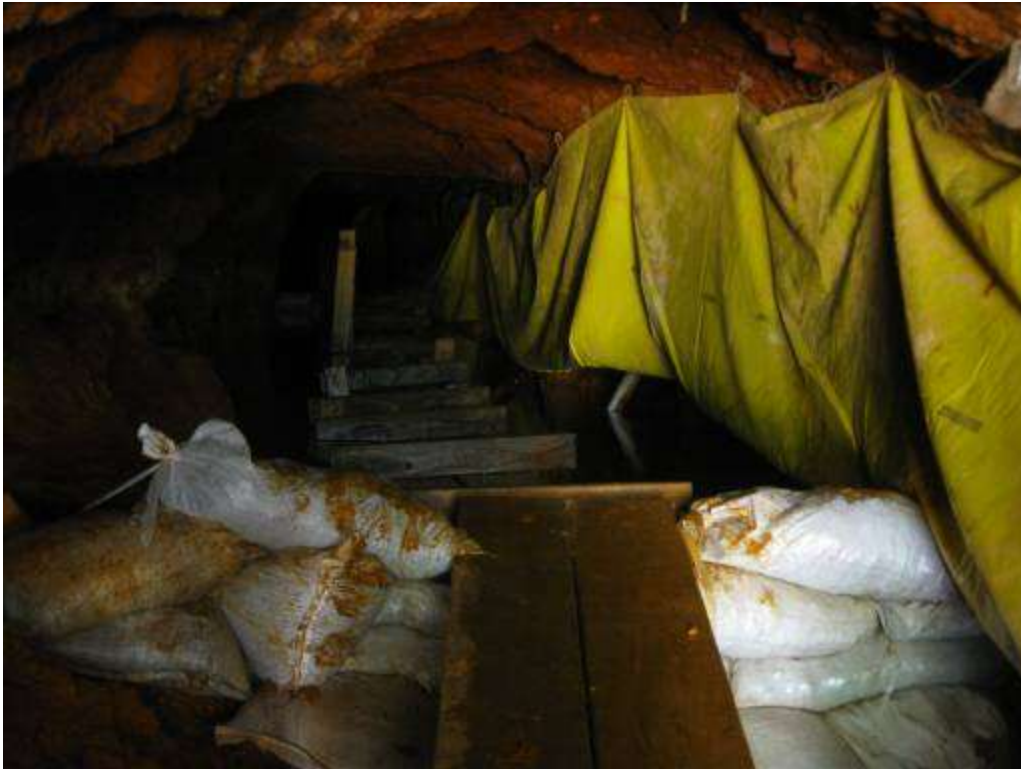
**PHOTO 11**

6-7-12. Temporary walkway inside mine adit as viewed from mine portal, placed above yellowboy accumulation. Note that adit is passing through ferricrete deposit, photo top.

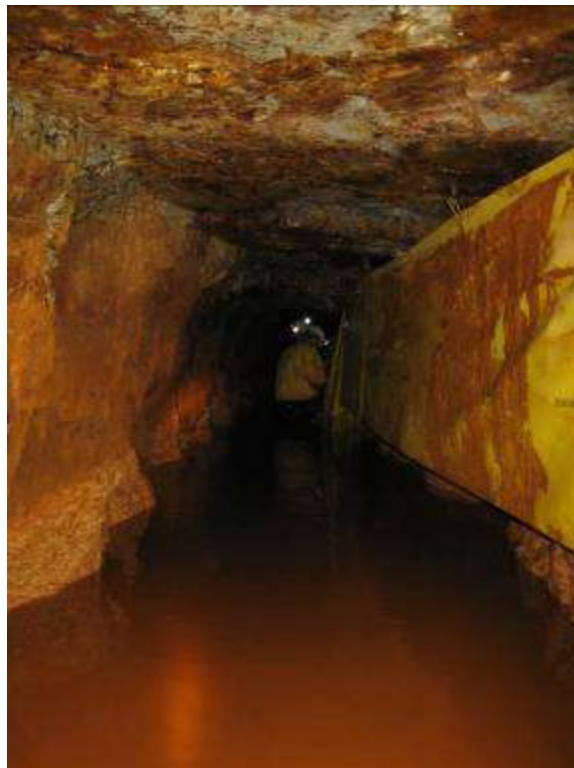
**PHOTO 12**

6-12-12. Securing collapsible air duct in adit approximately 100 feet inby. Note that adit appears competent, no required supports through andesitic rock.

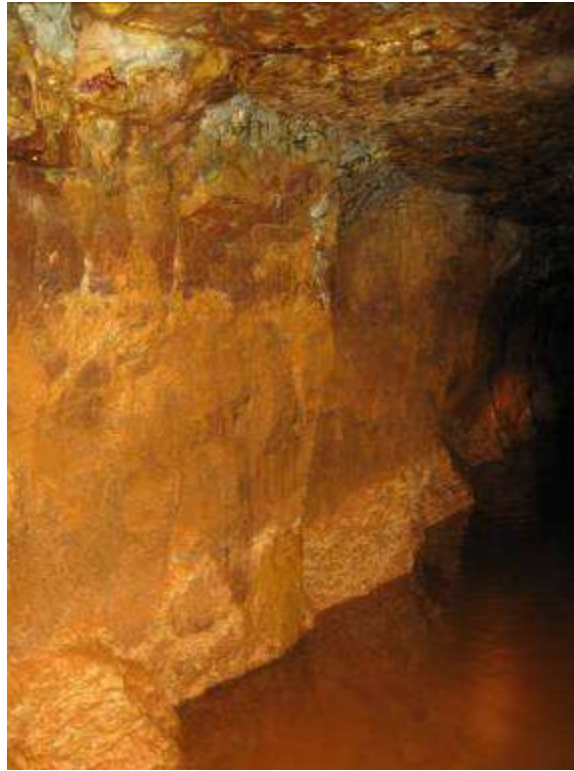
**PHOTO 13**

6-12-12. Adit left rib at approximately 60 feet inby. Note yellowboy stain and accumulation near (current) water line.

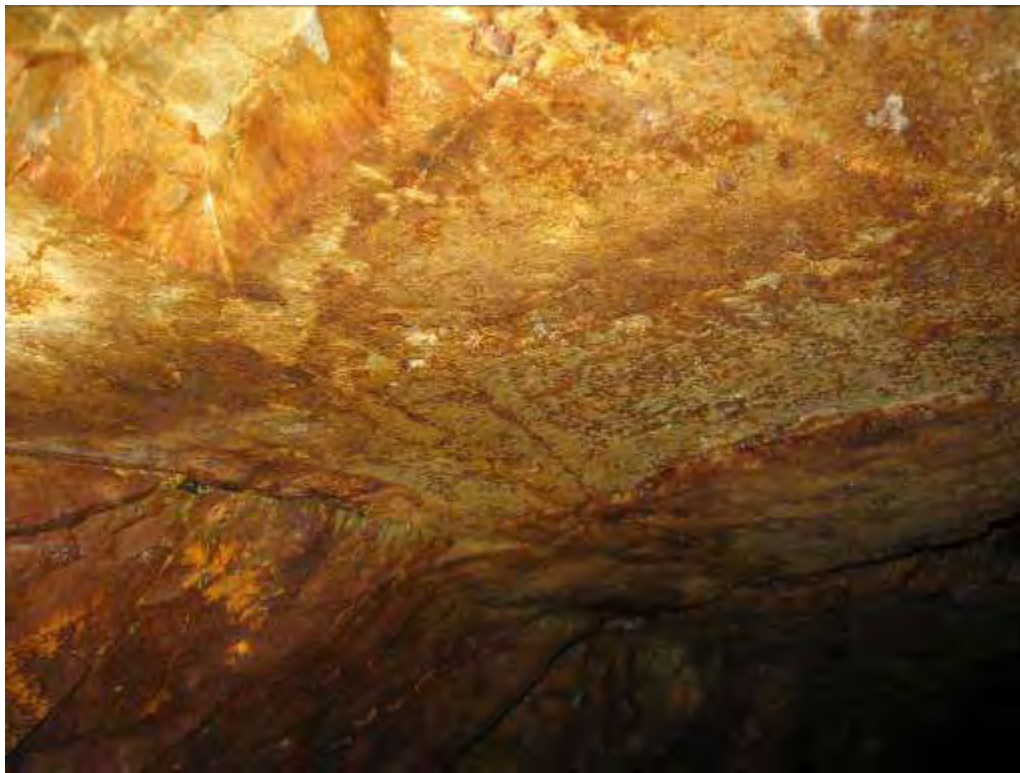
**PHOTO 14**

6-12-12. Adit back at approximately 60 feet inby. Note competent andesitic rock and fracture planes.

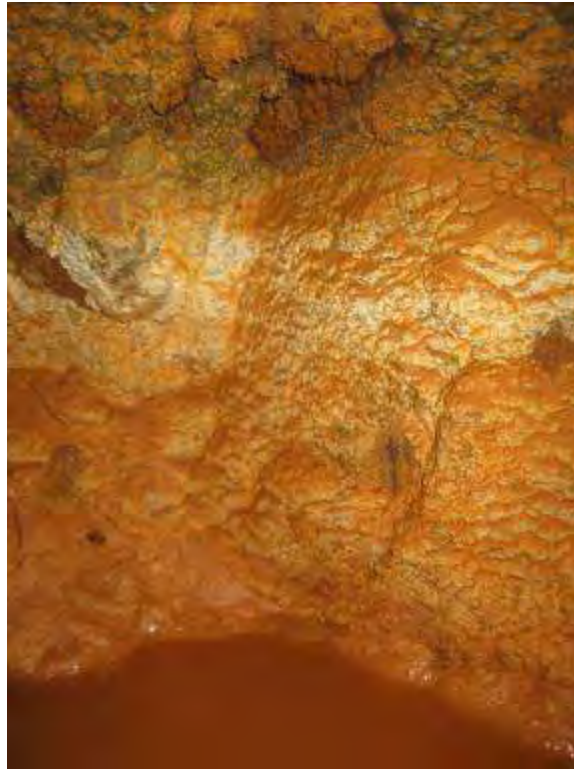
**PHOTO 15**

6-12-12. Yellowboy accumulation in adit at (current) water line, approximately 50 feet inby. Note red, orange, yellow colors.

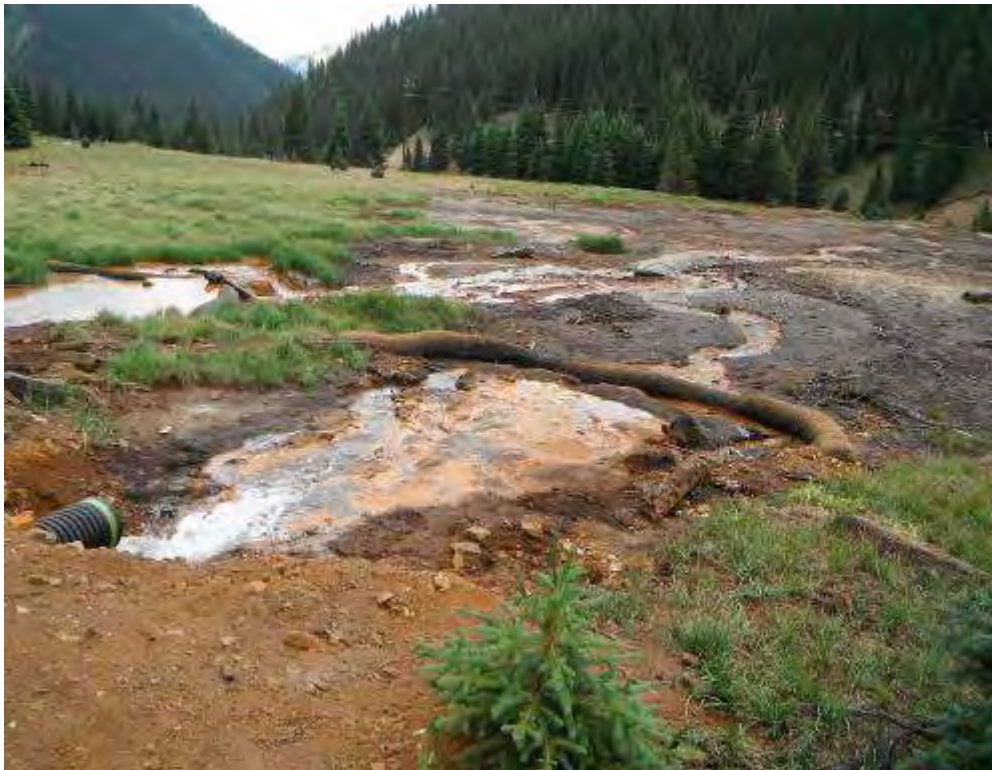
**PHOTO 18**

7-13-12. KoirLog erosion control barriers placed at culvert outfalls. Two culverts under CR53 below the Red & Bonita mine. Overland flow is toward Cement Creek.

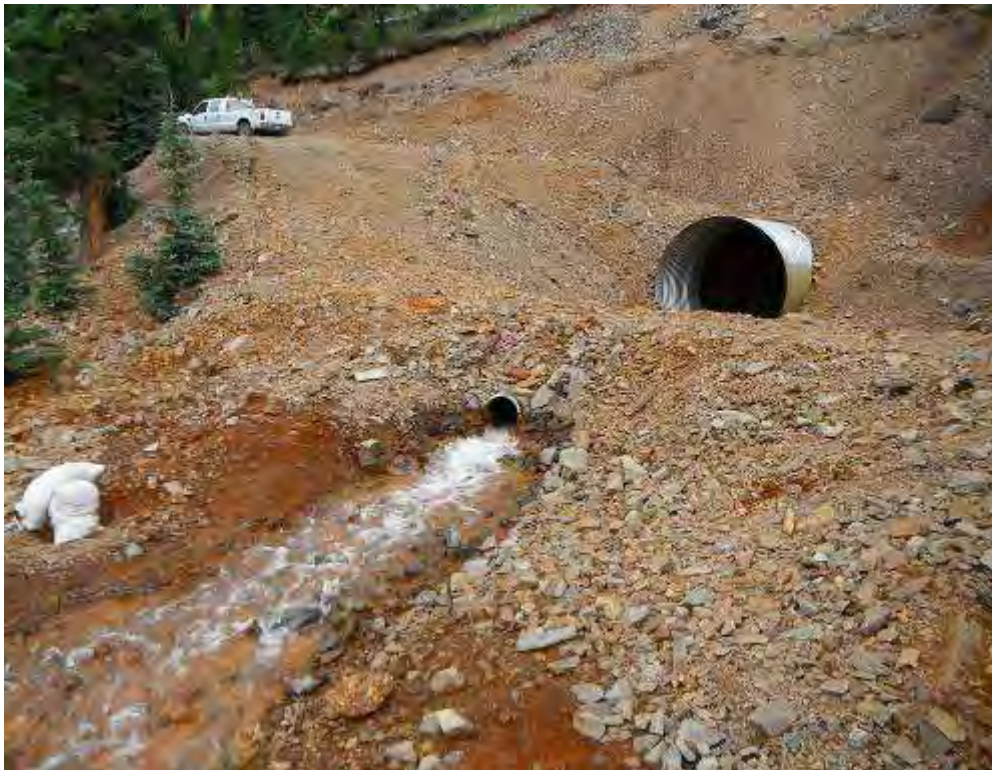
**PHOTO 20**

7-13-12. Mine portal area, post adit entry activities. Water discharge flowing over top of mine dump.

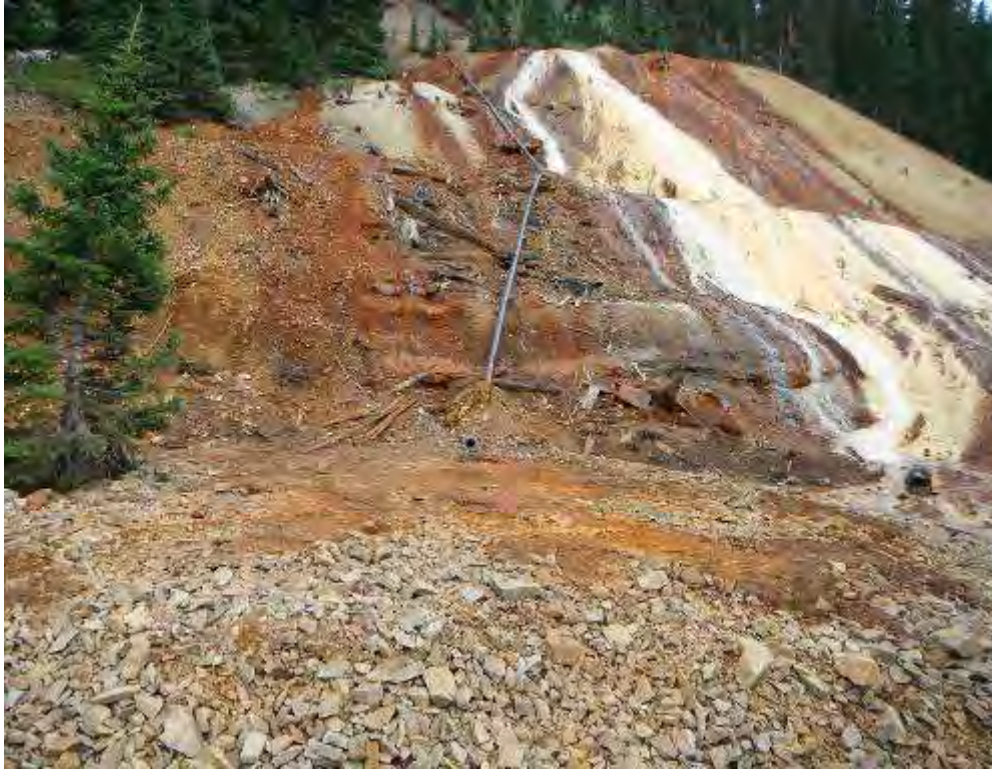
**PHOTO 21**

7-13-12. Red & Bonita mine, post adit entry activities. Mine drainage over dump face, drain pipe to manifolded filter bag area left in place for future use.
