U.S. ENVIRONMENTAL PROTECTION AGENCY

No Significant Residual Contamination Found at Deleted Superfund Sites, But Security Fences Were Damaged at Some Sites

Report No. 15-P-0013

November 10, 2014

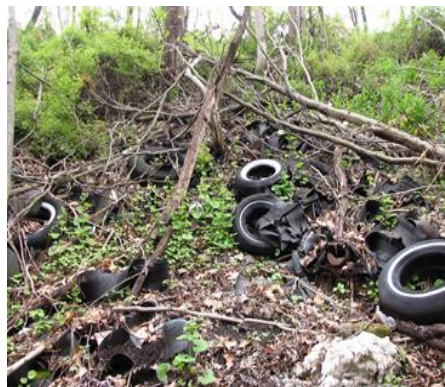
HSI analysis detected vegetation stress and/or anomalies at the Taylor Borough Dump, Hranica Landfill and Bruin Lagoon sites. On-site observations found substantial amounts of debris, metal equipment and other discarded material at the Taylor Borough Dump and Hranica Landfill. The following images provide an example of the correlation between HSI-detected anomalies and debris at the Taylor Borough Dump.

Photo at left is of debris at the Taylor Borough Dump. These areas of debris correlated to the anomalies identified by the light blue-colored areas on the HSI image on the right. (Photo and image from USGS)

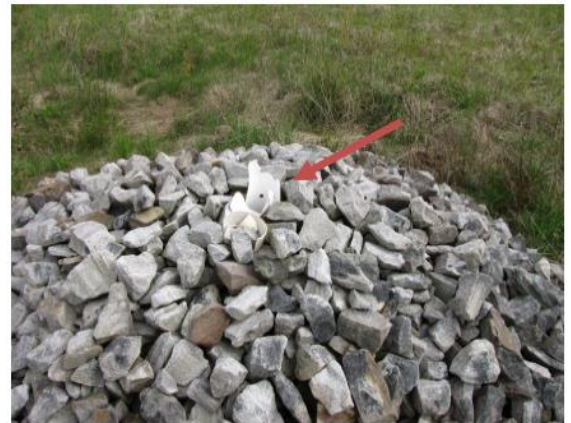
Protective rock mound installed around a damaged gas vent (see arrow) at the Lackawanna Refuse site. (USGS Photo.)

Protection. The fence surrounding the site was damaged and portions of it had been removed. The site showed evidence of ATV use and vandalism, which has been a recurring problem as noted in the 2009 5-year review. For example, the tops of the plastic off-gas vents appeared to have been shot off. Consequently, the Pennsylvania Department of Environmental Protection had built mounds of rock around the base of the vents to protect them from further damage. This remedy appeared to be successful in protecting the remaining undamaged portions of the vents. Table 2 summarizes the results of our work for the 11 Pennsylvania sites we visited.

1. Establish procedures for ensuring that corrective actions have been completed in accordance with EPA Manual 2750 before the Audit Follow-Up Coordinator attests to this information in the EPA's Management Audit Tracking System.
2. Document the results of our reviews for the 16 sites in their respective case files so that they can be considered for future reference and during any subsequent 5-year reviews.
3. Verify whether repairs were made to the damaged fence at the Lackawanna site.
