**Second Five-Year Review Report
McGraw-Edison Superfund Site
City of Centerville
Appanoose County, Iowa**

July 2014

**Region 7
United States Environmental Protection Agency
Lenexa, Kansas**

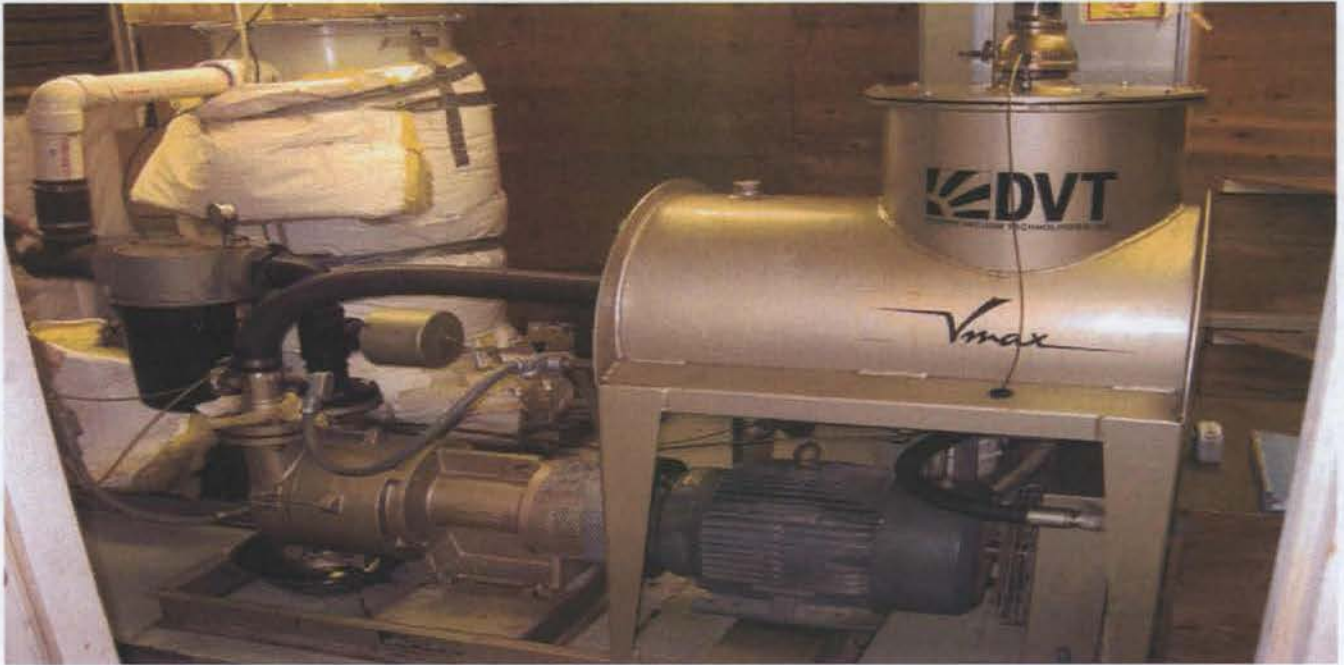
Photo 3 – Soil Vapor Extraction System blower.

In July 2011, the blower developed electrical and mechanical problems. After several attempts at repair it was decided that the unit was not worth repair costs. A rebuilt replacement blower and new knock-out tank were installed and the system was made fully functional by December 2011 and has run without incident since then.
