Ballard Roadside Raingardens, Phase 1 – Lessons Learned

Background

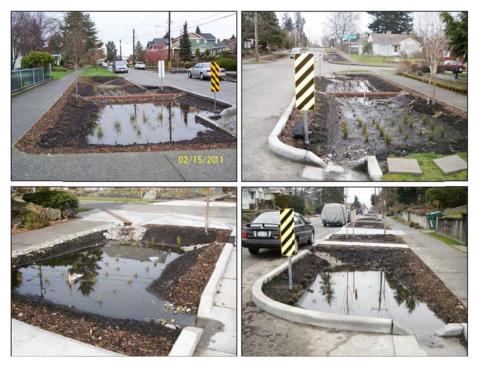
Figure G - Examples of Nonperforming Cells and Community Concerns

- Long-term (>24 hours) ponded water
 - o Drowning hazard for young children and the elderly
 - o Mosquito breeding
 - o Aesthetics
 - o Smell
- Cell design
 - o Side slopes too steep
 - Depth of allowable ponding
 - Depth of cell
- The presence of object marker signage on the curb extensions (the size, 12" wide by 36" tall, and look)
- Lack of communication and community input
- Loss of parking spaces

Figure G illustrates some of the non-functioning cells and the community concerns, such as long-term ponded water, the large black and yellow striped object marker signs, the parking restrictions, cell depth, and general aesthetics.

Based on the outcome of the Task Force meetings, the raingardens on 29th Ave NW and NW 77th St. will be completely removed, with the curb replaced back to its original location. Most of the raingardens on 31st Ave NW, along the east and west side of 28th Ave NW between NW 71st St and NW 72nd St, and along the east side of 28th Ave NW between NW 65th St and NW 67th St were retrofitted to be more shallow and remove any visible ponding, with several being completely removed.

The cells that were retrofitted to be more shallow have varying levels of infiltration due to the native soils conditions, but generally do not provide anything close to the intended performance and are classified as low performing or low infiltrating raingardens. Along the west side of 28th Ave NW, many of the raingardens are being redesigned as a detention system with an orifice-controlled underdrain. This design will capture the stormwater in the cell and temporarily store it in the bioretention soil (there is no surface ponding) while it waits to be slowly metered out to the combined sewer system by moving through the soil into the underdrain fitted with an orifice, which controls the rate of flow. A detention system helps with reducing CSOs by only allowing a little of the stormwater into the system when it is at capacity. Raingardens along 30st Ave NW work as designed and do not have any long term ponded water issues or community concerns, so no additional work or redesign is required.
