NONPOINT SOURCE PROGRAM SUCCESS STORY

Maryland

Restoring Stream Improves Water Quality and Fish Community Health

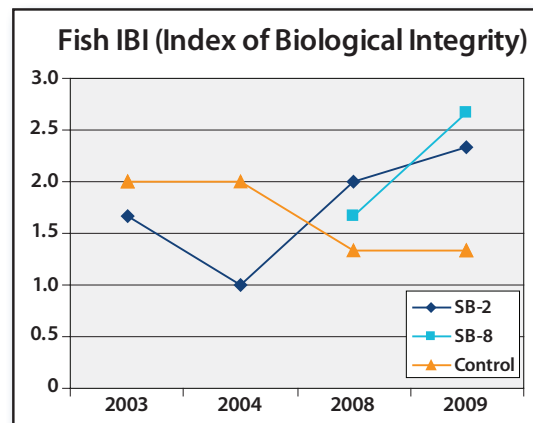
Figure 4. After phase II of the restoration (2008), fish IBI levels increased above (SB-8) and below (SB-2) the project area.

The phase I work reduced phosphorus loads by 27 percent, nitrogen loads by more than 30 percent and sediment loads by 45 percent. In 2003 and 2004, monitoring at station SB-2 (downstream end of the phase I portion of the project) showed that few or no fish were present, and the fish index of biotic integrity score (IBI) was classified as *very poor* (score of less than 1.9). However, the fish community responded to phase II restoration efforts. Fish monitoring in 2009 (less than one year after phase I was completed) showed significant increases in fish biomass and fish IBI at stations SB-2 and SB-8 (headwaters). Removing the concrete channel (see Figure 2) allowed the fish to swim upstream and colonize the area. As seen in Figure 4, Fish IBI scores at both stations improved to a classification of *poor* (scores between 2.0 and 2.9).
