NONPOINT SOURCE PROGRAM SUCCESS STORY

Maryland

Restoring Stream Improves Water Quality and Fish Community Health

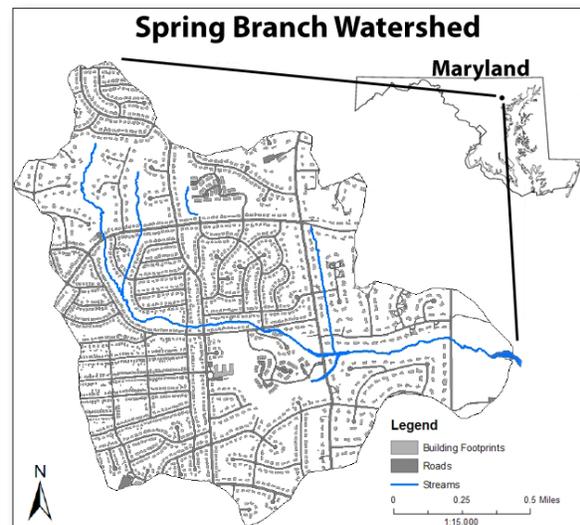
Figure 1. Impervious surfaces in northern Maryland's Spring Branch watershed.

Spring Branch was once a narrow, shallow trout stream. Fifty years of rapid urbanization created many impervious surfaces with few stormwater controls (Figure 1). Consequently, rainfall generates high volumes of runoff that quickly exceed the capacity of Spring Branch. Stormwater flows have eroded the stream channel so that it is now 30 feet deep and 15 feet wide. Erosion has exposed sewer pipes and created high sediment and nutrient loads that flow into the Loch Raven Reservoir.

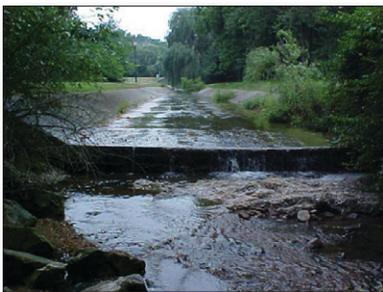
Figure 2. At this site (looking toward Pot Spring Road) before restoration efforts, Spring Branch flowed through a concrete channel. The concrete step seen here obstructed fish passage.

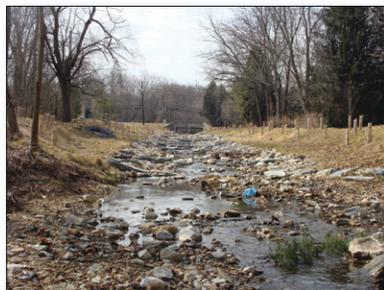
Figure 3. After restoration, the concrete channel seen in Figure 2 has been removed.

Sewer lines running along both sides of the stream prevented partners from restoring a natural meandering pattern.

In phase I, DEPRM created a new channel of Spring Branch and added step pools, meander patterns and flood plains. That and other parts of the stream channel were stabilized using natural materials such as boulders, tree root wads, brush mattresses and live branch layers. In addition, DEPRM removed 1,740 feet of concrete channel (Figure 2), stabilized or removed sanitary sewer lines, added rock-lined step pools below storm drain pipes to dissipate energy from the flow, and constructed a stormwater wet pond to treat runoff from the headwaters. Replanting 12 acres with native trees and shrubs restored 10,000 linear feet of stream (Figure 3).

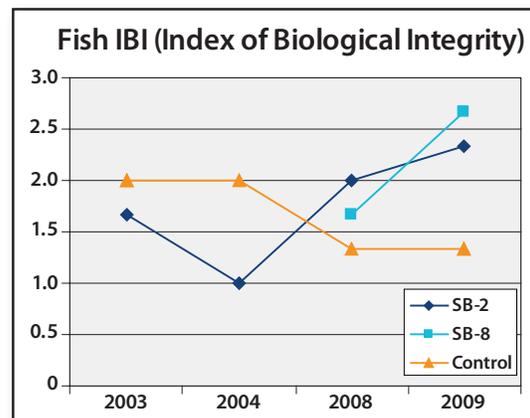
Figure 4. After phase II of the restoration (2008), fish IBI levels increased above (SB-8) and below (SB-2) the project area.

The phase I work reduced phosphorus loads by 27 percent, nitrogen loads by more than 30 percent and sediment loads by 45 percent. In 2003 and 2004, monitoring at station SB-2 (downstream end of the phase I portion of the project) showed that few or no fish were present, and the fish index of biotic integrity score (IBI) was classified as *very poor* (score of less than 1.9). However, the fish community responded to phase II restoration efforts. Fish monitoring in 2009 (less than one year after phase I was completed) showed significant increases in fish biomass and fish IBI at stations SB-2 and SB-8 (headwaters). Removing the concrete channel (see Figure 2) allowed the fish to swim upstream and colonize the area. As seen in Figure 4, Fish IBI scores at both stations improved to a classification of *poor* (scores between 2.0 and 2.9).
