# NONPOINT SOURCE PROGRAM SUCCESS STORY

# Vermont

## Ski Resort Improves Stormwater Management and Restores Rice Brook

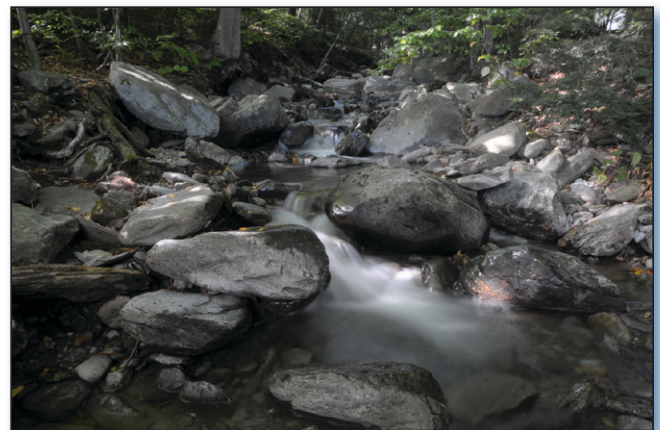
Figure 1. Rice Brook flows through Sugarbush Resort, Vermont.

The 1.6 mile-long Rice Brook (Figure 1) flows through the Sugarbush Resort, a ski area and resort in central Vermont. The Vermont Department of Environmental Conservation (VTDEC) has classified the brook as a Class B water—a designation defined as “suitable for bathing and recreation, irrigation and agricultural uses; aquatic biota sustained by high quality habitat; good aesthetic value; acceptable for public water supply with filtration and disinfection.”

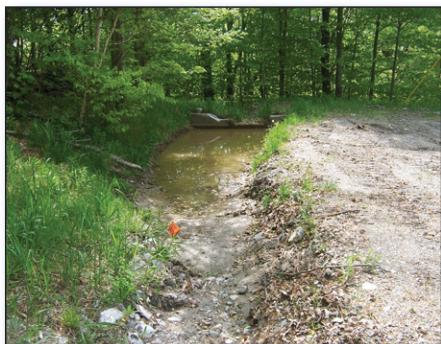
Figure 2. Sugarbush Resort built treatment swales to control stormwater flow in ditches along private roads in the Sugarbush Village area.

the summer of 2005, the resort installed 29 swales (Figure 2) to stabilize 6,700 linear feet of eroding ditches in 10 subwatersheds in the upper Sugarbush Village area. About one-third of the swales had slopes greater than 4 percent and were stabilized

with 8 to 12 inches of crushed stone. The remaining swales were vegetated. In addition, the resort replaced two degraded and undersized culverts and removed approximately 200 cubic yards of sediment from sediment basins and check dams in the drainage system. The resort also contracted with a local vendor to ensure regular maintenance of all runoff control measures.
