Section 319

NONPOINT SOURCE PROGRAM SUCCESS STORY

Watershed Restoration Efforts Improve Dissolved Oxygen Levels

EPA 841-F-09-001R
August 2009

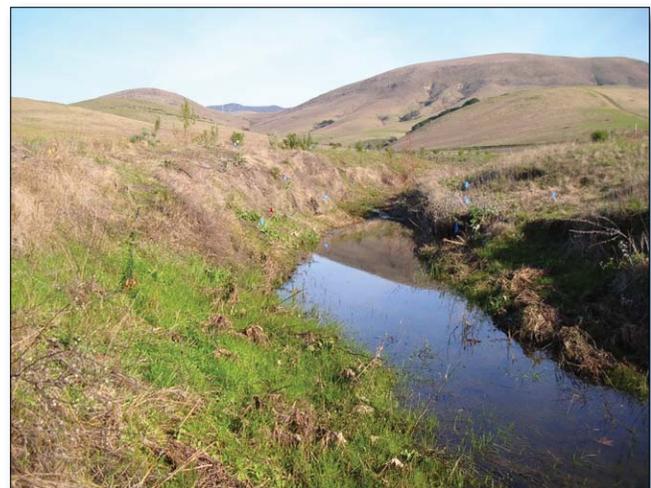
Figure 1. This fencing and revegetation project occurred along a tributary in Chorro Creek's valley grassland area.

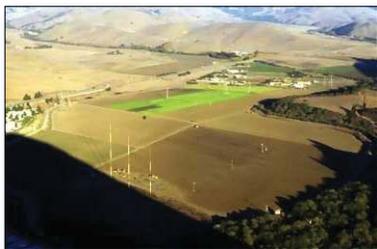
Figure 2. A view of the Chorro Flats floodplain before the restoration.

quality management practices in place. Key projects include restoring Chorro Flats floodplain, which is designed to reestablish riparian habitat and trap sediment upstream of Morro Bay. In this project, partners converted approximately 100 acres of agricultural land to a floodplain by realigning the Chorro Creek channel (i.e., removing levees and planting appropriate native riparian vegetation to trap sediments). The project restored approximately 67 acres of riparian and wetland habitat (Figures 2 and 3).

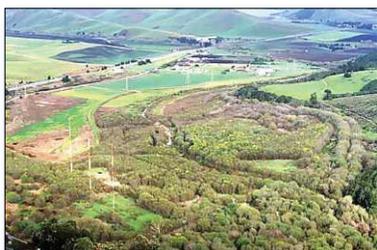
Figure 3. After restoration, Chorro Flats' channel sinuosity and riparian vegetation has been reestablished. For additional photos, see www.pwa-ltd.com/projects/pr_res_chorro_flats.html.

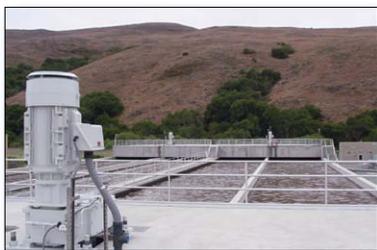
Figure 4. Building this new wastewater treatment plant helped remove point source discharges from Chorro Creek.

Other projects included switching from conventional (i.e., free roaming) grazing to intensive rotational grazing with offchannel watering facilities; excluding cattle from the riparian corridor adjacent to upper Chorro Creek and Dairy Creek; and replacing an aging wastewater treatment plant at the California Men's Colony Prison (Figure 4). In addition, the CCRWQCB and the California State Polytechnic University implemented a study comparing Chumash and Walters creeks (tributaries to Chorro Creek) to evaluate and demonstrate how erosion control practices can improve water quality.
