# NONPOINT SOURCE PROGRAM SUCCESS STORY

# Michigan

## Stabilizing Stamp Sand Deposits and Streambanks Improve Water Quality and In-stream Habitat

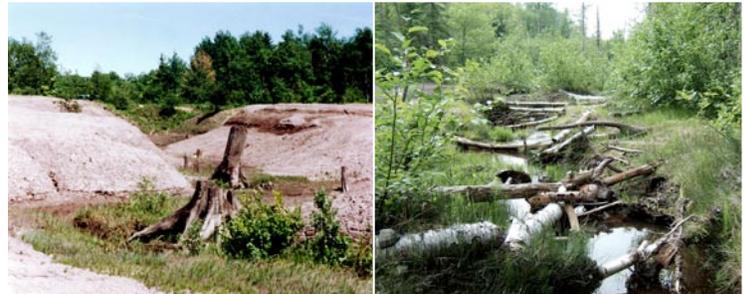
**Figure 1. Kearsarge Creek before and after restoration.**

Before: Stamp sand deposits cover streambanks and riparian area.

After: Removal of upstream stamp sand source allows revegetation of streambanks and riparian area.

Project partners isolated two areas of stamp sand deposits from the streams by stabilizing the stream banks and capping and revegetating the upland areas. The Houghton/Keweenaw Conservation District stabilized one 2.5-acre deposit in the Kearsarge

Creek watershed in 1998 (Figure 1). U.S. EPA stabilized another 19-acre deposit along Scales Creek in 2005 using Superfund Program funds (Figure 2).

The Kearsarge Creek project stabilized a 2.5-acre stamp sand deposit and triggered natural revegetation downstream. This improved the in-stream habitat conditions and benthic macroinvertebrate communities. In-stream copper concentrations fell by a factor of 10, total macroinvertebrate taxa tripled, sensitive macroinvertebrate taxa (mayflies, caddisflies, and stoneflies, also known as EPT) returned, and the in-stream habitat assessment noted steadily less sediment deposition between 1991, 2001, and 2006 (Table 1). Michigan Department of Environmental Quality (MIDEQ) uses a macroinvertebrate community scoring procedure to identify impaired waterbodies. Possible scores range from -9 to +9; a score of less than -4 is considered unacceptable. Macroinvertebrate scores improved from a score of -7 in 1991 to +2 and +1 in 2001 and 2006, respectively.

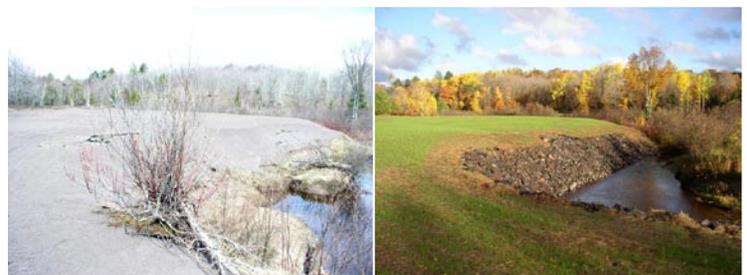
**Figure 2. Scales Creek before and after restoration.**

Before: Stamp sand deposits cover streambanks and riparian area.

After: Habitat improves once stamp sand source is removed and streambanks and riparian area are stabilized.

The Scales Creek project stabilized 19 acres of stamp sand deposits and restored 1,205 linear feet of Scales Creek streambank. MIDEQ noted

measurable improvements within one year of this project's completion; between 1991 and 2006 in-stream copper concentrations decreased slightly, total macroinvertebrate taxa increased by 40 percent, sensitive macroinvertebrate taxa doubled, and in-stream habitat features such as substrate embeddedness and sediment deposition improved substantially (Table 2). Macroinvertebrate scores, as determined by MIDEQ's scoring procedure, improved from 0 in 1991 to +4 in 2006. MIDEQ expects scores to continue to improve as biota colonizes the improved habitat. Given the positive results from both projects, MIDEQ expects to remove Kearsarge/Scales Creek from the state's 303(d) list by 2008. MIDEQ will survey the creeks again in 2011.
