NE Fremont Street Green Street Project

NE Fremont Street between NE 131st and NE 132nd avenues Portland, Oregon

NE Fremont Stormwater Curb Extension

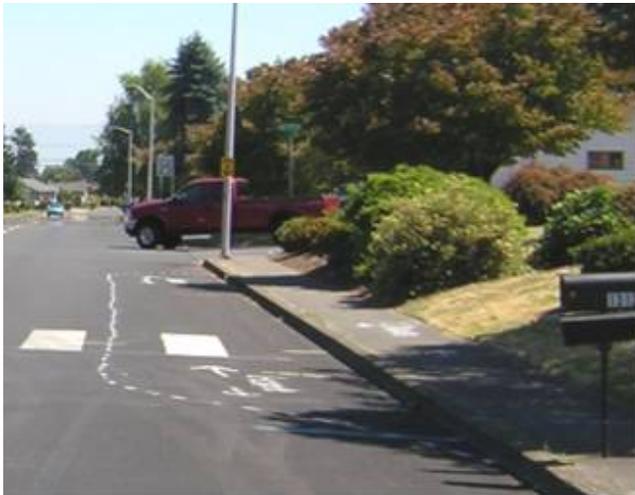
Before

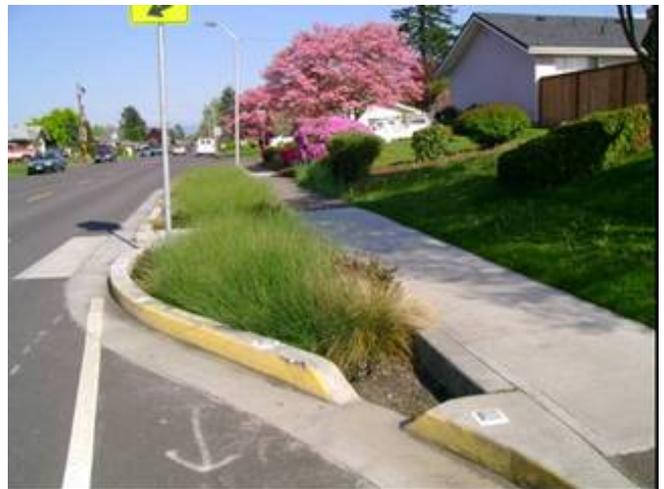
After.

- This project removed 300 square feet of paved street surface and transformed it into a vegetated system for stormwater management. The stormwater curb extension provides water quality treatment and maximizes infiltration of street runoff. It retains stormwater to a depth of about 6 inches.
- This is Portland's first Green Street project to integrate an ADA-compliant pedestrian crossing into the design of a stormwater curb extension facility.
- The project provides an attractive addition to the neighborhood and enhances the urban environment.

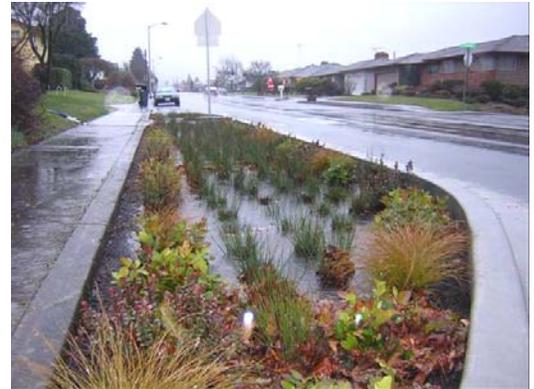
Fremont stormwater curb extension during a rainstorm

- Length: 65 feet
- Width: 7 feet
- Total landscape area: 300 square feet
- Depth from sidewalk grade to finish grade of curb extension: 8 inches
- Maximum ponding depth: Approximately 6 inches
- Radius of curb taper: 10 feet

- Overflow exits the facility through a 6-inch curb notch at the downhill end, draining to the separated sewer via an existing street inlet. No modifications were made to the inlet.

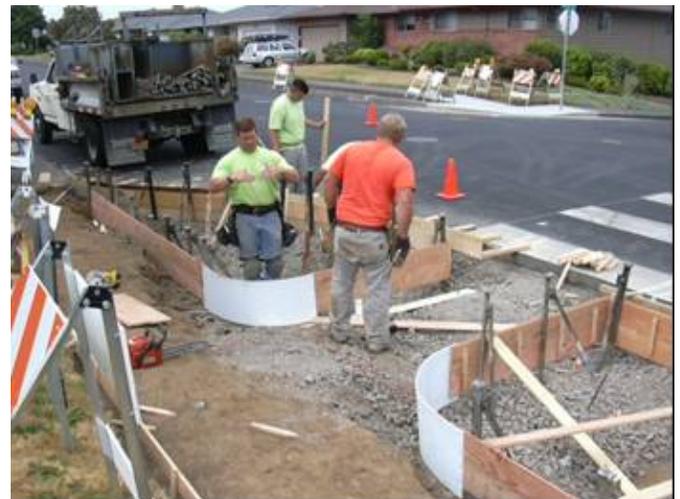
Constructing the stormwater facility; forming the curbs.

- The curb extension was excavated to a depth of 18 inches below the sidewalk grade. The native soil was tilled before importing 12 inches of a three-way soil mix, consisting of sand, topsoil, and compost. No rock or sub-base material was added below the soil.
- The three-way soil mix was tilled into the native soil and spread to create a shallow parabolic cross section.
- The curb opening at the inflow point is 18 inches wide.
- A 12-inch-wide grated concrete trench conveys stormwater under the pedestrian ramp.

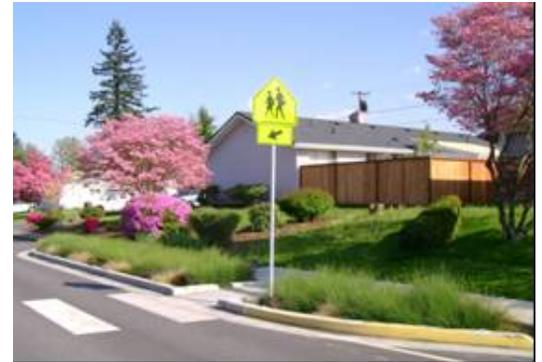
Plants were selected for their drought tolerance, evergreen foliage, and height. The typical mature height of the plants is less than 2 feet. These characteristics were a priority because they minimize maintenance and address safety concerns. Most of the plants are native to the Pacific Northwest; some non-native plants were included to provide seasonal color accents. Rushes are the dominant plant in the bottom of the facility because their stiff structure helps slow the passage of water and they survive well in the variable moist and dry soil conditions.

The plants were installed at a density greater than required by the city’s Stormwater Management Manual. This was done to reduce weeding and watering requirements and to quickly create an aesthetically appealing landscape.

- All of the plants, with the exception of *Gaultheria shallon* (salal), grew vigorously during the first year. As a result, little weeding is required. Some plants appeared to suffer from cold east winds in the winter, evidenced by some browning of leaves. Most species of the salal died during the establishment period, probably as a result of cold winds and intense solar exposure at this location. The salal was replaced with more hebe plants.
- In the first year, little sediment accumulated in the forebay. This may be because of a lack of contributing elements, such as street trees. Because there is little sediment input, city staff removes the sediment an average of twice per year, using a shovel and rake.
