**Subject: Removal Action Report, Revision No. 4
Ellisville Site (RV007), Wildwood, Missouri
U.S. EPA Region 7 START 4, Contract No. EP-S7-13-06, Task Order No. 0048
Task Monitor: Heath Smith, EPA On-Scene Coordinator**

**REMOVAL ACTION REPORT
REVISION NO. 4**

**REGARDING THE
ELLISVILLE SITE (RV007)
WILDWOOD, MISSOURI**

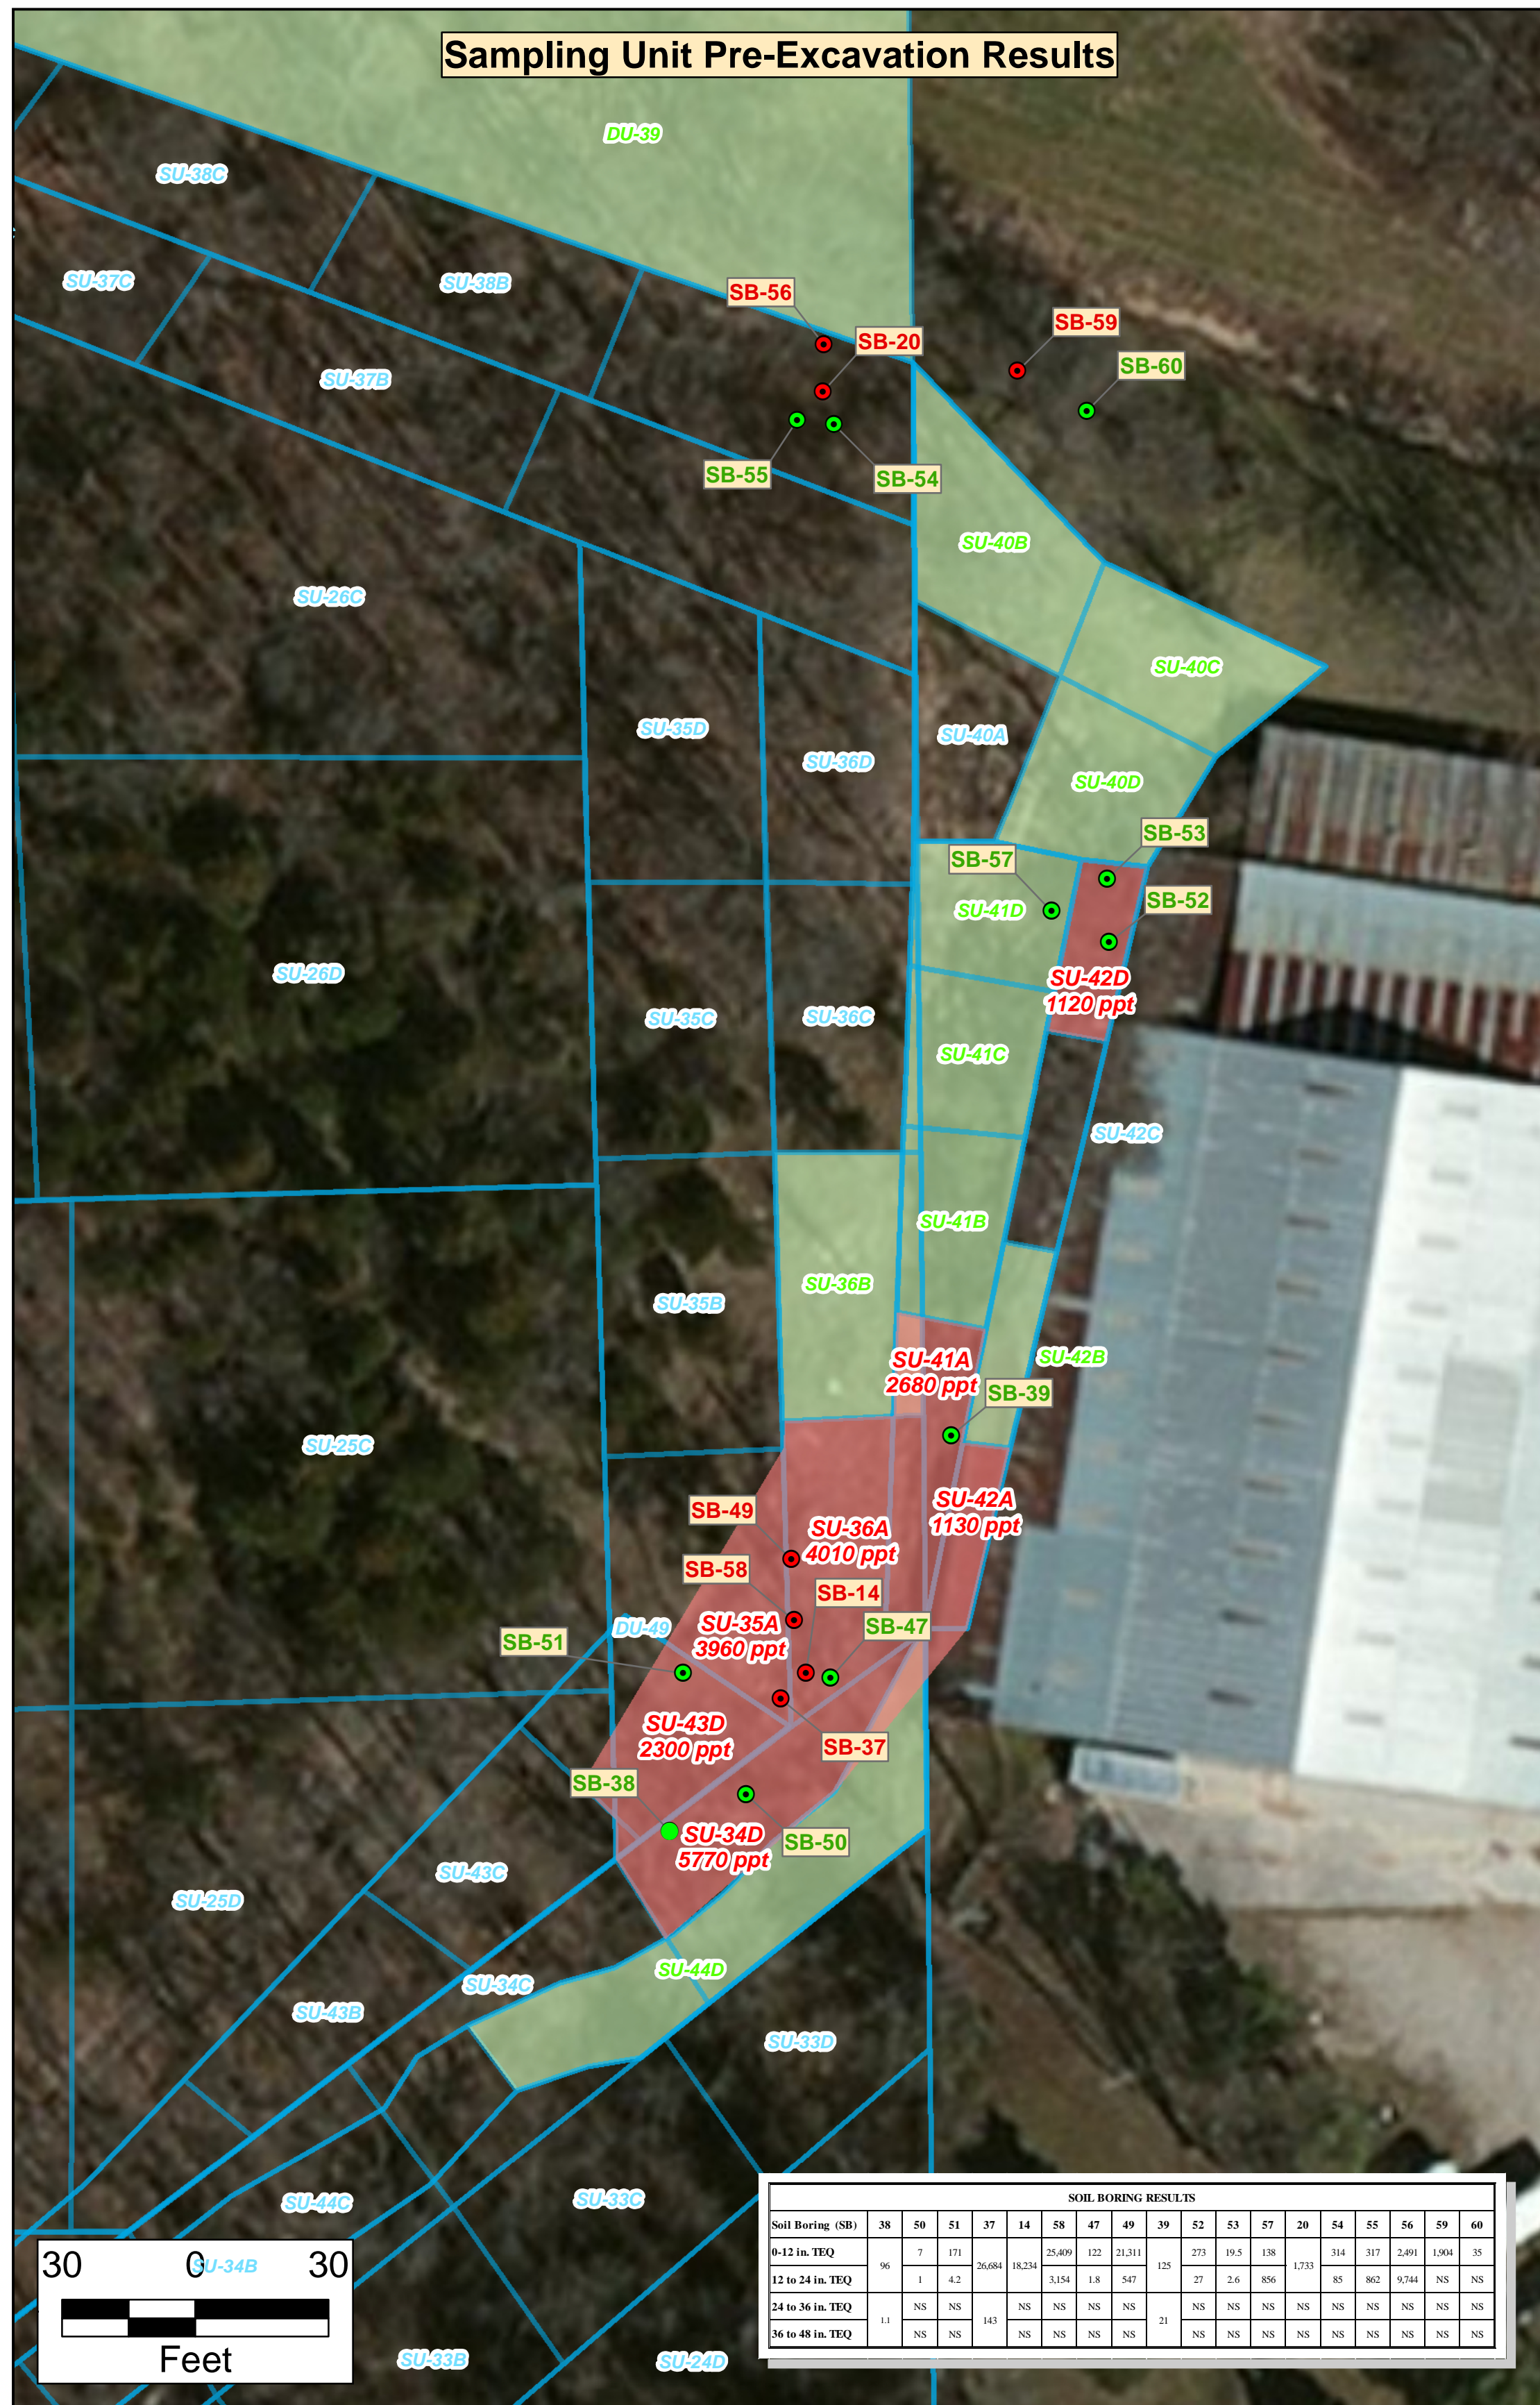
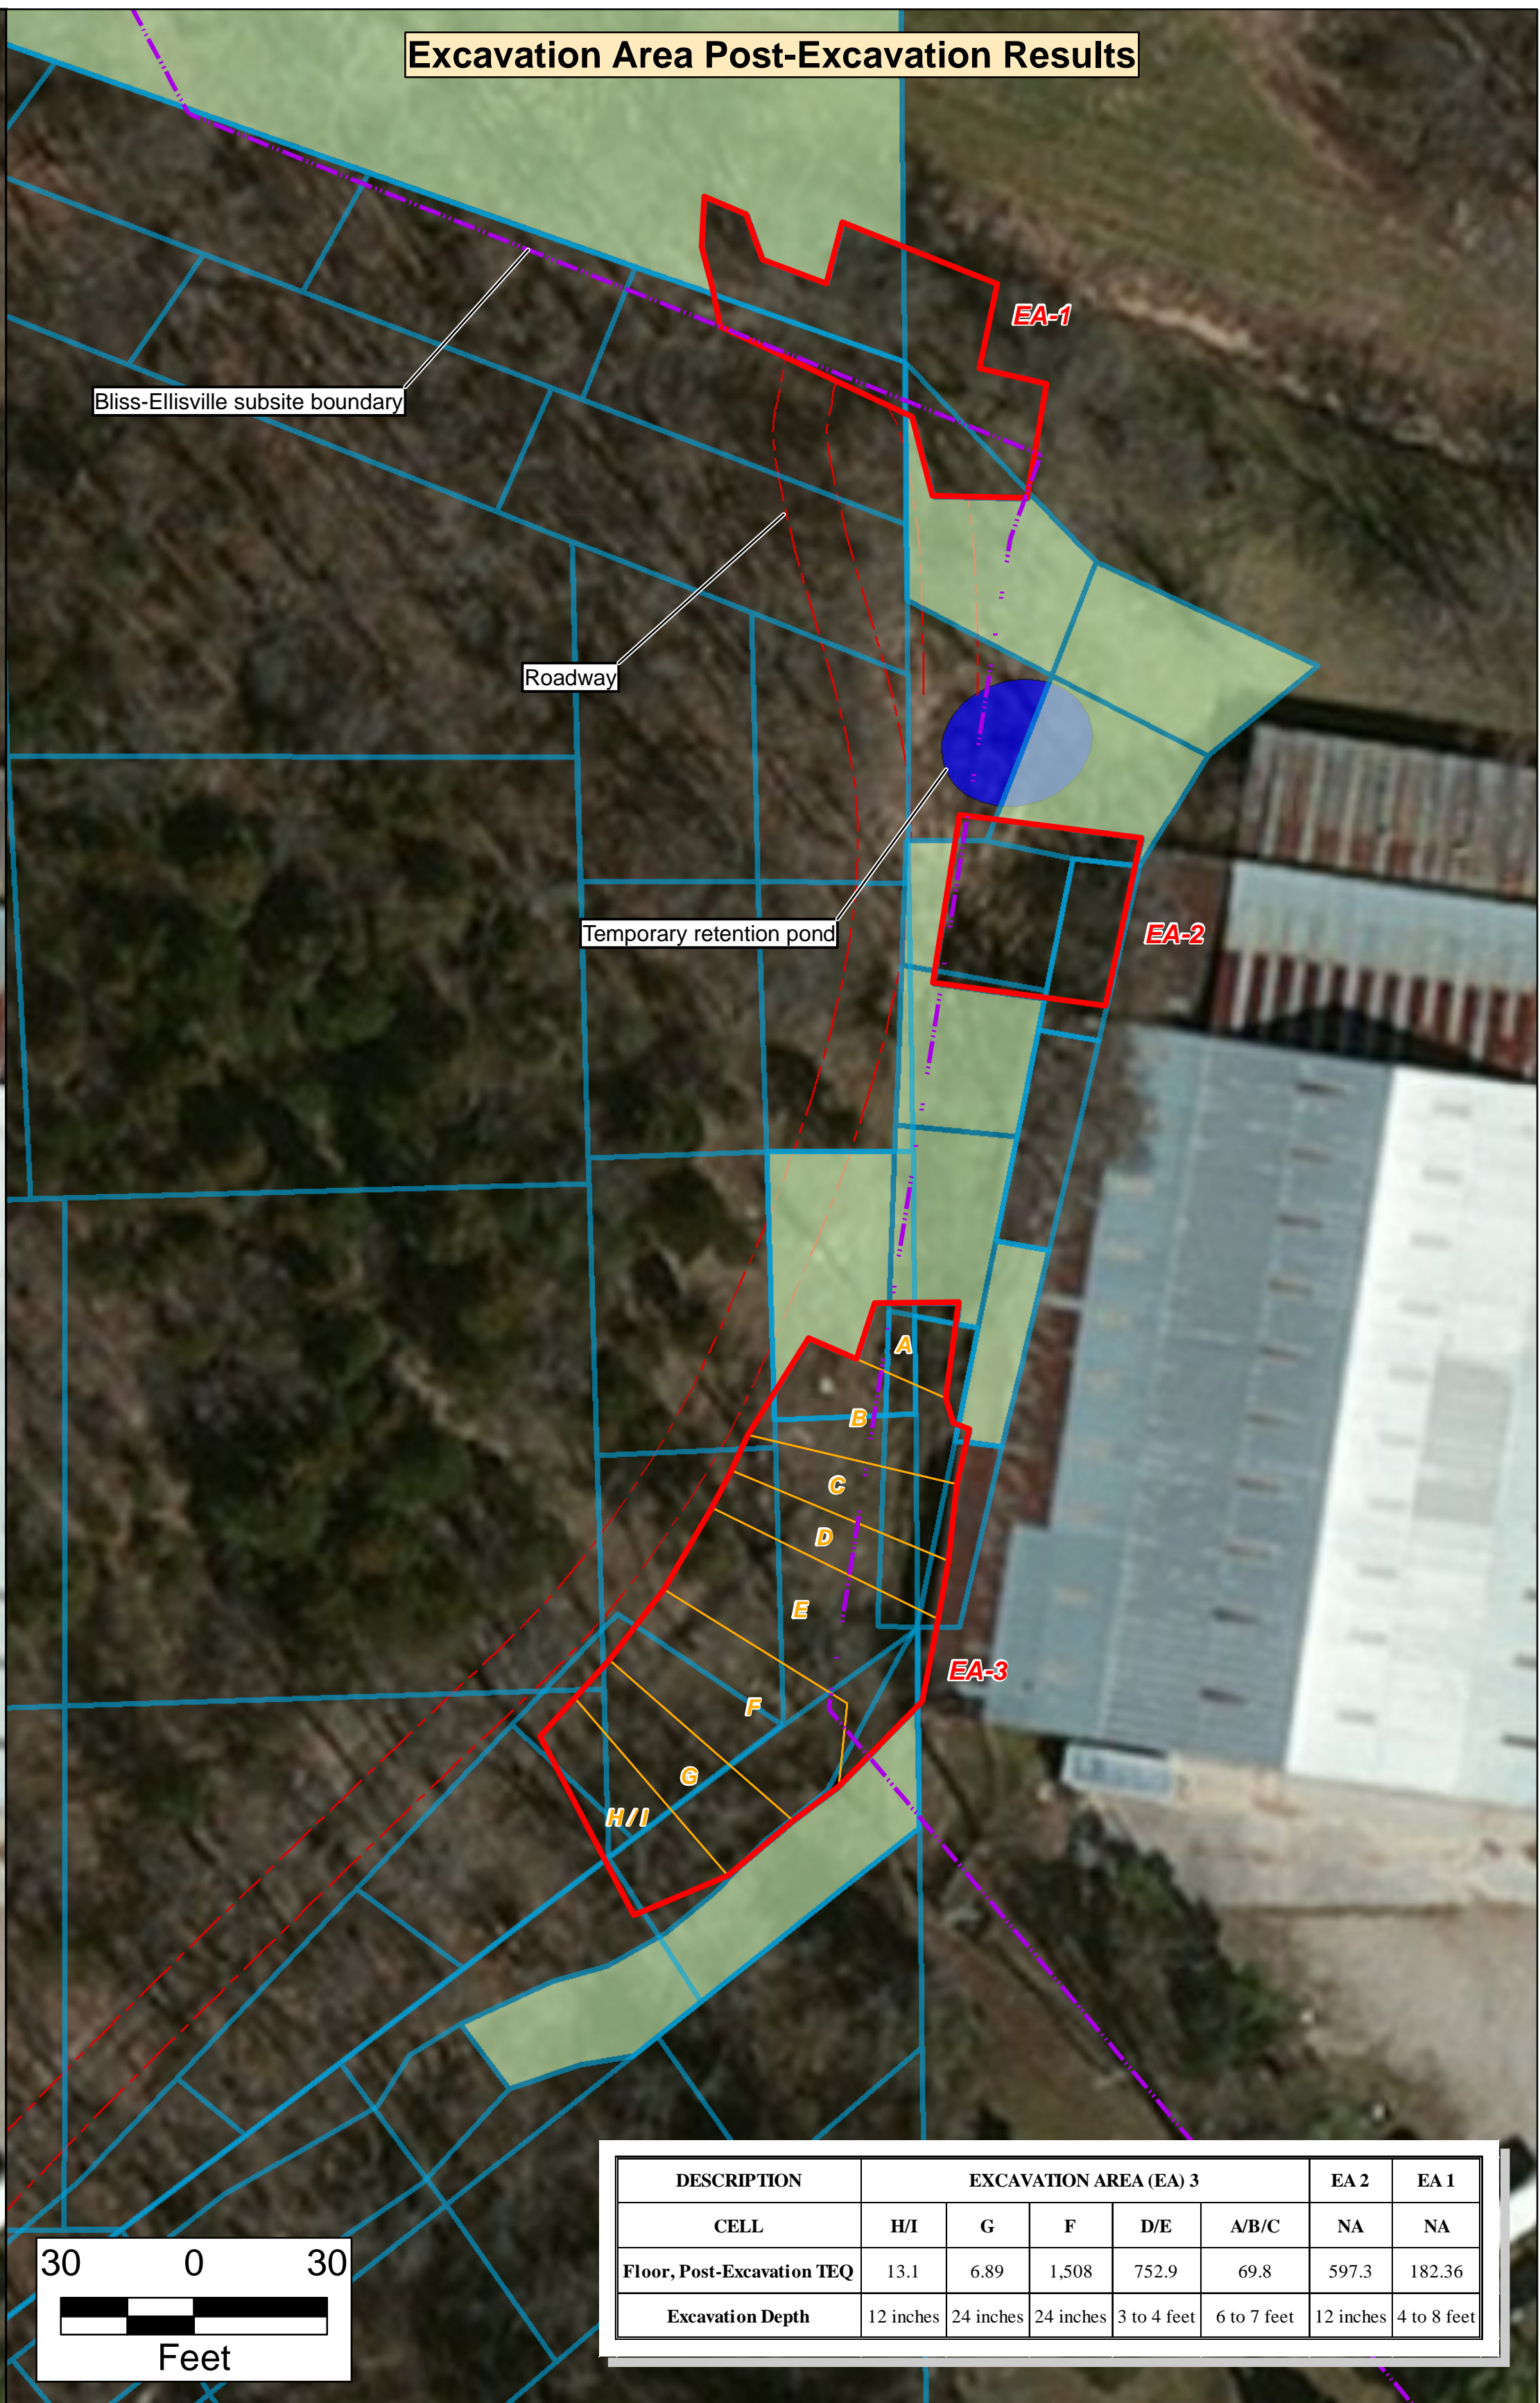
- Legend**
- Soil boring - below action level
 - Soil boring - above action level
 - Decision / sampling unit boundary
 - Excavation area
 - Excavation sub-area
- Pre-excitation sample results:**
- 50 - 820 ppt
 - > 820 ppt
 - NA Not applicable
 - NS Not sampled
 - ppt Parts per trillion
 - TEQ Toxic equivalence (dioxin) in ppt

DESCRIPTION	EXCAVATION AREA (EA) 3					EA 2	EA 1
	H/I	G	F	D/E	A/B/C	NA	NA
Floor, Post-Excavation TEQ	13.1	6.89	1,508	752.9	69.8	597.3	182.36
Excavation Depth	12 inches	24 inches	24 inches	3 to 4 feet	6 to 7 feet	12 inches	4 to 8 feet

Excavation to at least 3 feet below ground surface (bgs) at localized areas of the site was determined necessary to achieve cleanup goals. The map on the right side of Figure 2 in Appendix A identifies the areas addressed during removal activities (Excavation Areas [EA] 1, 2, and 3). Photos from the RA are in Appendix B. Field sheets for all samples collected during this RA are in Appendix C (provided on compact disk [CD]).

On April 7, 2014, after the roadway to the removal area had been established, excavation activities were initiated at the south portion of EA 3 in cells H and I (see Appendix A, Figure 2). A Komatsu 200 excavator was used by ERRS to remove 1 foot of soil from those cells; the excavated soil was placed into poly-lined, 25-cubic-yard, roll-off boxes. Post-excavation soil samples for dioxin TEQ analysis were collected by START from the floor and side walls of the (combined) excavated cells. Laboratory data confirmed that the RALs for those cells had been met. A representative sample of excavated soil was also

On April 24 and 25, 2014, excavation activities were conducted at EA 2 (see Appendix A, Figure 2), where 6 to 12 inches of soil was excavated by use of a Caterpillar 308 excavator. Confirmation samples were collected from the floor of the area (SFRA-26) and from the side walls (SFRA-27). Laboratory data confirmed that the RALs had been achieved. Table 2 summarizes the sampling activities at EA 2.

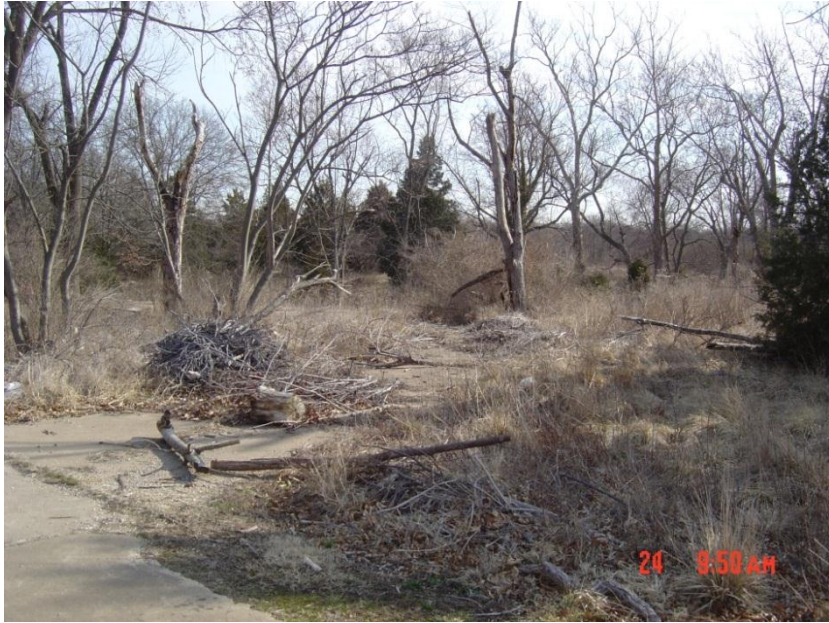
TETRA TECH PROJECT NO. X9025.14.0048.000 DIRECTION: Northeast	DESCRIPTION	This photograph shows the site entrance driveway and upper support zone prior to brush clearing in preparation for removal activities.	1
	CLIENT	Environmental Protection Agency - Region 7	DATE 3/24/14
	PHOTOGRAPHER	Dave Kinroth

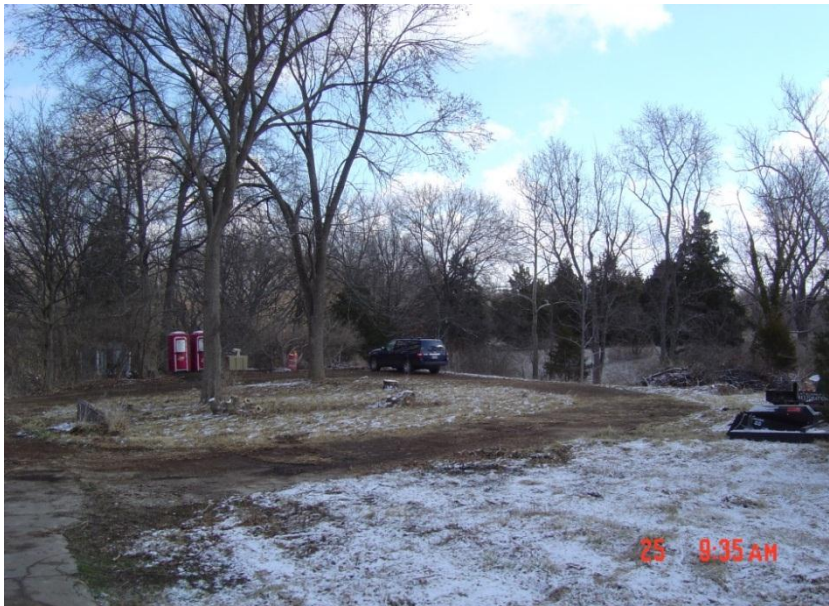
TETRA TECH PROJECT NO. X9025.14.0048.000 DIRECTION: Northeast	DESCRIPTION	This photograph shows the site entrance driveway and upper support zone area after brush clearing in preparation for removal activities.	2
	CLIENT	Environmental Protection Agency - Region 7	DATE 3/25/14
	PHOTOGRAPHER	Dave Kinroth

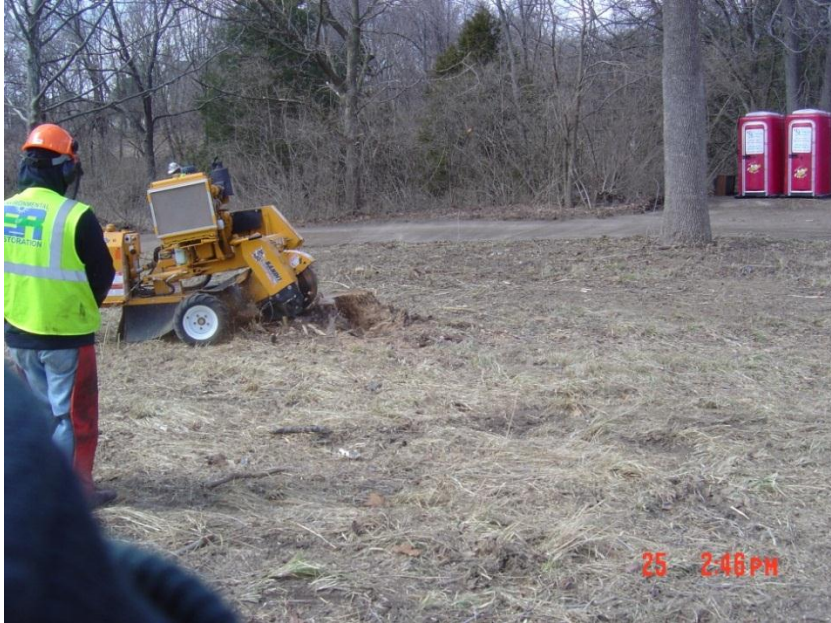
TETRA TECH PROJECT NO. X9025.14.0048.000 DIRECTION: Northwest	DESCRIPTION	This photograph shows Emergency and Rapid Response Services (ERRS) personnel grinding tree stumps in the upper support zone area in preparation for removal activities.	3
	CLIENT	Environmental Protection Agency - Region 7	DATE 3/25/14
	PHOTOGRAPHER	Dave Kinroth

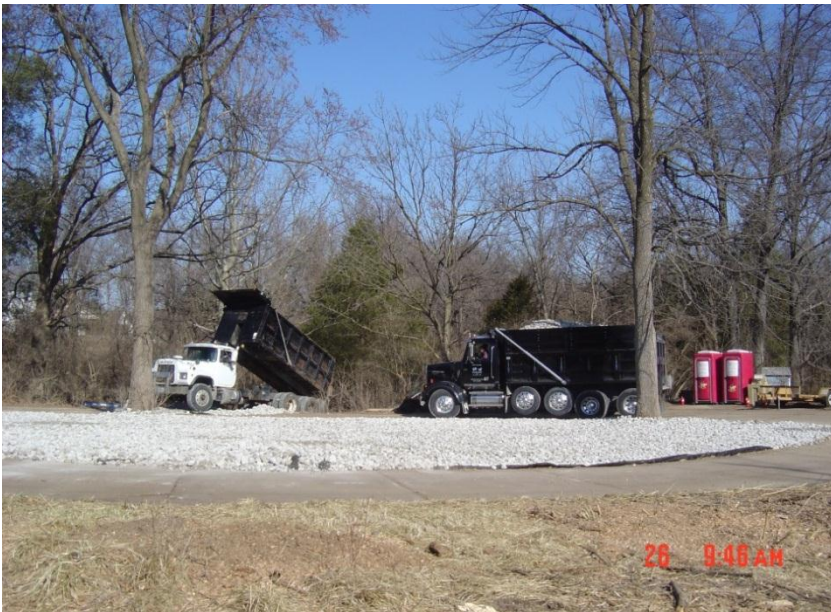
TETRA TECH PROJECT NO. X9025.14.0048.000 DIRECTION: North	DESCRIPTION	This photograph shows gabian stone being delivered to prepare site access roads and support zones for the removal action.	4
	CLIENT	Environmental Protection Agency - Region 7	DATE 3/26/14
	PHOTOGRAPHER	Dave Kinroth

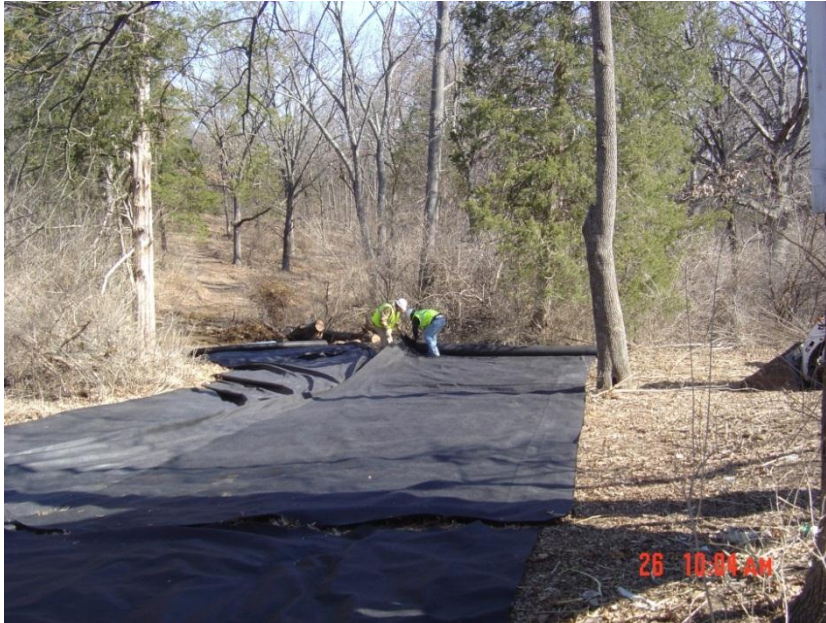
TETRA TECH PROJECT NO. X9025.14.0048.000 DIRECTION: North	DESCRIPTION	This photograph shows ERRS personnel laying base fabric in the area where gabian stone would be placed for a roadbed .	5
	CLIENT	Environmental Protection Agency - Region 7	DATE 3/26/14
	PHOTOGRAPHER	Dave Kinroth

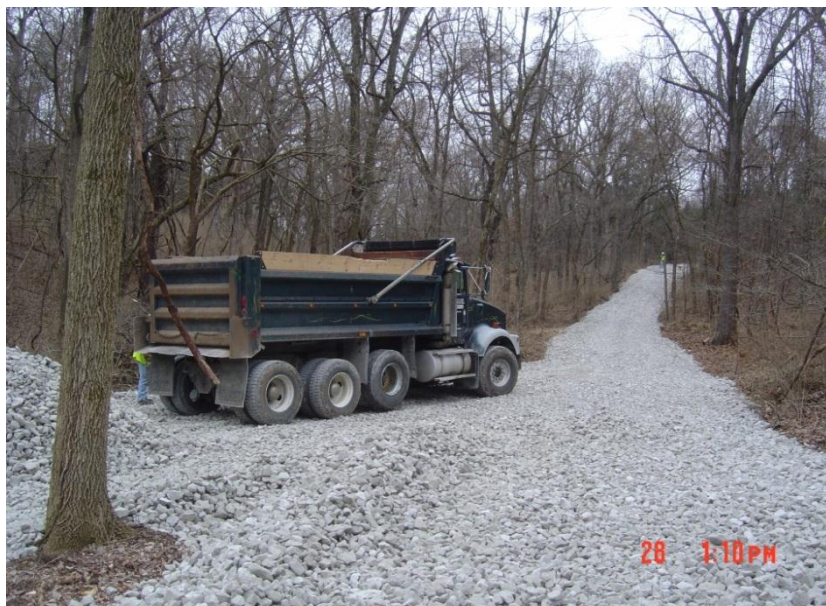
TETRA TECH PROJECT NO. X9025.14.0048.000 DIRECTION: South	DESCRIPTION	This photograph shows gabian stone on the haul road at the site.	6
	CLIENT	Environmental Protection Agency - Region 7	DATE 3/28/14
	PHOTOGRAPHER	Dave Kinroth

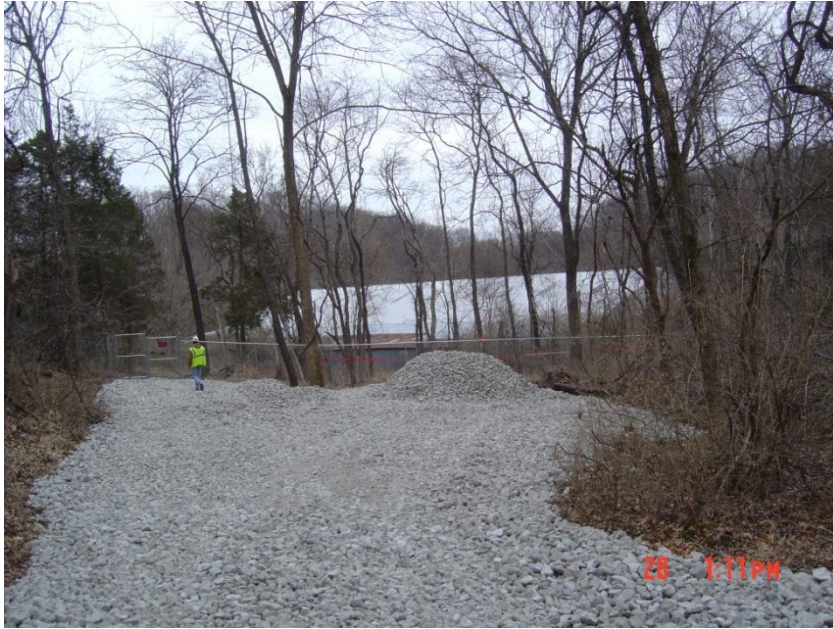
TETRA TECH PROJECT NO. X9025.14.0048.000 DIRECTION: North	DESCRIPTION	This photograph shows the lower support zone and haul road (near completion) to be used for the removal action.	7
	CLIENT	Environmental Protection Agency - Region 7	DATE 3/28/14
	PHOTOGRAPHER	Dave Kinroth

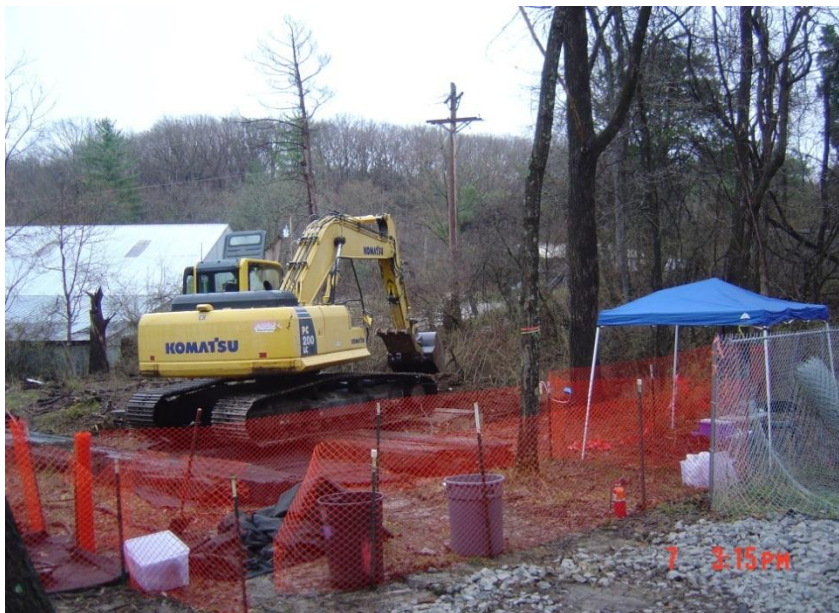
TETRA TECH PROJECT NO. X9025.14.0048.000 DIRECTION: East/Northeast	DESCRIPTION	This photograph shows ERRS personnel beginning excavation of dioxin-contaminated soil at the south end of Excavation Area (EA) 3.	8
	CLIENT	Environmental Protection Agency - Region 7	DATE 4/7/14
	PHOTOGRAPHER	Dave Kinroth

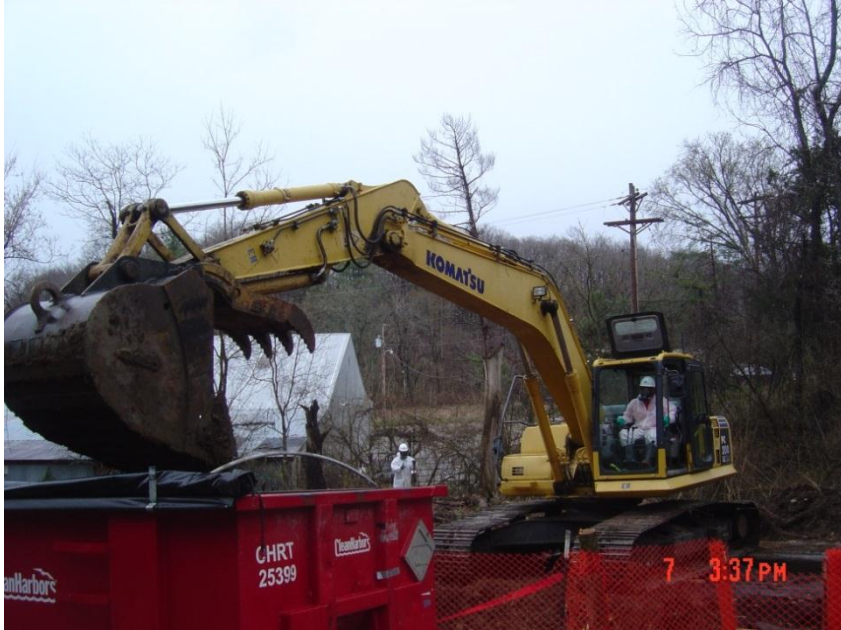
TETRA TECH PROJECT NO. X9025.14.0048.000 DIRECTION: East	DESCRIPTION	This photograph shows ERRS loading dioxin-contaminated soil into a roll-off box for transport to a disposal facility.	9
	CLIENT	Environmental Protection Agency - Region 7	DATE 4/7/14
	PHOTOGRAPHER	Dave Kinroth

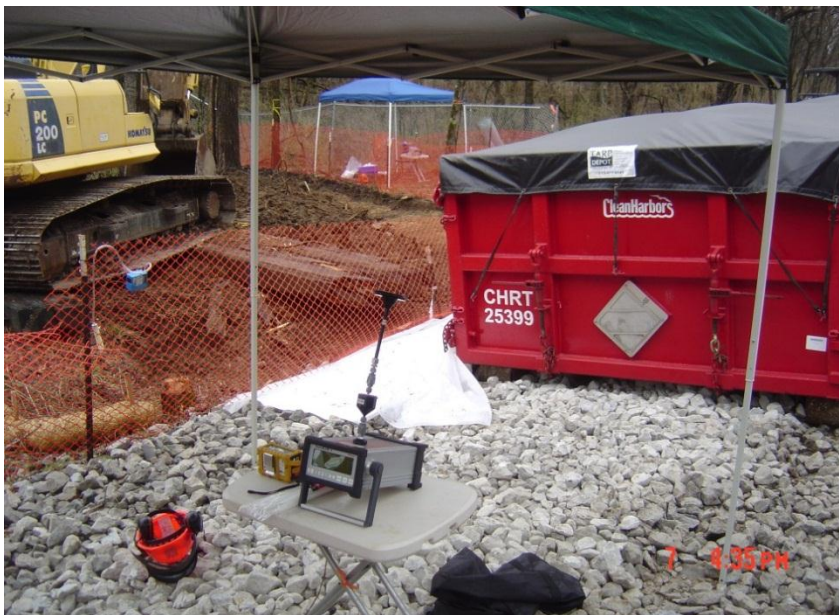
TETRA TECH PROJECT NO. X9025.14.0048.000 DIRECTION: Southeast	DESCRIPTION	This photograph shows an air monitoring station operated by Superfund Technical Assessment and Response Team (START) personnel during soil excavation activities.	10
	CLIENT	Environmental Protection Agency - Region 7	DATE 4/7/14
	PHOTOGRAPHER	Dave Kinroth

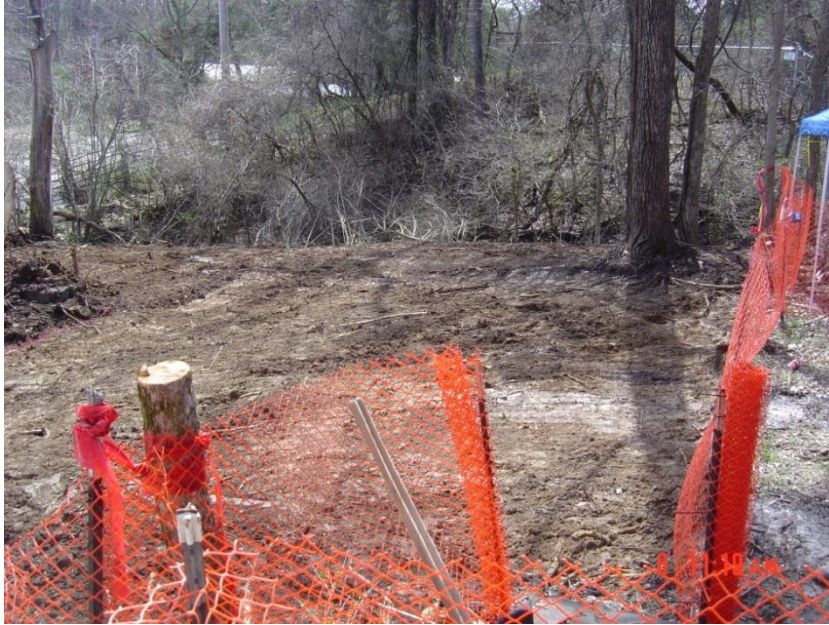
TETRA TECH PROJECT NO. X9025.14.0048.000 DIRECTION: Southeast	DESCRIPTION	This photograph shows the south end of EA 3 as soil excavation was nearing completion.	11
	CLIENT	Environmental Protection Agency - Region 7	DATE 4/8/14
	PHOTOGRAPHER	Dave Kinroth

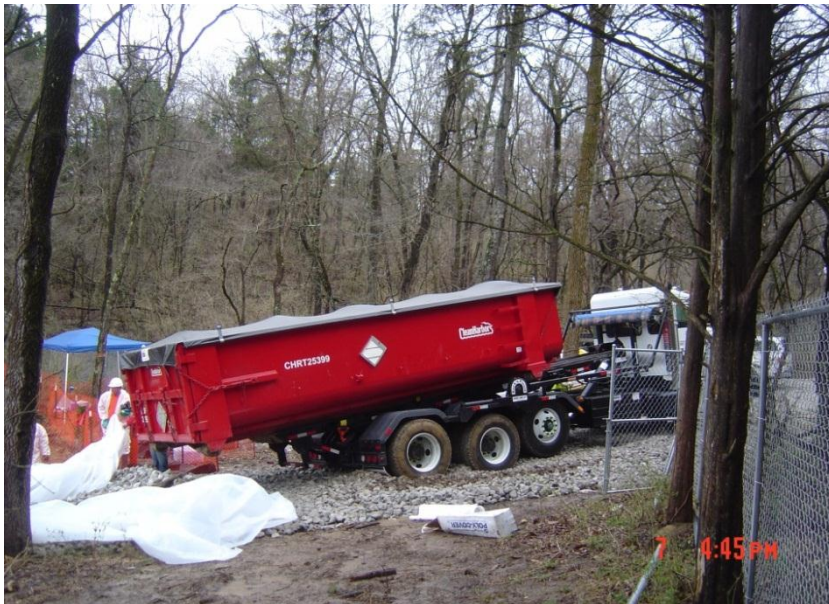
TETRA TECH PROJECT NO. X9025.14.0048.000 DIRECTION: East	DESCRIPTION	This photograph shows a roll-off box with excavated dioxin-contaminated soil being moved for temporary staging on site.	12
	CLIENT	Environmental Protection Agency - Region 7	DATE 4/7/14
	PHOTOGRAPHER	Dave Kinroth

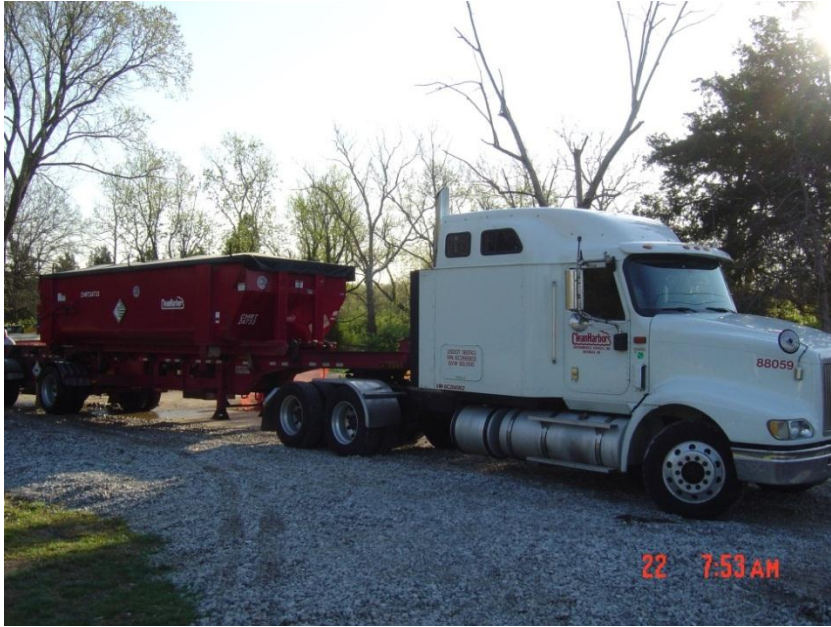
TETRA TECH PROJECT NO. X9025.14.0048.000 DIRECTION: Northwest	DESCRIPTION	This photograph shows a roll-off box with excavated dioxin-contaminated soil being removed for transport to an off-site disposal facility.	13
	CLIENT	Environmental Protection Agency - Region 7	DATE 4/22/14
	PHOTOGRAPHER	Dave Kinroth

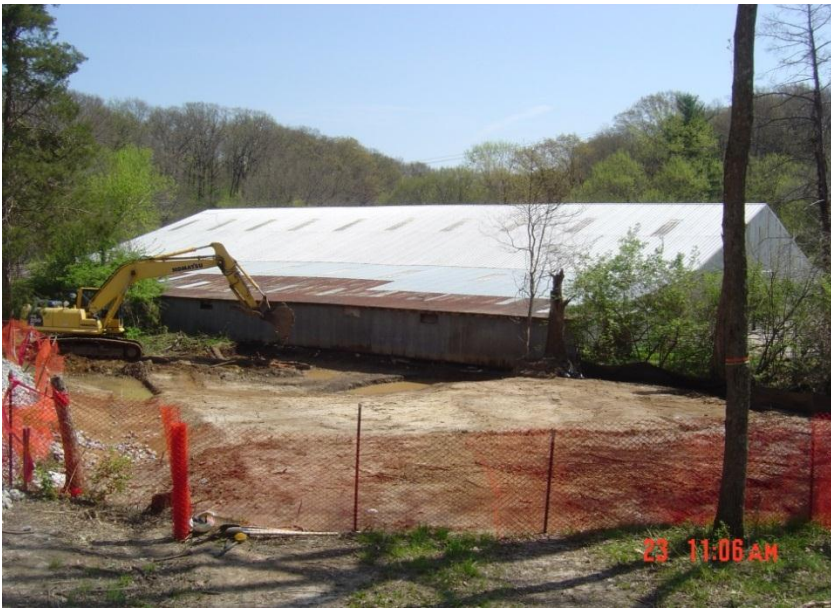
TETRA TECH PROJECT NO. X9025.14.0048.000 DIRECTION: Northeast	DESCRIPTION	This photograph shows an overview of EA 3 with excavation in progress.	14
	CLIENT	Environmental Protection Agency - Region 7	DATE 4/23/14
	PHOTOGRAPHER	Dave Kinroth

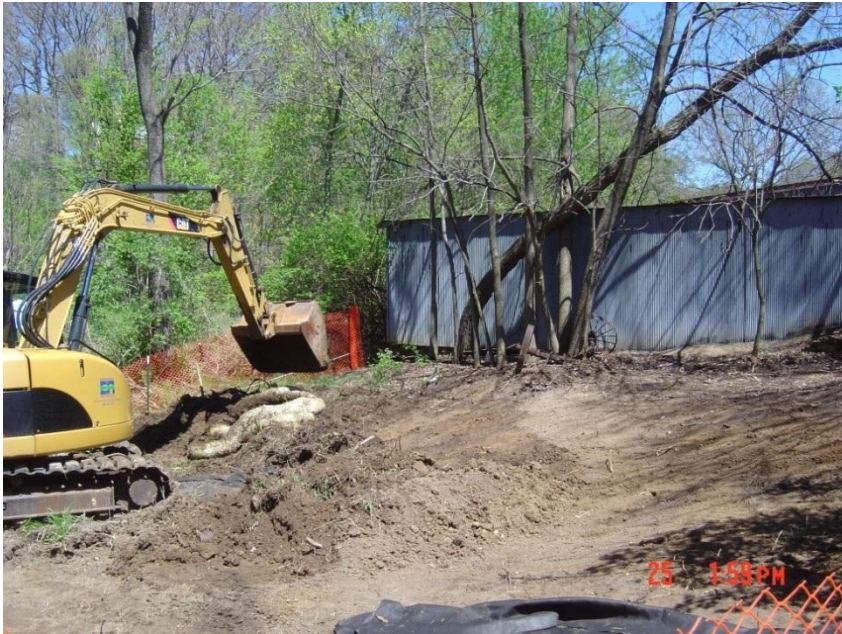
TETRA TECH PROJECT NO. X9025.14.0048.000 DIRECTION: Northeast	DESCRIPTION	This photograph shows excavation at EA 2.	15
	CLIENT	Environmental Protection Agency - Region 7	DATE 4/25/14
	PHOTOGRAPHER	Rick Claytor

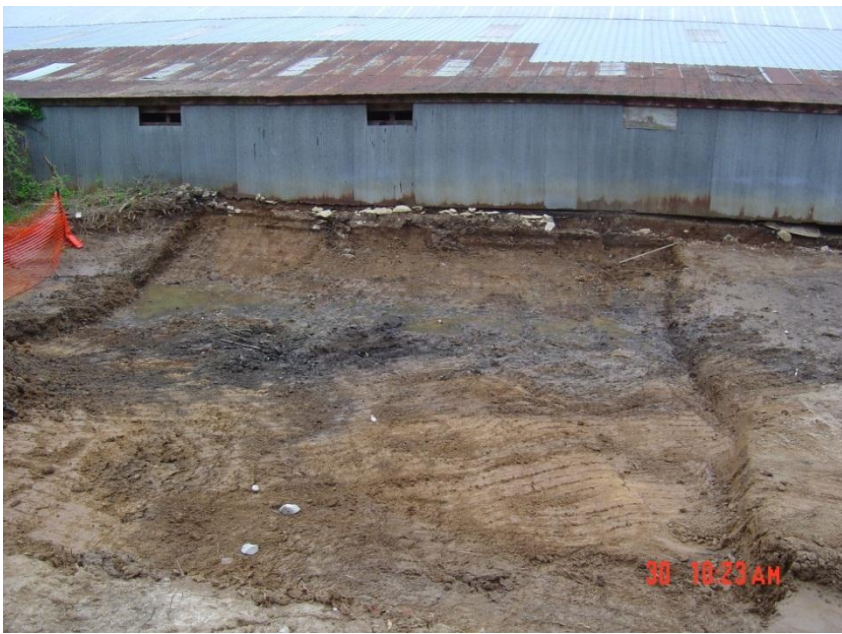
TETRA TECH PROJECT NO. X9025.14.0048.000 DIRECTION: East	DESCRIPTION	This photograph shows dark-stained soil encountered during excavation at EA 3 (cells D and E).	16
	CLIENT	Environmental Protection Agency - Region 7	DATE 4/30/14
	PHOTOGRAPHER	Rick Claytor

On April 29, 2014, additional excavation was conducted in EA 3 cells D and E, because previous post-excavation sample results remained above the dioxin TEQ RAL. In the central portion of these cells, additional odorous, stained soil and debris were exposed; excavation was again halted, and it was determined that additional disposal profile sampling would occur. On May 6, 2014, three multi-aliquot subsurface soil samples were collected by START and EPA from the stained portion of cells D and E. The samples were collected at depths of 0 to 1, 1 to 2, and 2 to 3 feet bgs. These samples (SFRA-34, 35, and 36) were submitted to Test America Laboratory in Earth City, Missouri, for disposal profiling analyses (VOCs, SVOCs, PCBs, and TCLP metals). The laboratory data, received on May 15, 2014, did not indicate elevated contaminant concentrations that would result in additional disposal requirements. These data are in Appendix D (provided on CD).

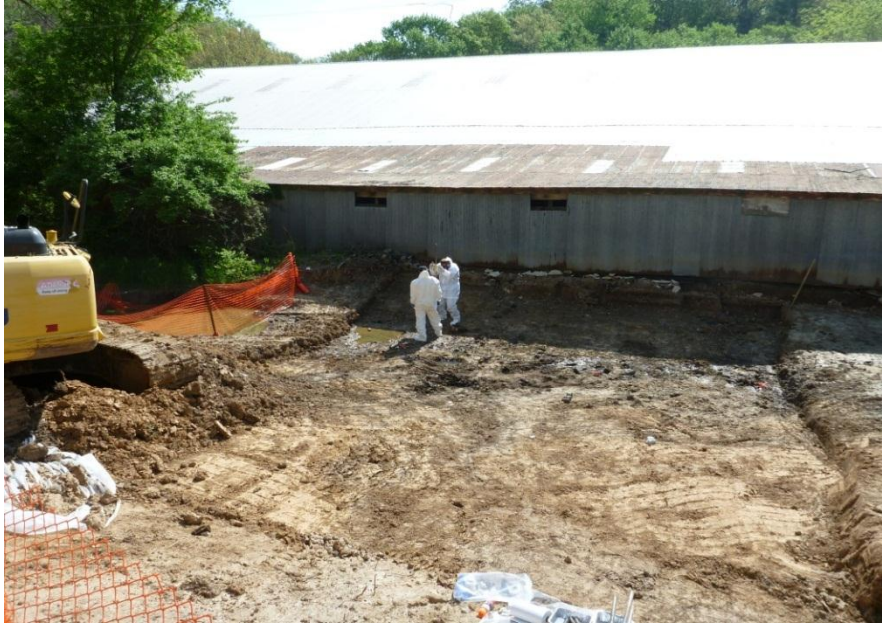
TETRA TECH PROJECT NO. X9025.14.0048.000 DIRECTION: East	DESCRIPTION	This photograph shows sampling of stained soil at EA 3.	17
	CLIENT	Environmental Protection Agency - Region 7	DATE 5/6/14
	PHOTOGRAPHER	Dave Kinroth

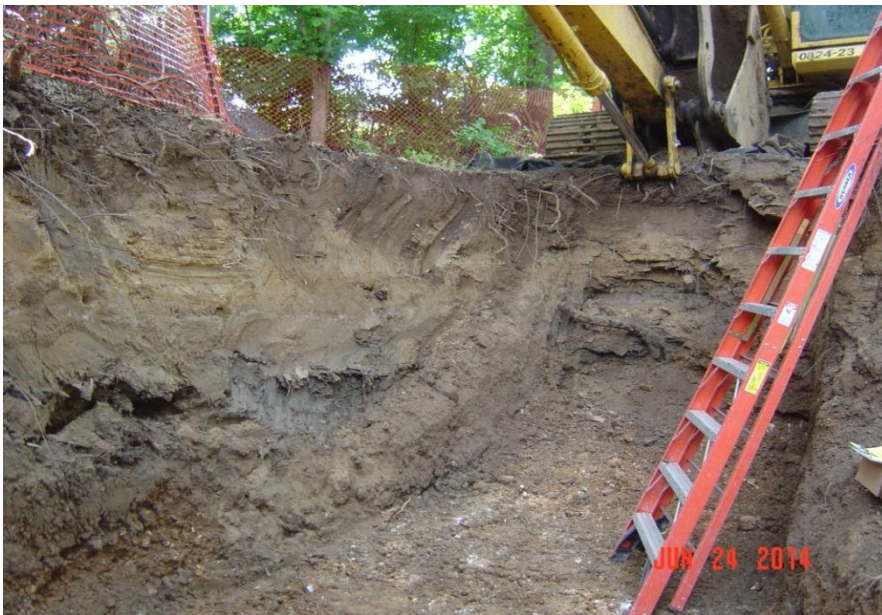
TETRA TECH PROJECT NO. X9025.14.0048.000 DIRECTION: Southeast	DESCRIPTION	This photograph shows the southeast portion of EA 1 after excavation to approximately 8 feet below ground surface (bgs) had been completed.	18
	CLIENT	Environmental Protection Agency - Region 7	DATE 6/24/14
	PHOTOGRAPHER	Rick Claytor

Excavation activities at EA 1 resumed June 11, 2014. At the southeast corner of EA 1, approximately 8 feet of debris and stained soil was excavated before the RAL was achieved (see Appendix B). A composite sample (SFRA-128) was collected from two roll-off boxes containing soil excavated from the southeast portion of EA 1. This sample was submitted to Test America in Earth City, Missouri, for analysis for PCBs and SVOCs. The boxes were held until the laboratory results confirmed that concentrations of those analytes were not elevated.

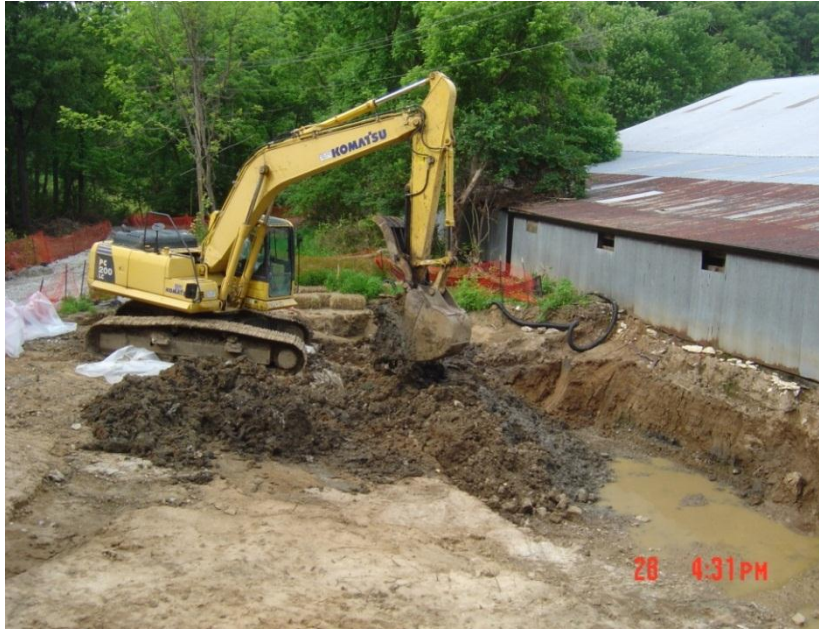
TETRA TECH PROJECT NO. X9025.14.0048.000 DIRECTION: Northeast	DESCRIPTION	This photograph shows ERRS excavating a vein of dark-stained soil at EA 3.	19
	CLIENT	Environmental Protection Agency - Region 7	DATE 6/28/14
	PHOTOGRAPHER	Rick Claytor

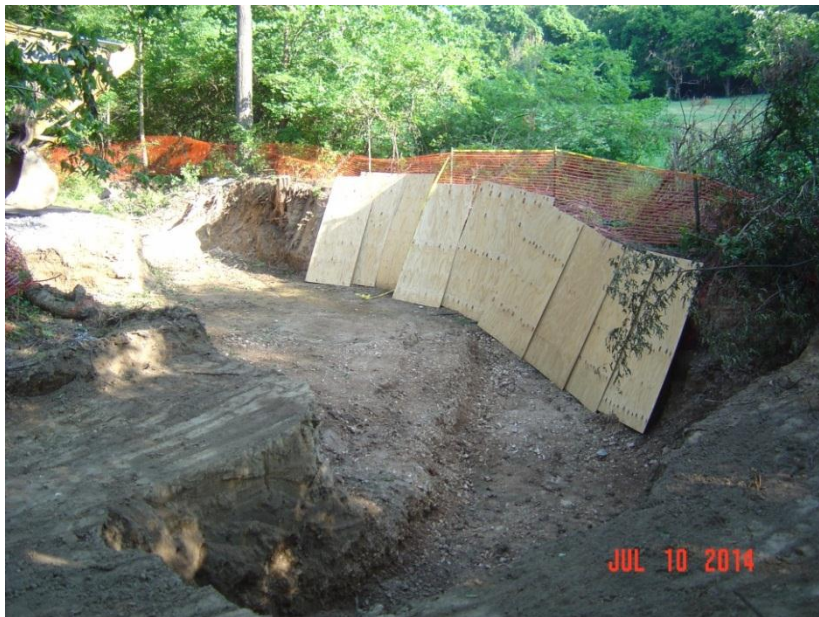
TETRA TECH PROJECT NO. X9025.14.0048.000 DIRECTION: Northwest	DESCRIPTION	This photograph shows preparation for backfilling at EA 1, along the tributary to Caulks Creek on the north perimeter of the site.	20
	CLIENT	Environmental Protection Agency - Region 7	DATE 7/10/14
	PHOTOGRAPHER	Rick Claytor

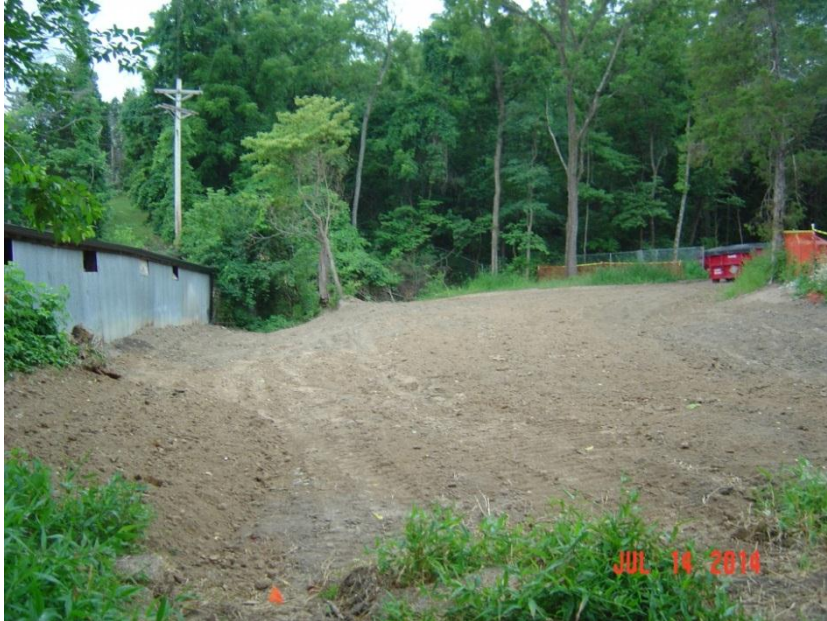
TETRA TECH PROJECT NO. X9025.14.0048.000 DIRECTION: Southeast	DESCRIPTION	This photograph shows EA 3 after excavation had been completed, and the area had been backfilled with clean topsoil.	21
	CLIENT	Environmental Protection Agency - Region 7	DATE 7/14/14
	PHOTOGRAPHER	Rick Claytor

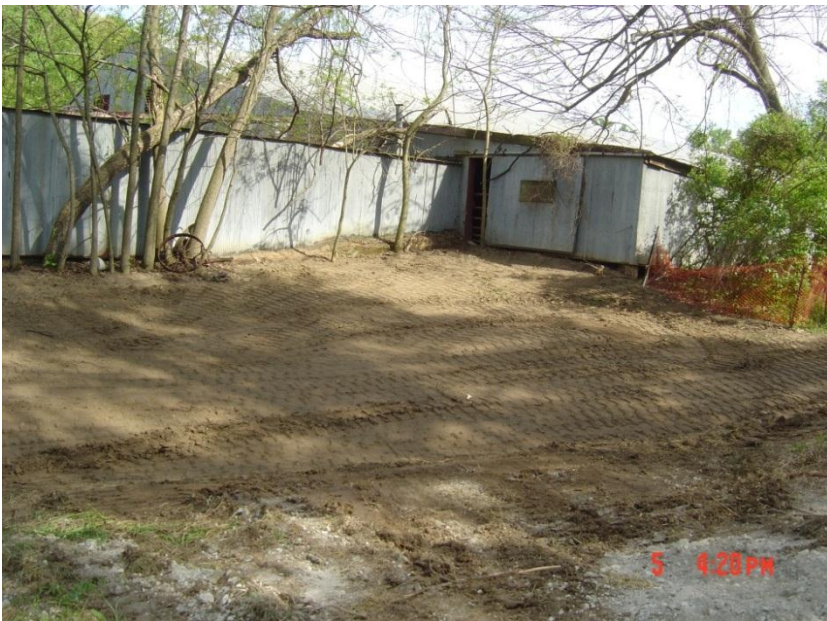
TETRA TECH PROJECT NO. X9025.14.0048.000 DIRECTION: Southeast	DESCRIPTION	This photograph shows EA 2 after excavation had been completed, and the area had been backfilled with clean topsoil.	22
	CLIENT	Environmental Protection Agency - Region 7	DATE 5/5/14
	PHOTOGRAPHER	Rick Claytor

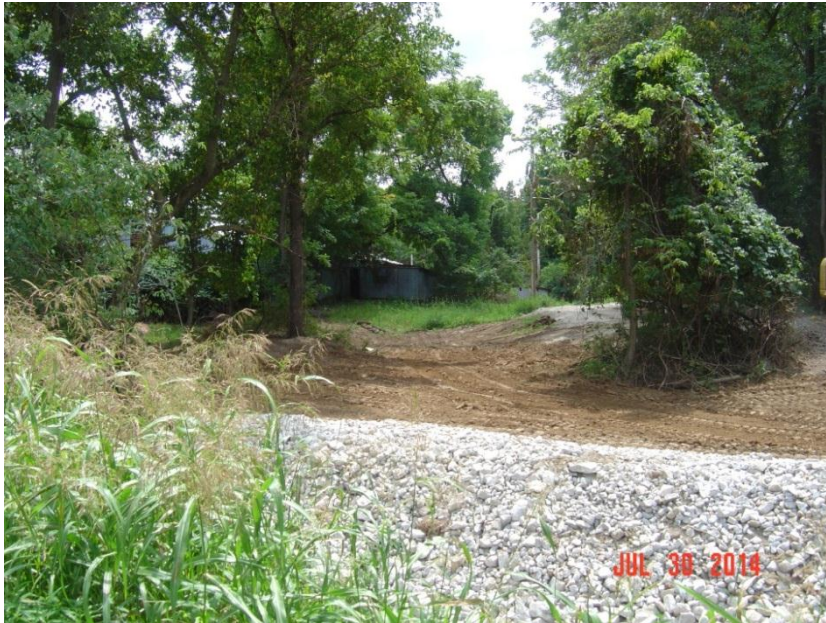
TETRA TECH PROJECT NO. X9025.14.0048.000 DIRECTION: South	DESCRIPTION	This photograph shows EA 1 after excavation had been completed, the area had been backfilled with clean topsoil, and rip-rap had been placed along the creek bank.	23
	CLIENT	Environmental Protection Agency - Region 7	DATE 7/30/14
	PHOTOGRAPHER	Rick Claytor

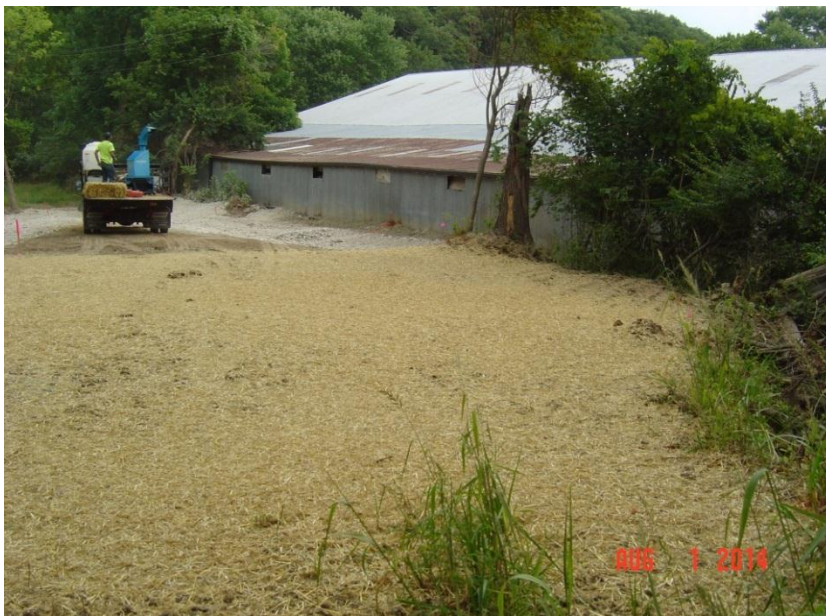
TETRA TECH PROJECT NO. X9025.14.0048.000 DIRECTION: Northeast	DESCRIPTION	This photograph shows ERRS applying straw at EA 3 after the area had been backfilled with clean topsoil and seeded.	24
	CLIENT	Environmental Protection Agency - Region 7	DATE 8/1/14
	PHOTOGRAPHER	Rick Claytor
