**Subject: Removal Action Report, Revision No. 4
Ellisville Site (RV007), Wildwood, Missouri
U.S. EPA Region 7 START 4, Contract No. EP-S7-13-06, Task Order No. 0048
Task Monitor: Heath Smith, EPA On-Scene Coordinator**

**REMOVAL ACTION REPORT
REVISION NO. 4**

**REGARDING THE
ELLISVILLE SITE (RV007)
WILDWOOD, MISSOURI**

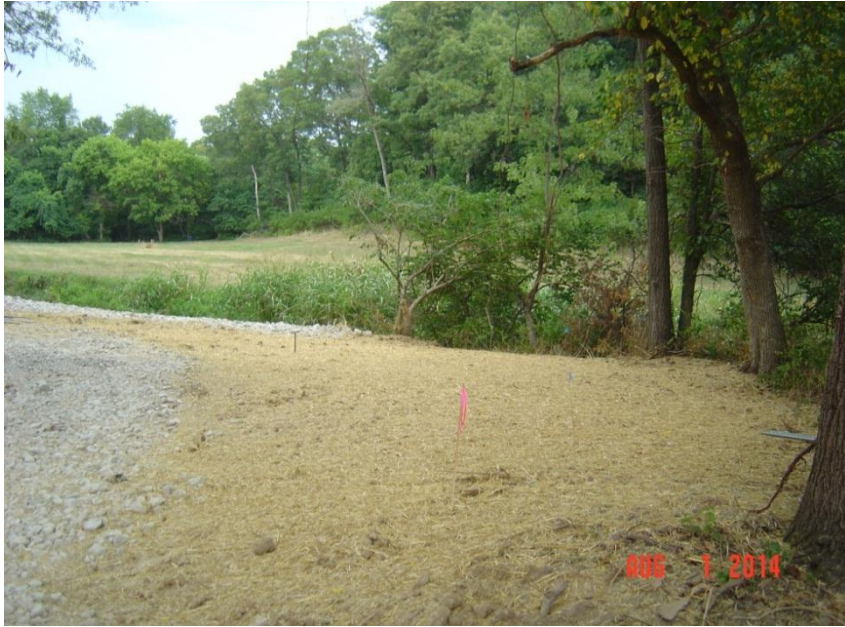
TETRA TECH PROJECT NO. X9025.14.0048.000 DIRECTION: North	DESCRIPTION	This photograph shows EA 1 after excavation had been completed, and seed and straw had been applied to clean topsoil backfill.	25
	CLIENT	Environmental Protection Agency - Region 7	DATE 8/1/14
	PHOTOGRAPHER	Rick Claytor

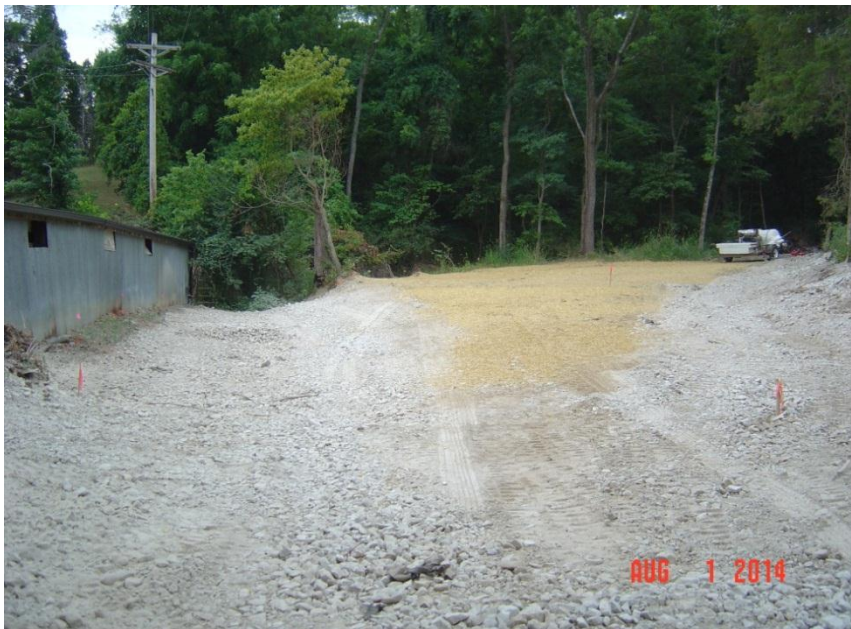
TETRA TECH PROJECT NO. X9025.14.0048.000 DIRECTION: South	DESCRIPTION	This photograph shows gabian stone taken from the site haul road to line drainage pathways for erosion control at EA 3.	26
	CLIENT	Environmental Protection Agency - Region 7	DATE 8/1/14
	PHOTOGRAPHER	Rick Claytor
