The SF₆ ReUse Program **A Case Study**

> November 21-22, 2002 San Diego, CA

Case Study - Background ▲ 138 kV circuit breaker failed when initially energized ▲ Arc over open contacts – 44,000 amps measured ▲ Believed to be sustained for 20 minutes Rupture disk burst – immediately covered & SF₆ pulled from breaker into gas cart & SO₂ concentration remained too high **▲** Gas deemed corrupt & Gas filled into empty N₂ cylinders ▲ No other cylinders on site AGA Gas contacted for assistance

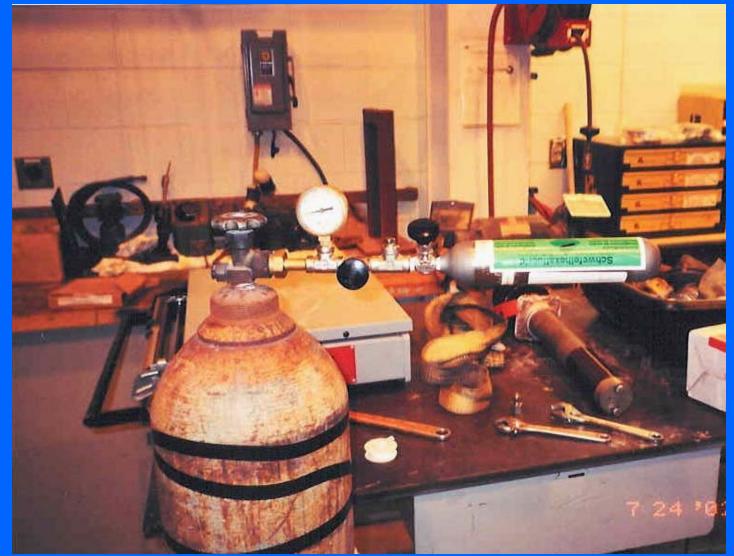
Analysis – Sampling at AEP

Sample kit dispatched

Weigh scale did not record a weight gain on sample cylinder

▲ Accurate only to plus/minus 1 lb

- Counted on ∆P sufficient to obtain
 reasonable quantity
- ▲ Lecture bottle sent to Solvay Fluor, Germany
 - Software glitch with analysis equipment in Catoosa OK.

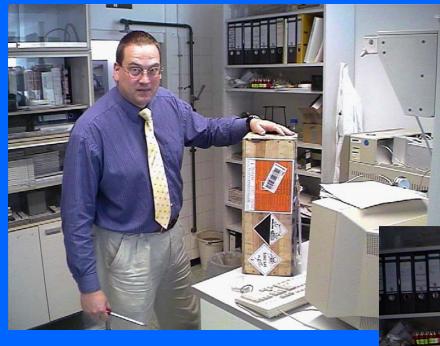
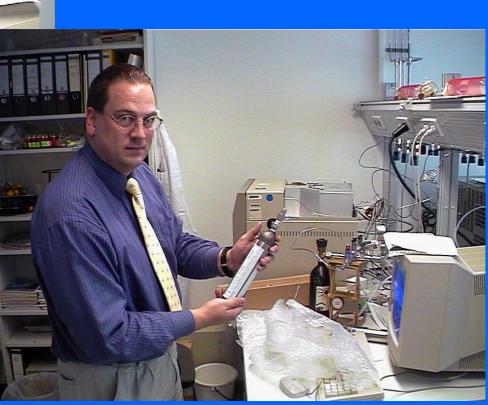
Analysis – Hannover, Germany

Analysis Results Hydrogen Air carbon tetrafluoride carbon dioxide trifluoromethane thionyl fluoride sulfuryl fluoride nitrogen trifluoride sulfur dioxide

< 1 ppmw233 ppmw 1031 ppmw 152 ppmw <1 ppmw 4881 ppmw < 1 ppmw< 1 ppmw6545 ppmw

Within Solvay's allowable limits

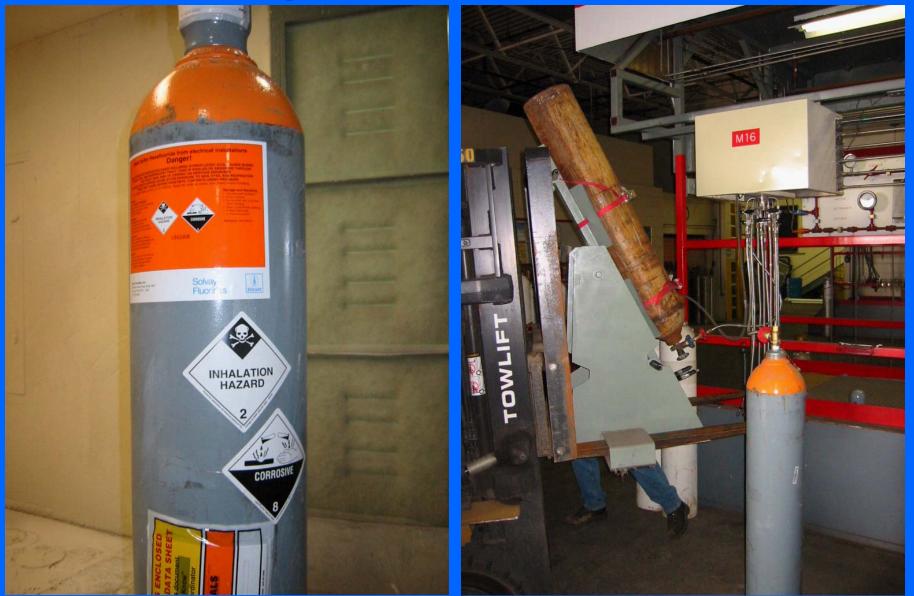
Trans-filling in ReUse Cylinders

SF₆-filled N₂ cylinder transported to AGA Gas, Inc.
 Trans-filling in ReUse cylinders conducted by
 trained personnel
 in controlled environment
 appropriate safety measures

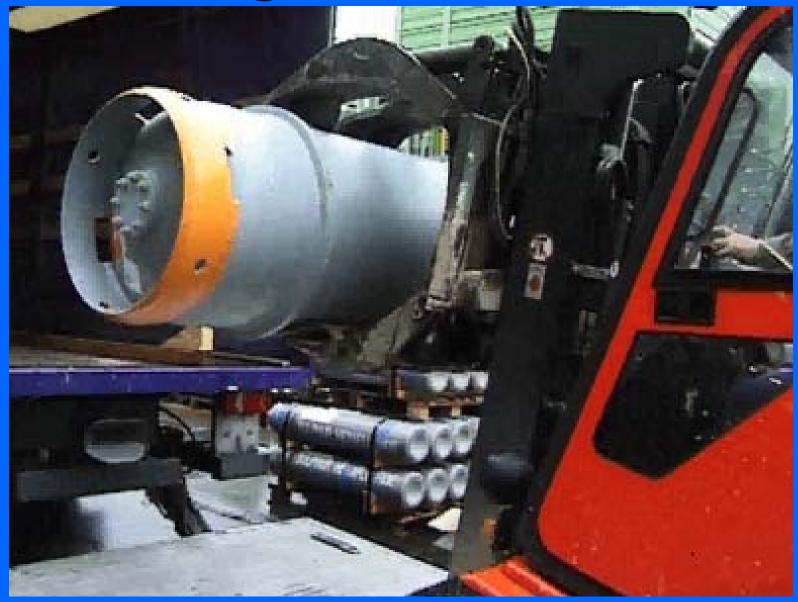
Gas Handling – Bad Wimpfen, Germany \land At the time the ship was set to sail, SF₆ ReUse cylinder, as classified, was deemed incompatible with other goods on ship & ReUse cylinder was rolled to another cargo vessel, set to sail at later date Unforeseen delay, no photos available from actual ReUse cylinder in Germany \land Archived photos show typical Used SF₆ gas handling procedures
