RE: January 2014 Monthly Progress Report Former Crawford Station MGP Site Chicago, Illinois Peoples Gas Light and Coke Company

CERCLA Docket No. V-W-08-C-917 and V-W-11-C-981 CERCLIS ID – ILN0000510192

## Crawford Station Manufactured Gas Plant Parcel L Chicago, Illinois Weekly Field Progress Report

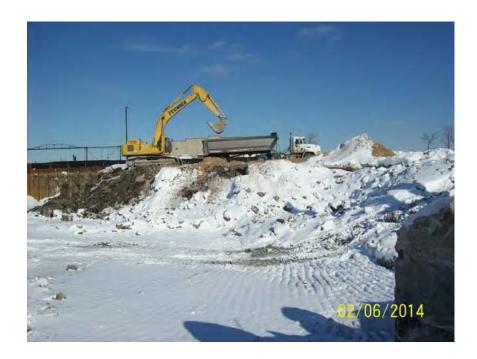
Description: View is from the south of Area 5S facing north. TES continued to load out impacted soils from the north area adjacent to the sheet pile wall.
