LESSONS LEARNED FROM CEDAR HILLS
10,000 SCFM High BTU Project
Maple Valley, Washington

Cedar Hills Landfill

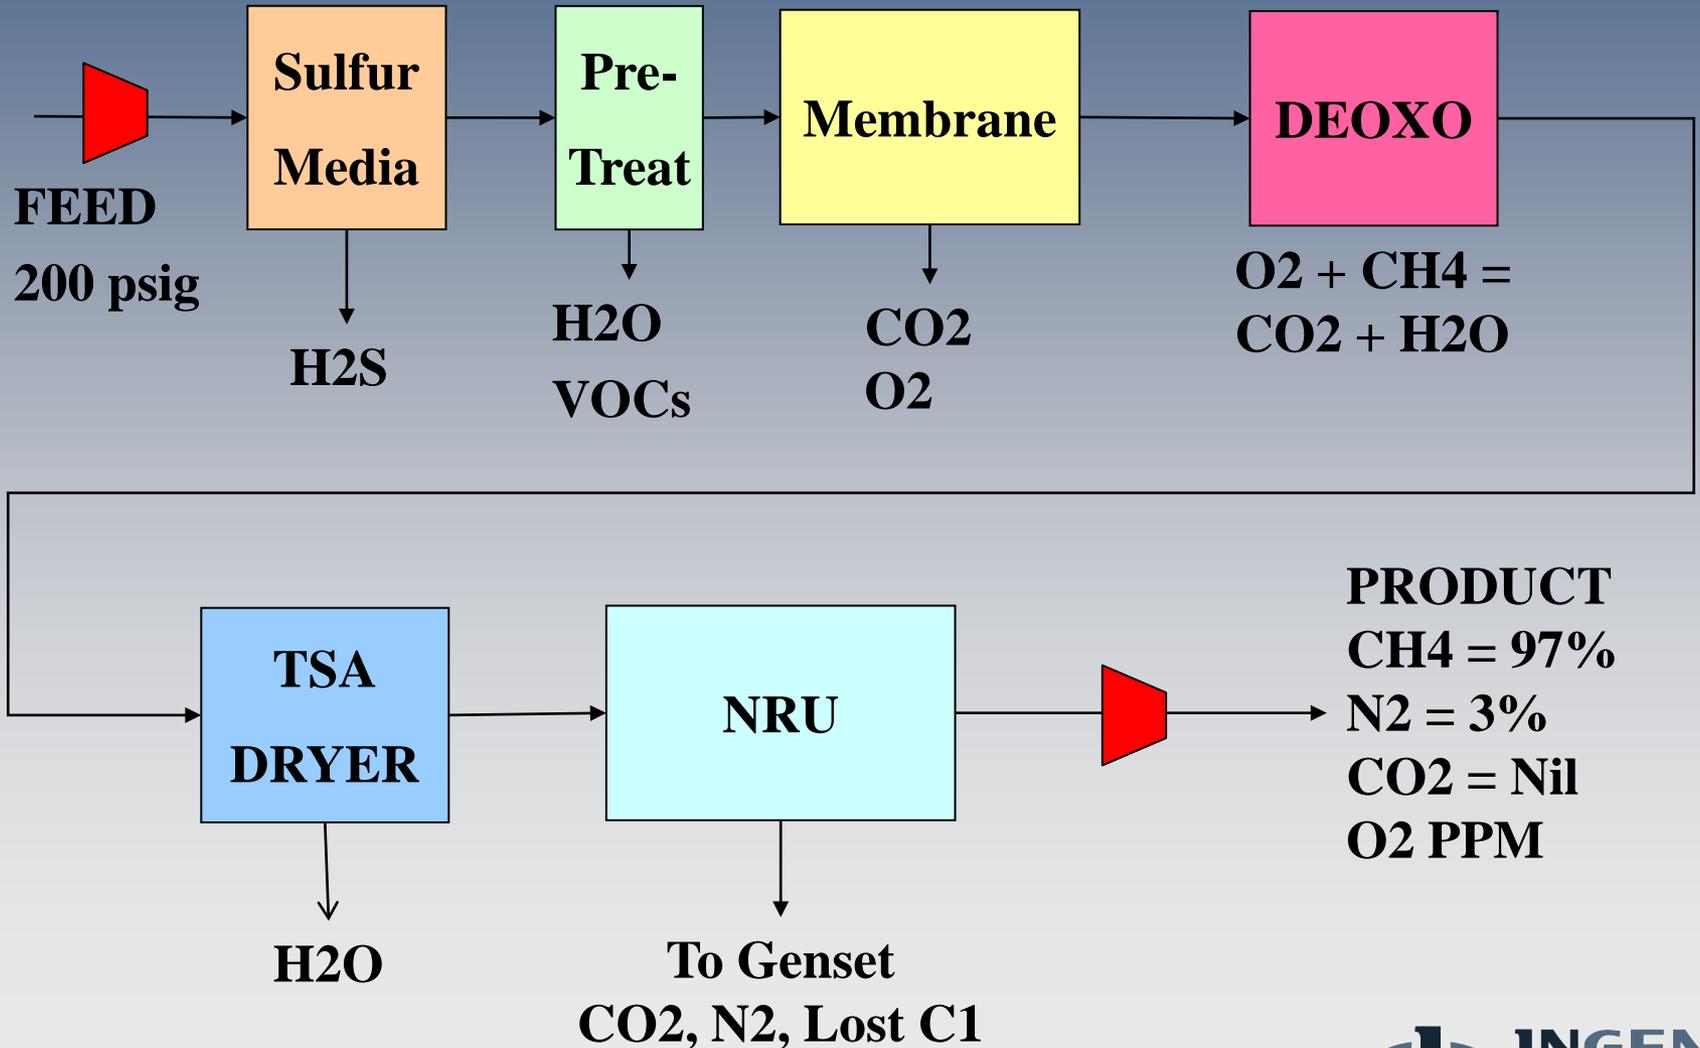
ORIGINAL DESIGN

Initial Startup – MAY 2009

- Worked through normal start-up issues
- H₂S removal and compressor issues
- Additional membranes added for CO₂ removal to handle volume

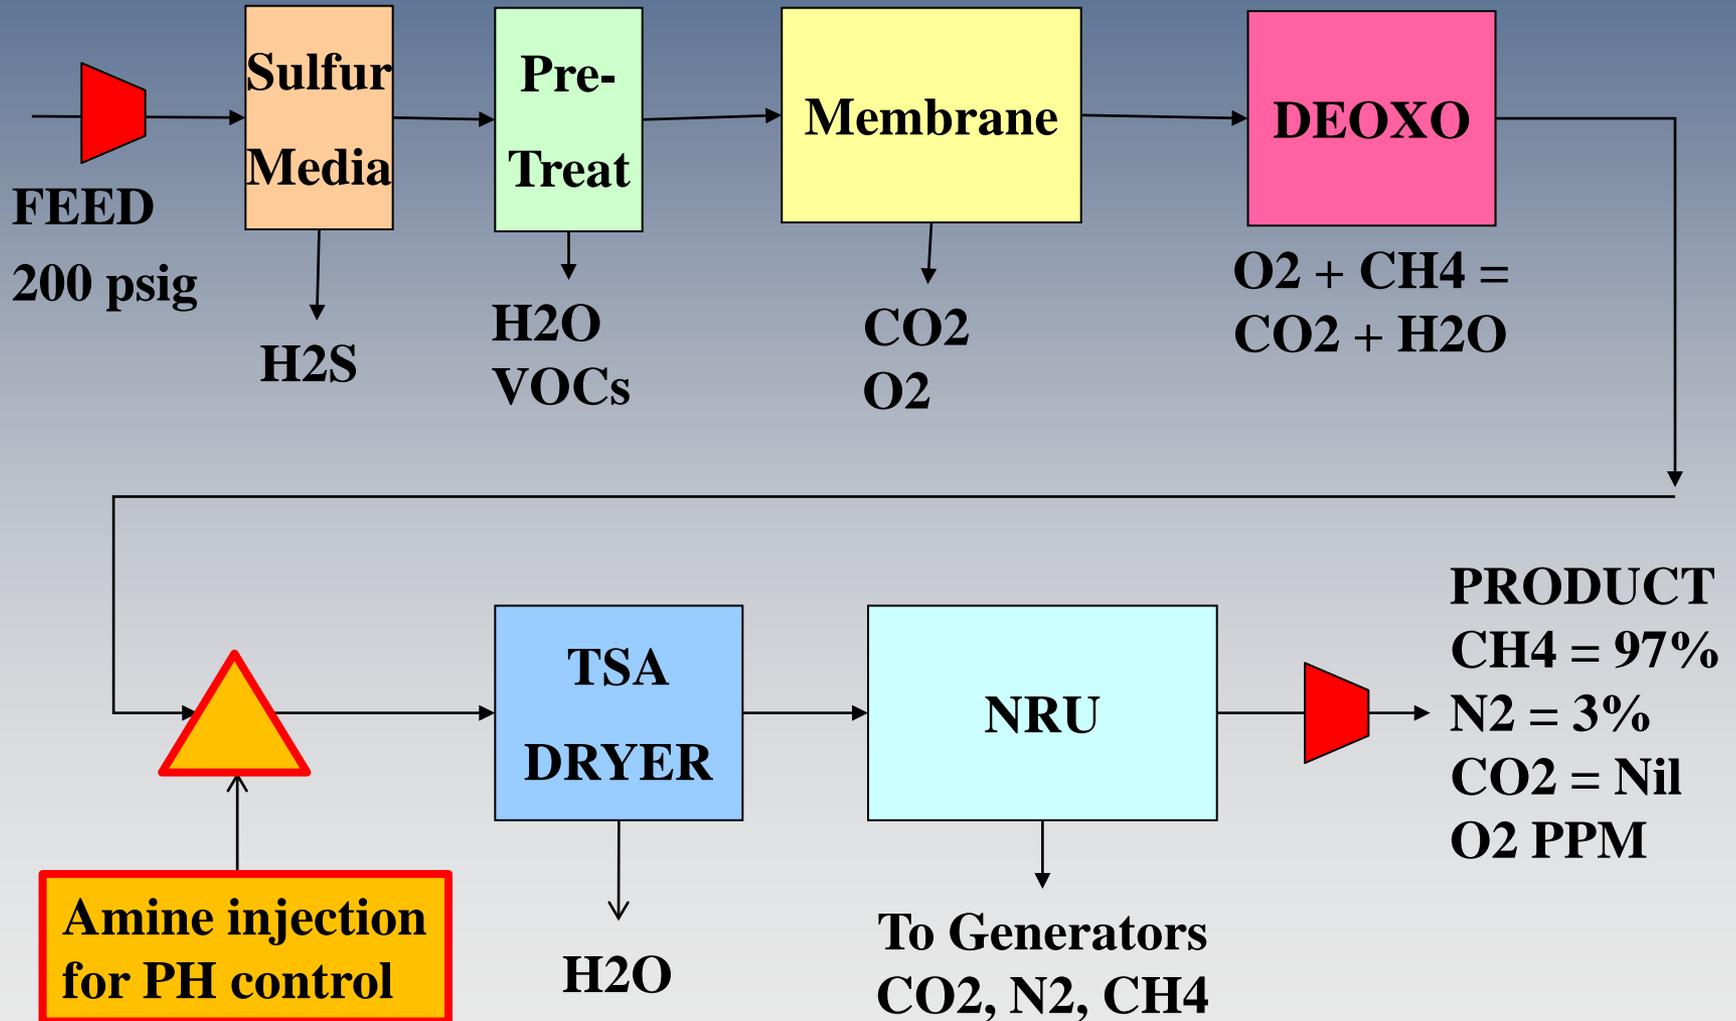
INTERIM SOLUTION

Early Operation

- **Media in NRU began degrading and turning into dust upon startup**
- **Discovered low PH condensate downstream of De-Oxo converter and corroded heat exchanger**
- **Added amine and water injection to control PH**

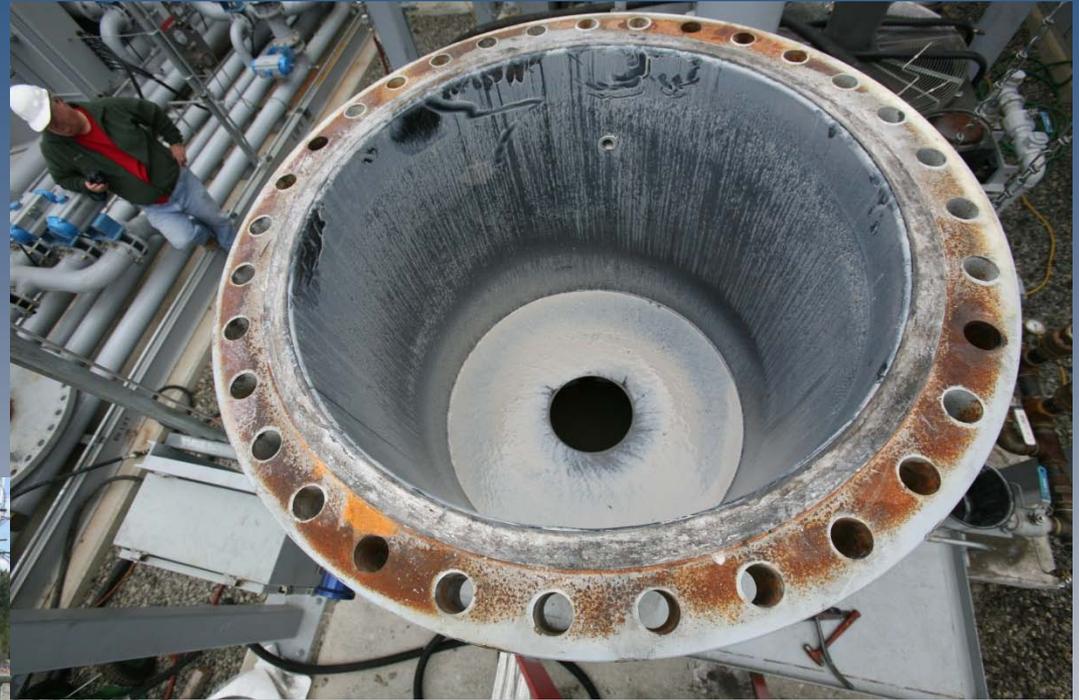
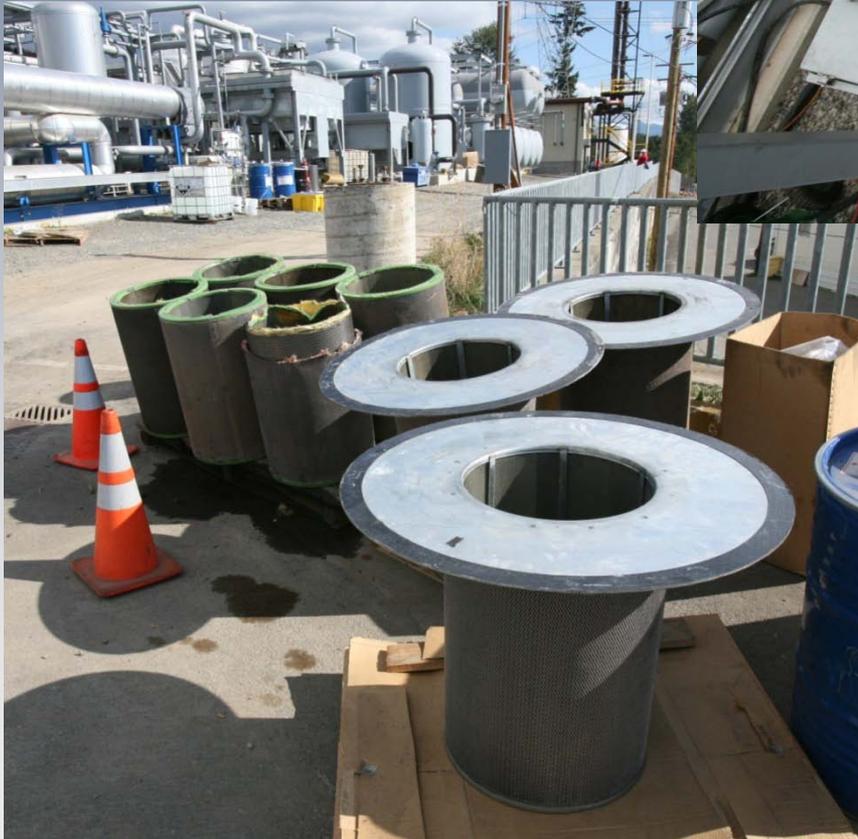
NRU FAILURE

- **Extra filtration installed to trap dust**
- **In first 3 months media replenishment required**
- **Consequential failures caused additional dusting and eventual total plant shutdown and replacement of all media**

**Filters changed
again and again
and . . .**

**Bought so many
filters
manufacturer ran
out of components**

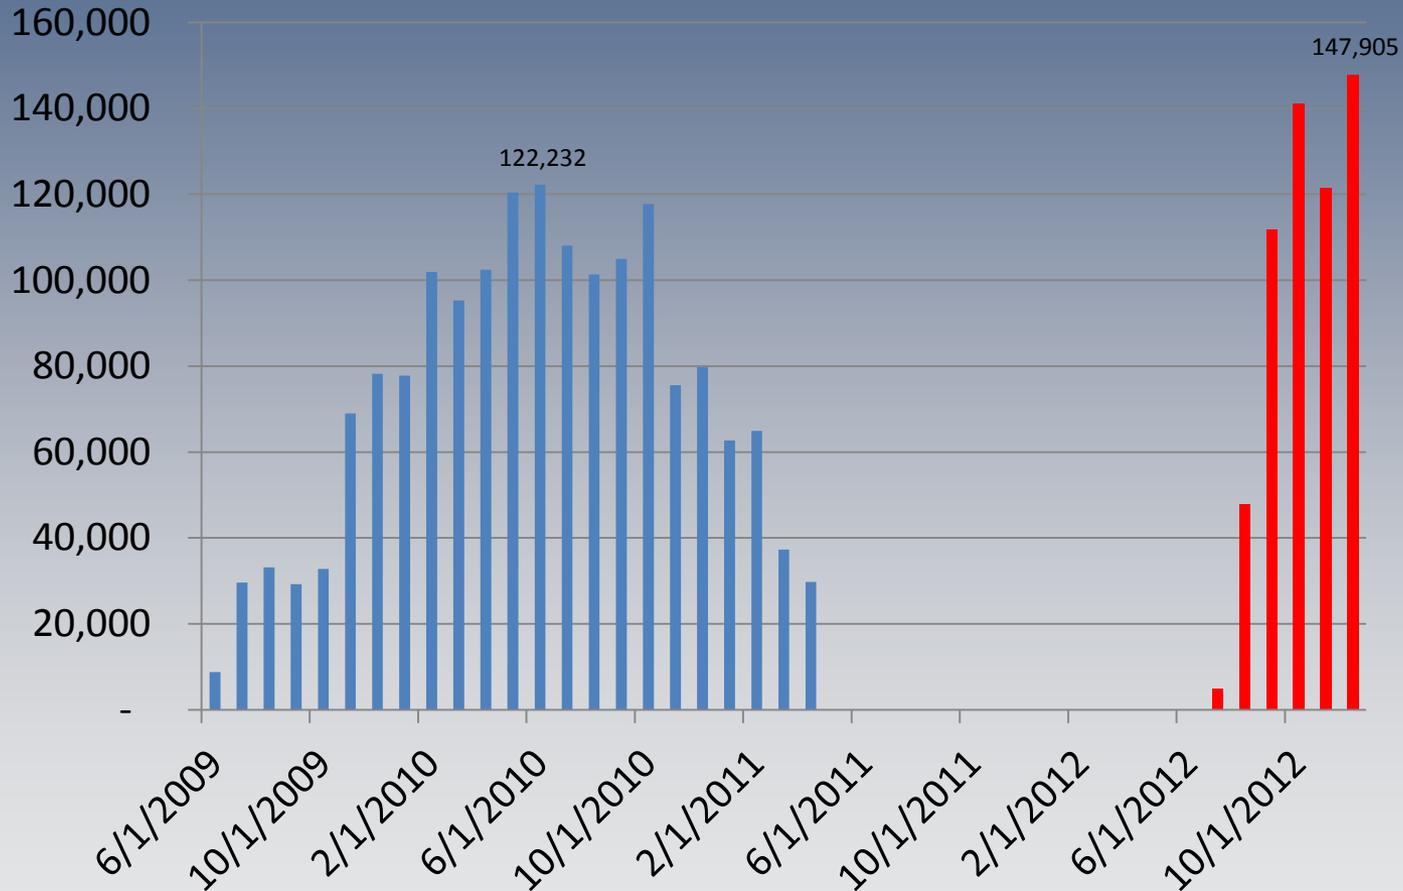
Results Much Improved

21% greater monthly output
