# Lincoln County, WV Onsite Treatment Project Overview

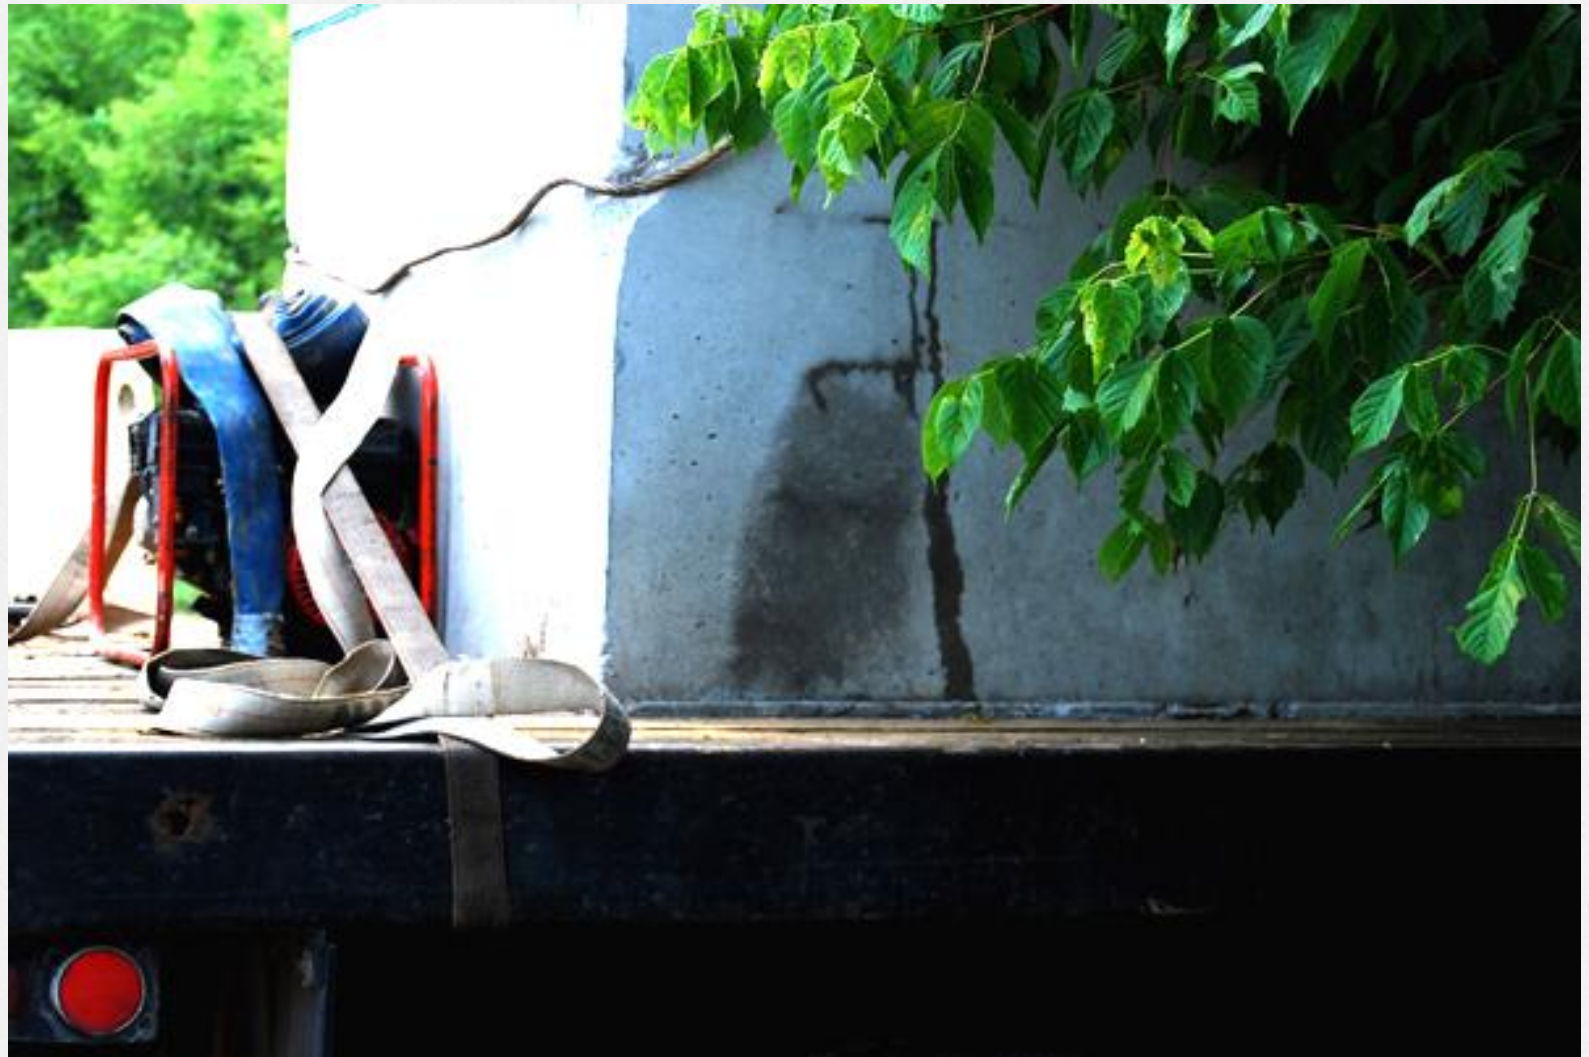
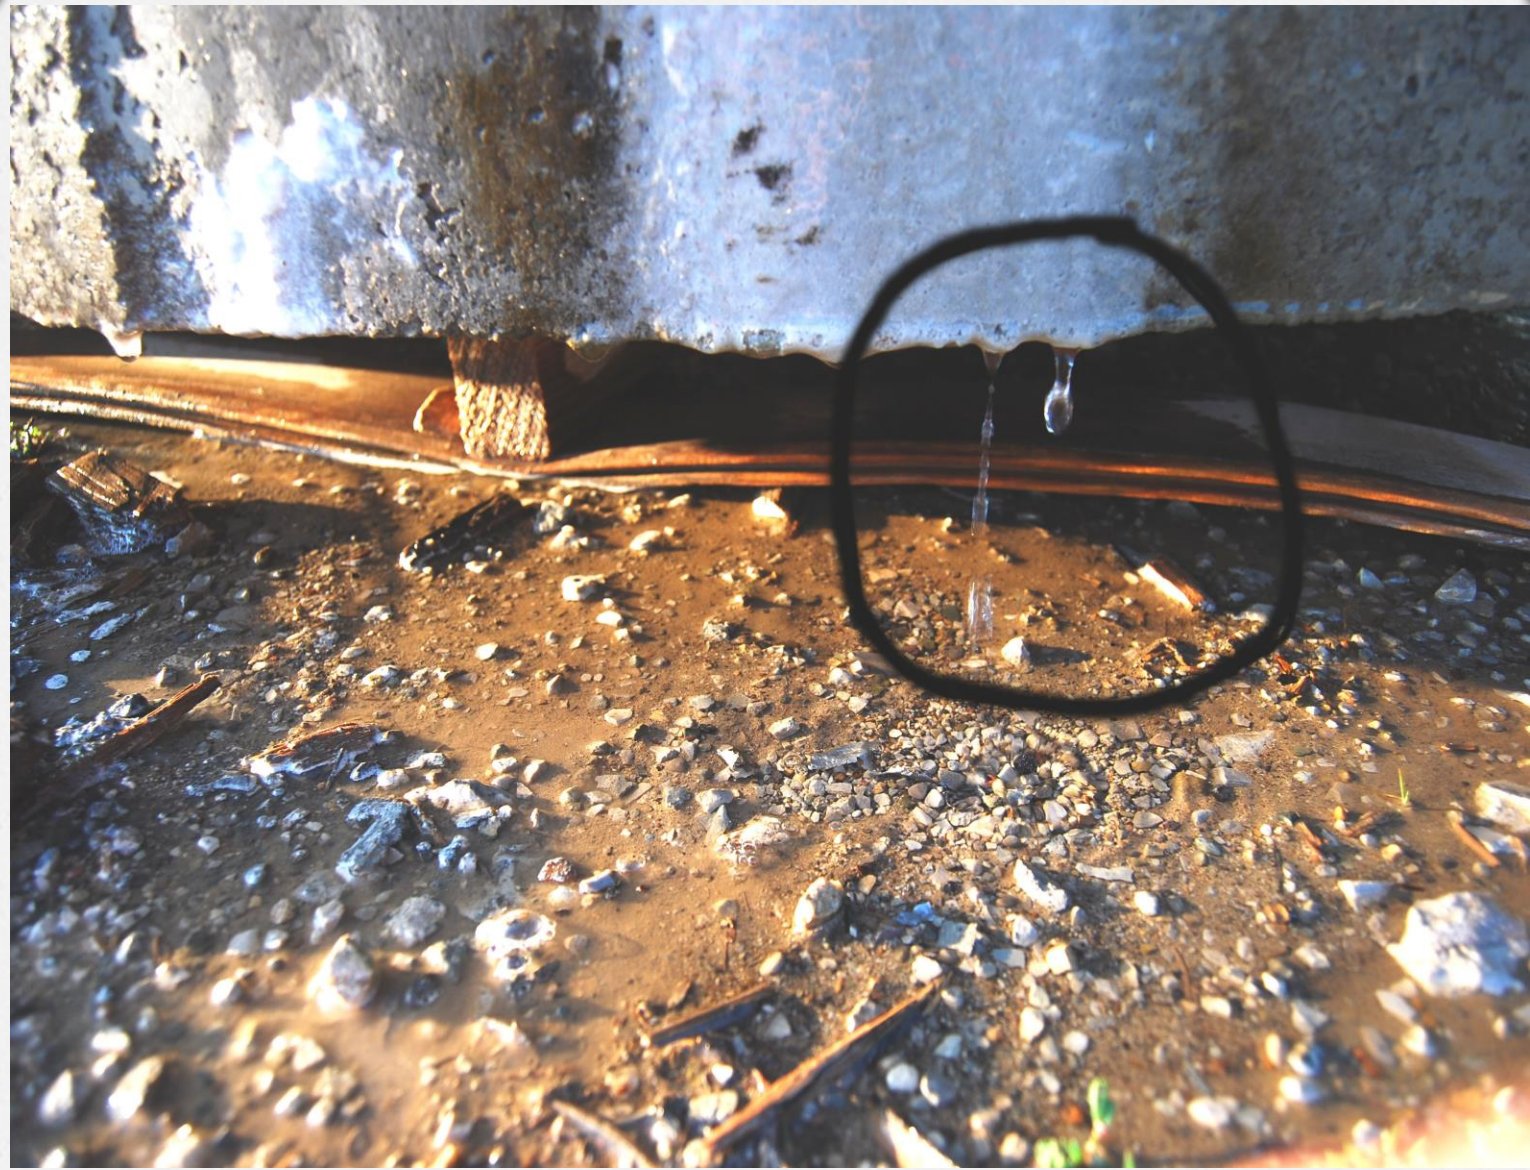
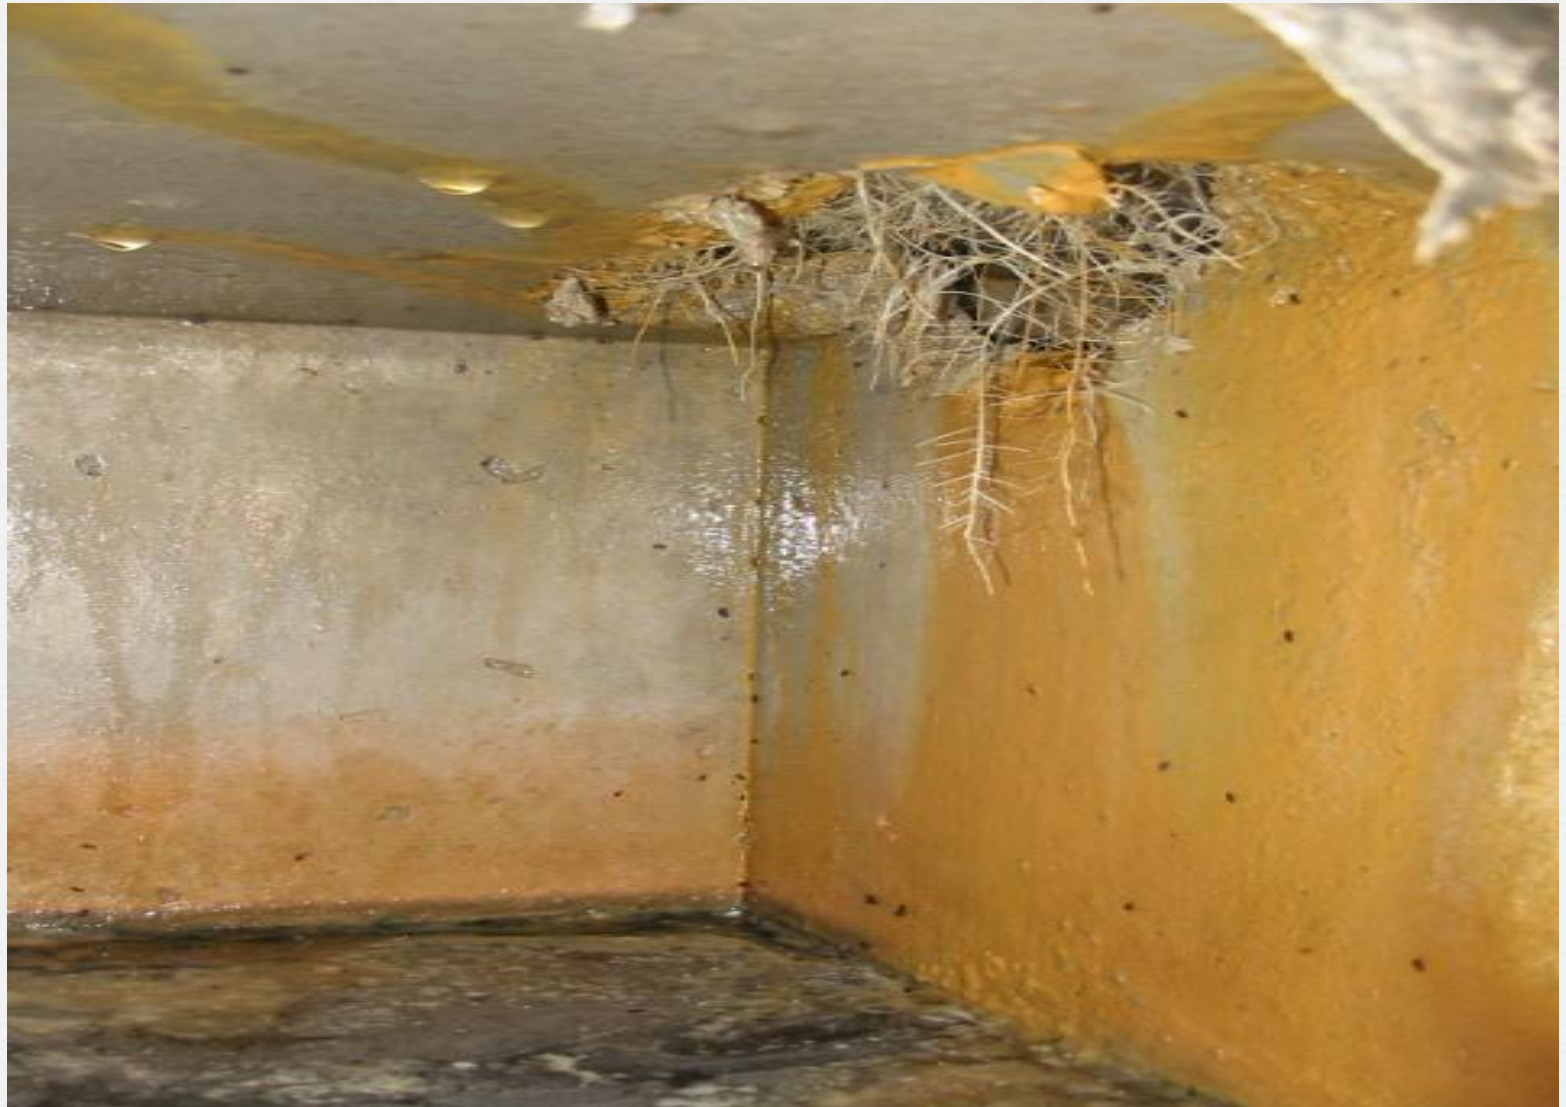
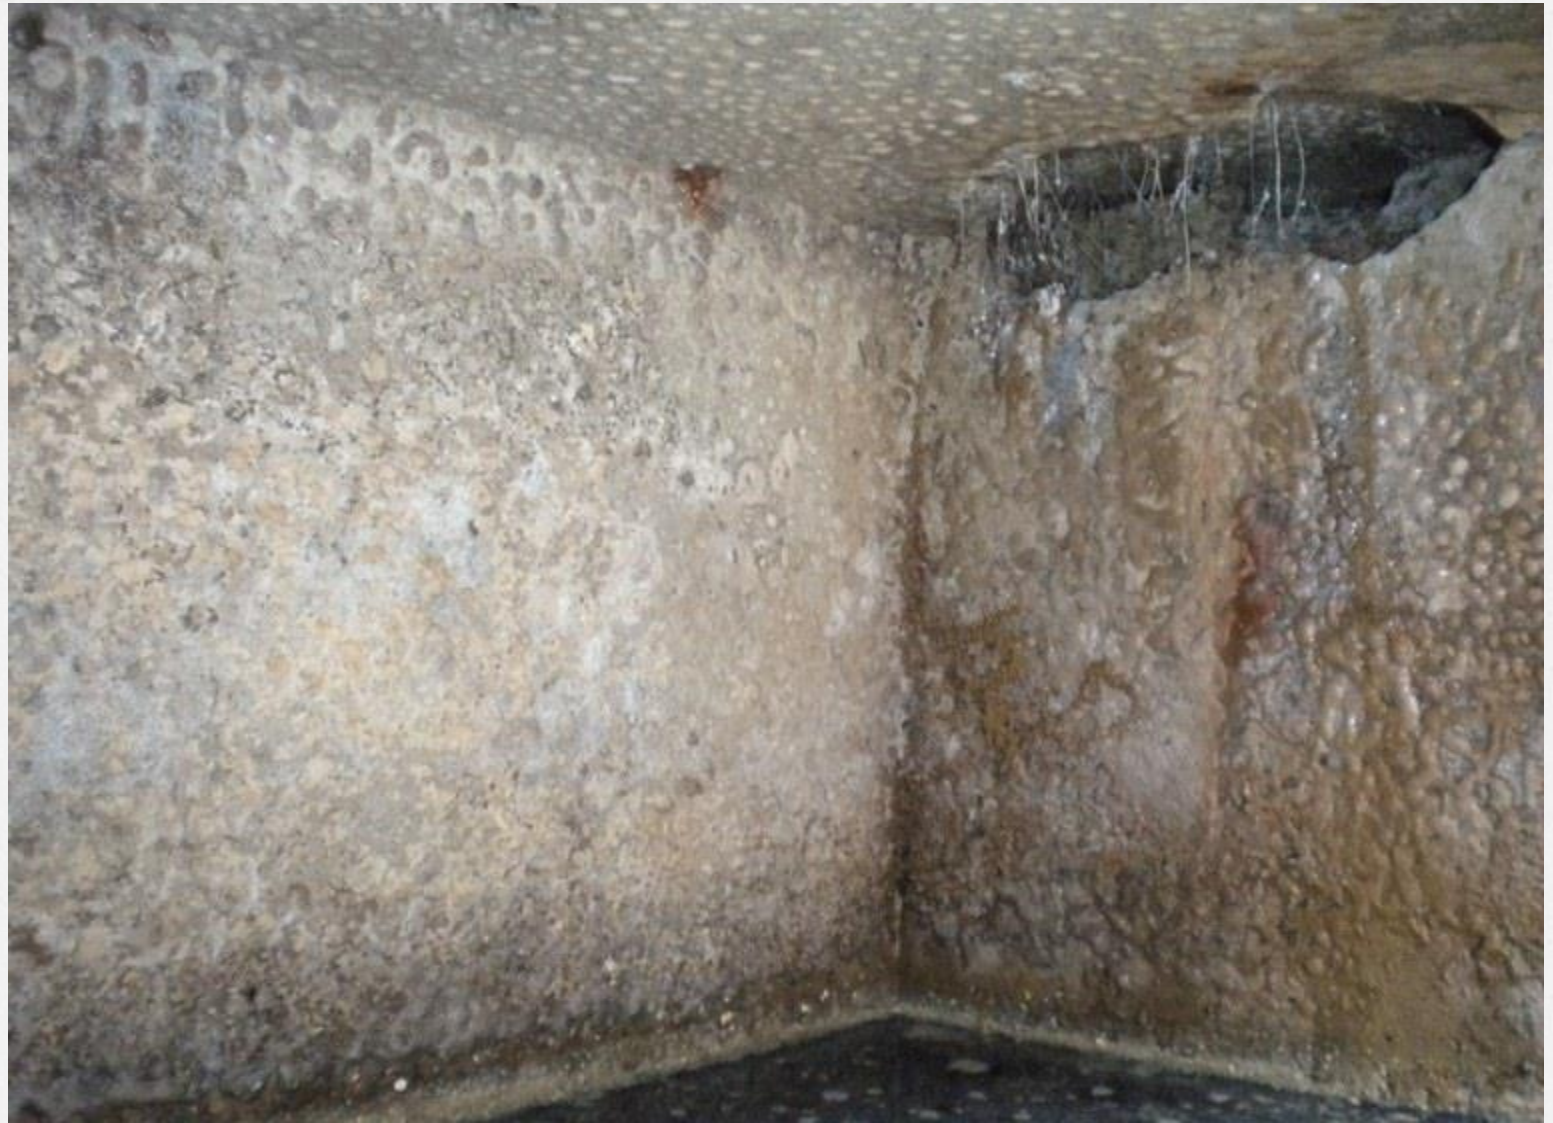
# Concrete Tanks

- Were used in Phase I, but almost immediately had problems.
- Holes developed allowing water both in and out.
- Manufacturer wasn't willing or able to completely satisfy the Commission with his attempts at solving issues.
- Commission had to switch to polyethylene tanks and exclude Manufacturer's products from being used in the project.
