Investigation Of Corrosion-Influencing Factors In Underground Storage Tanks With Diesel Service

U.S. Environmental Protection Agency
Office of Underground Storage Tanks

EPA 510-R-16-001
July 2016

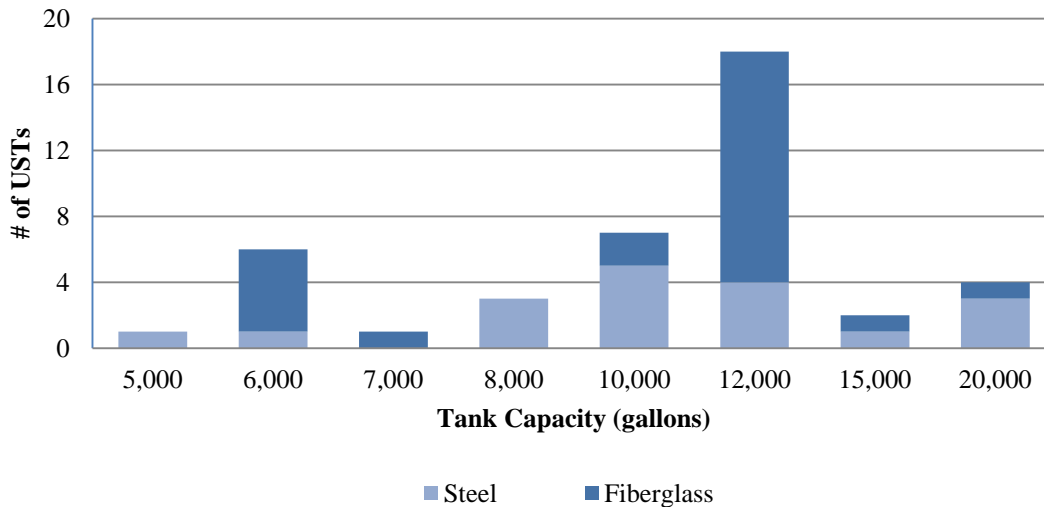
Figure 2. Summary Of 42 UST Systems By Capacity And Material

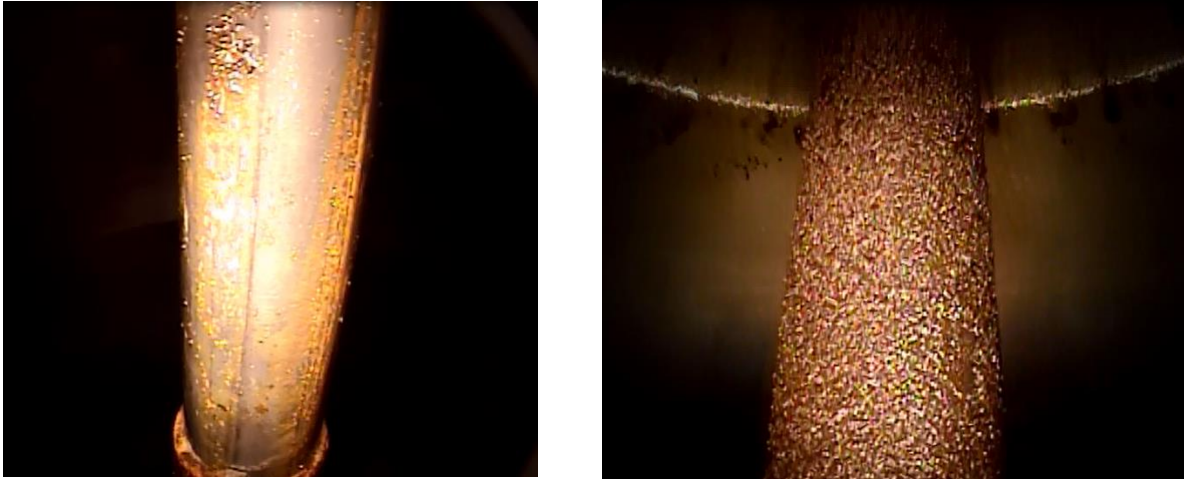
One important observation was that the steel surfaces exposed to the vapor phase above the fuel generally appeared to show more corrosion than the surfaces that were generally fully immersed in the fuel. In multiple USTs, we observed corrosion appearing to be more advanced on portions of the STP shaft, which are generally in the vapor space than on the section generally in the fuel level. See an example from UST system 9-IN-FG in Figure 5.

**Figure 5. UST System 9-IN-FG STP Shaft Corrosion
(Left Photo: Middle Of Shaft [Generally Submersed], Right Photo: Top Of Shaft
[Generally Exposed To Air])**

The STP shaft is situated vertically in the tank, and much of the shaft is exposed to both fuel and vapor space as fuel is dispensed and resupplied and the fuel level line rises and lowers in the tank. In some moderate corrosion cases observed in our research, the STP shaft was coated with corrosion in the vapor space, but was not yet affected in the wetted or sometimes wetted portions of the shaft. In some severe cases, the STP was entirely covered with corrosion. With the corrosion generally appearing heaviest in the highest points of the vapor space, the ATG riser and undersides of the manways, also referred to as tank bungs, are where the initial signs of corrosion should be expected, making these areas ideal for observing the beginning of corrosion development. In addition, we observed heavier corrosion in some areas of the ATG riser where vapor cannot circulate as easily around the rest of the tank.

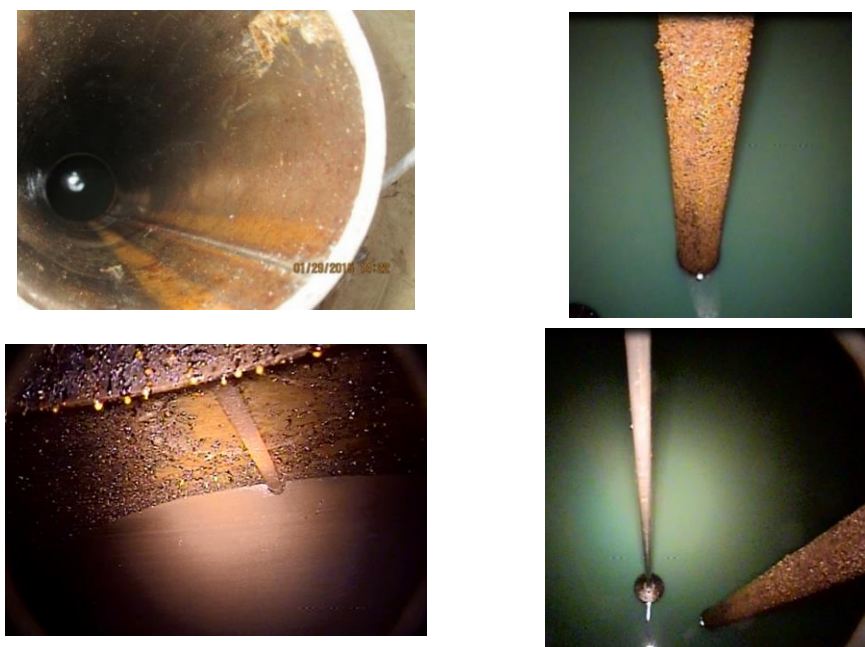
Figure 9. UST System With Steel Tank With Severe Metal Corrosion (43-MD-ST: Installed 1992; Age Of Filter Unknown). Top Left: Fill Pipe Opening; Top Right: STP Shaft; Bottom Left: Tank Top Showing Manway; Bottom Right: ATG Probe And STP Shaft

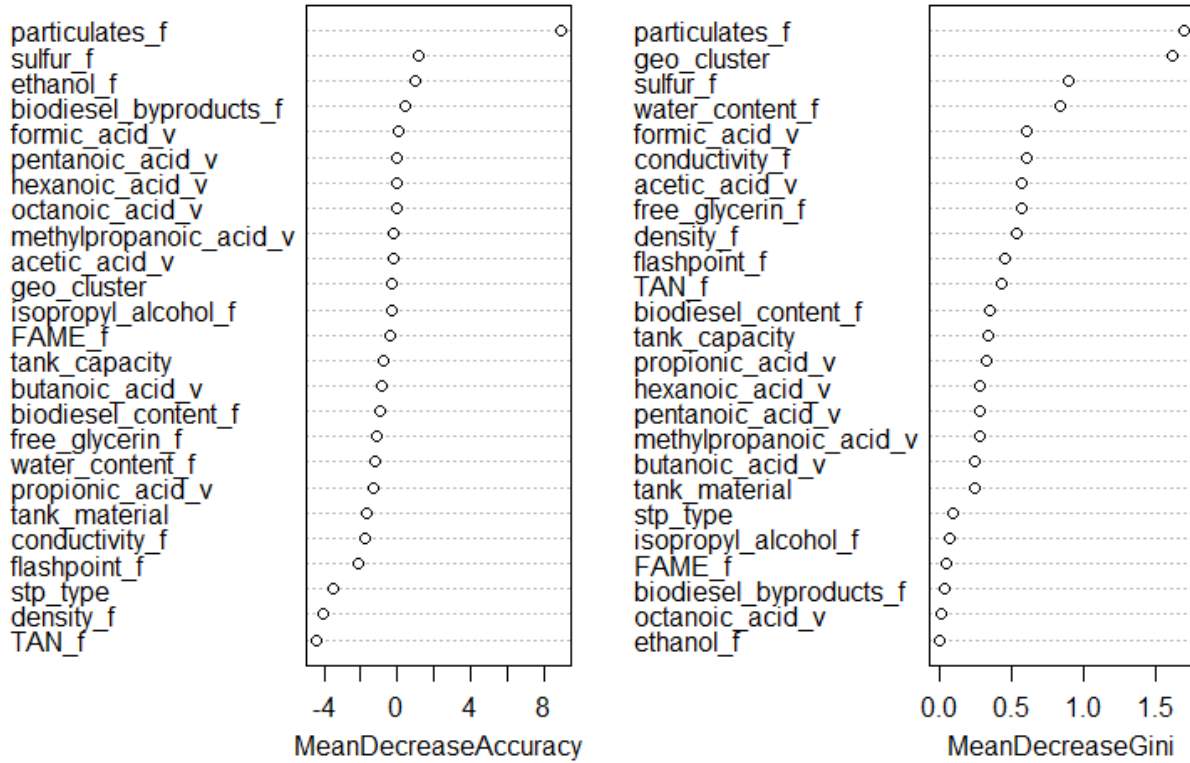
Corrosion Class	Predicted Class		Error In Predicting Class
	Minimal	Moderate + Severe	
Minimal	0	7	1
Moderate + Severe	1	34	0.03

Figure 11. Random Forest Analysis And OOB Accuracy Assessment Results Of Each Variable Evaluated Individually According To Minimal And Moderate + Severe Categories
