Section 2.0 Site Background

2.0 Site Background

Barr Engineering Co. 2006. Current Conditions/Release Assessment Report Corrective Action Order on Consent Docket No. RCRA-08-2004-0001., Rhodia Silver Bow Plant, Butte, Montana, February 2006.

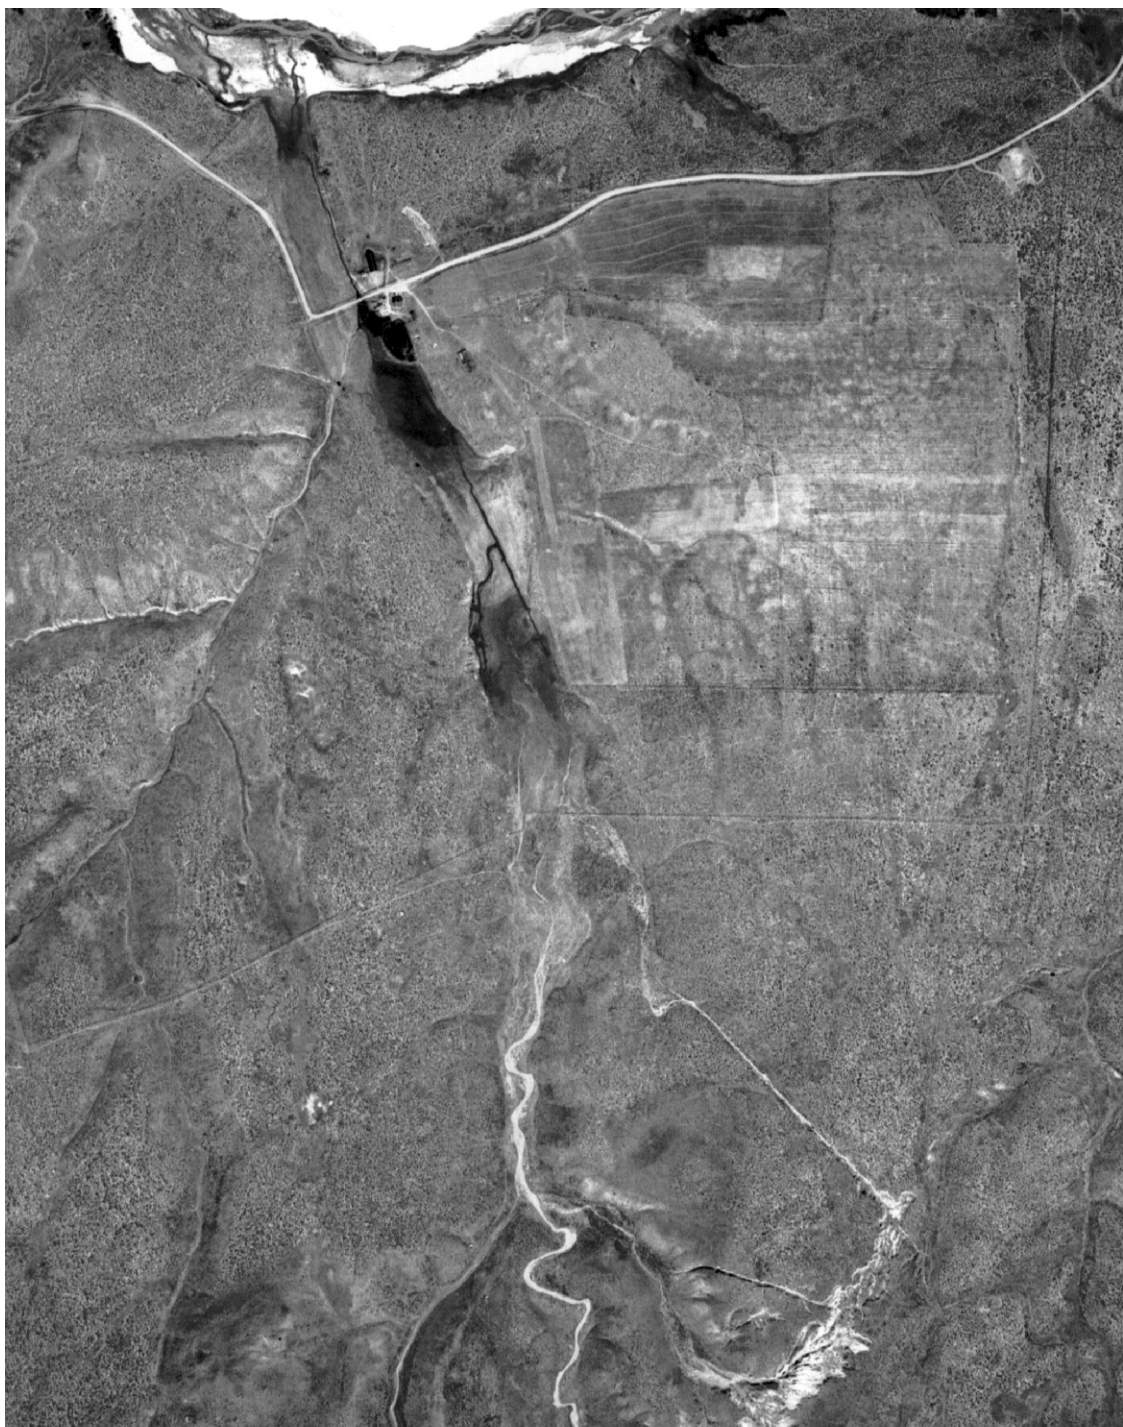
AERIAL PHOTO:
August 27, 1947
(Pre-Plant)

Prior to 1950, the property was agricultural land as seen in the August 27, 1947 aerial photo (CCRA Figure 2-6 in Appendix 2-B). Sheep Gulch, which appears to be a braided stream in the segment where the current tailing basin is located, flowed next to the small beaver pond that is north of the current tailing basin. Sheep Gulch and the beaver pond are visible in this photo. The Plant is present in the July 25, 1954, aerial photo (CCRA Figure 2-25 in Appendix 2-B), but the tailing basin had not been constructed. The Plant and the tailing basin are present in the 1977 aerial photo (CCRA Figure 2-26 in Appendix 2-B). By 1985, most of the buildings that existed in 1997 when the Plant was closed are visible (CCRA Figure 2-27 in Appendix 2-B). CCRA Figure 2-30 (Appendix 2-B) shows the September 2 and 12, 2002 recent aerial photo illustrating that much of the production Plant has been demolished.

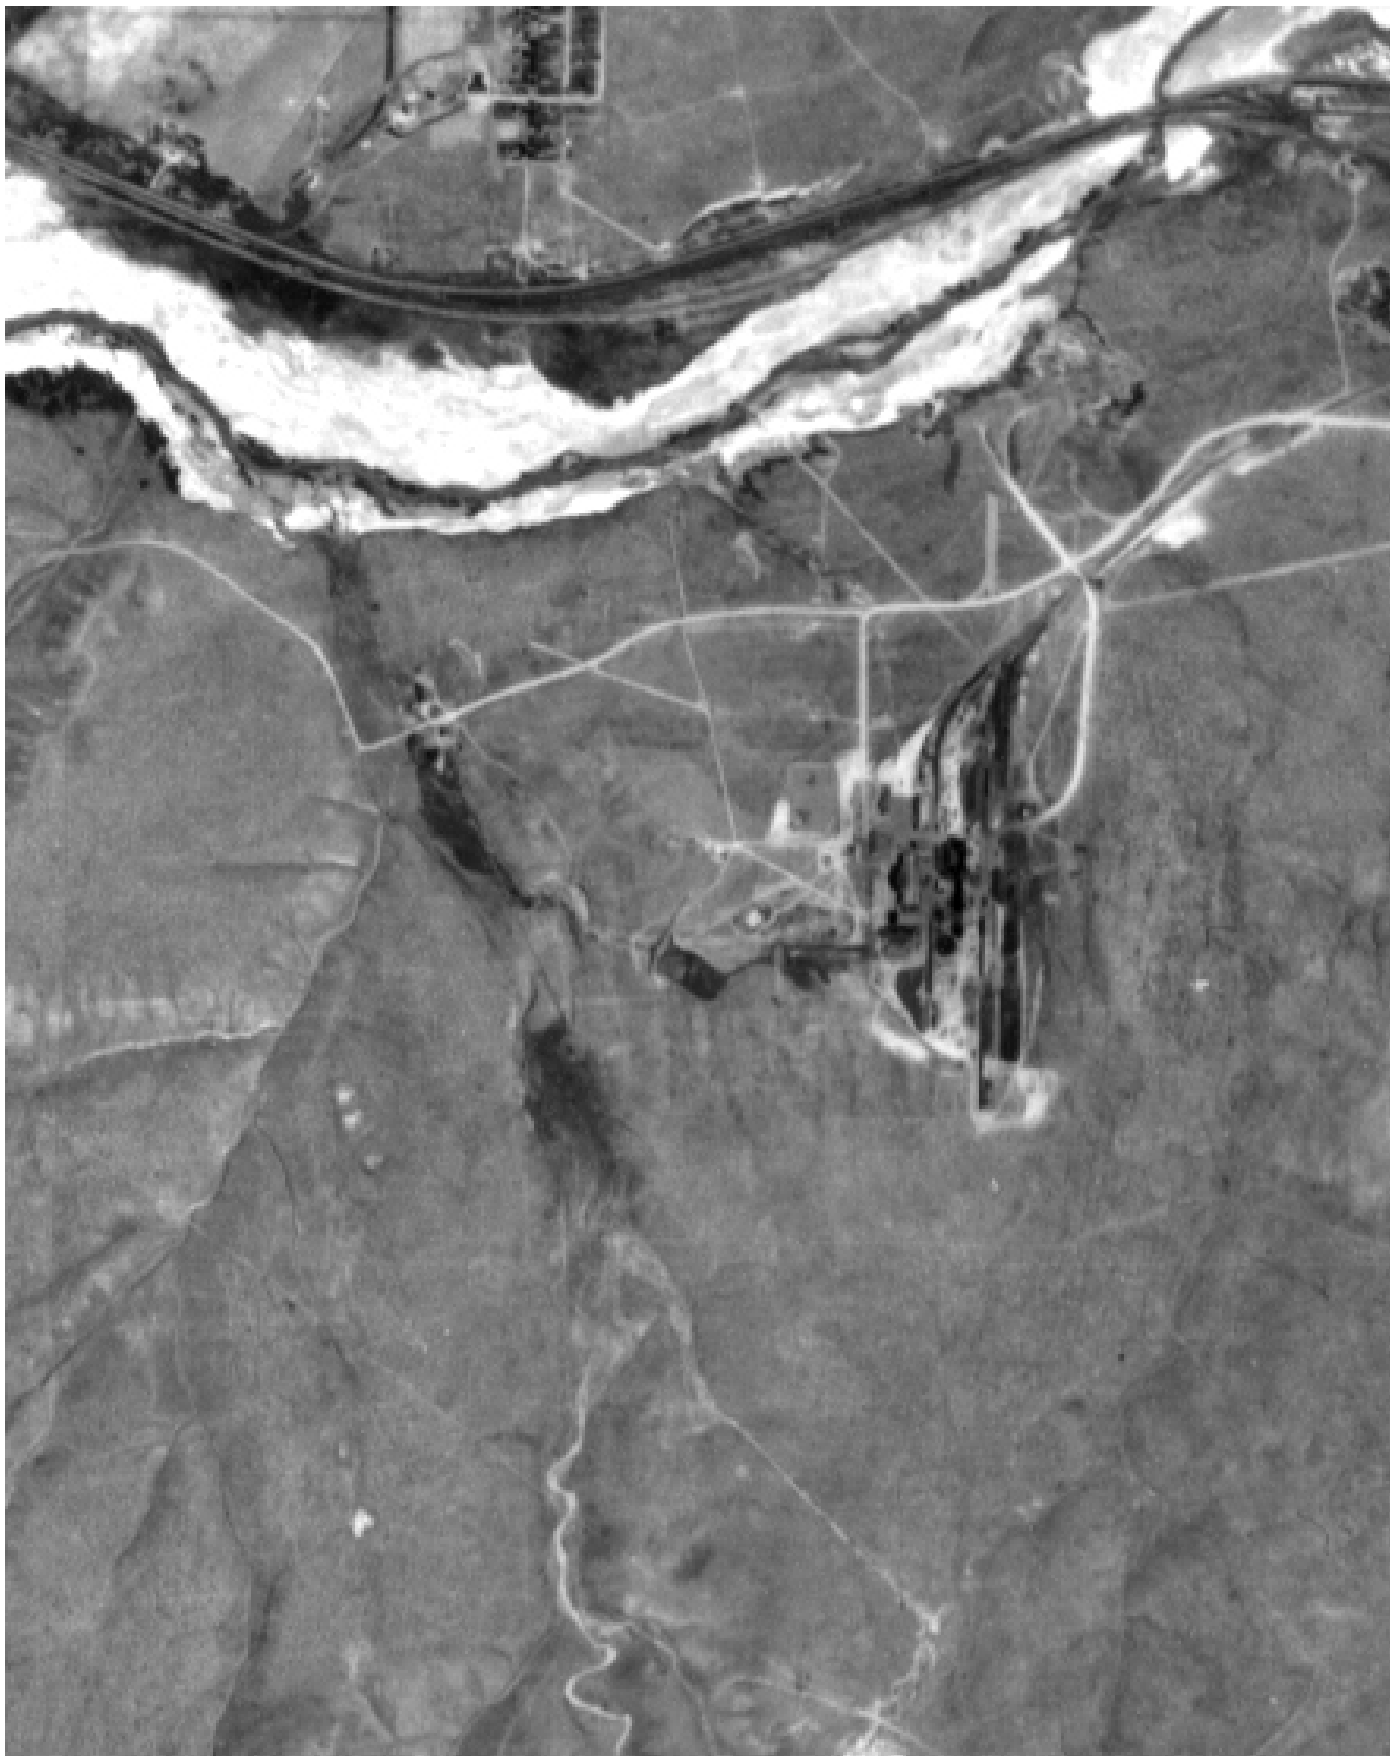
Figure 2-25

AERIAL PHOTO:
July 25, 1954
(Plant Present, Pre-Tailing Basin)

below. As an overview, aerial photos (CCRA Figures 2-6 and 2-25 through 2-30, included in Appendix 2-B), show the site development over time.

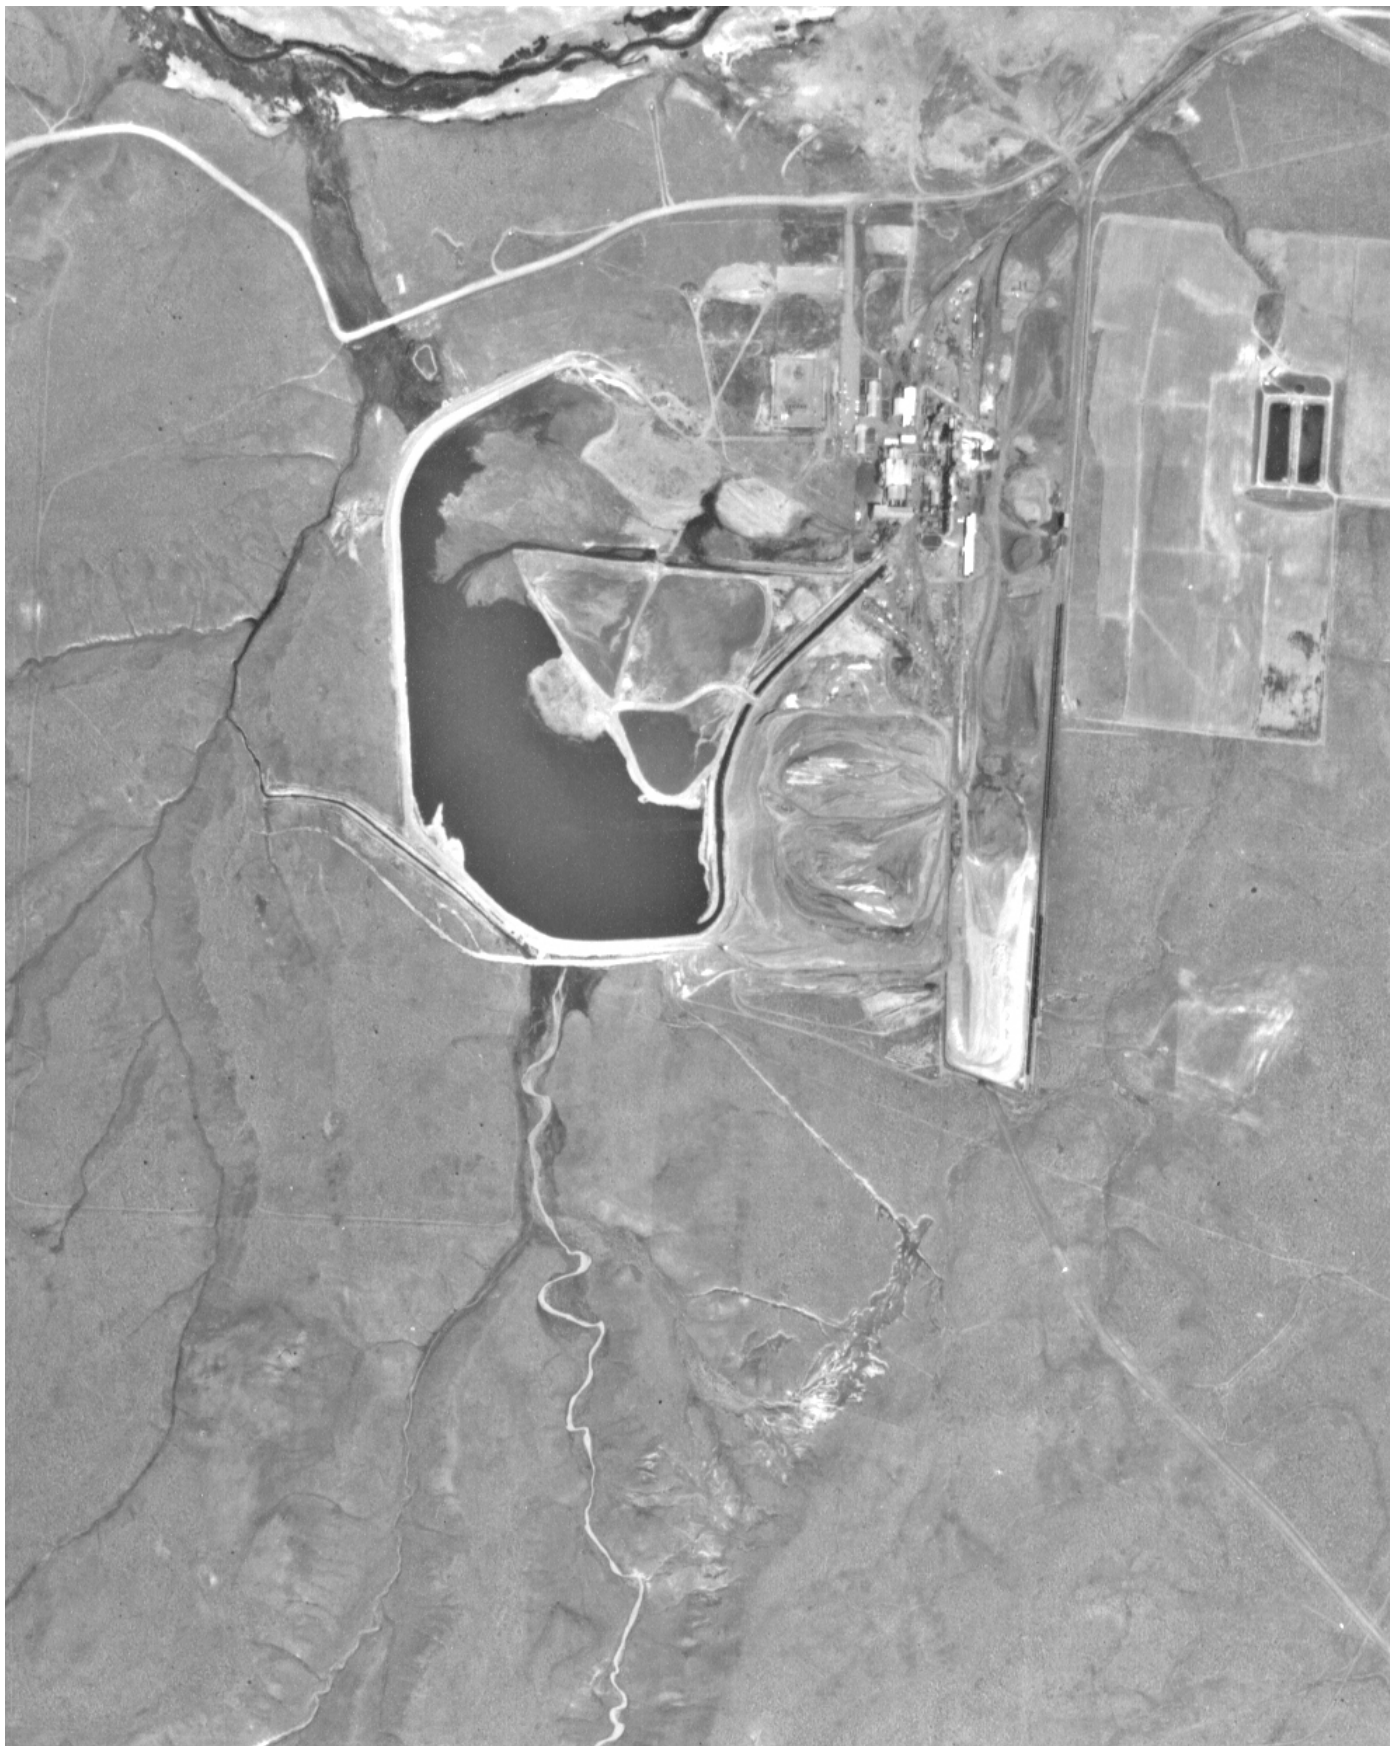
Figure 2-27

AERIAL PHOTO:
August 18, 1985

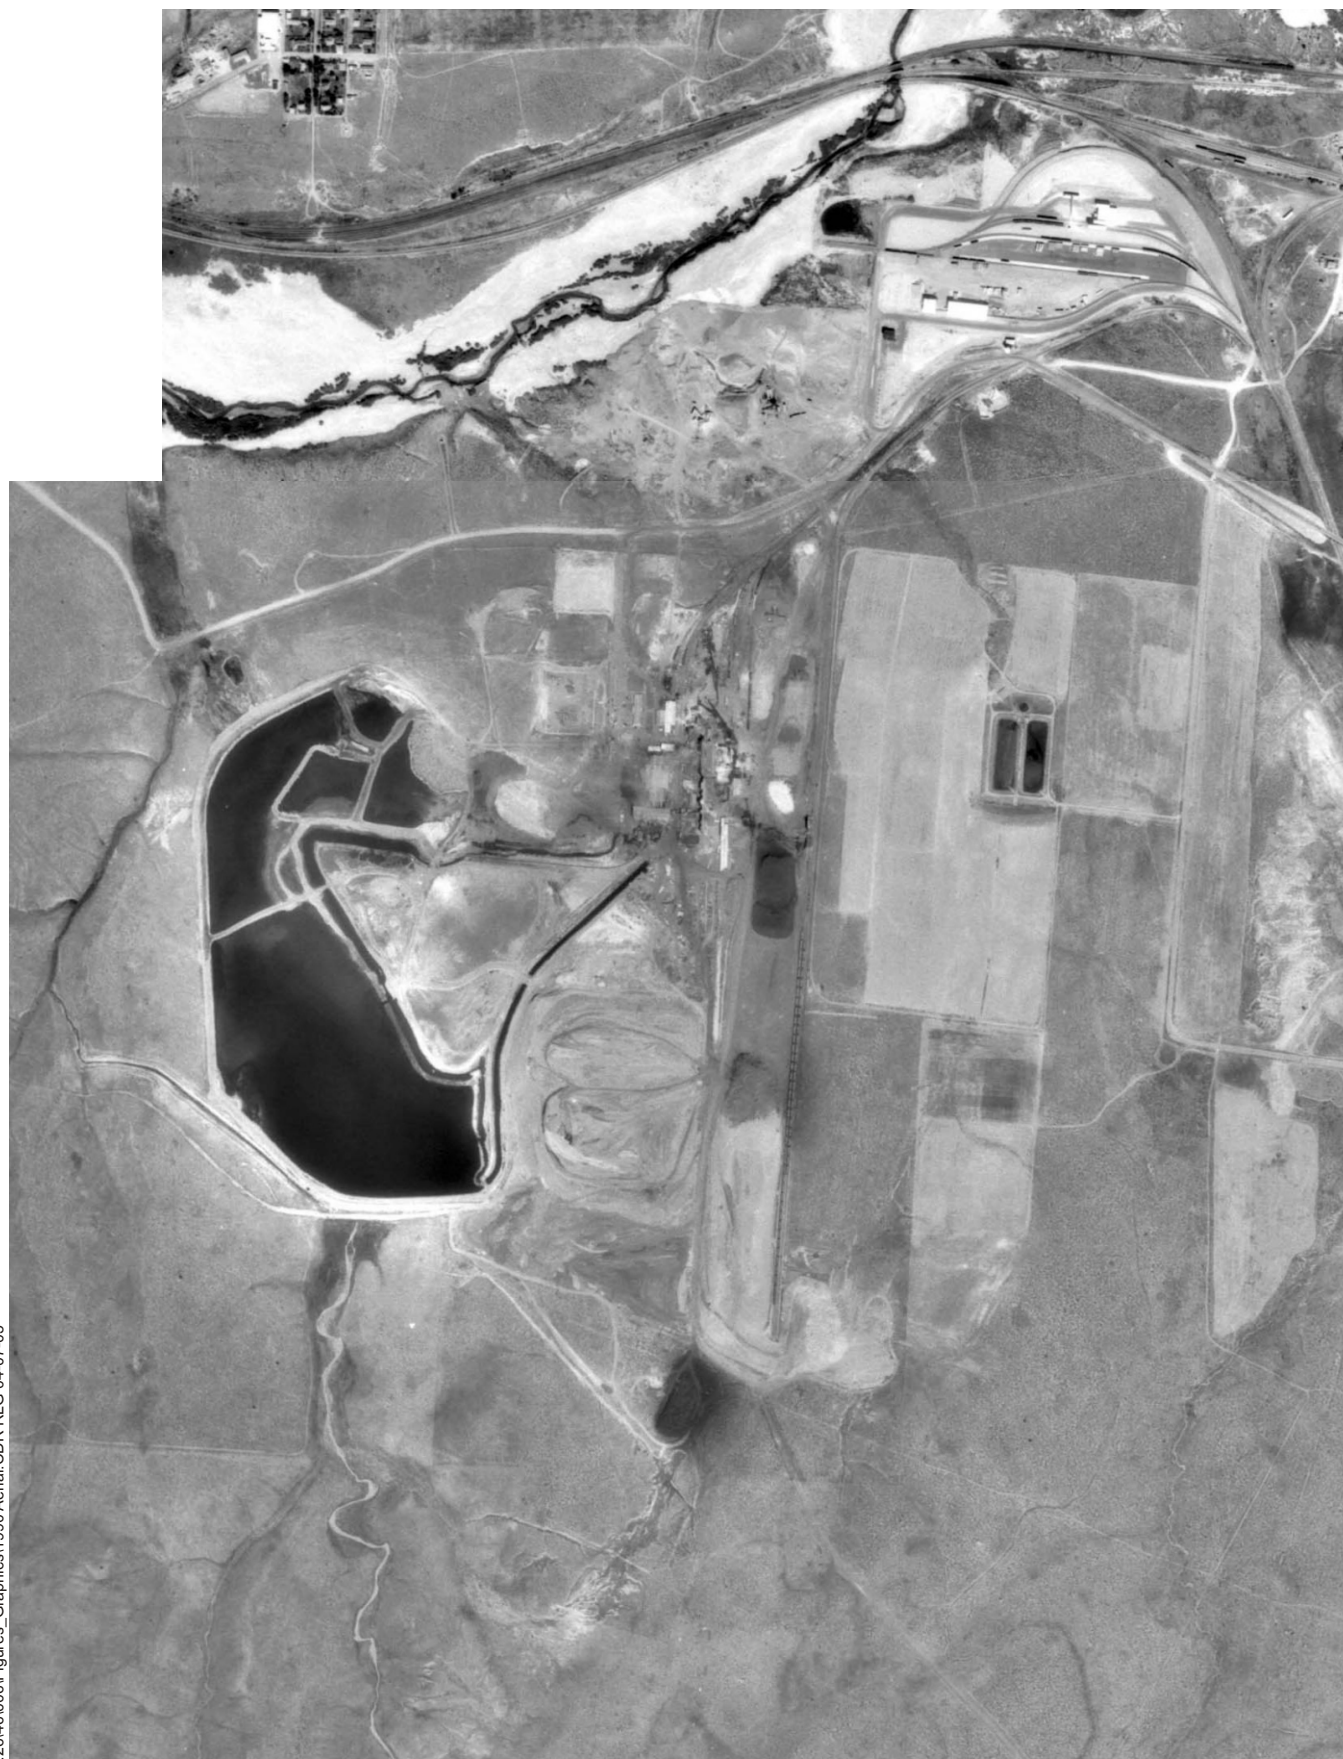
Figure 2-28

AERIAL PHOTO:
August 4, 1990

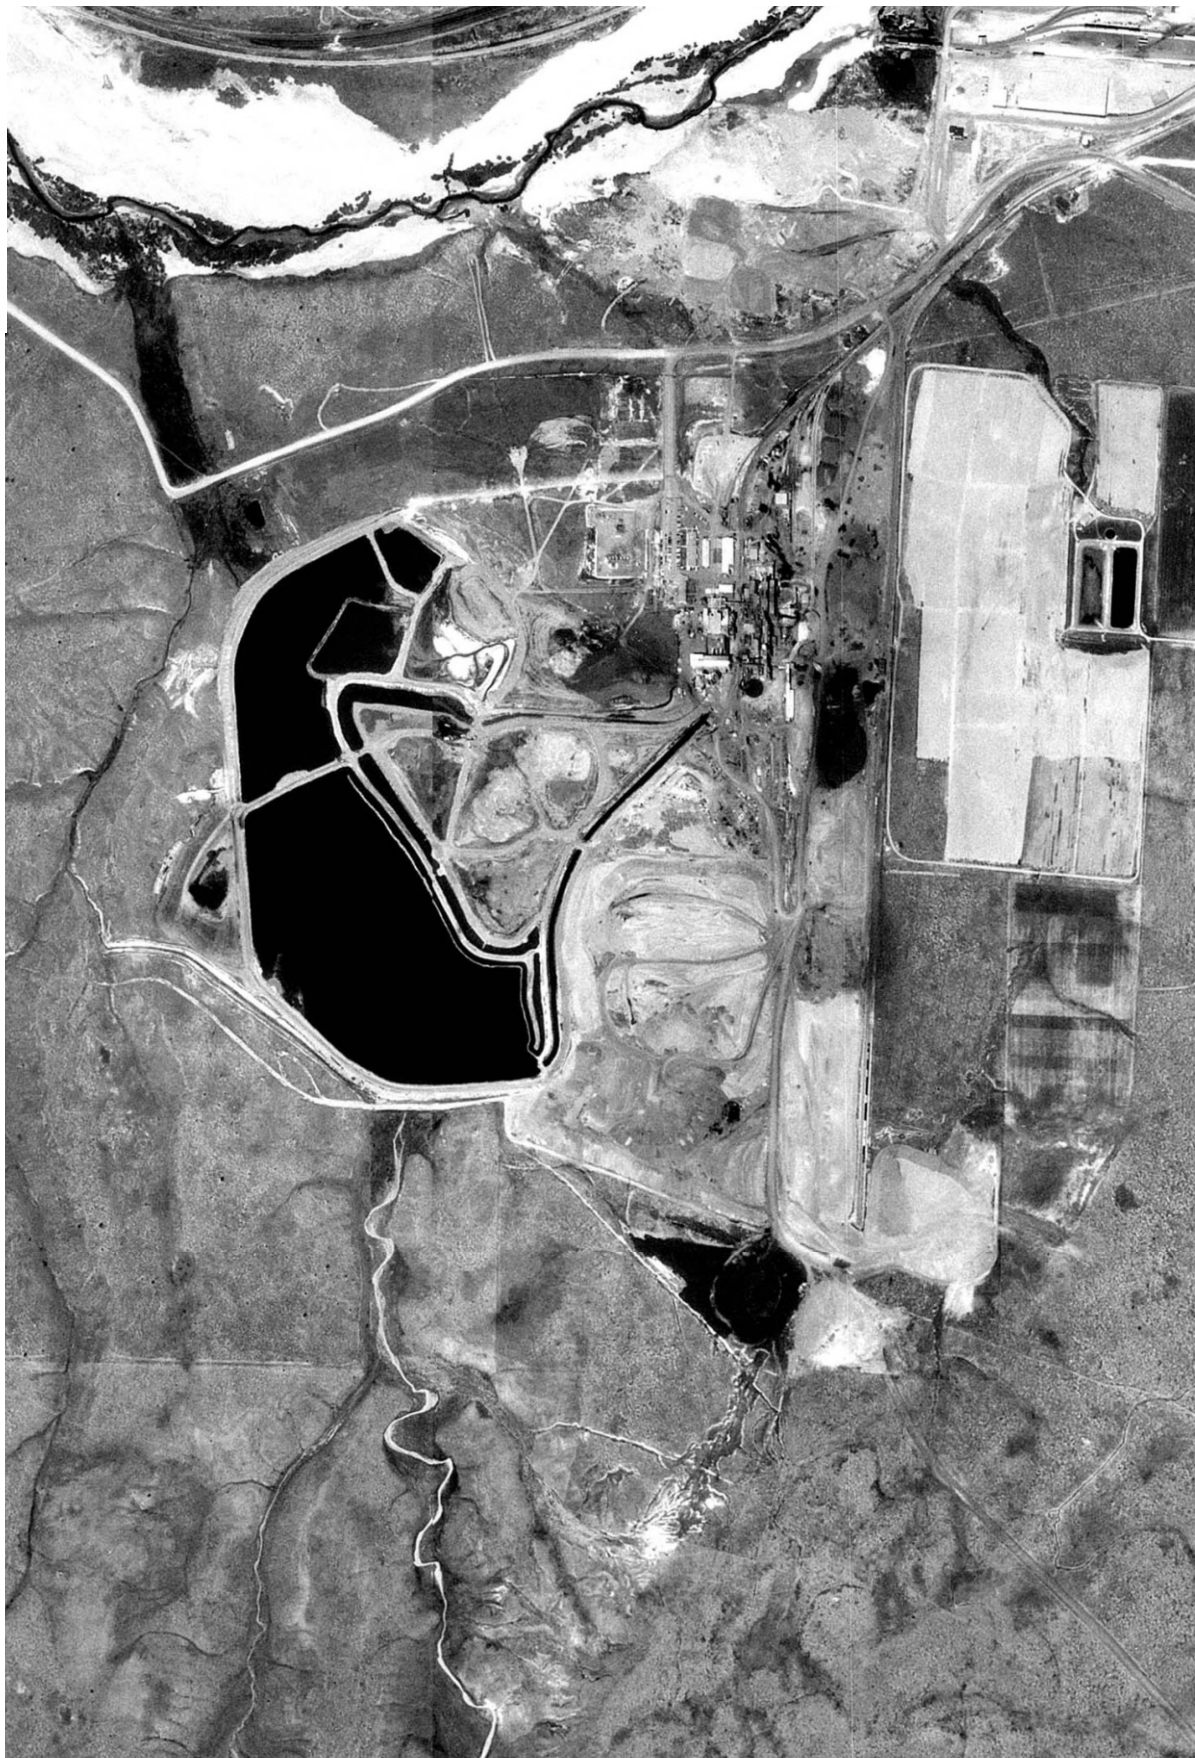
Figure 2-29

AERIAL PHOTO:
August 1, 1995

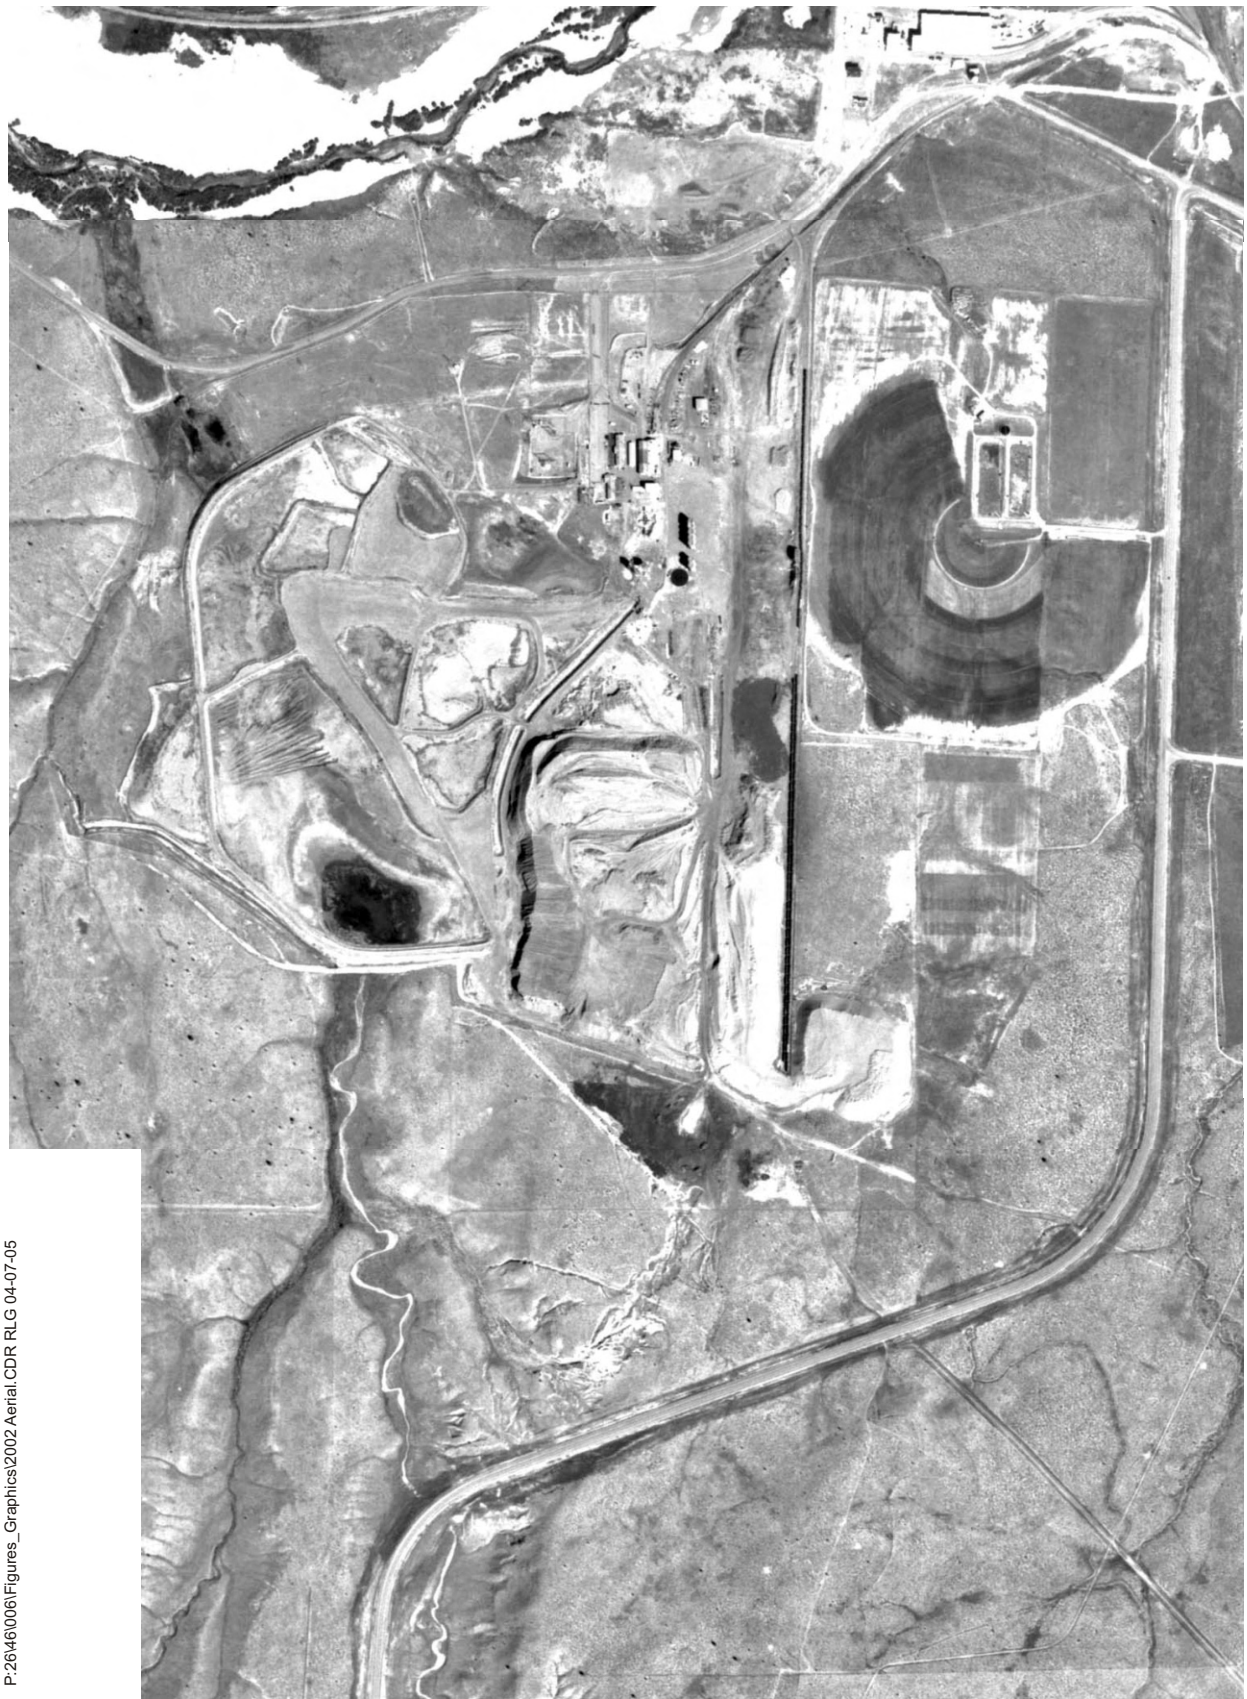
AERIAL PHOTO:
September 2 & 12, 2002

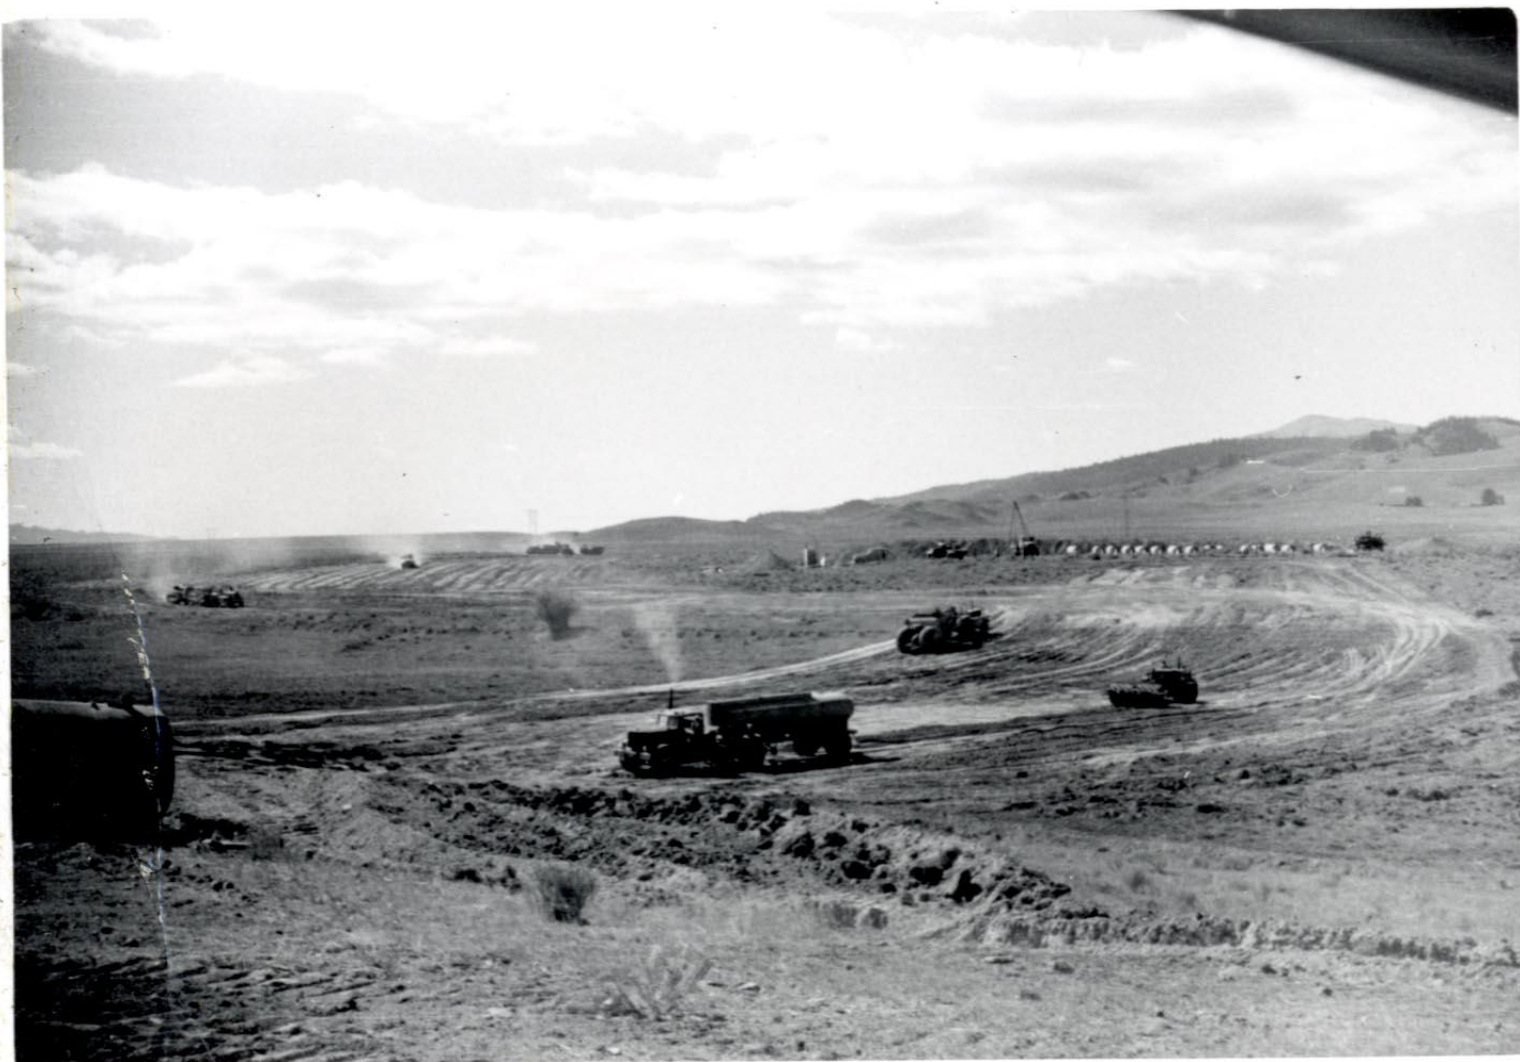
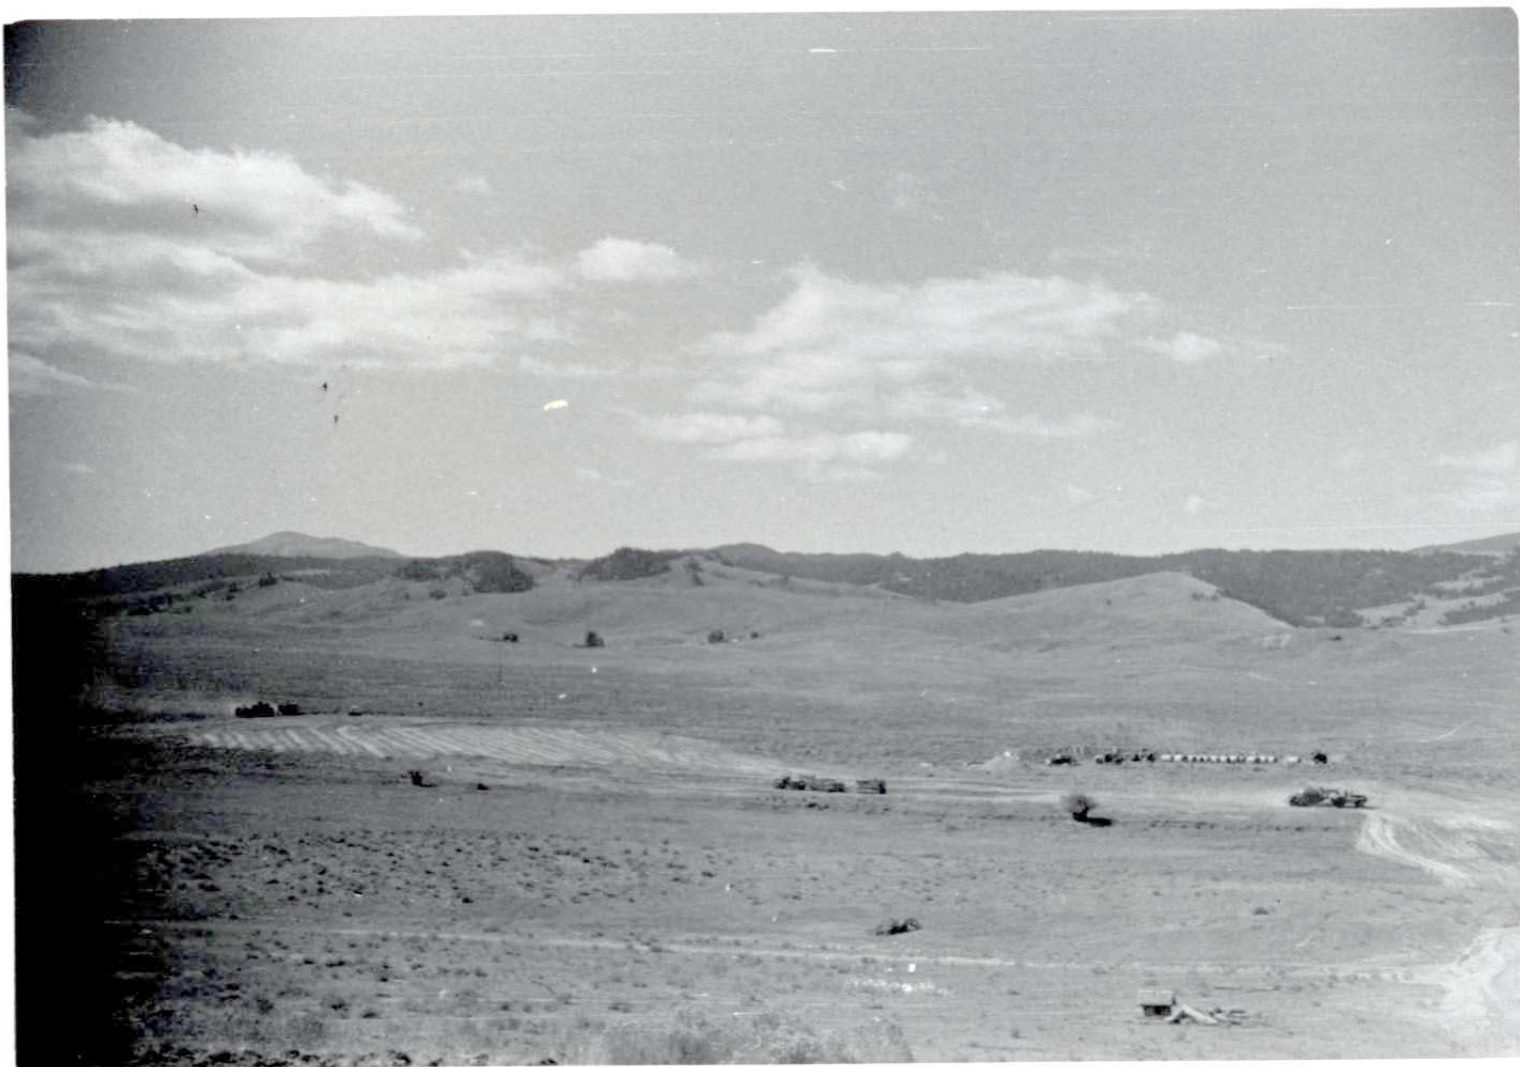
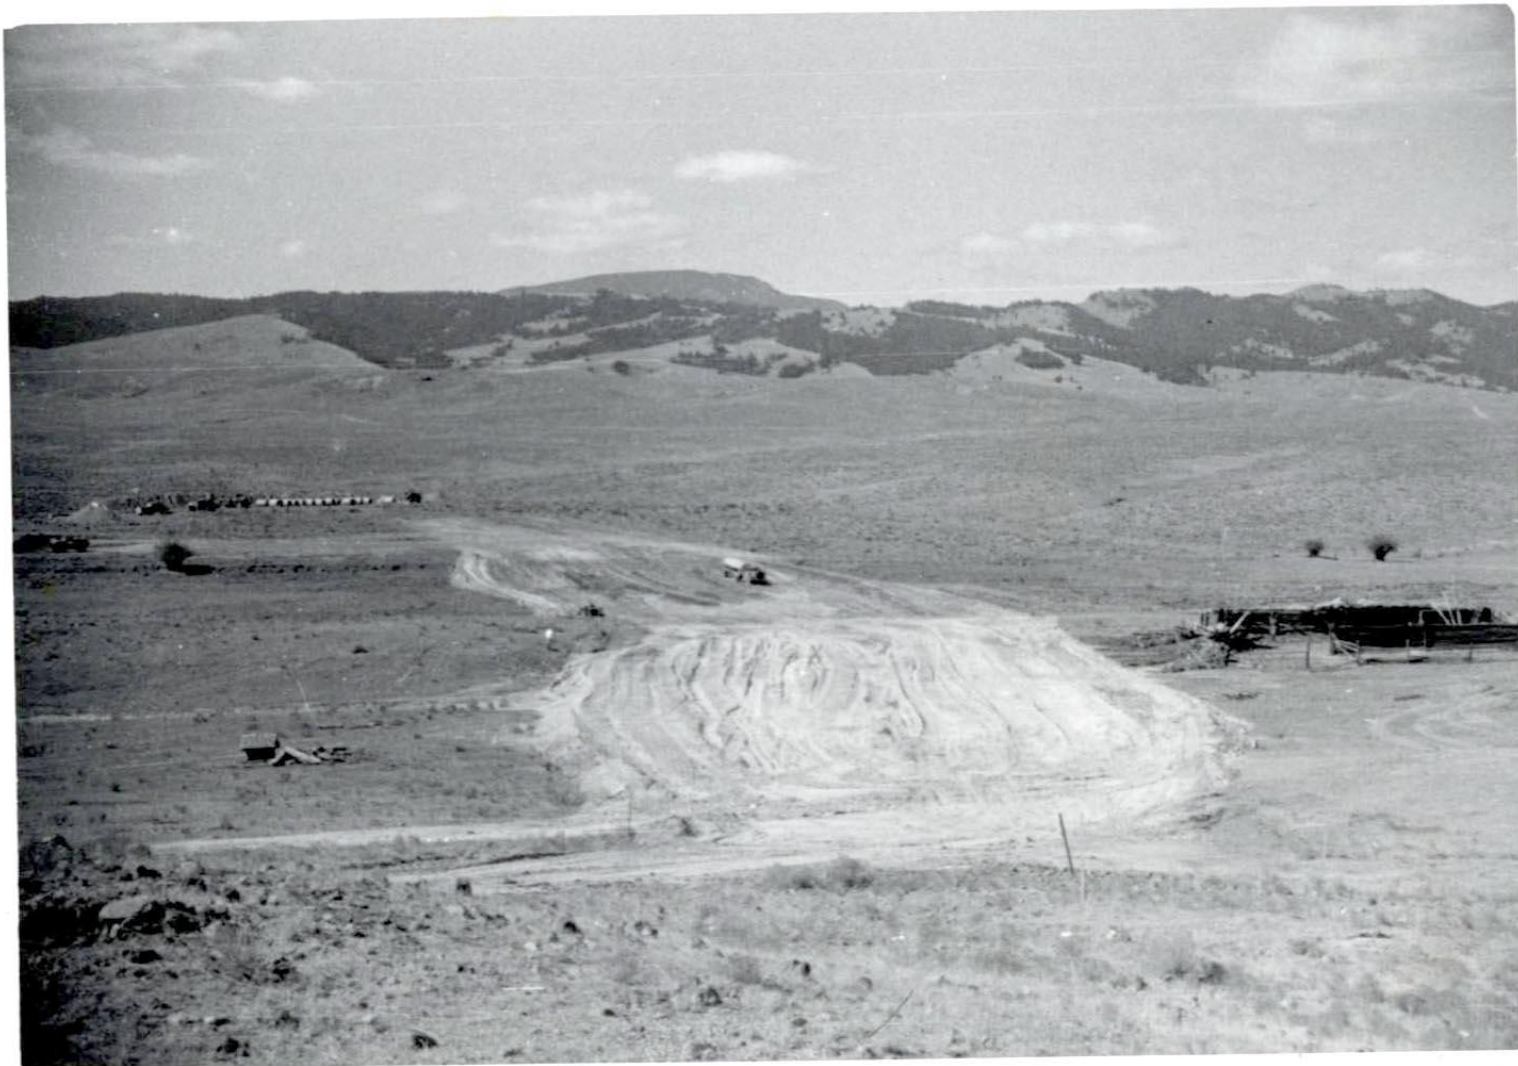
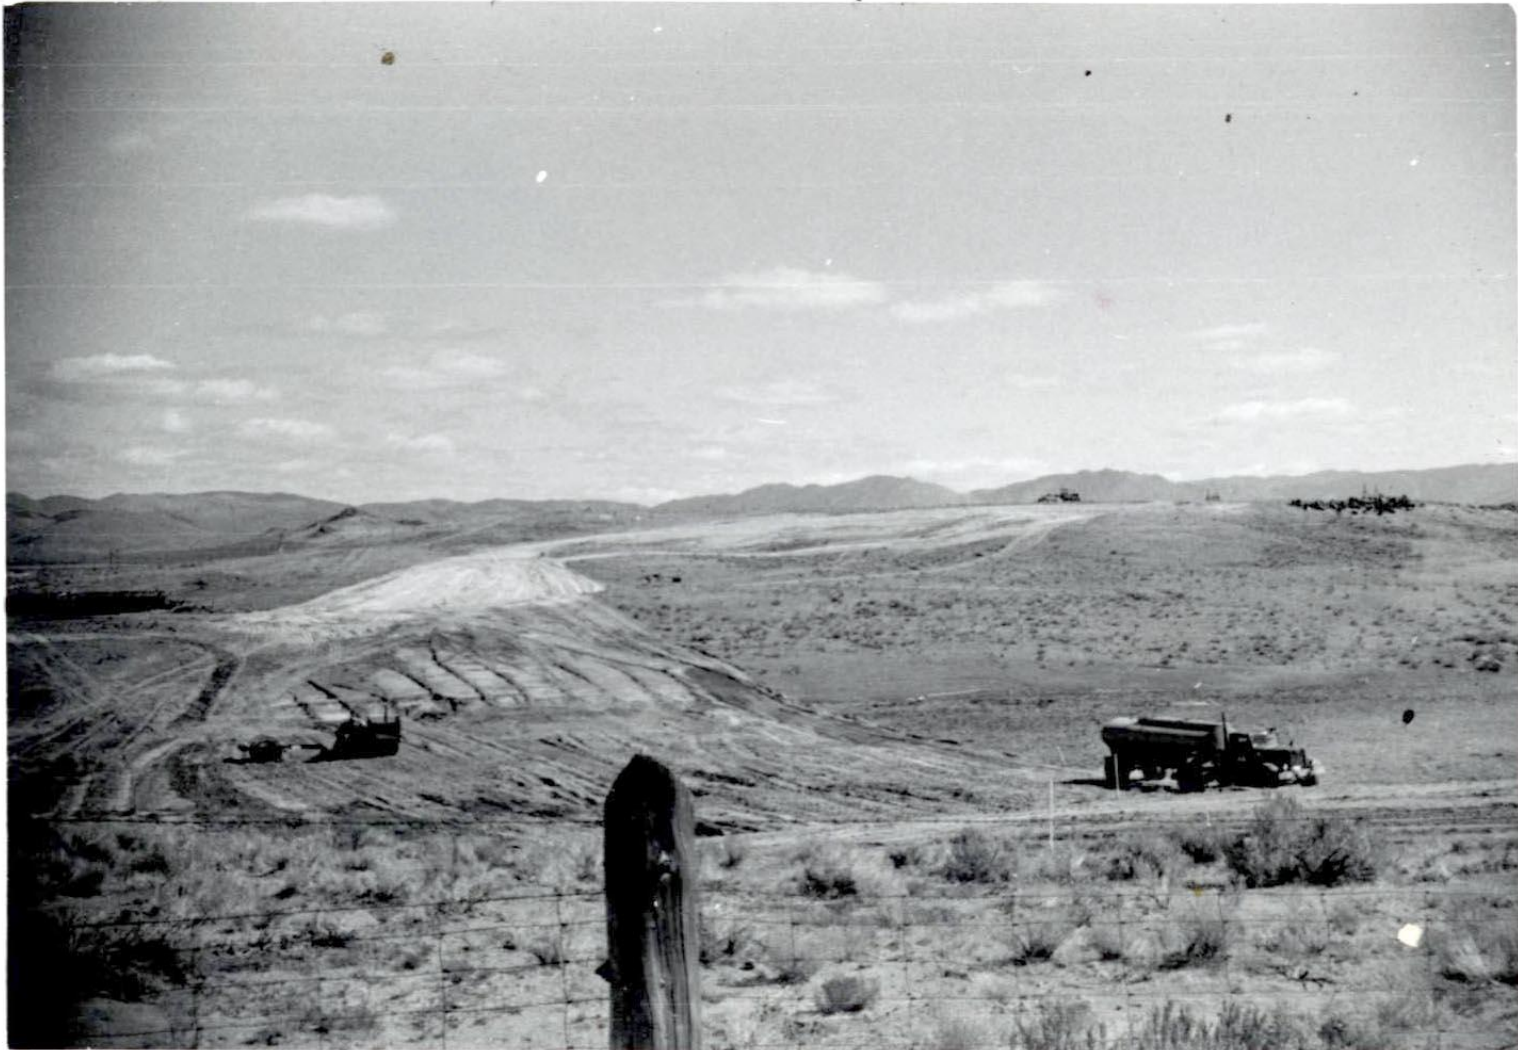
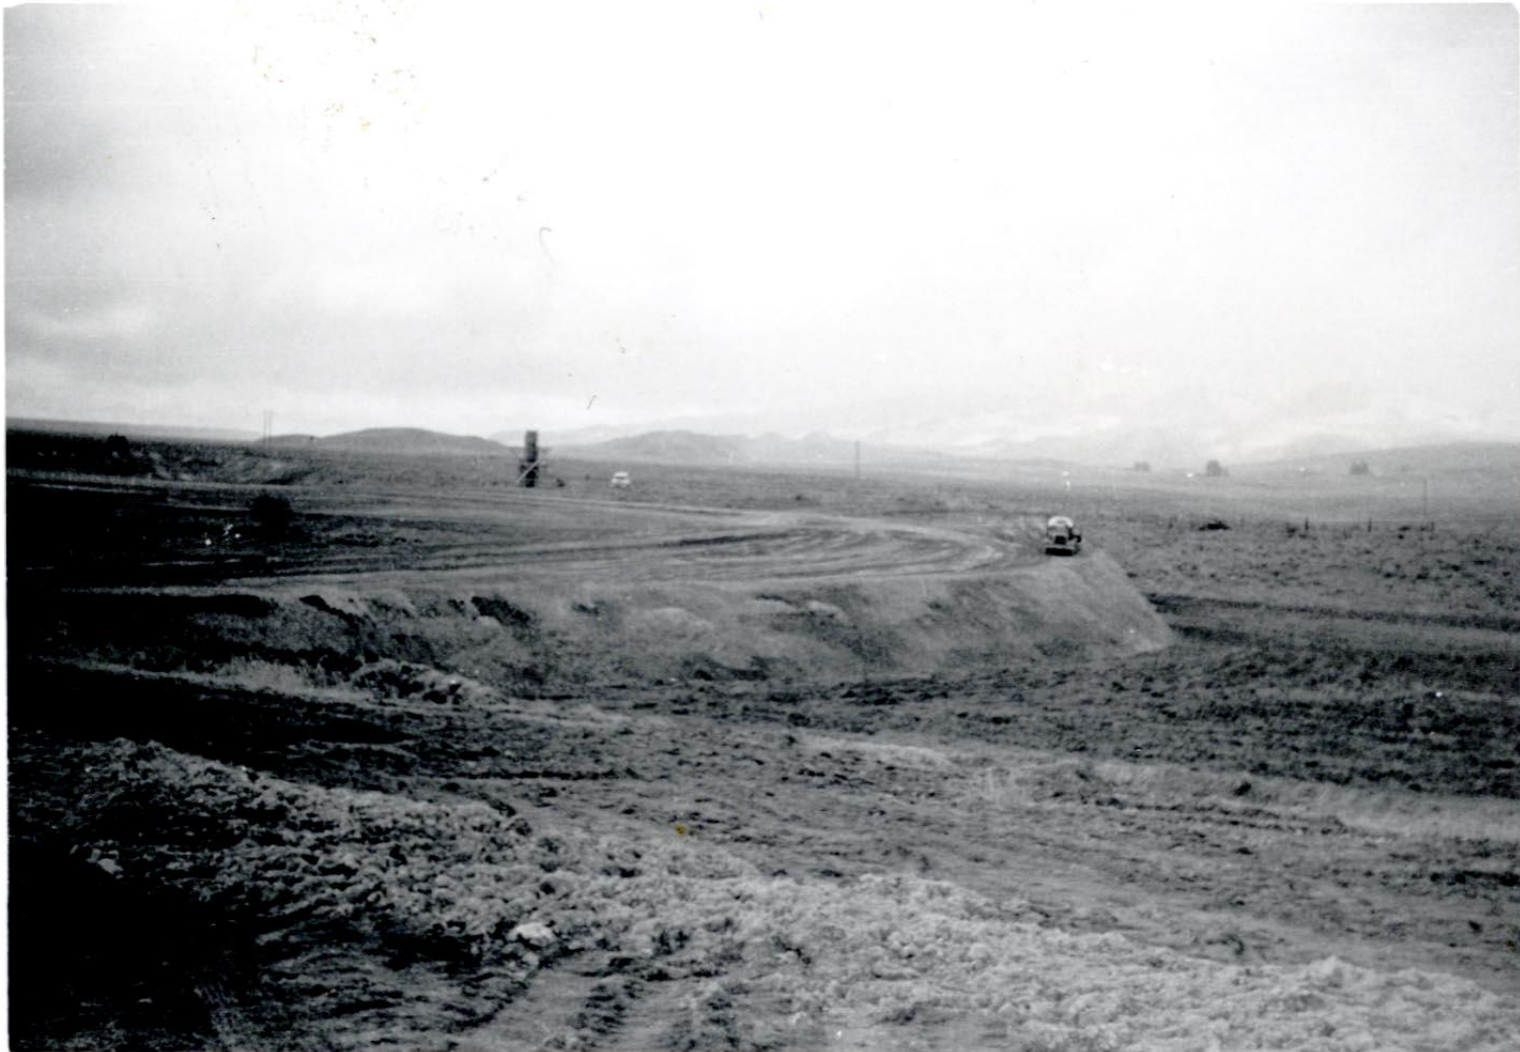
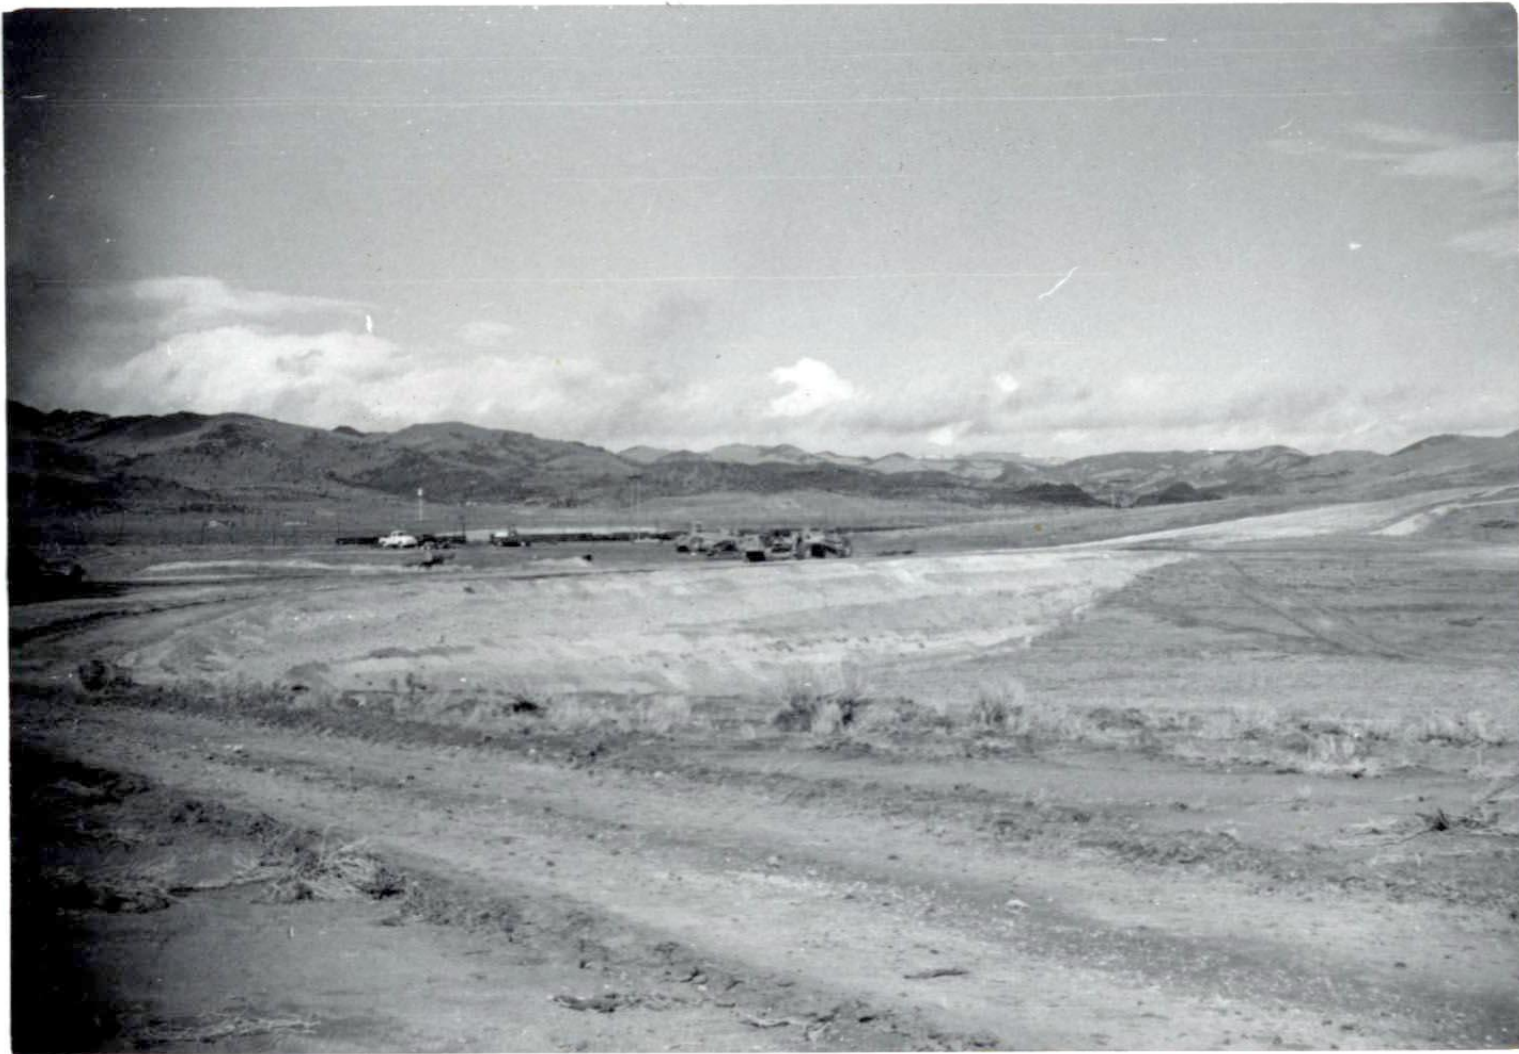
Photographs of Tailing Basin Dike During Construction

Tailings Dam

Several photographs of the dike construction have been found (Appendix 2-C). These photographs are dated September and October 1954, and show the construction methods which included transporting borrow to the construction area (trucks and scrapers), placing the borrow soils with bull dozers, and appropriate soils compaction equipment for construction of a water containment dike. One photo also shows a water truck spraying water on the work area, which suppresses dust and adjusts moisture to optimize compaction and minimize permeability of the borrow soils. The photos also indicate that the borrow soils were obtained from an area within the current footprint of the tailing basin.
