SWMU 1 - Tailing Basin & Water Recirculation System

Figure 5.5.1-1a

SWMU 1 LOCATION
Rhodia Silver Bow Plant
Montana

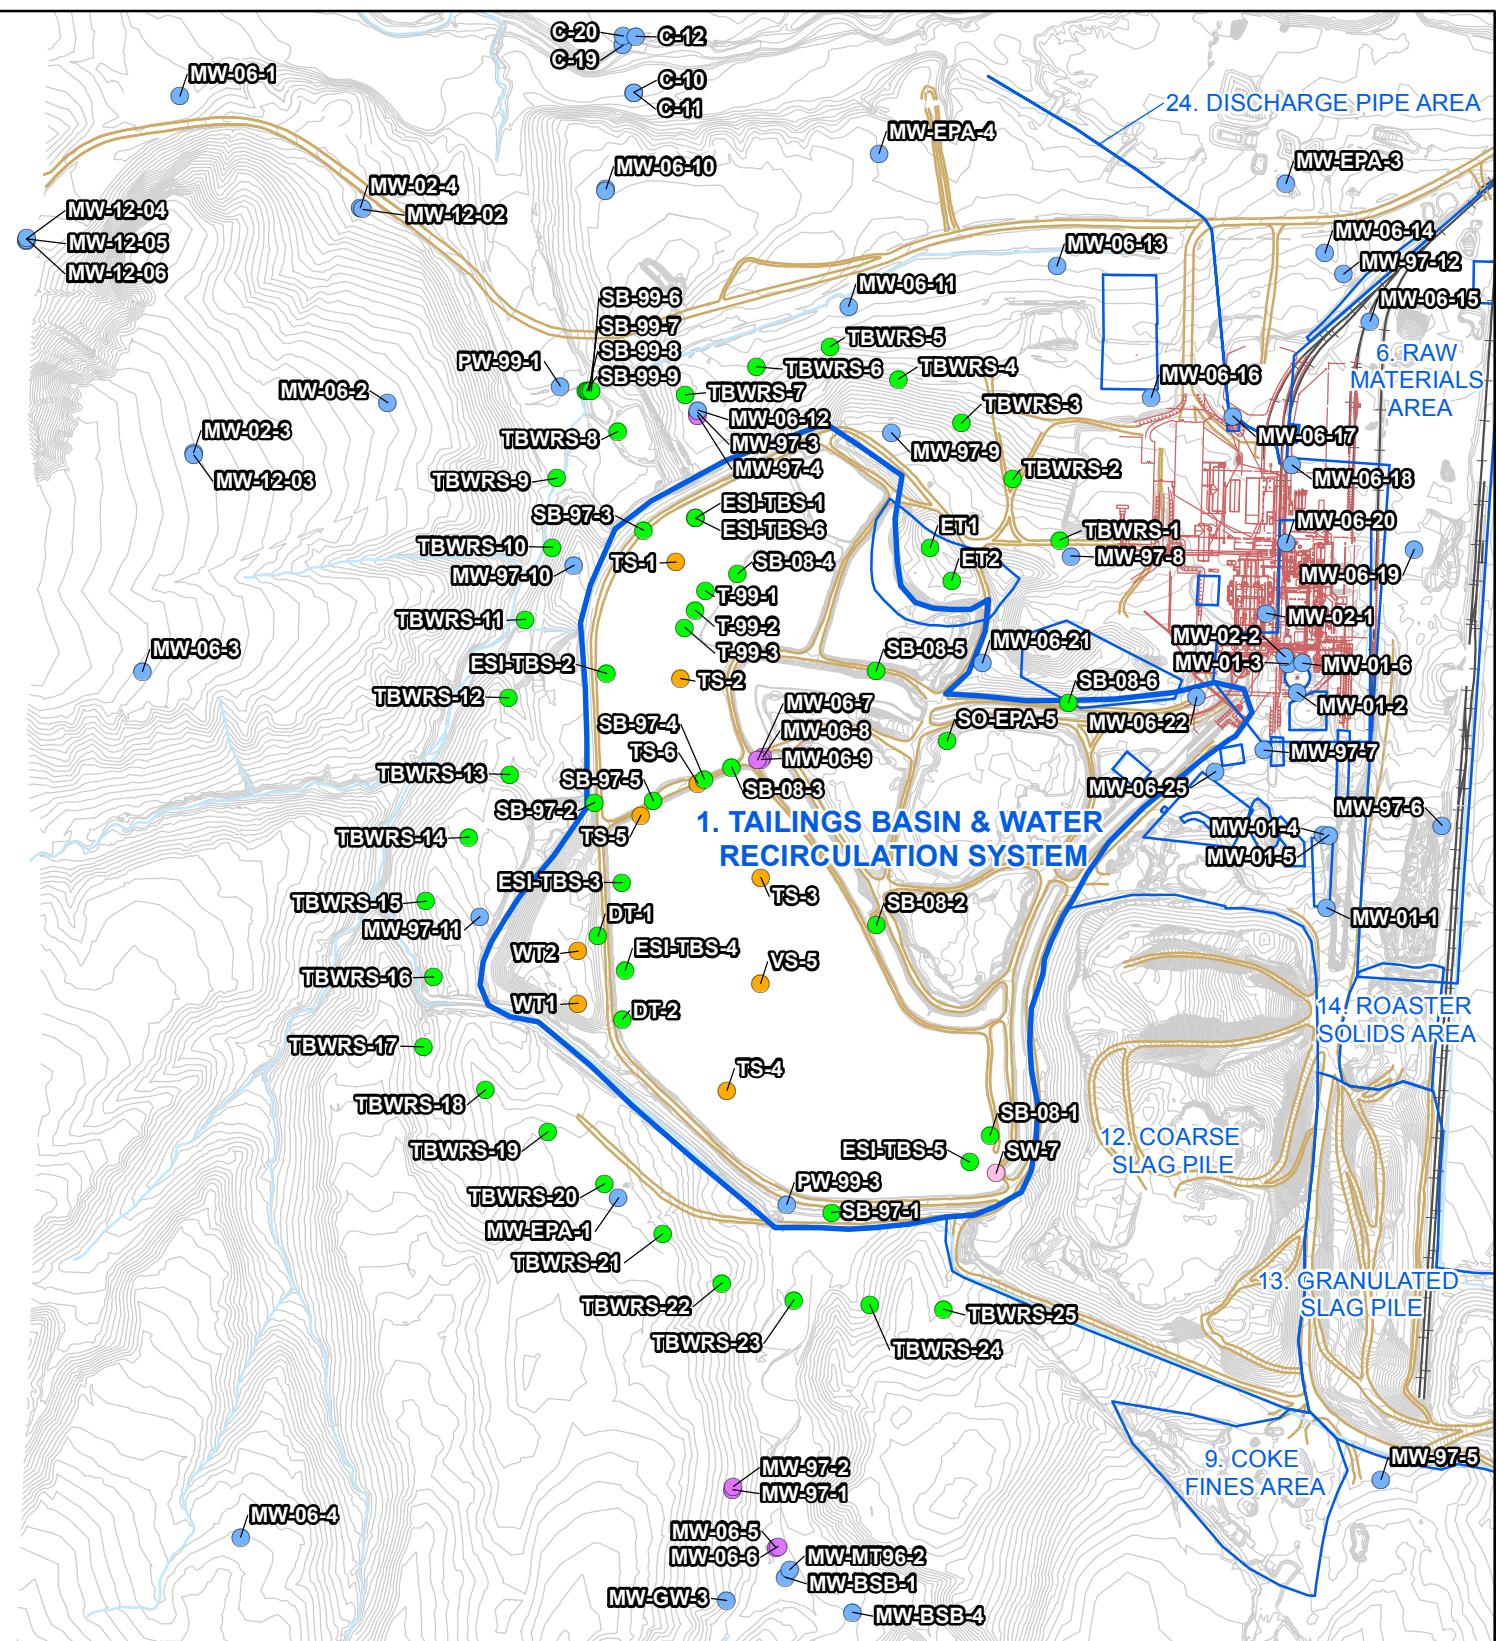
Figure 5.5.1-1b

SWMU 1
MONITORING STATIONS
AND SAMPLE LOCATIONS
Rhodia Silver Bow Plant
Montana

basin (*see* Figure 5.5.1-1b). The analytical laboratory and correlated XRF data for the soil samples were combined to assist the delineation of the hazardous constituents.

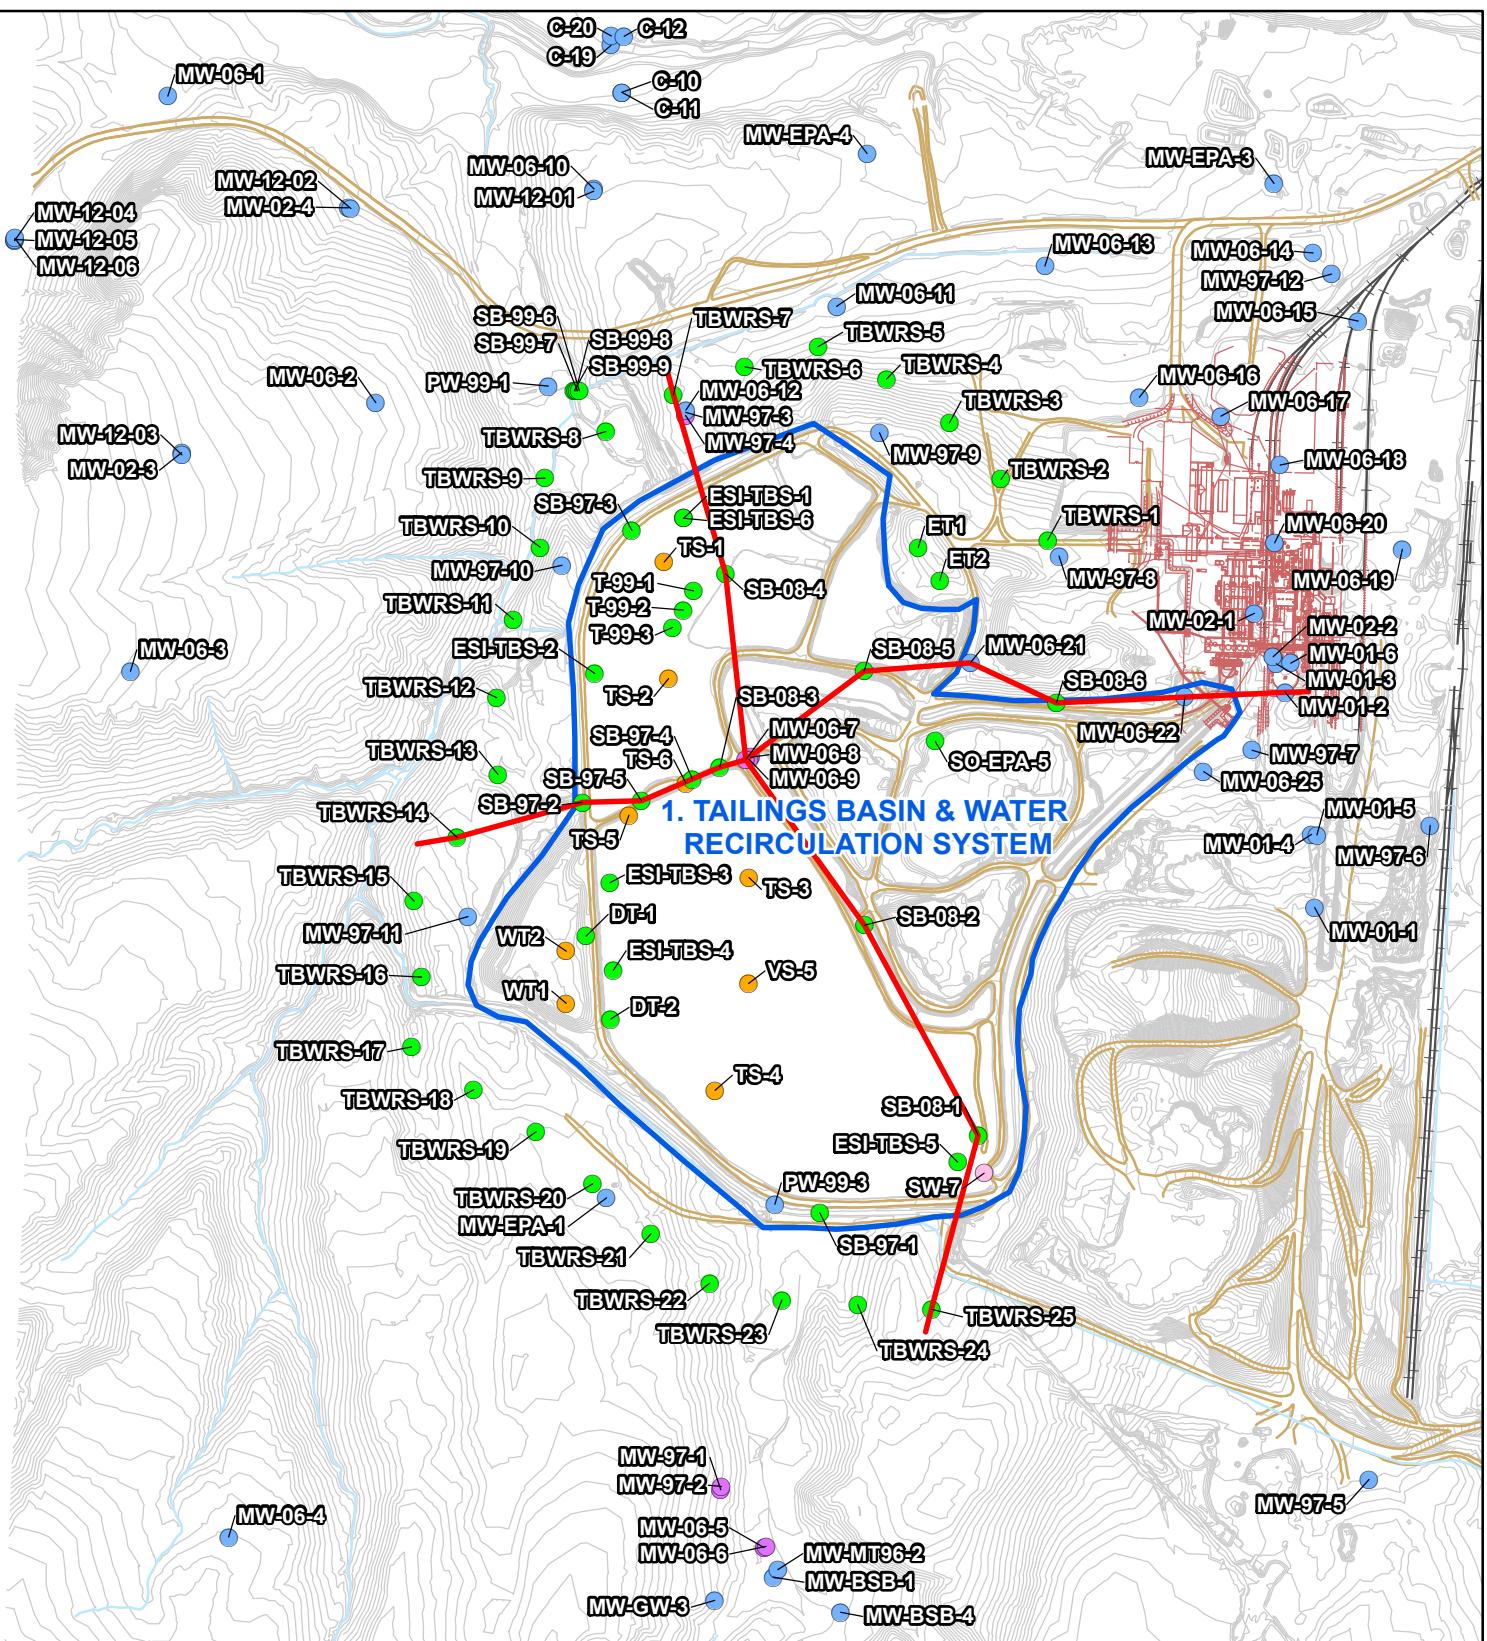
Figure 5.5.1-2

SWMU 1 CROSS SECTION LOCATIONS Rhodia Silver Bow Plant Montana

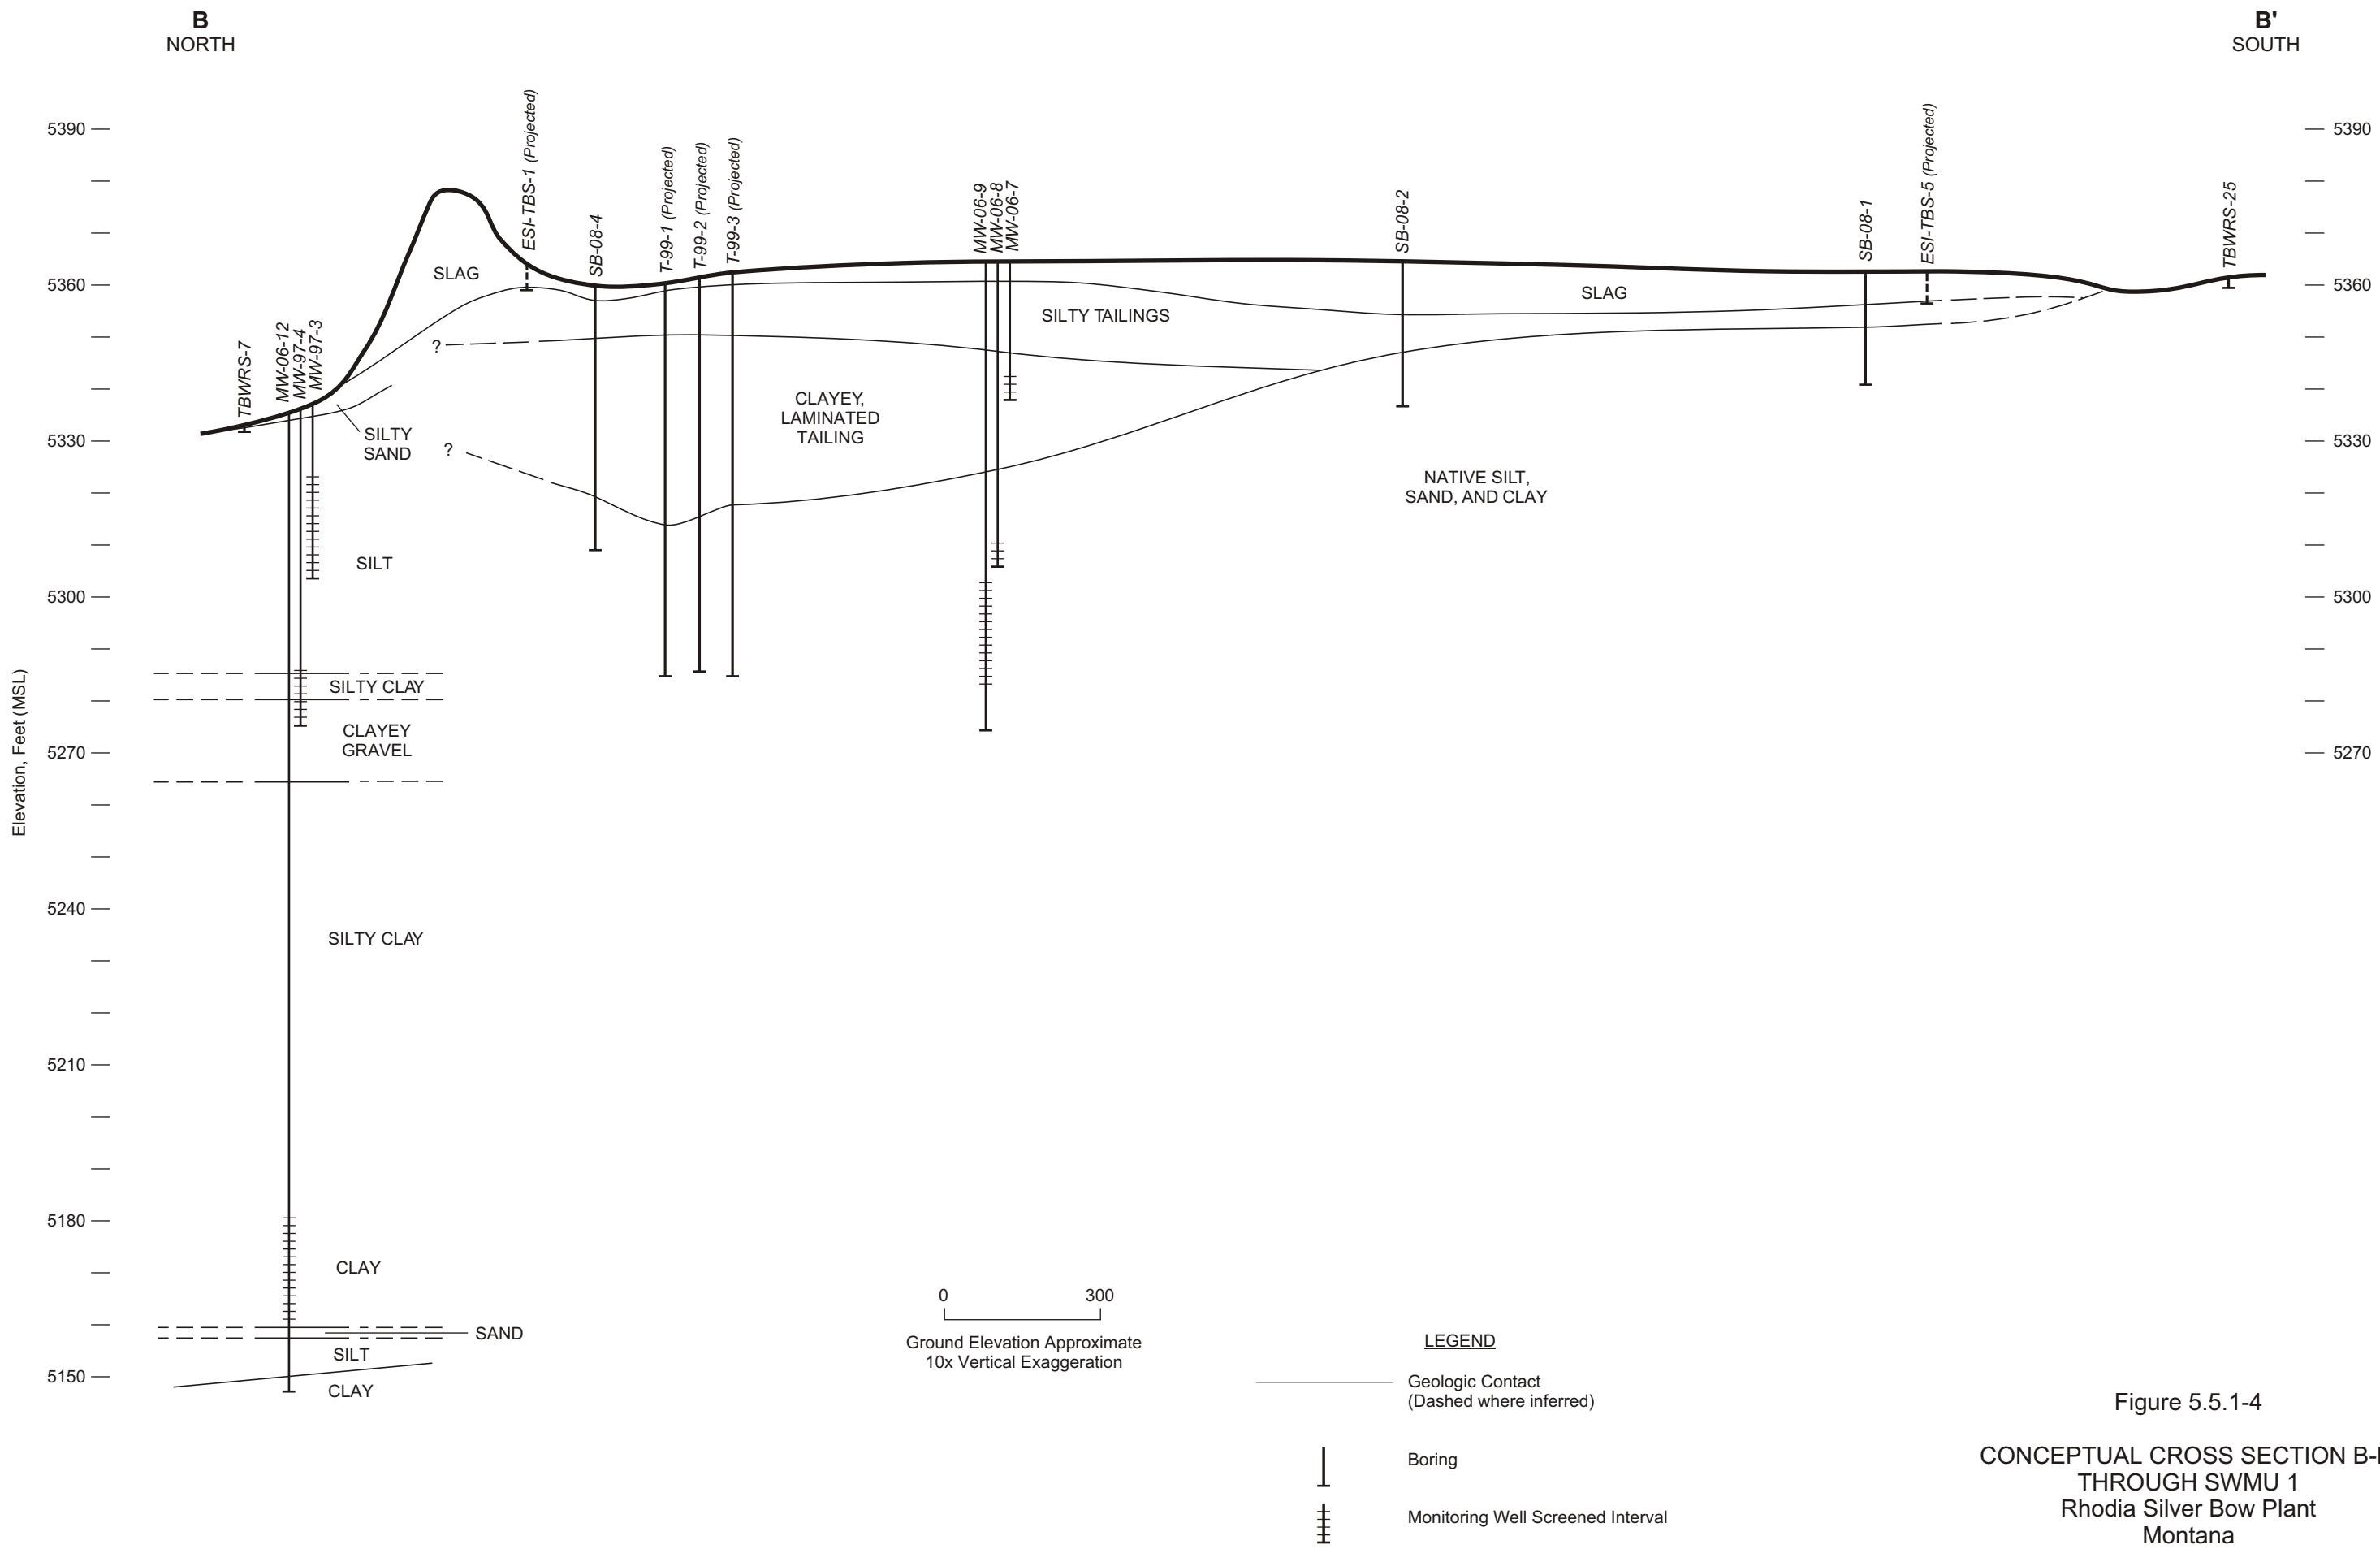
Figure 5.5.1-4

CONCEPTUAL CROSS SECTION B-B'
THROUGH SWMU 1
Rhodia Silver Bow Plant
Montana

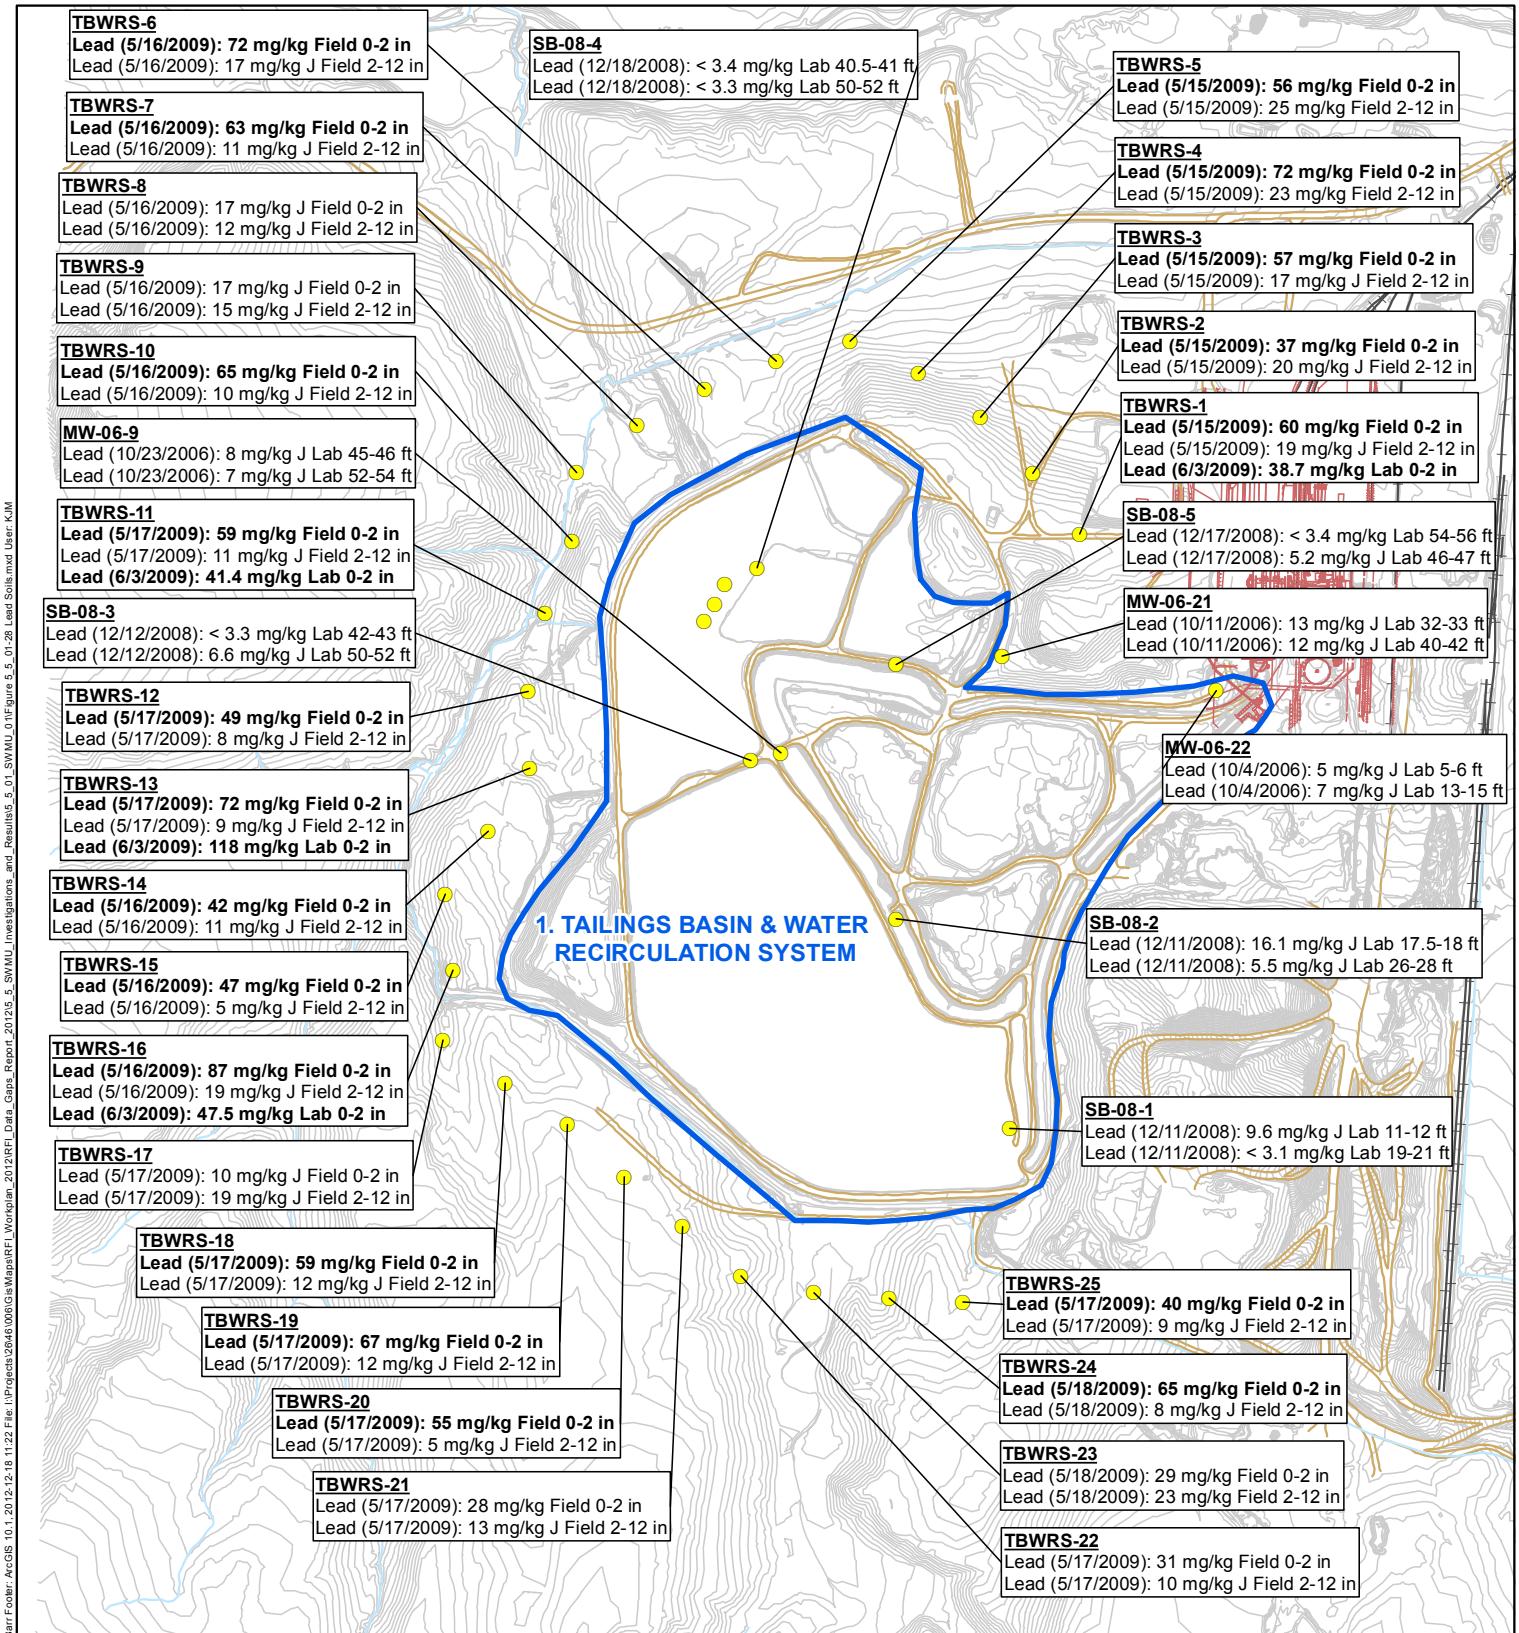
Figure 5.5.1-28

**SWMU 1
SOILS RESULTS:
LEAD
Rhodia Silver Bow Plant
Montana**

Lead is present in the tailing at concentrations above background soil concentrations. Lead ranges from 30.2 mg/kg to 451 mg/kg with an average concentration of 153 mg/kg. Lead concentrations in tailing and soil are shown on Figure 5.5.1-27 and 5.5.1-28, respectively. Lead concentrations in soil are consistent with background concentrations. The lead distribution is shown in cross section on Figures 5.5.1-61 and 5.5.1-62. Lead is distributed throughout the tailing. Higher concentrations are found in the silty tailing layer compared to the concentrations in the clayey laminated tailing layer. The lead profile shows a much lower lead concentration in the native soil compared to the overlying tailing.

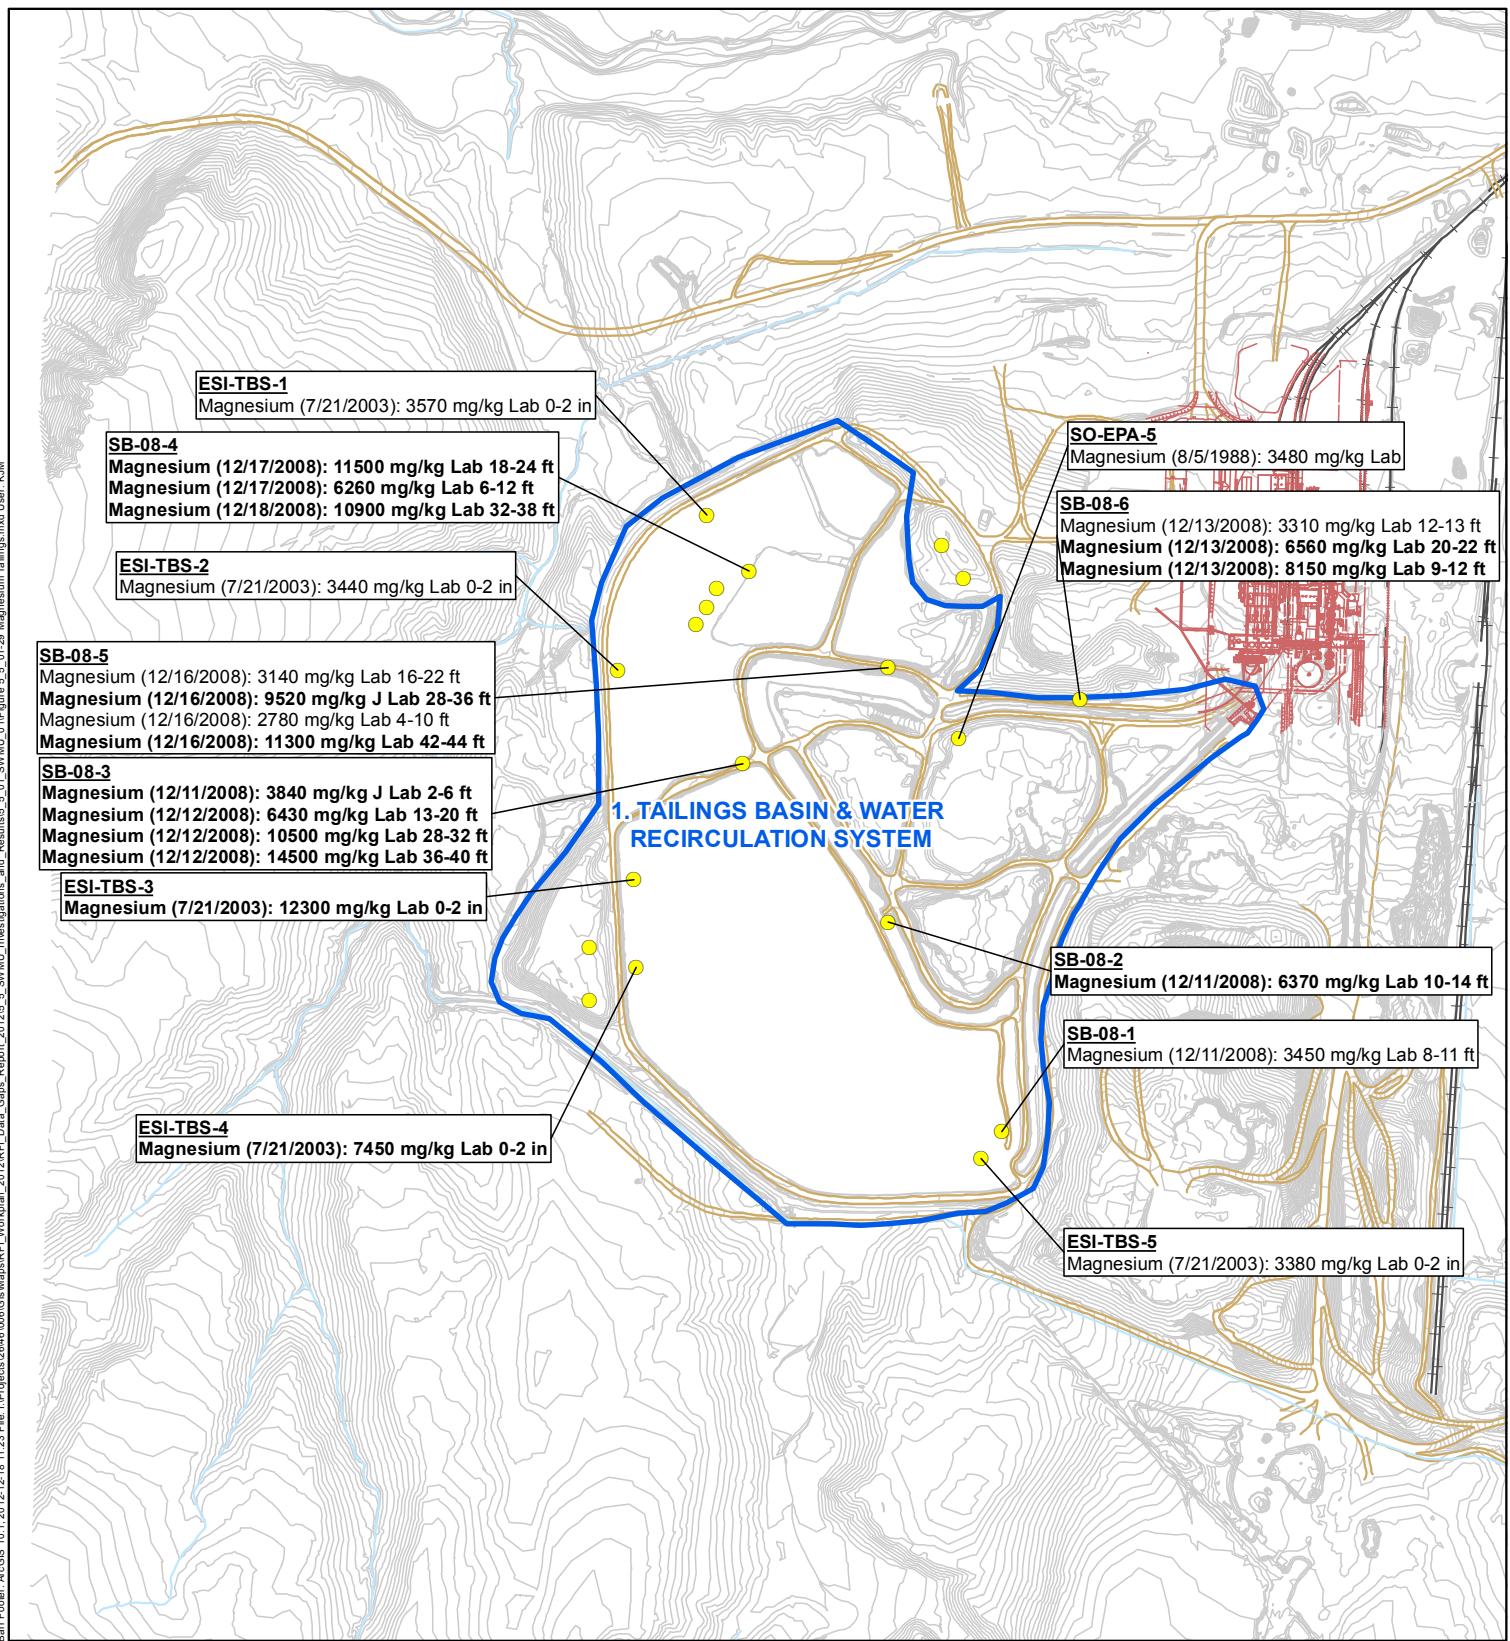
**SWMU 1
TAILINGS RESULTS:
MAGNESIUM
Rhodia Silver Bow Plant
Montana**

Magnesium concentrations in tailing and soil are shown on Figure 5.5.1-29 and 5.5.1-30, respectively. Magnesium concentrations in soil remain above background soil concentrations. The magnesium distribution is shown in cross section on Figures 5.5.1-63 and 5.5.1-64. The magnesium profile shows increasing magnesium concentrations with depth in the tailing. The highest magnesium concentrations are found in the deepest tailing samples. As with the other metals, the magnesium concentration in the underlying native soil is considerably lower.

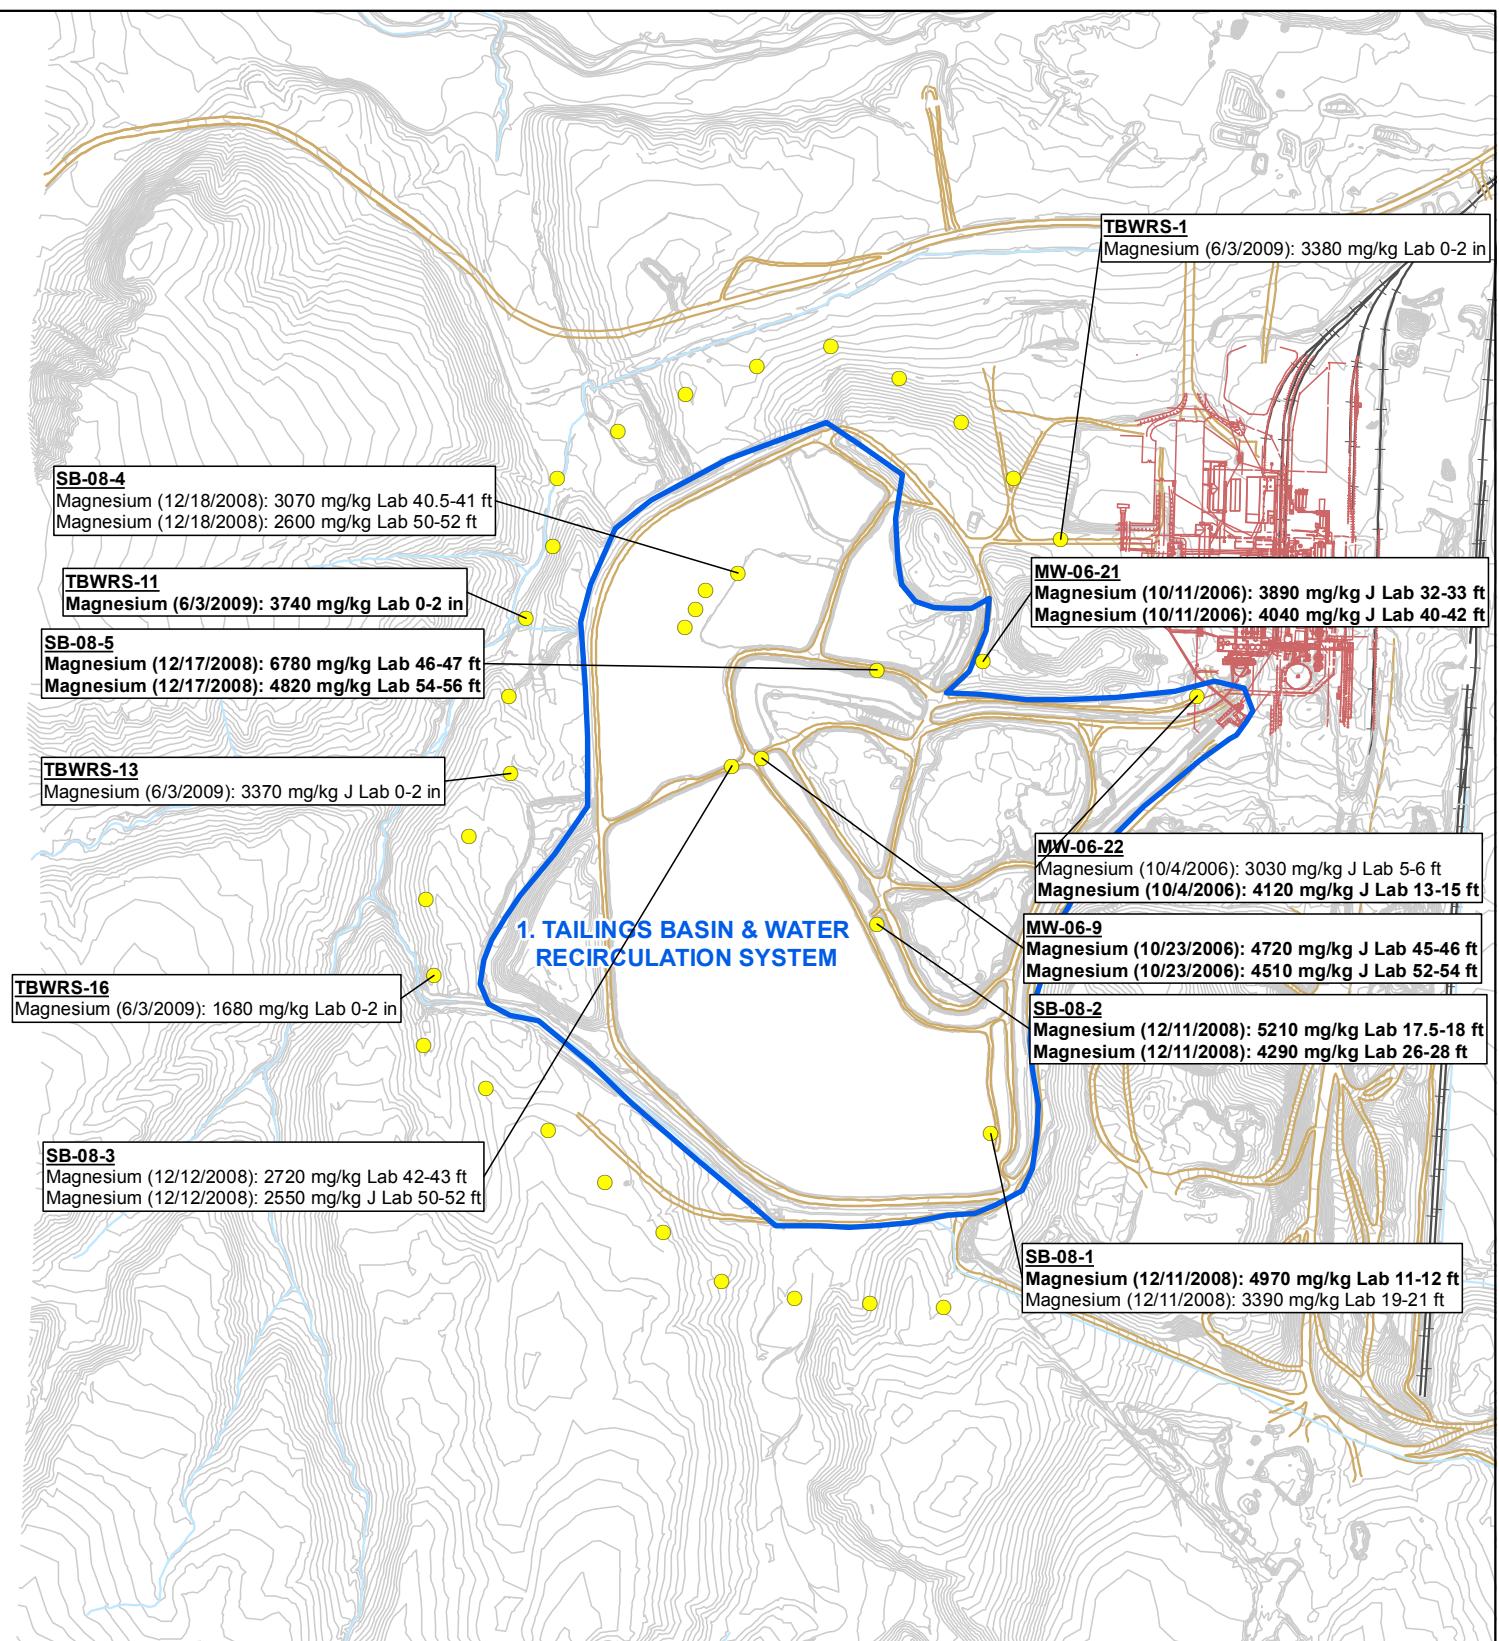
Figure 5.5.1-30

**SWMU 1
SOILS RESULTS:
MAGNESIUM
Rhodia Silver Bow Plant
Montana**

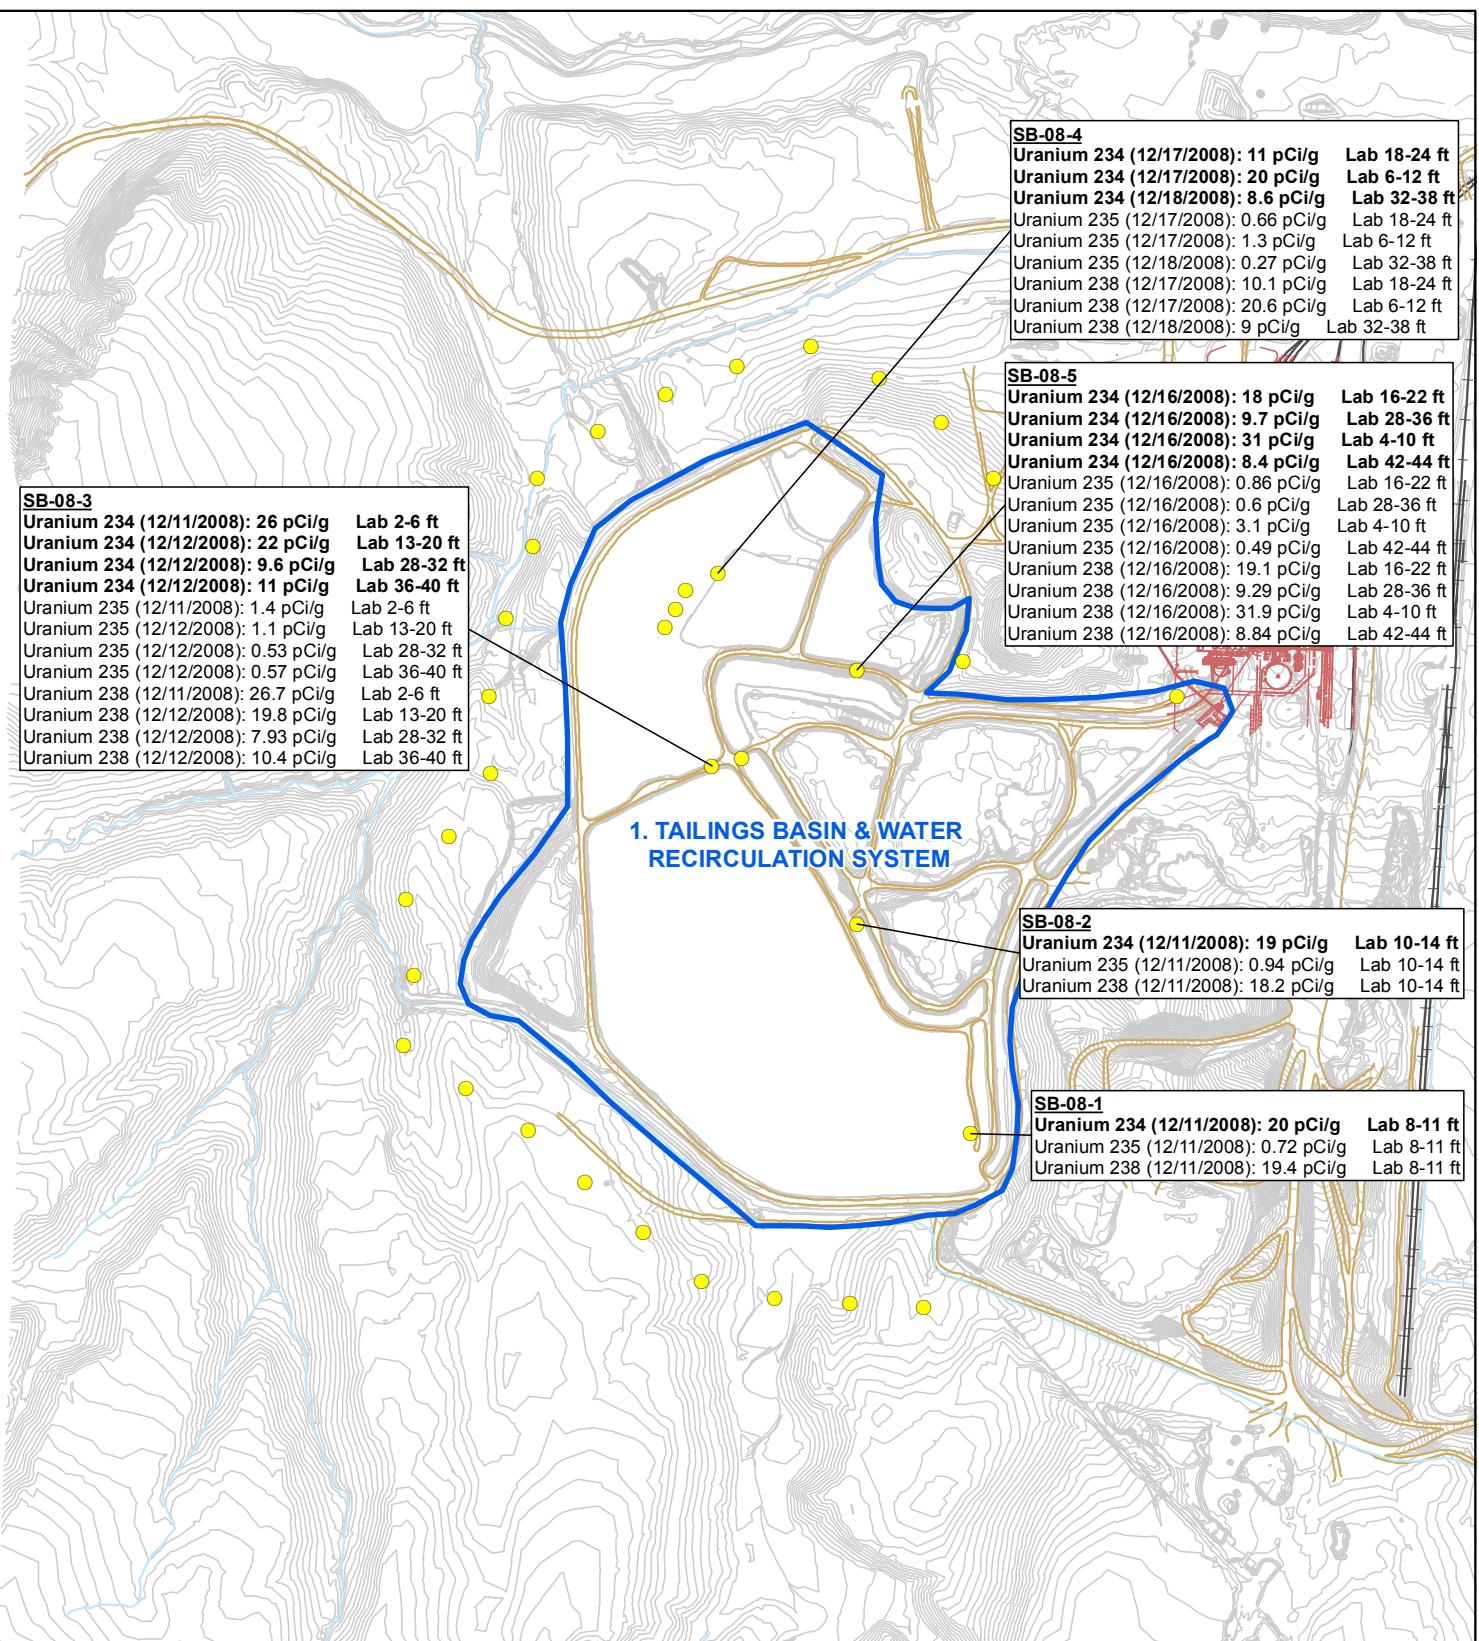
Figure 5.5.1-54

**SWMU 1
SOILS RESULTS:
URANIUM ISOTOPES
Rhodia Silver Bow Plant
Montana**

The highest concentrations of Ra-226 and U-238 were reported from the soil samples collected from the 0-2 inch sample interval at location TBRWS-1 and TBRWS-11 (*see* Table 5.5.1-14). Based on the sample locations, the higher Ra-226 concentrations were most likely due to trace amounts of slag material since the slag aggregate was used to extend the dikes of the tailing basin and construct roads in and around the tailing basin. In addition, Pb-210 was not detected in the soil samples from around the tailing basin and water recirculation area, whereas Pb-210 was found in tailing samples. Consequently, deposition of wind-blown tailing is not a likely source of the radionuclide constituents reported in the TBWRS-1 and TBWRS-16. The spatial distributions of radionuclides are shown on Figures 5.5.1-54 and 5.5.1-56.

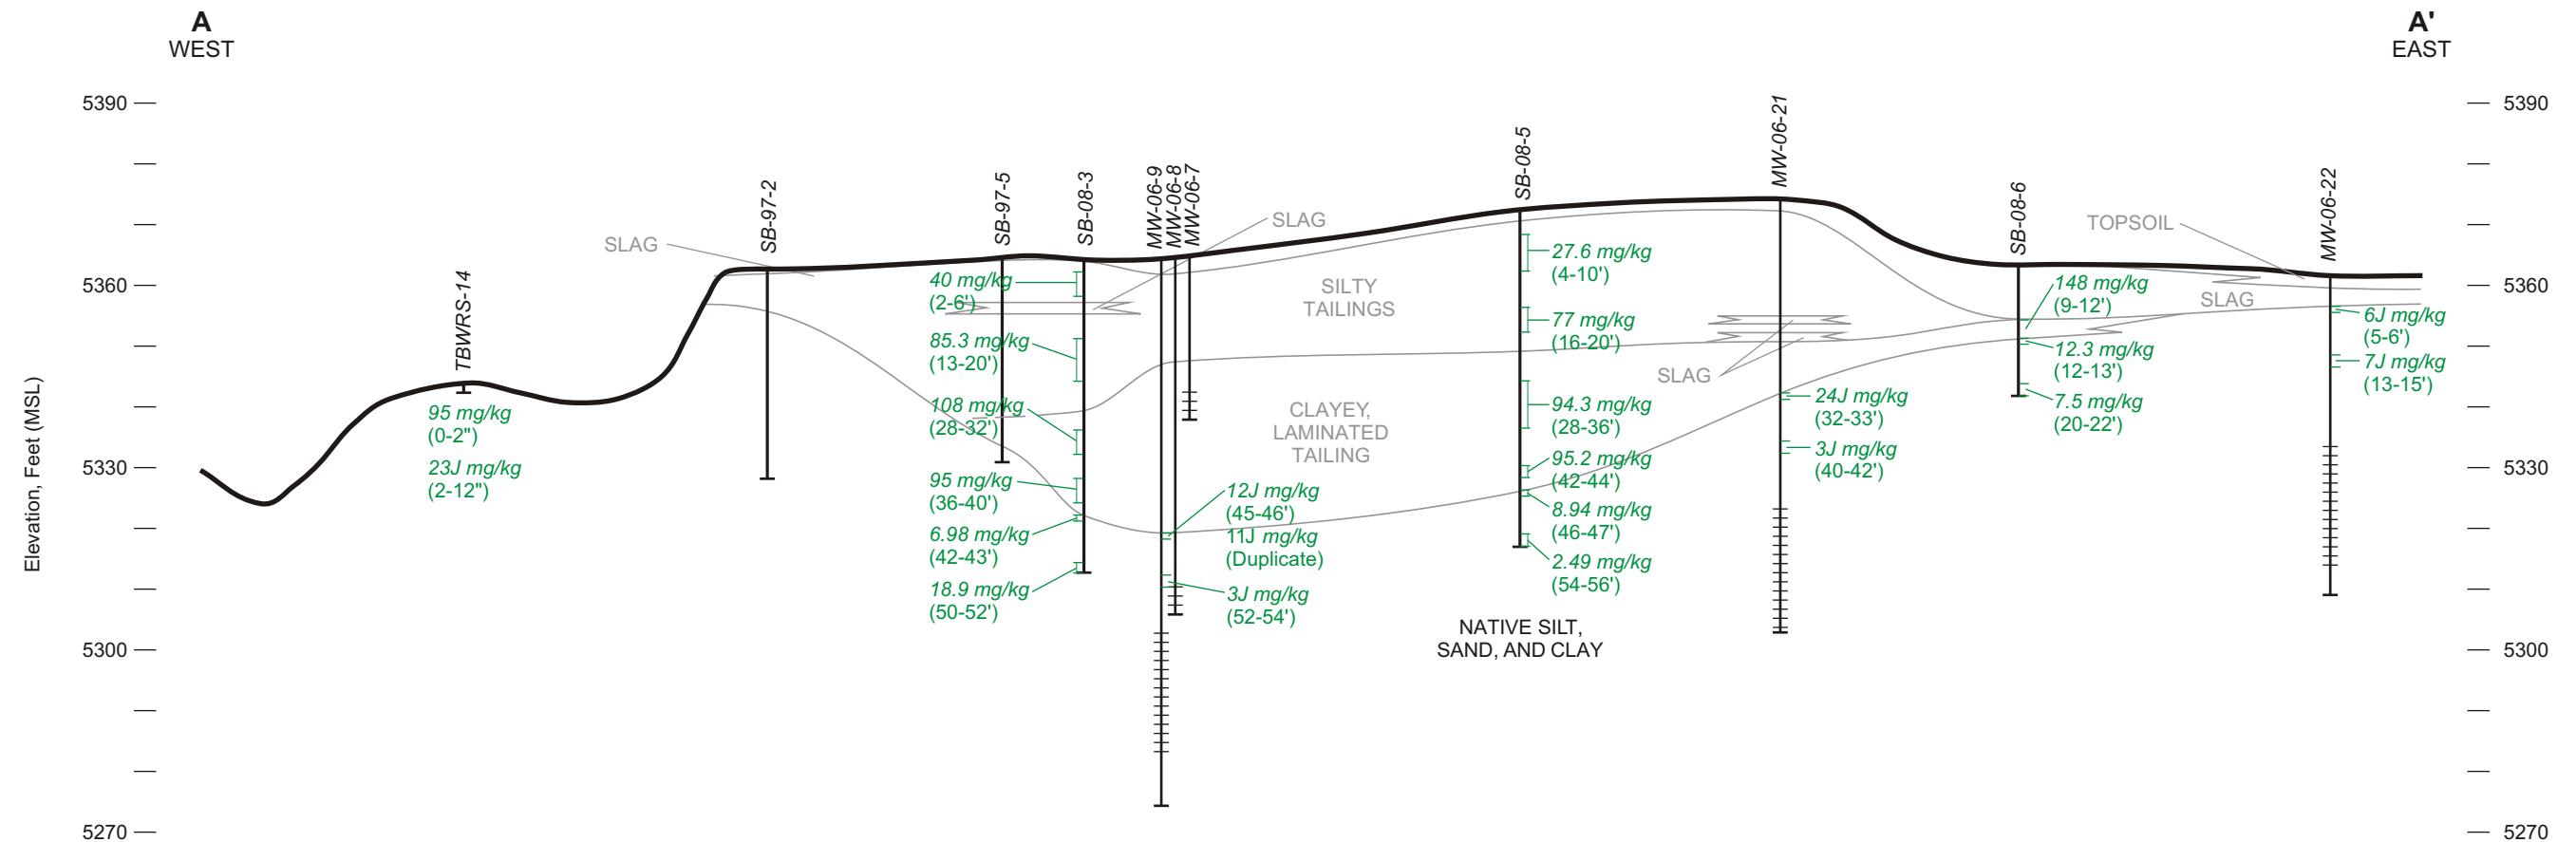
Figure 5.5.1-57

SWMU 1
CONCEPTUAL CROSS SECTION A-A'
ARSENIC DIAGRAM
Rhodia Silver Bow Plant
Montana
