SWMU 1 - Tailing Basin & Water Recirculation System

Figure 5.5.1-1a

SWMU 1 LOCATION
Rhodia Silver Bow Plant
Montana

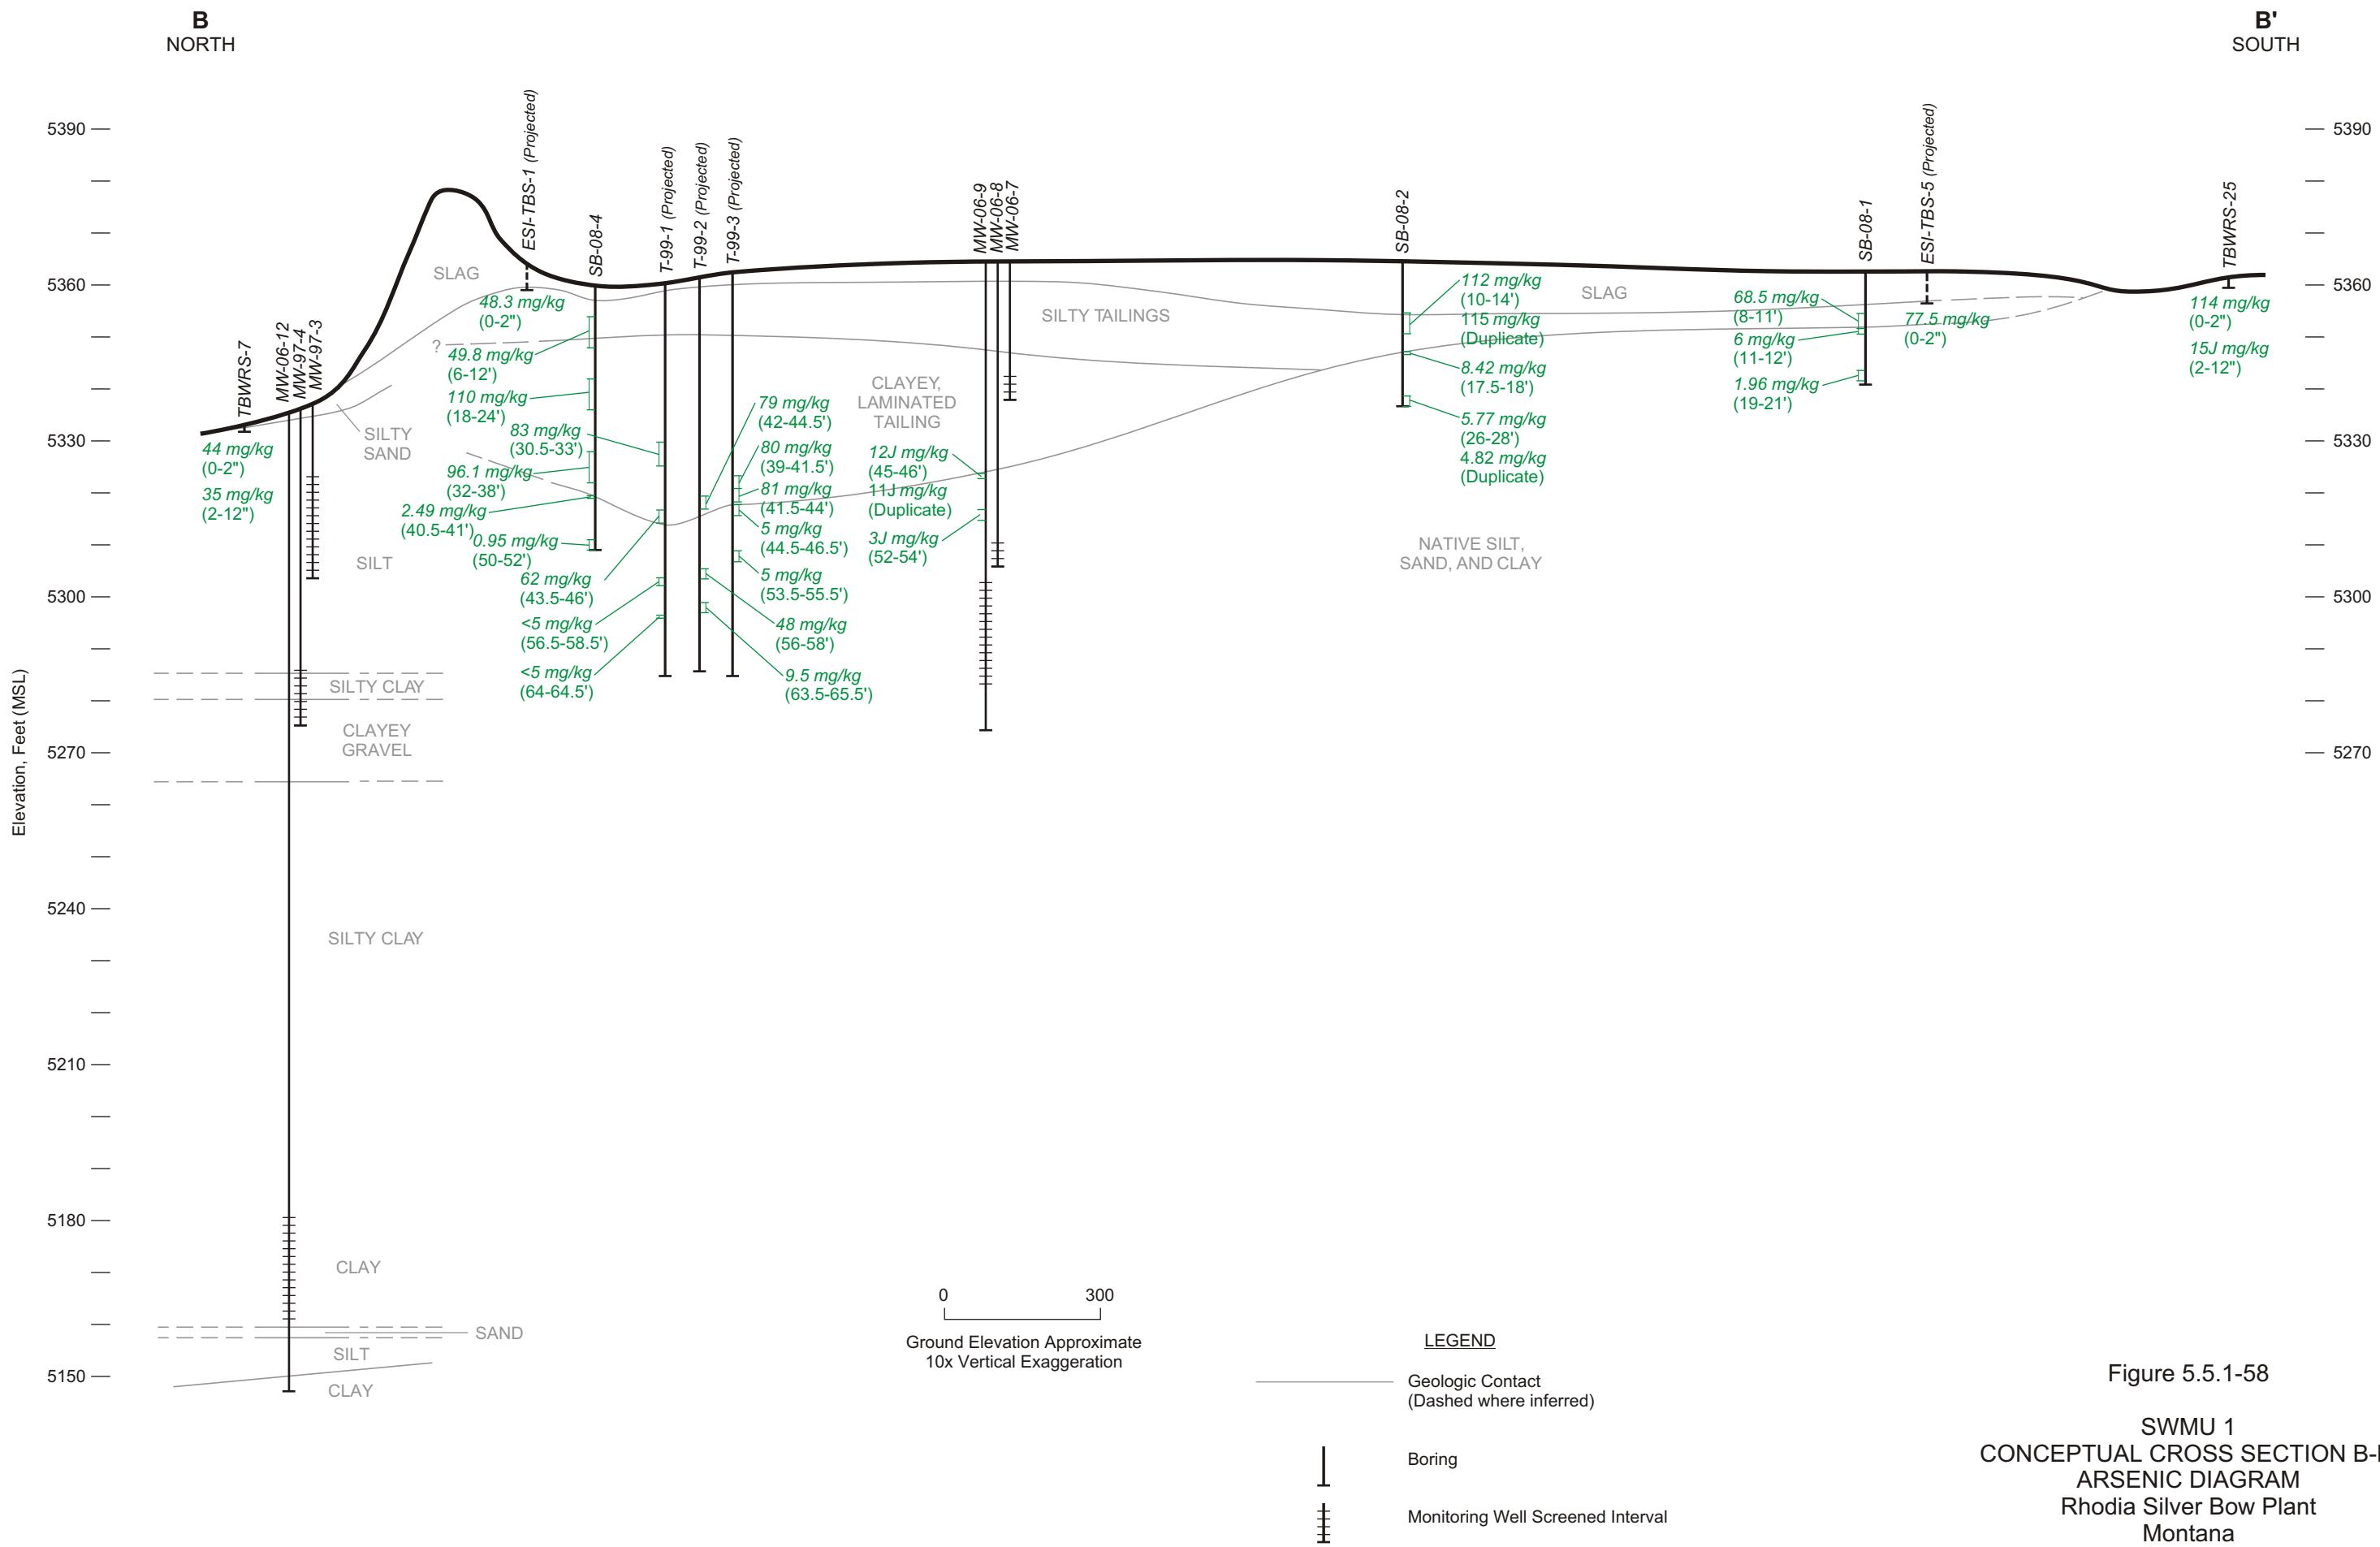
Figure 5.5.1-58

SWMU 1
CONCEPTUAL CROSS SECTION B-B'
ARSENIC DIAGRAM
Rhodia Silver Bow Plant
Montana

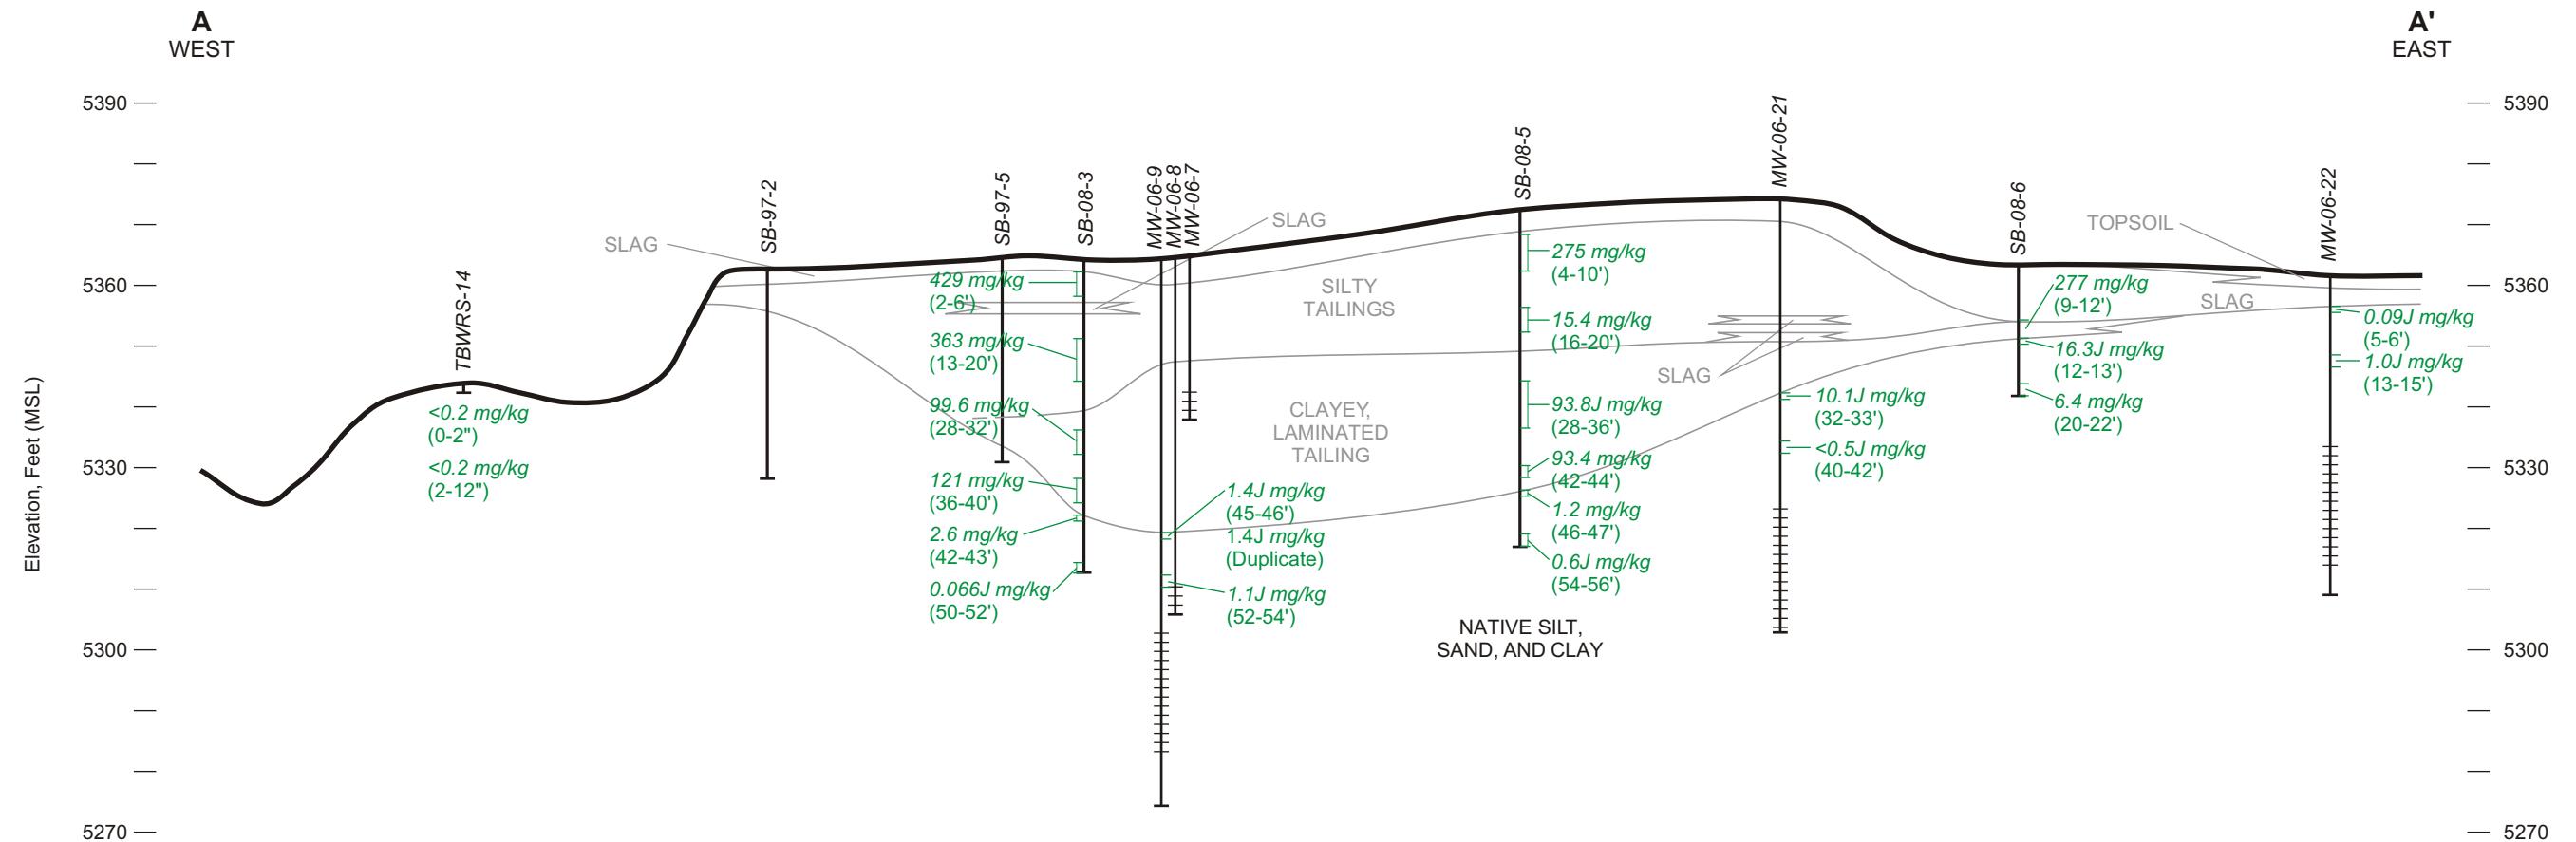
SWMU 1
CONCEPTUAL CROSS SECTION A-A'
CADMIUM DIAGRAM
Rhodia Silver Bow Plant
Montana

The cadmium distribution is shown in cross section on Figures 5.5.1-59 and 5.5.1-60. Cadmium is distributed throughout the tailing. Higher concentrations are found in the silty tailing layer compared to the concentrations in the clayey laminated tailing layer. The cadmium profile shows a much lower cadmium concentration in the native soil compared to the overlying tailing.

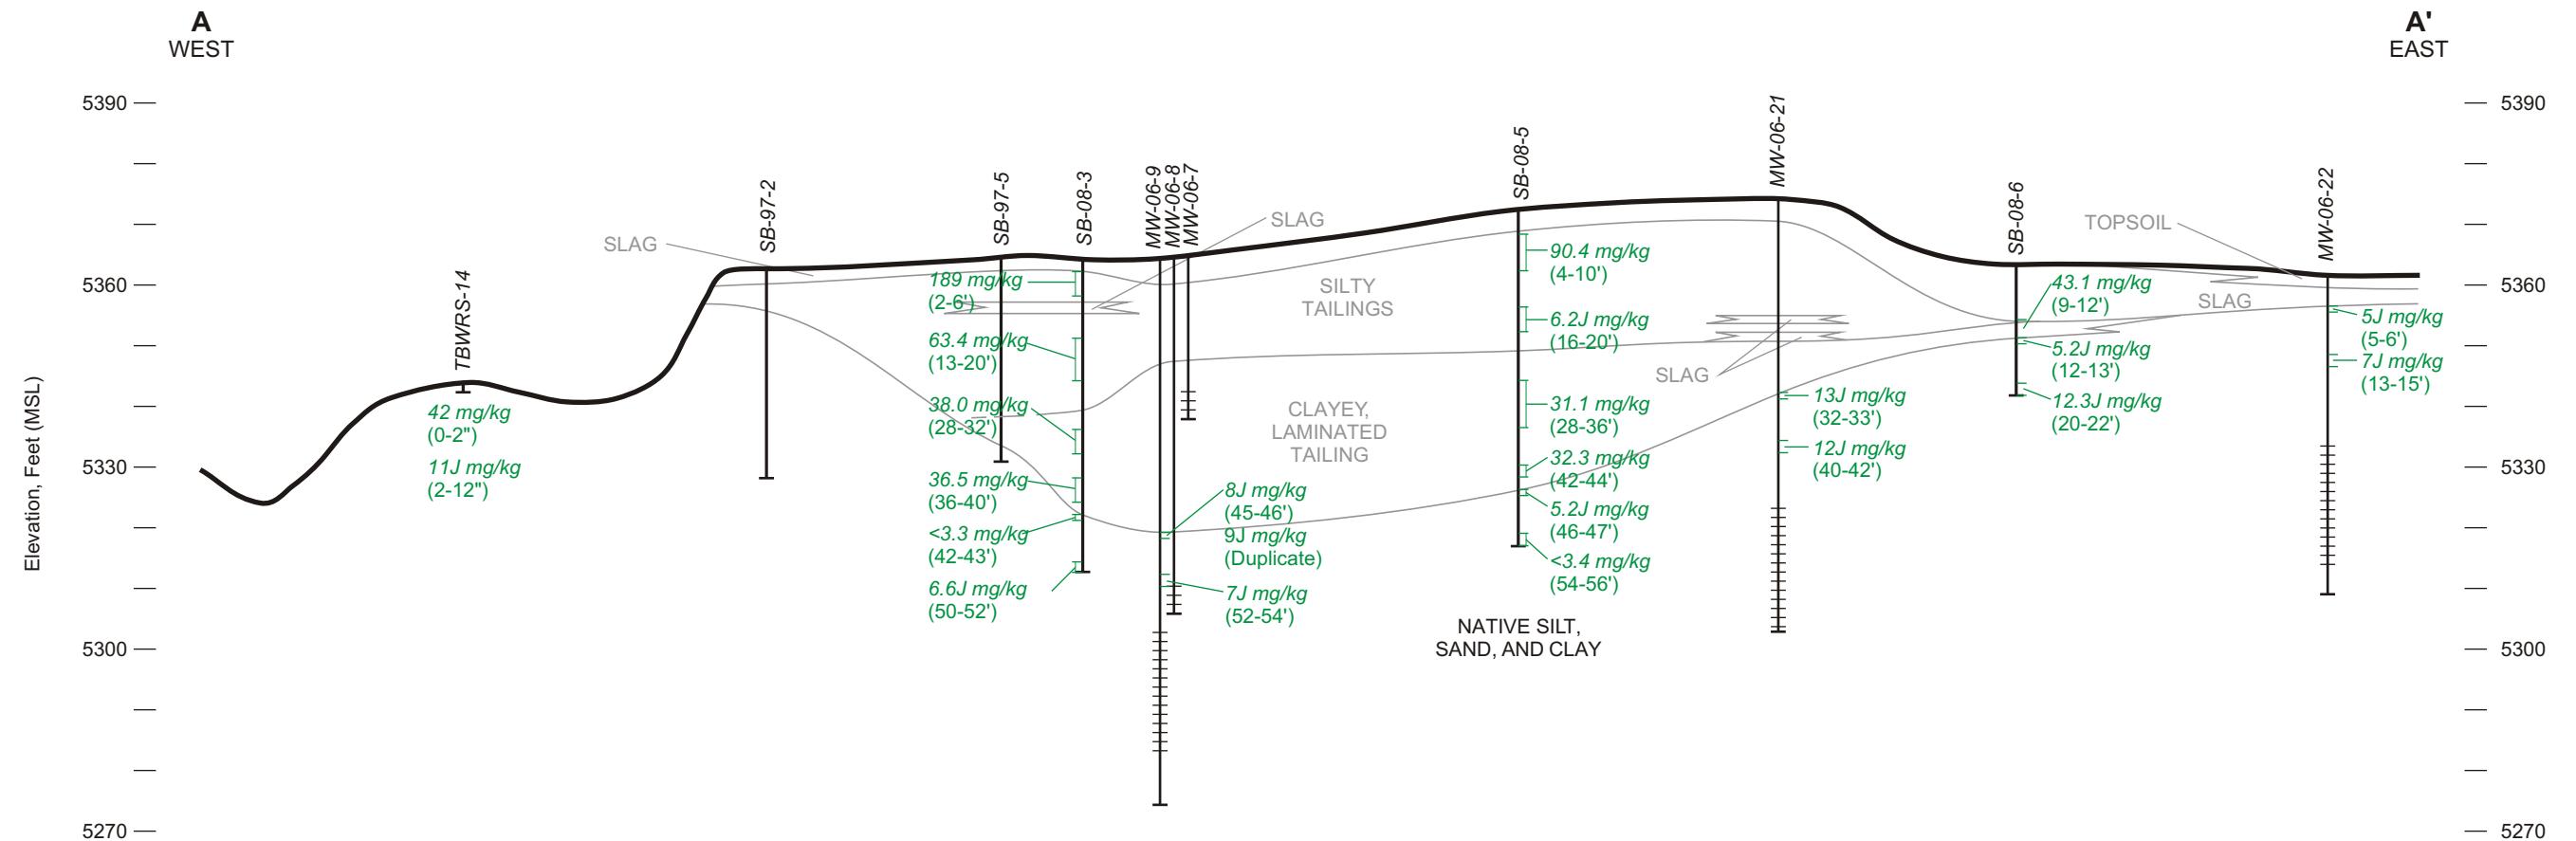
Figure 5.5.1-61

SWMU 1
CONCEPTUAL CROSS SECTION A-A'
LEAD DIAGRAM
Rhodia Silver Bow Plant
Montana

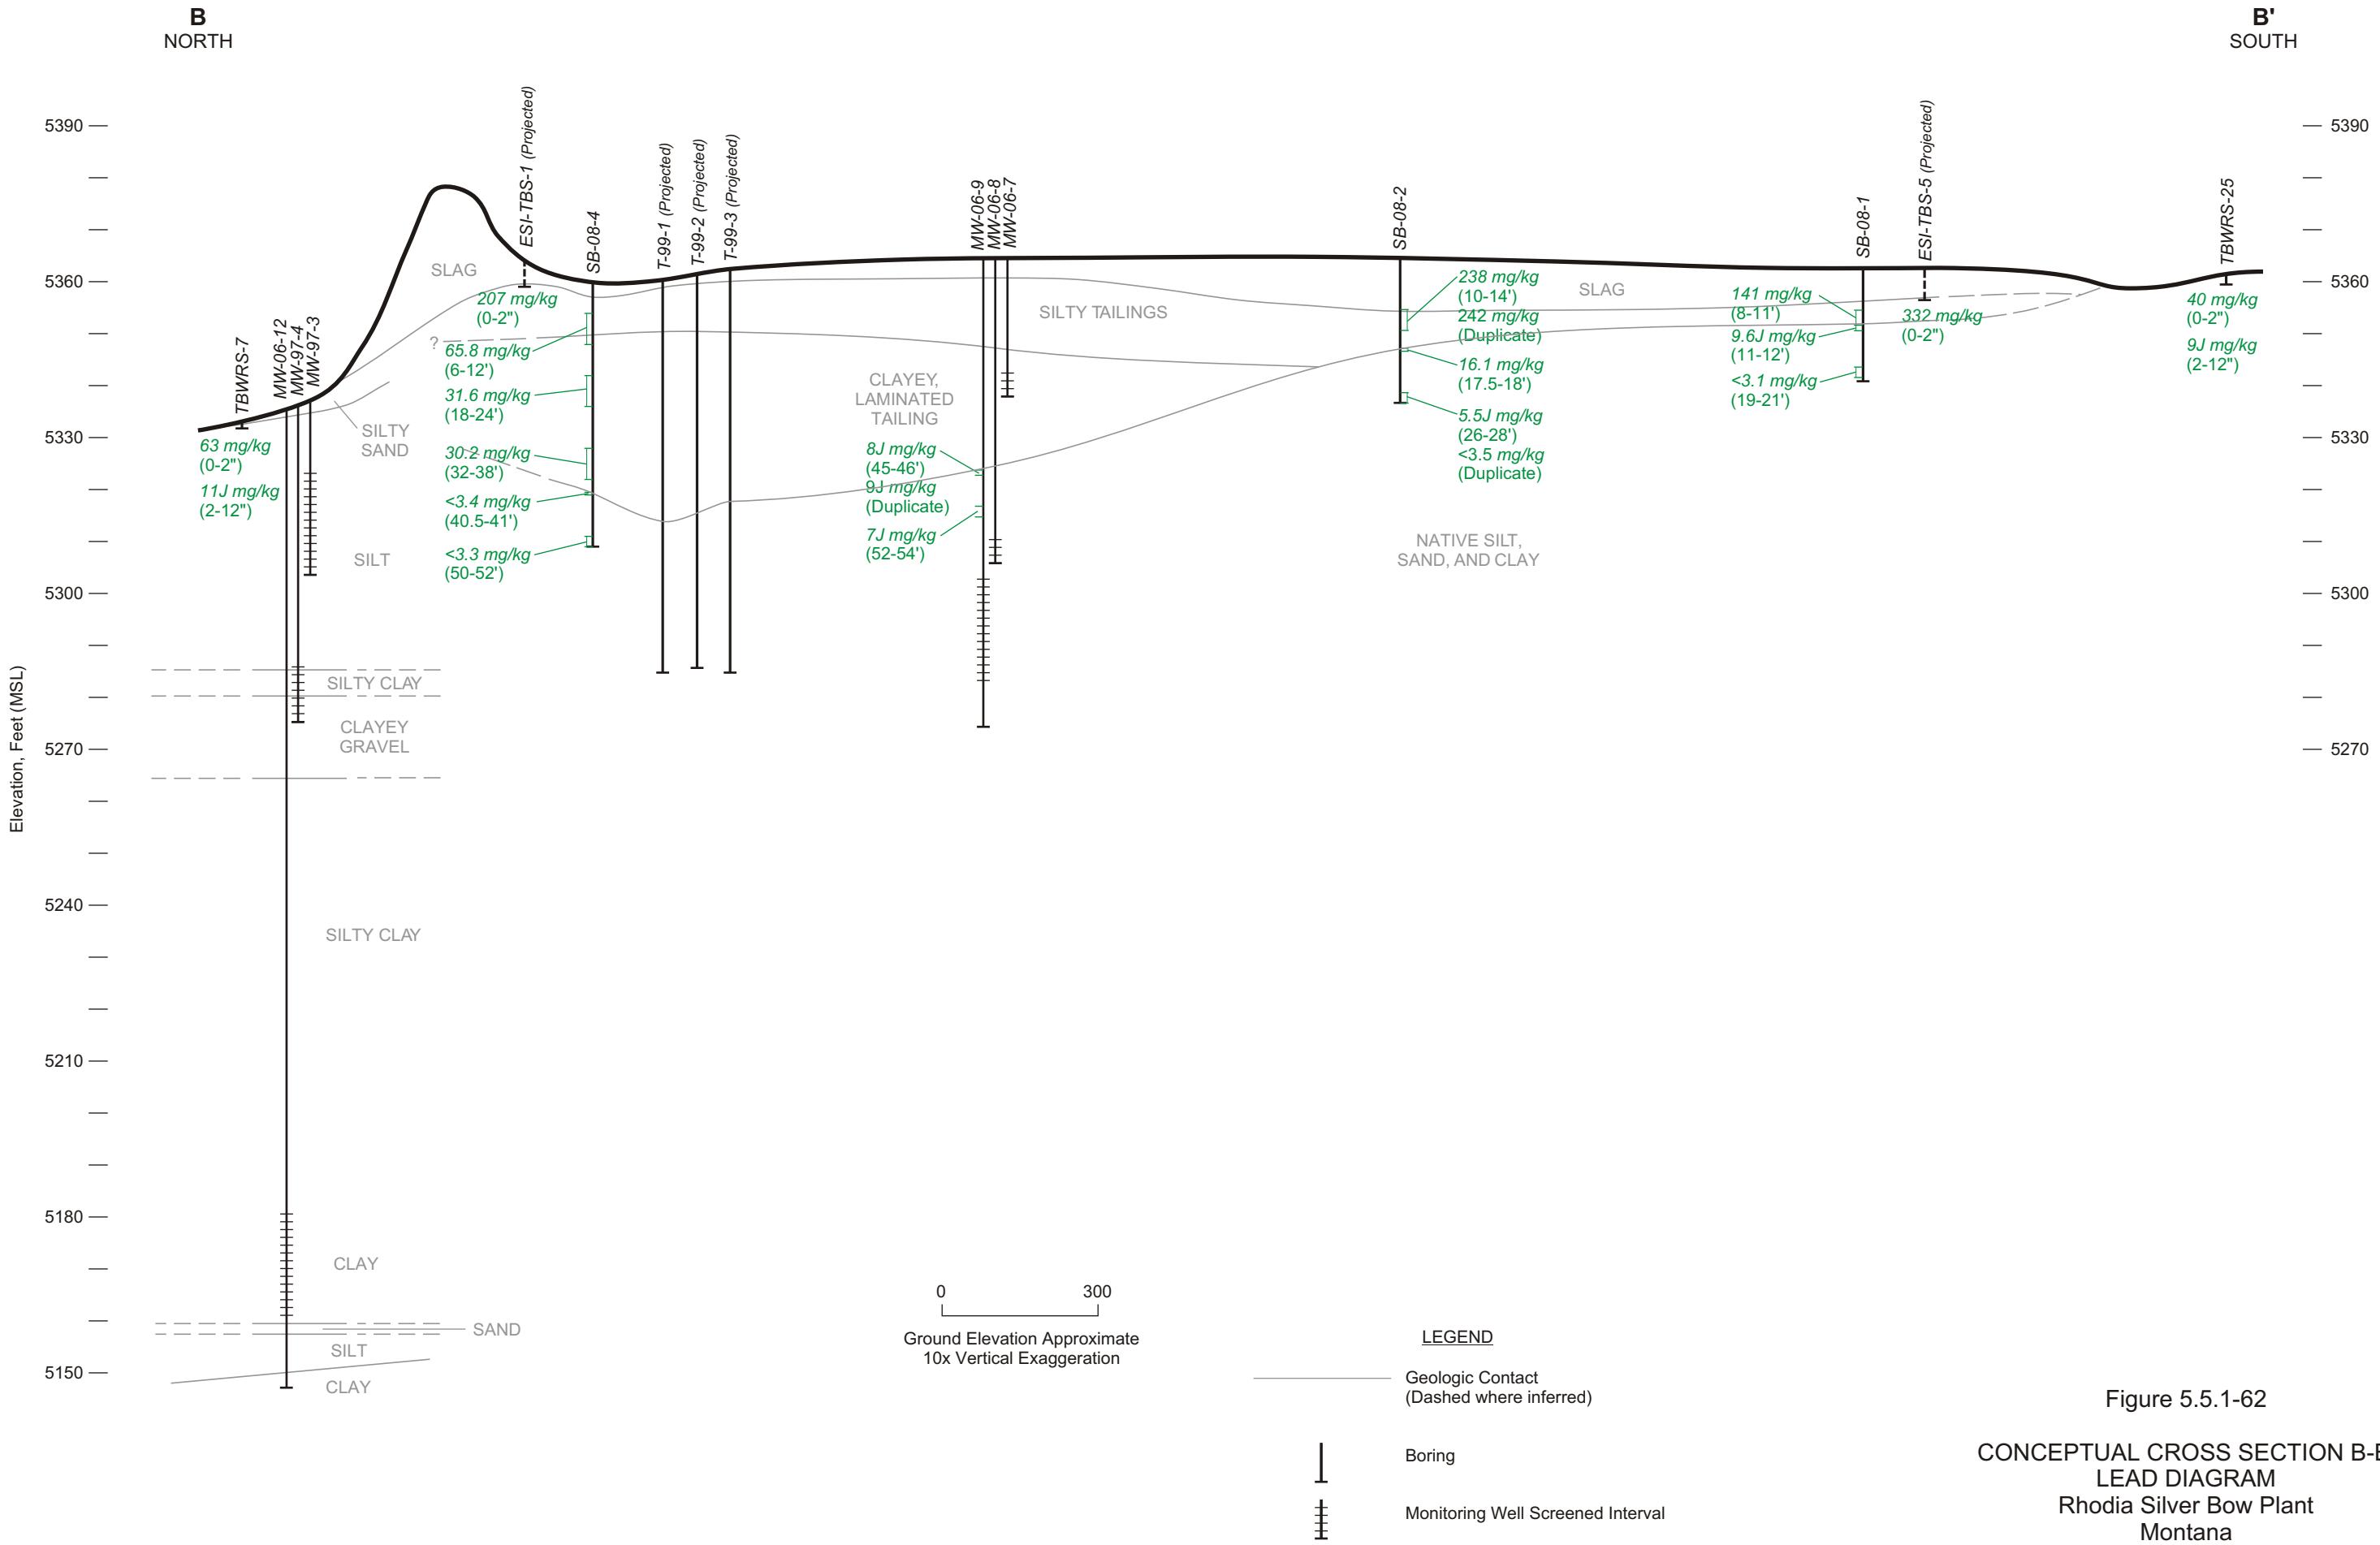
Figure 5.5.1-62

CONCEPTUAL CROSS SECTION B-B'
LEAD DIAGRAM
Rhodia Silver Bow Plant
Montana

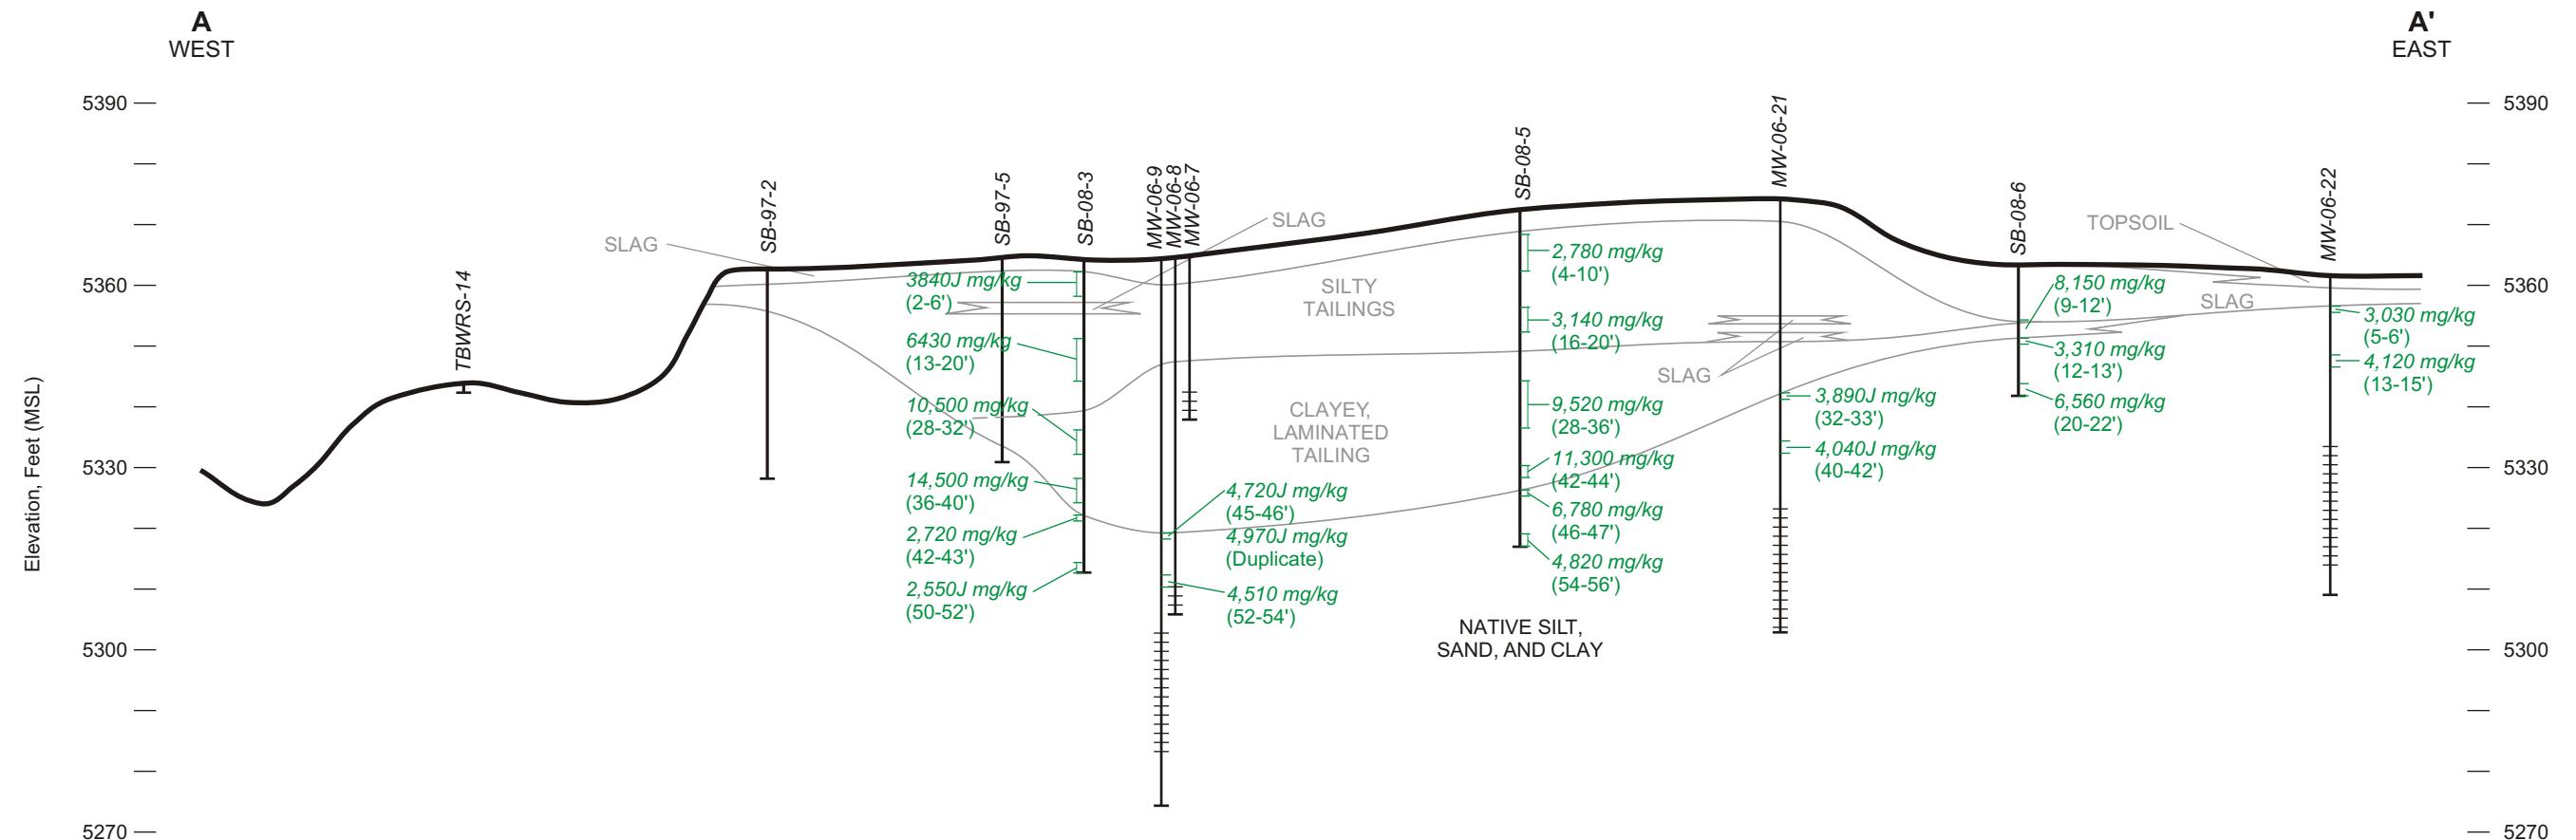
Figure 5.5.1-63

SWMU 1
CONCEPTUAL CROSS SECTION A-A'
MAGNESIUM DIAGRAM
Rhodia Silver Bow Plant
Montana

Magnesium concentrations in tailing and soil are shown on Figure 5.5.1-29 and 5.5.1-30, respectively. Magnesium concentrations in soil remain above background soil concentrations. The magnesium distribution is shown in cross section on Figures 5.5.1-63 and 5.5.1-64. The magnesium profile shows increasing magnesium concentrations with depth in the tailing. The highest magnesium concentrations are found in the deepest tailing samples. As with the other metals, the magnesium concentration in the underlying native soil is considerably lower.

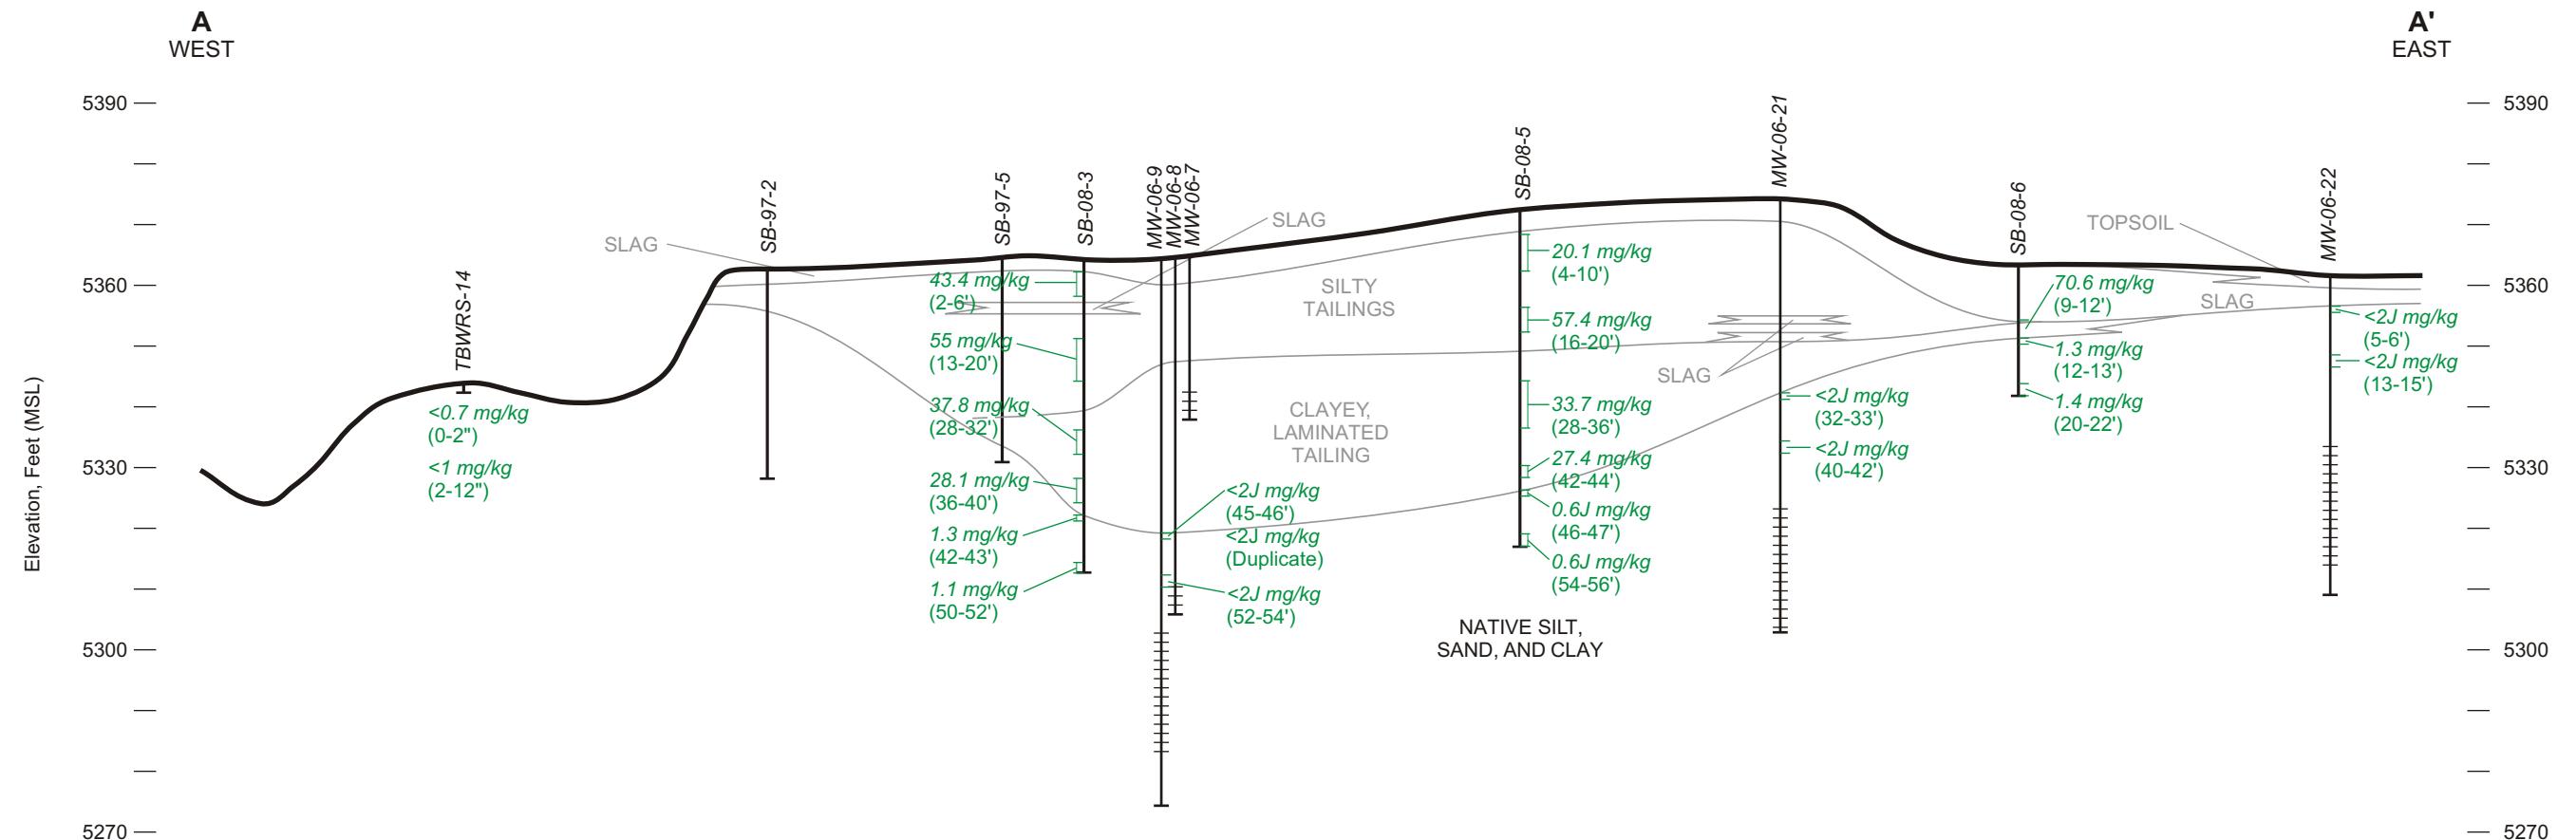
Figure 5.5.1-65

SWMU 1
CONCEPTUAL CROSS SECTION A-A'
SELENIUM DIAGRAM
Rhodia Silver Bow Plant
Montana

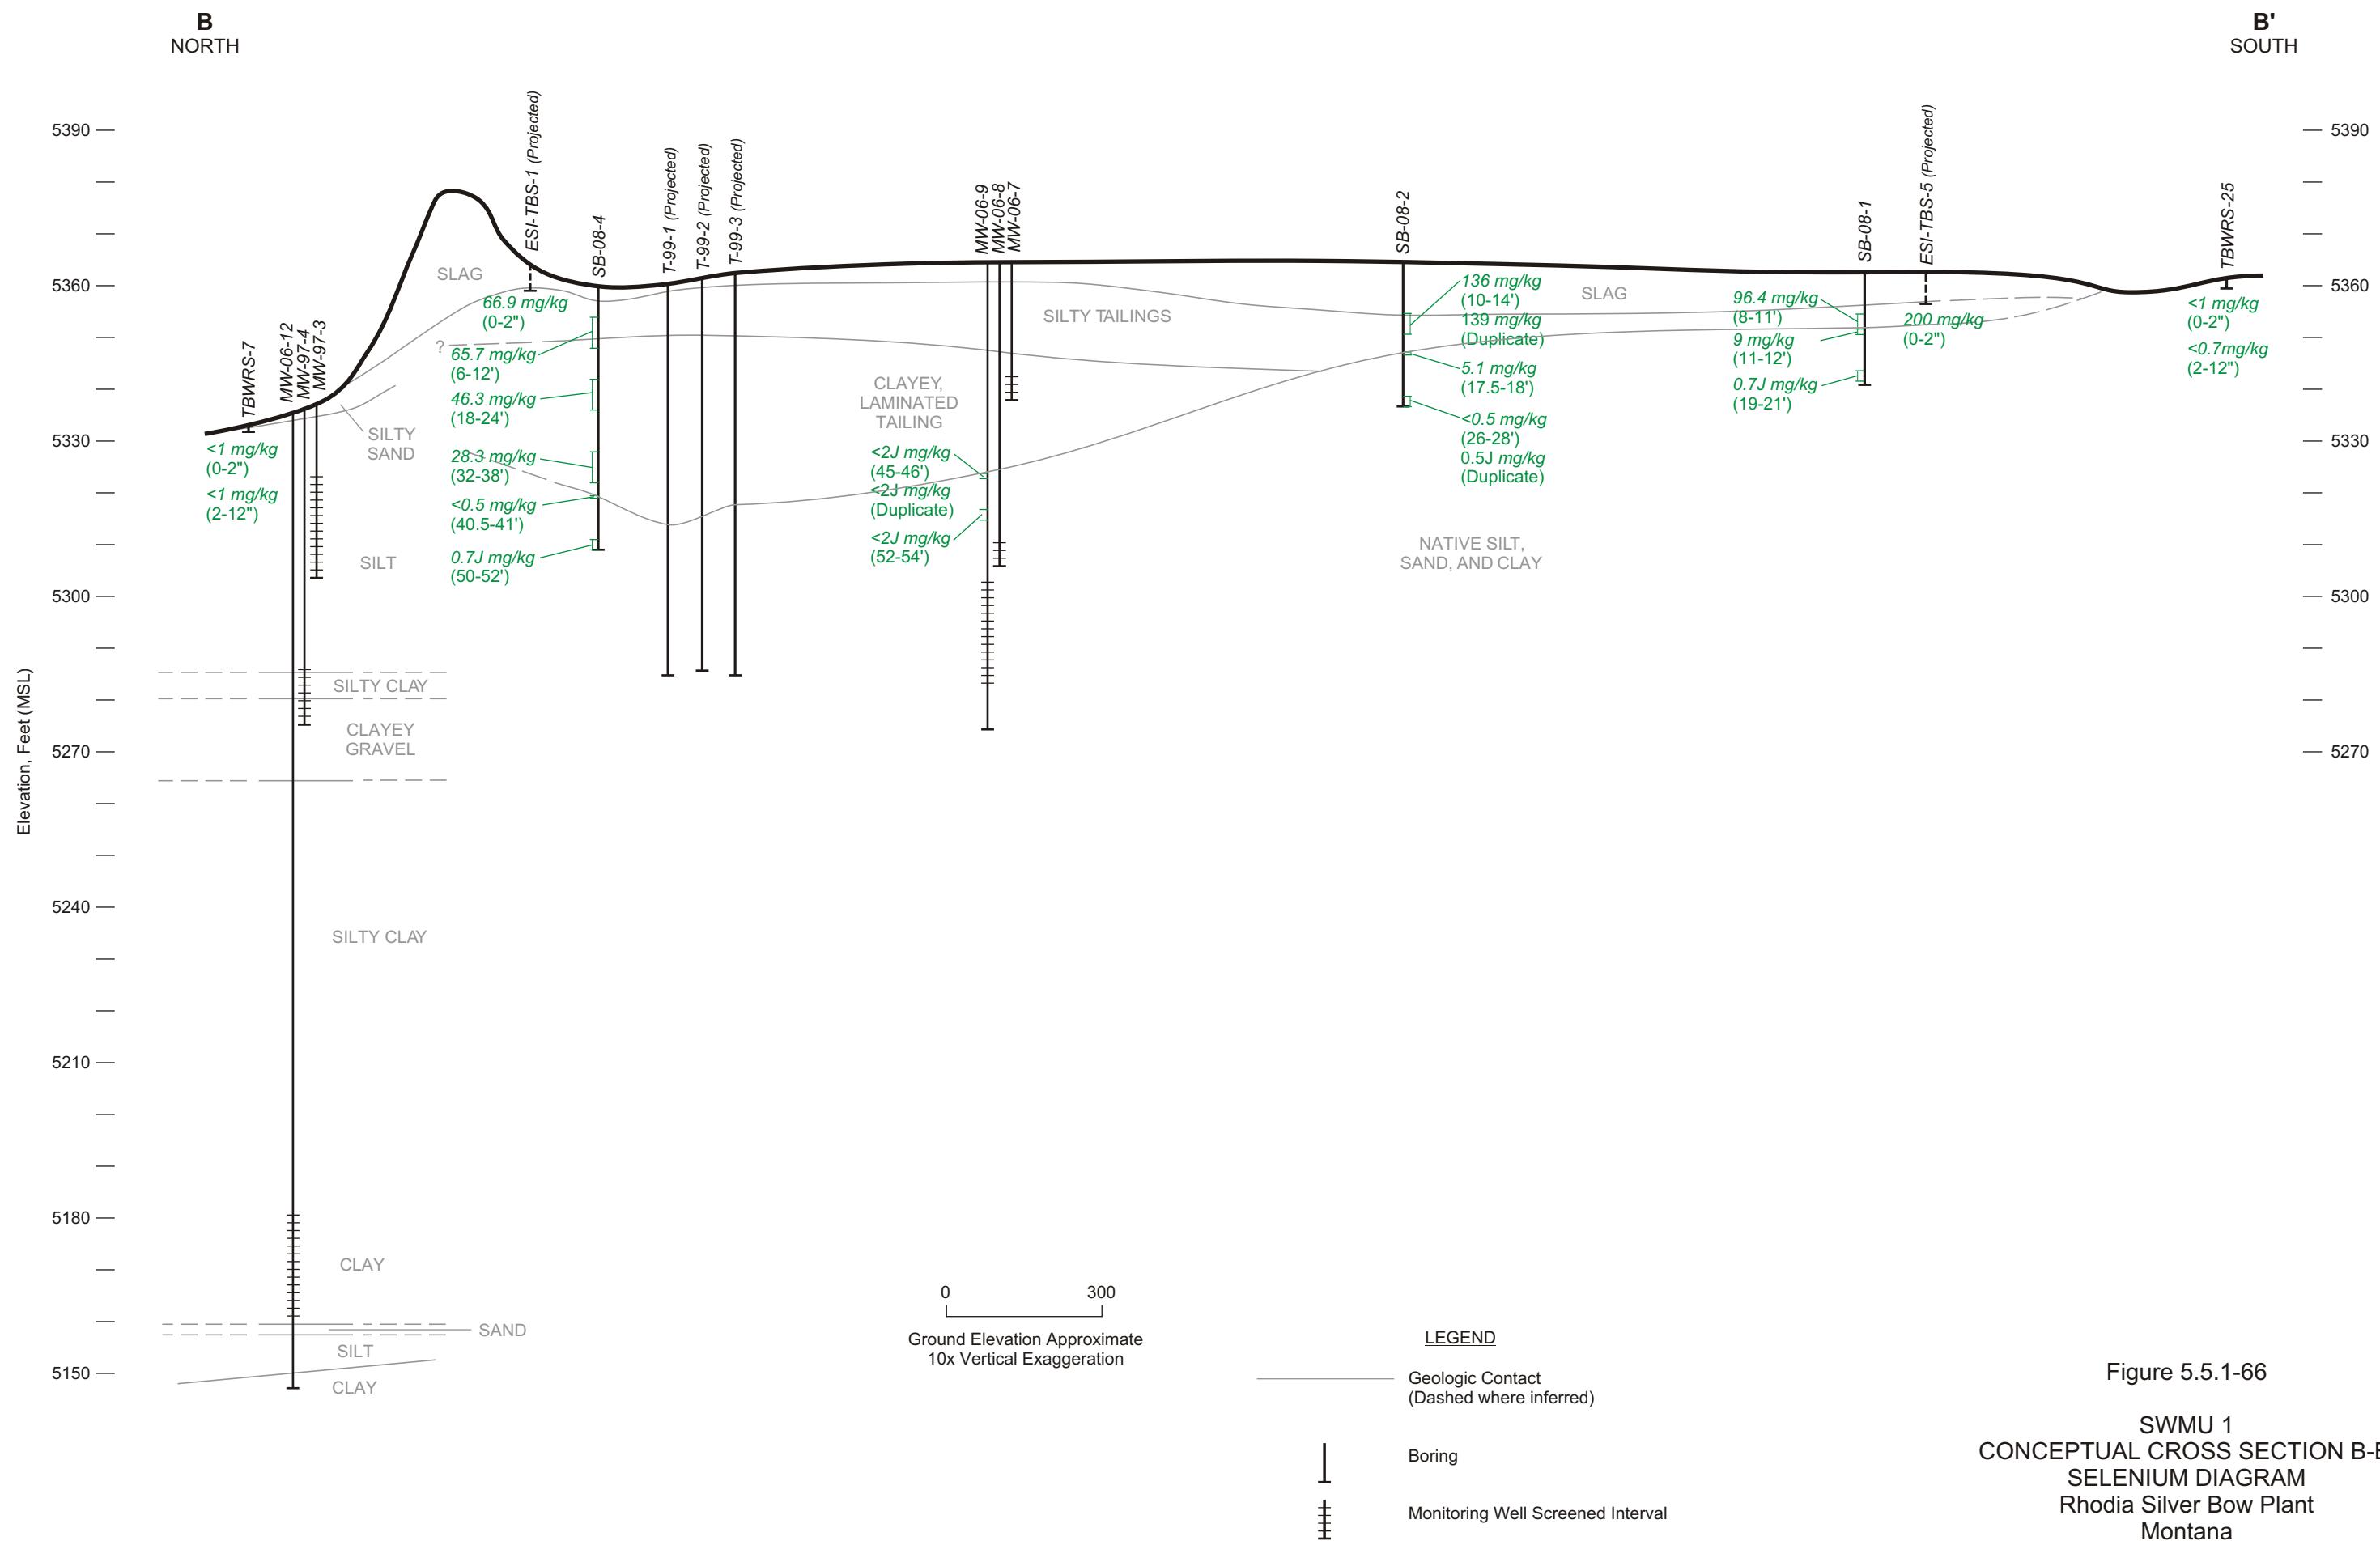
Figure 5.5.1-66

SWMU 1
CONCEPTUAL CROSS SECTION B-B'
SELENIUM DIAGRAM
Rhodia Silver Bow Plant
Montana

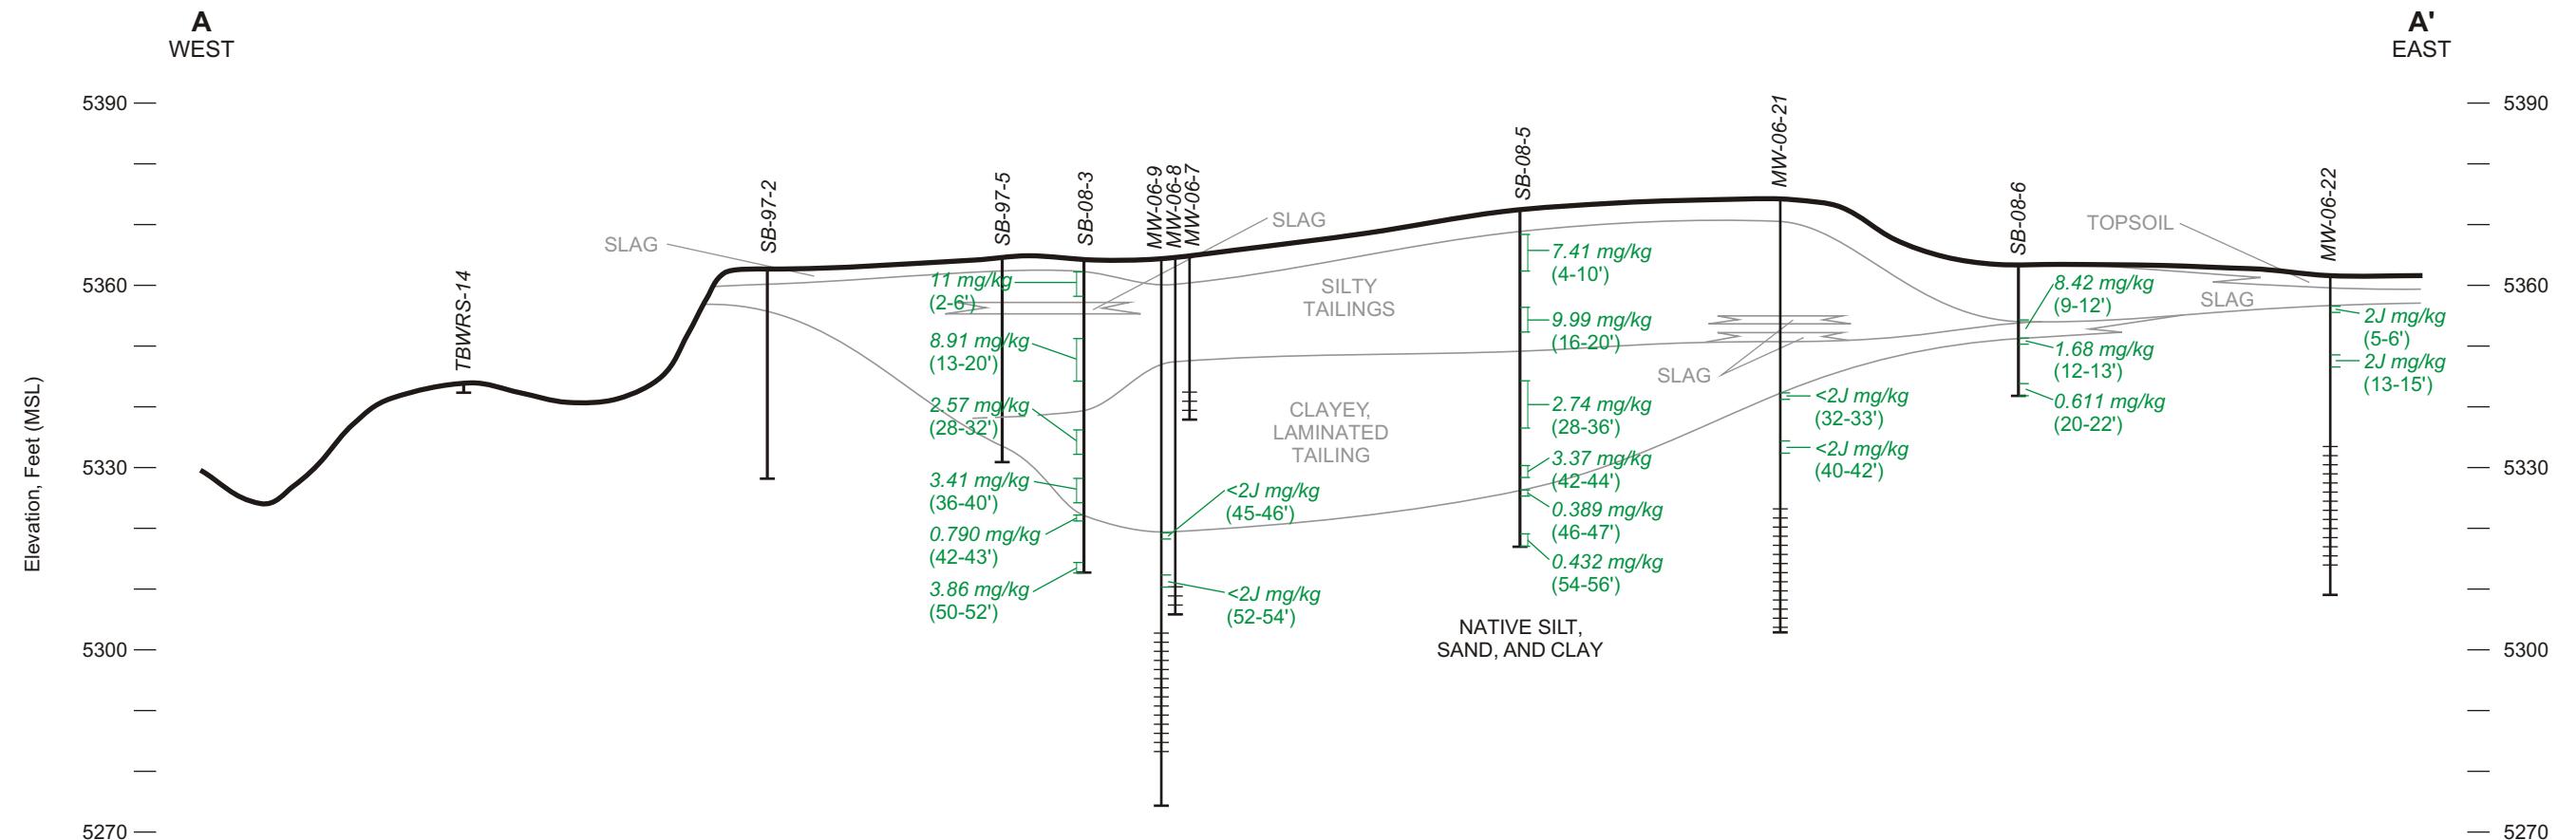
Figure 5.5.1-67

SWMU 1
CONCEPTUAL CROSS SECTION A-A'
THALLIUM DIAGRAM
Rhodia Silver Bow Plant
Montana

Thallium is present in the tailing at concentrations above background soil concentrations. Thallium ranges from 2.5 mg/kg to 33.1 mg/kg with an average concentration of 14.2 mg/kg. Thallium concentrations in tailing and soil are shown on Figure 5.5.1-45 and 5.5.1-46, respectively. Thallium concentrations in soil are lower, but remain above background soil concentrations. The thallium distribution is shown in cross section on Figures 5.5.1-67 and 5.5.1-68. Higher concentrations of thallium are found in the silty tailing layer.
