SWMU 1 - Tailing Basin & Water Recirculation System

Figure 5.5.1-1a

SWMU 1 LOCATION
Rhodia Silver Bow Plant
Montana

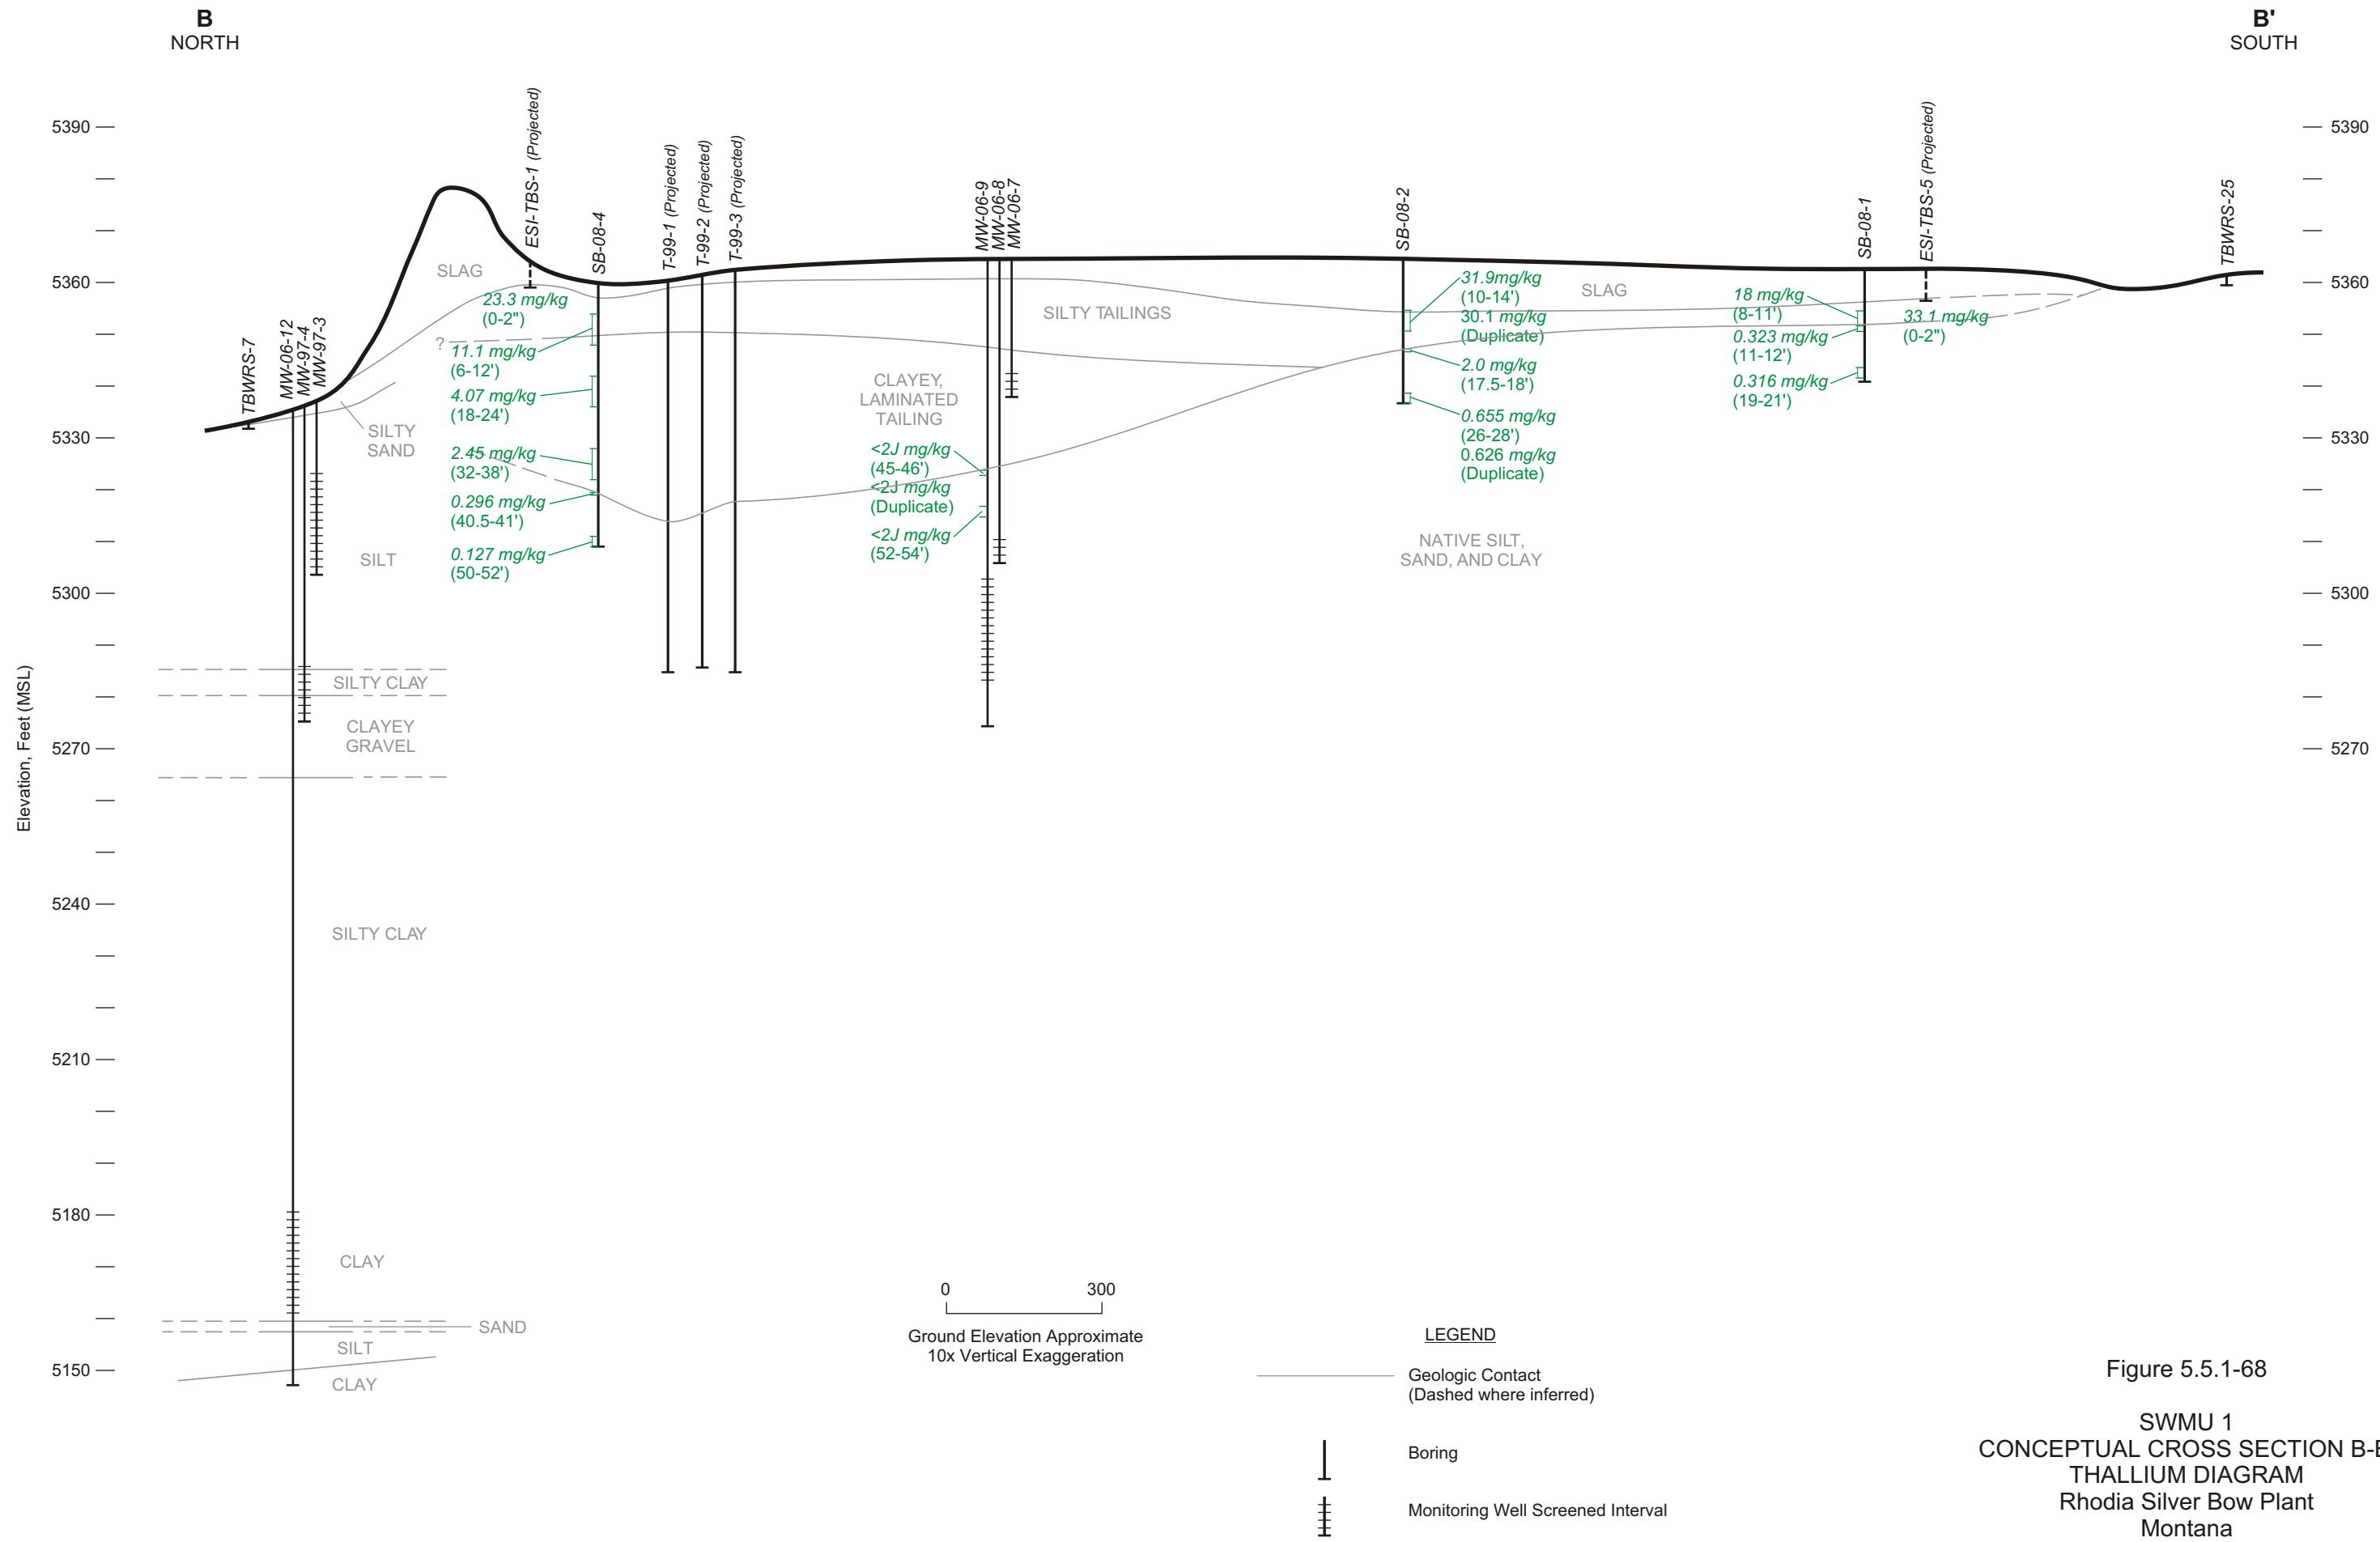
Figure 5.5.1-68

SWMU 1
CONCEPTUAL CROSS SECTION B-B'
THALLIUM DIAGRAM
Rhodia Silver Bow Plant
Montana

Thallium is present in the tailing at concentrations above background soil concentrations. Thallium ranges from 2.5 mg/kg to 33.1 mg/kg with an average concentration of 14.2 mg/kg. Thallium concentrations in tailing and soil are shown on Figure 5.5.1-45 and 5.5.1-46, respectively. Thallium concentrations in soil are lower, but remain above background soil concentrations. The thallium distribution is shown in cross section on Figures 5.5.1-67 and 5.5.1-68. Higher concentrations of thallium are found in the silty tailing layer.
