**Site Reassessment
Mesa I, Mines 10-15
Abandoned Uranium Mine
Apache County, Arizona**

**EPA ID No.: NND983466772
USACE Contract Number: W91238-11-D-0001
Interagency Agreement No.: 95777001-0
Document Control Number: 20074.063.100**

**Prepared for:
United States Environmental Protection Agency
Region 9**

**Prepared by:
Weston Solutions, Inc.
1340 Treat Blvd
Suite 210
Walnut Creek, CA 94597**

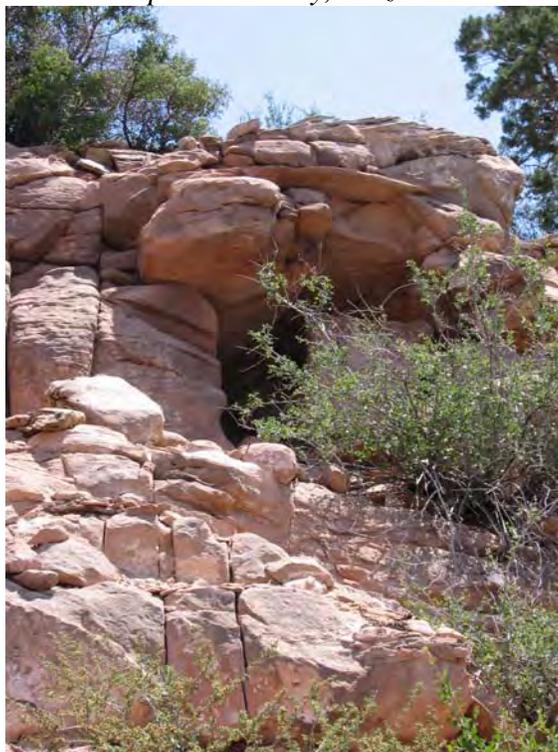
Photo 1: Potential reclaimed adit located at Mine 11.

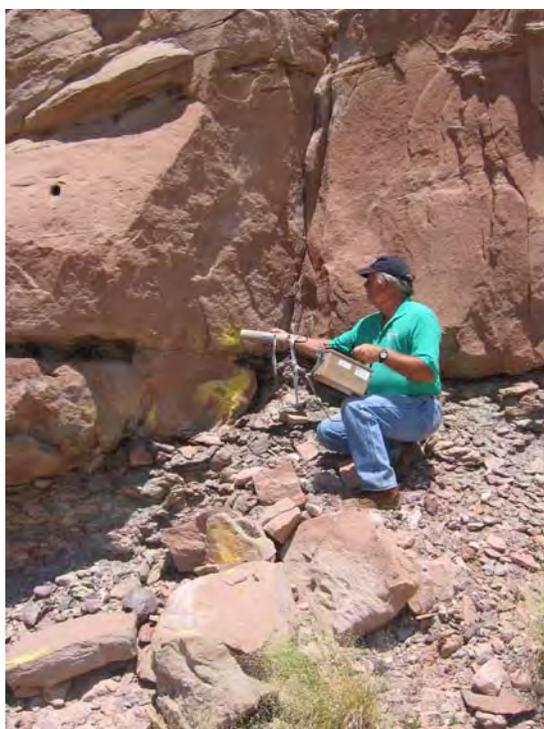
Photo 2: WESTON employee holds sodium-iodide scintillation detector to exposed uranium ore at Mine 12.

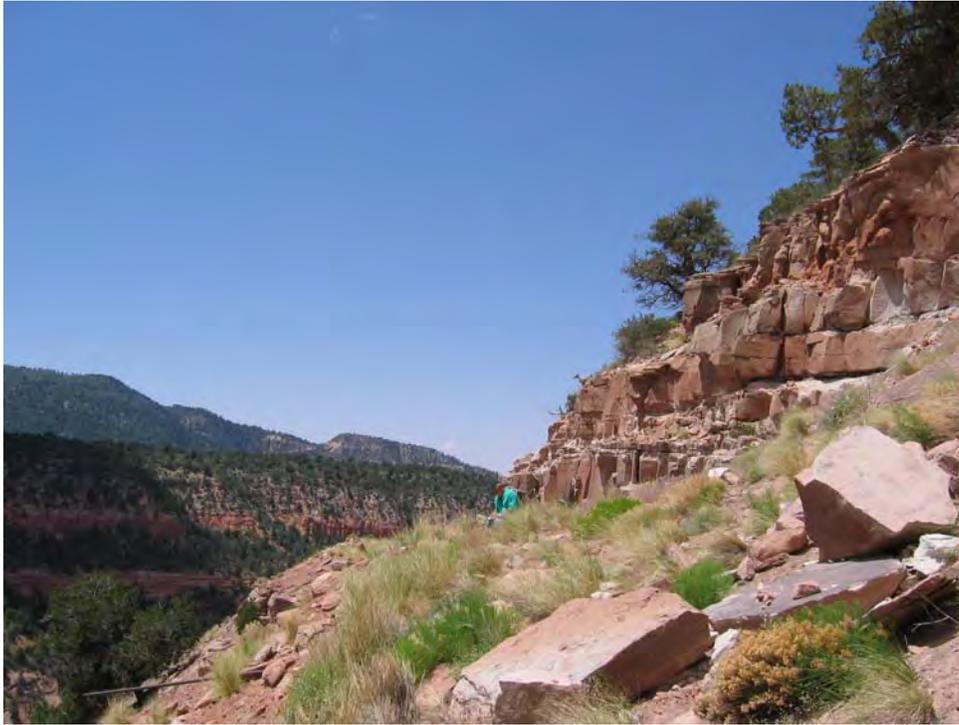
Photo 3: Mine tailings at Mine 12 mesa ridge.

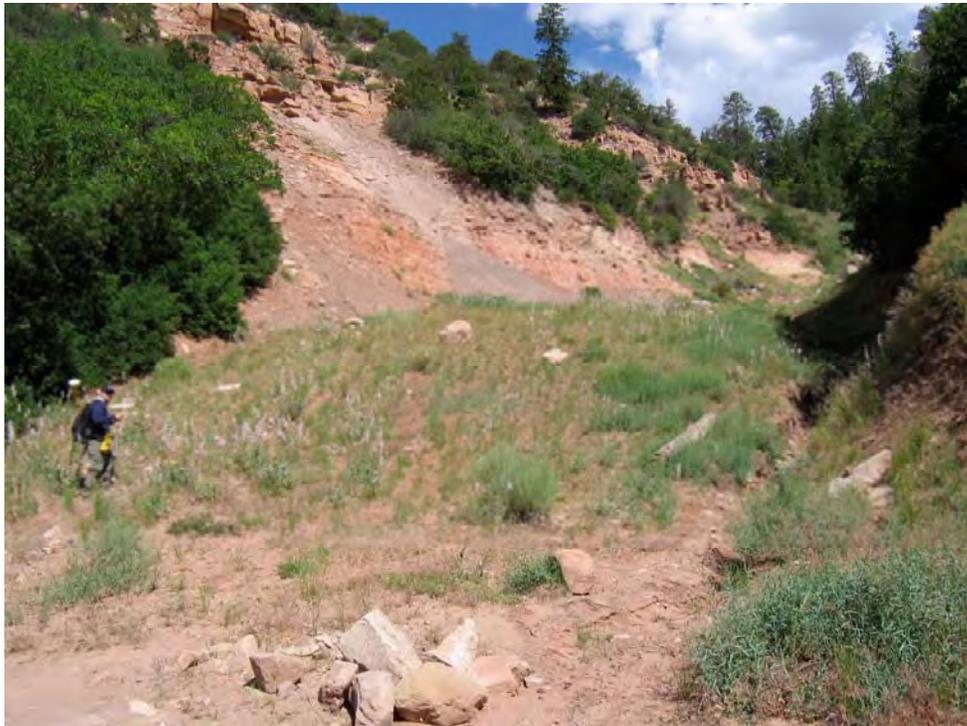
Photo 4: Area reclaimed by the Navajo Abandoned Mines Reclamation Program at Mine 13.

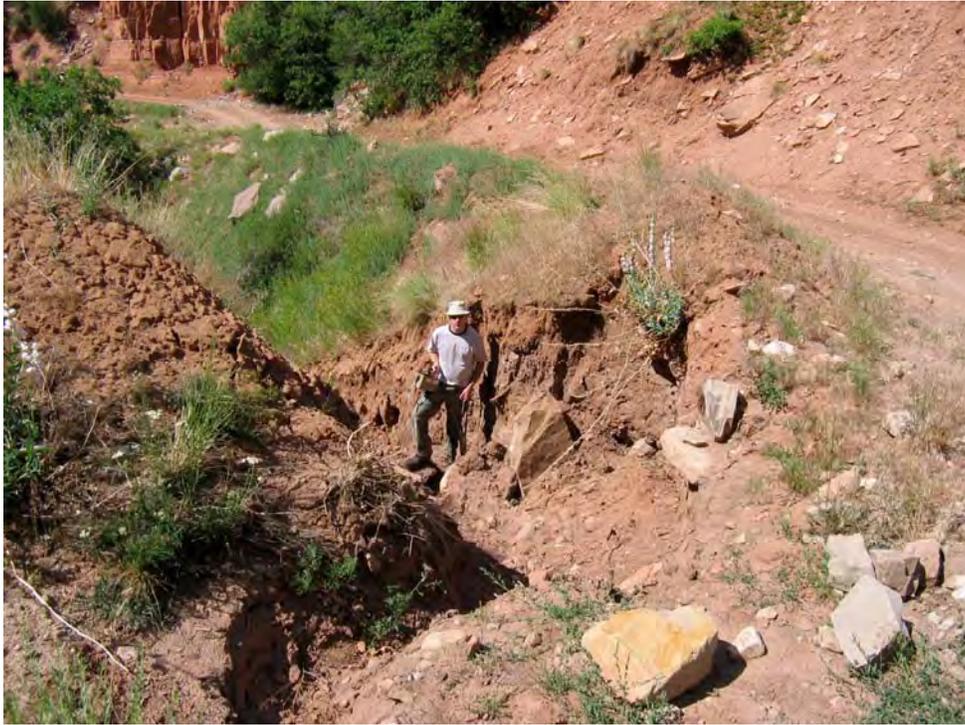
Photo 5: A WESTON employee collects gamma radiation readings in the drainage from the reclaimed portion of Mine 13.

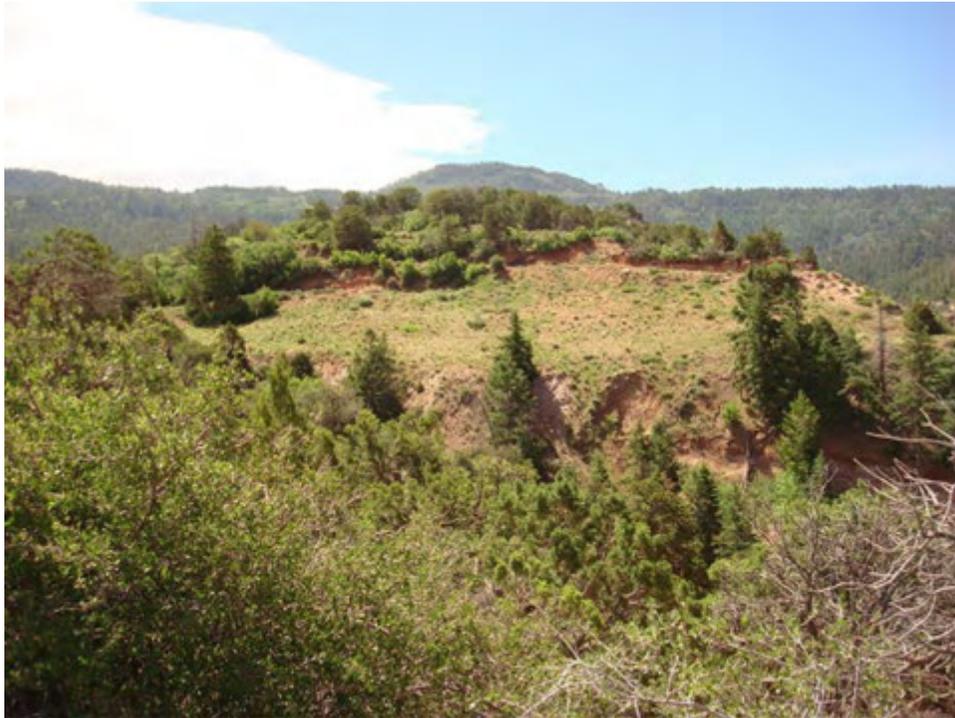
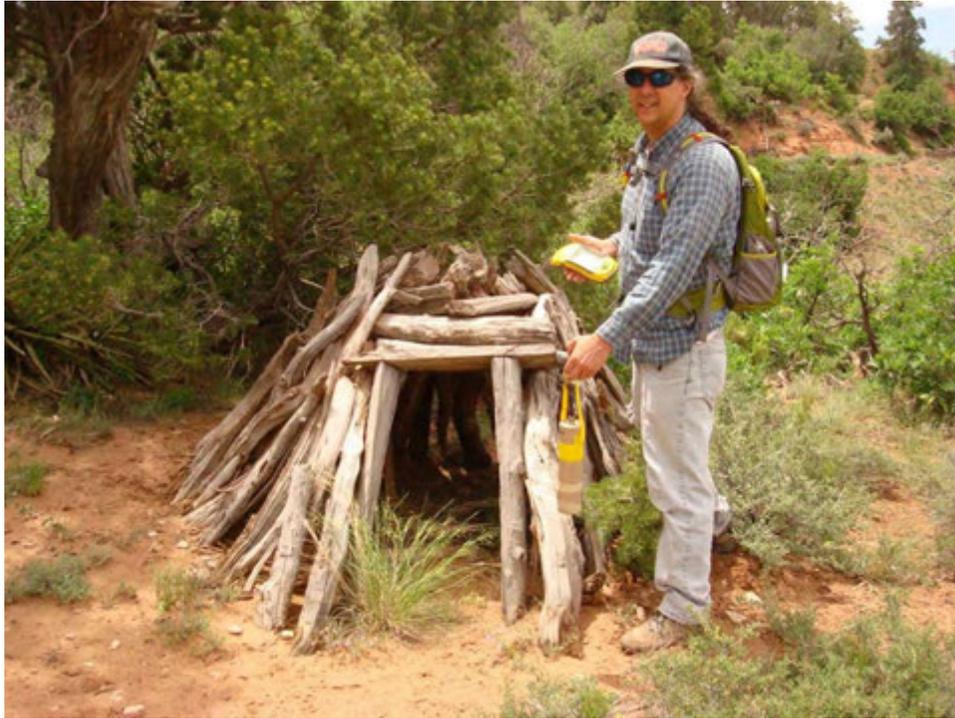
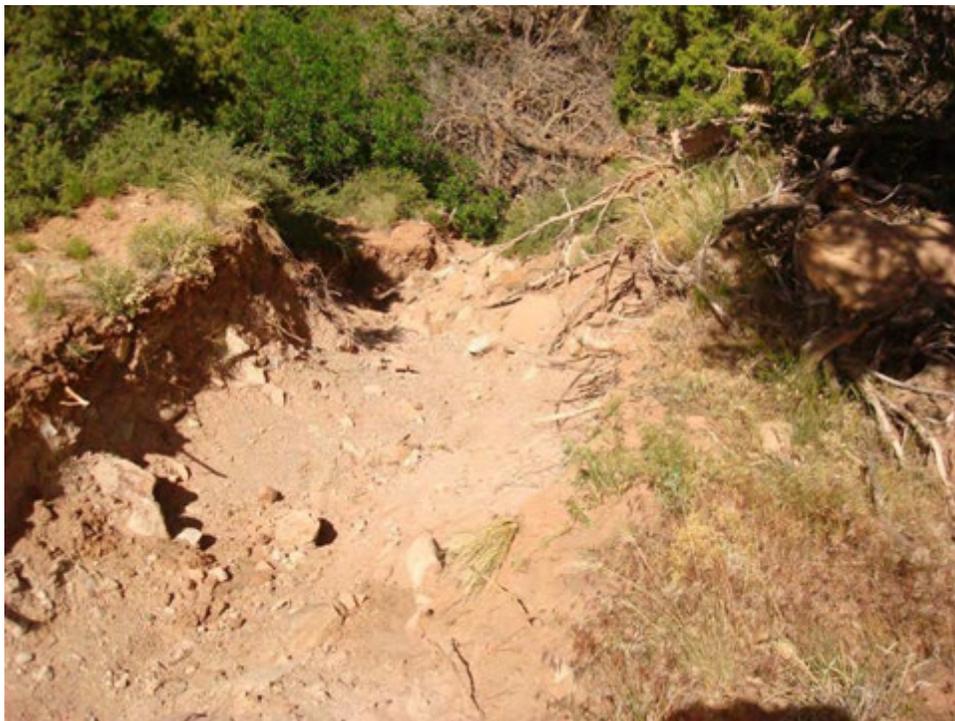
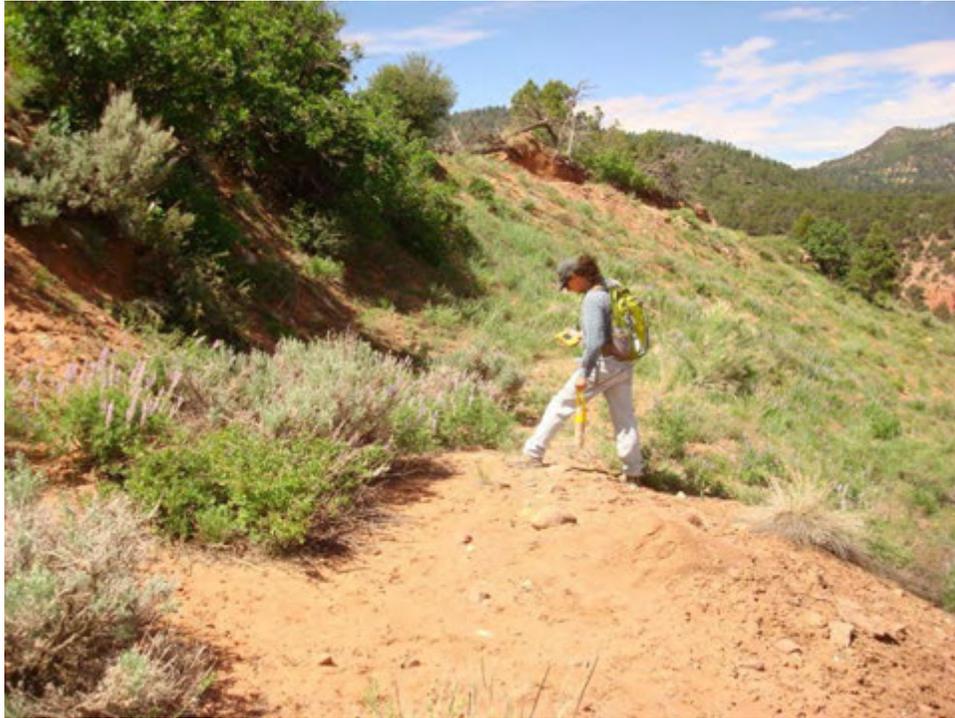
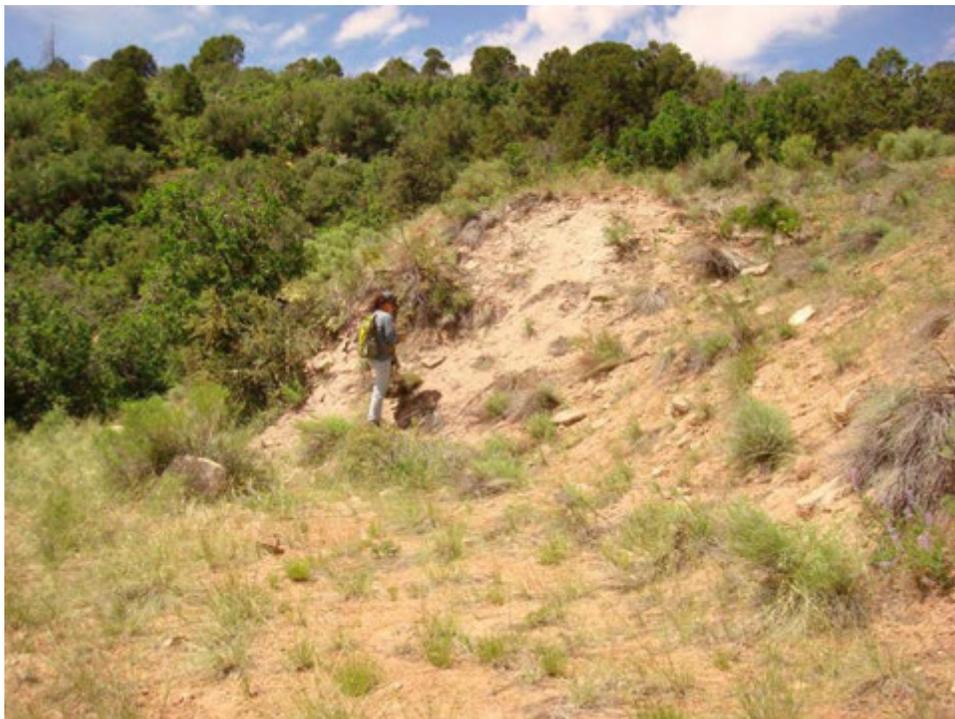
Photo 1: Mesa I, Mine No. 11 (93) site

A total of 4,643 gamma radiation measurements were collected from the mine site, ranging from 7,054 cpm to 805,281 cpm.

Average background = 15,624 cpm

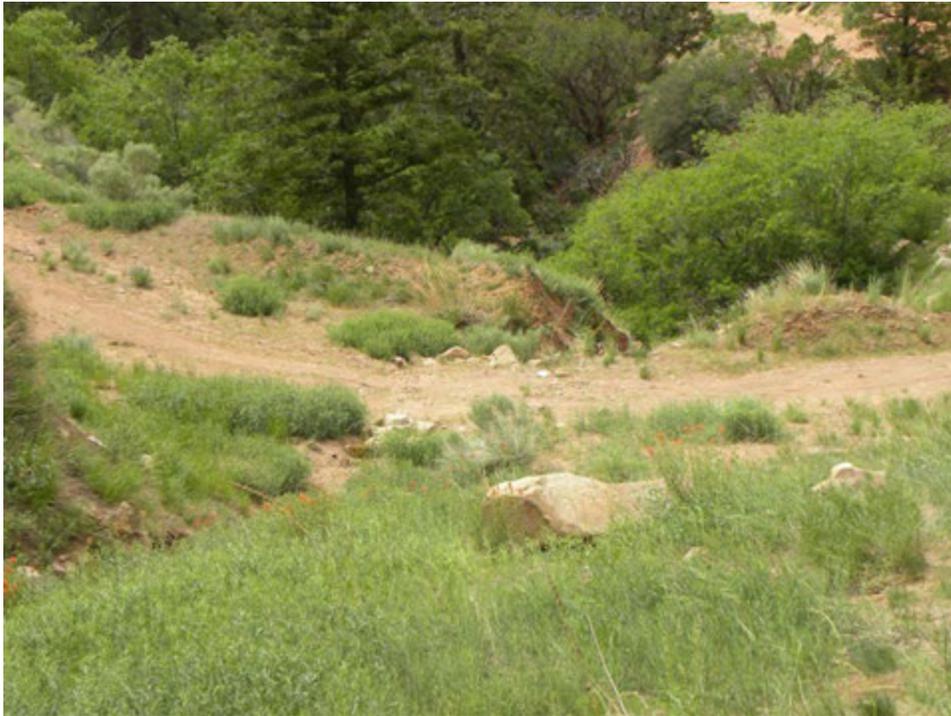
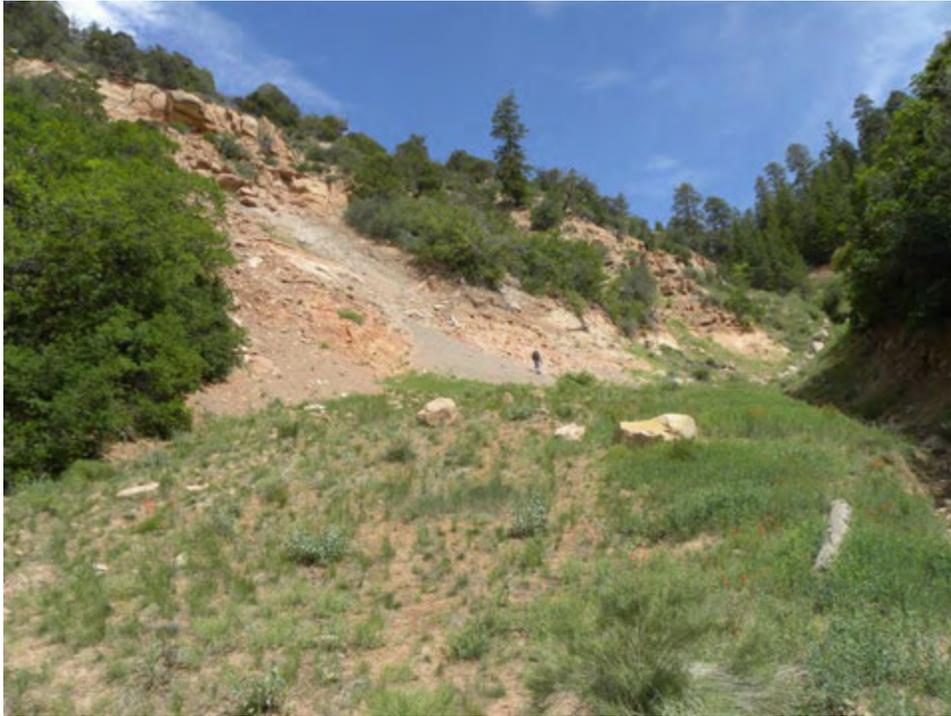
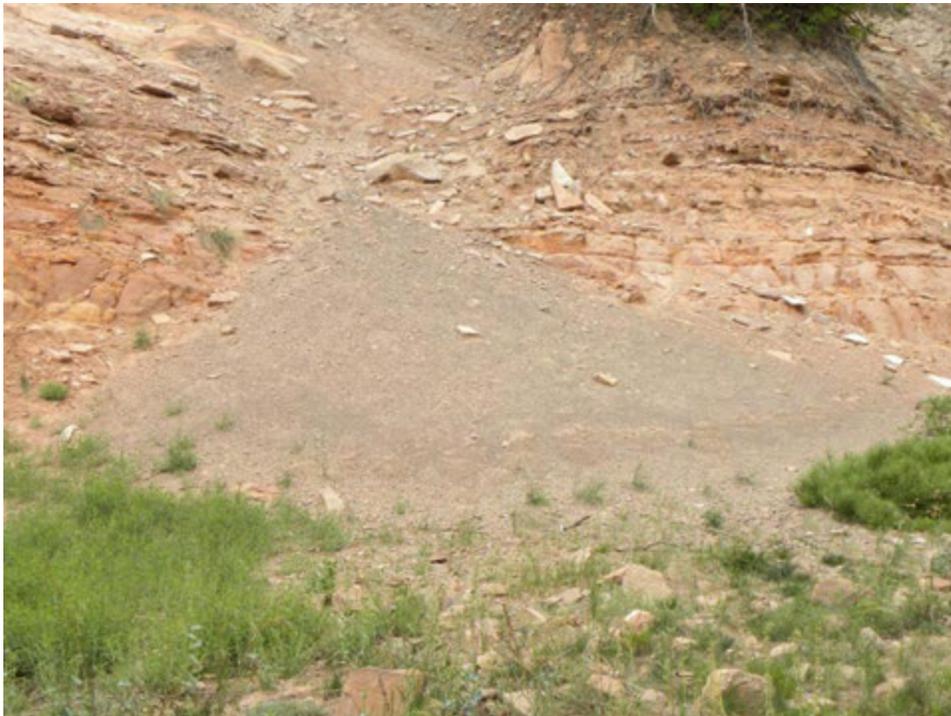
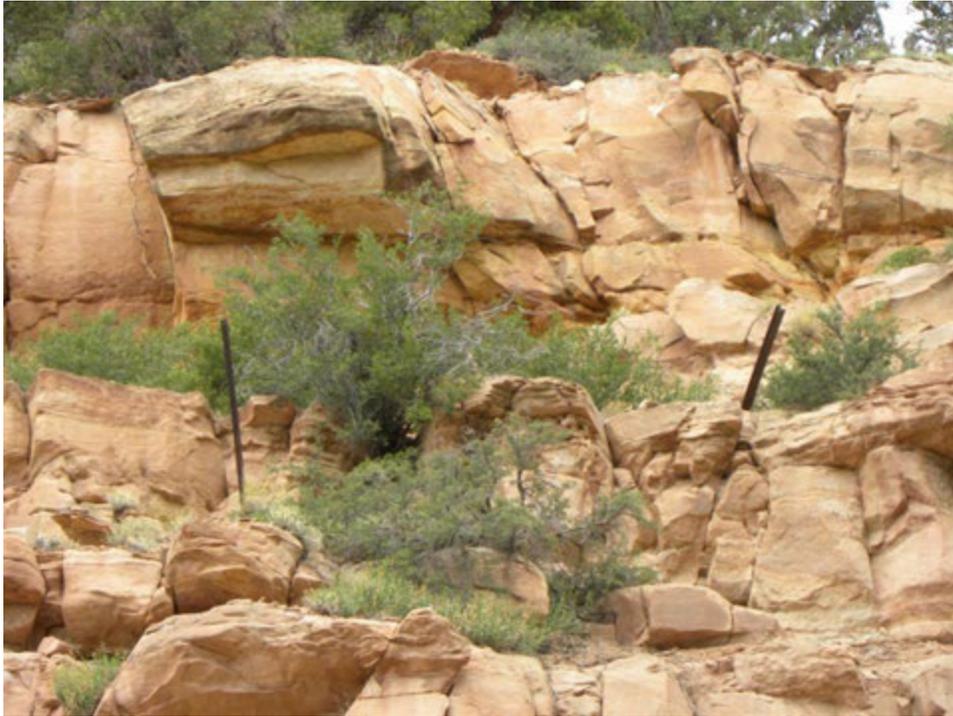
Photo 1: Mesa I, Mine No. 13 (94) site

A total of 2,224 gamma radiation measurements were collected from the mine site, ranging from 14,339 cpm to 235,955 cpm.

Average background = 14,842 cpm

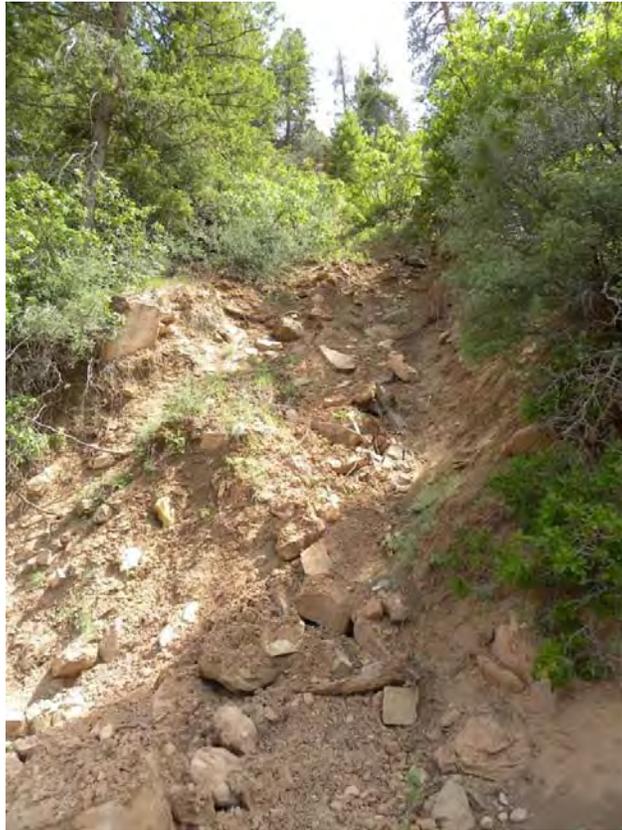
Photo 1. Mesa I, Mine No. 10 (654) site

A total of 536 gamma radiation measurements were collected from the mine site, ranging from 14,085 cpm to 68,482 cpm.

Average background = 14,842 cpm

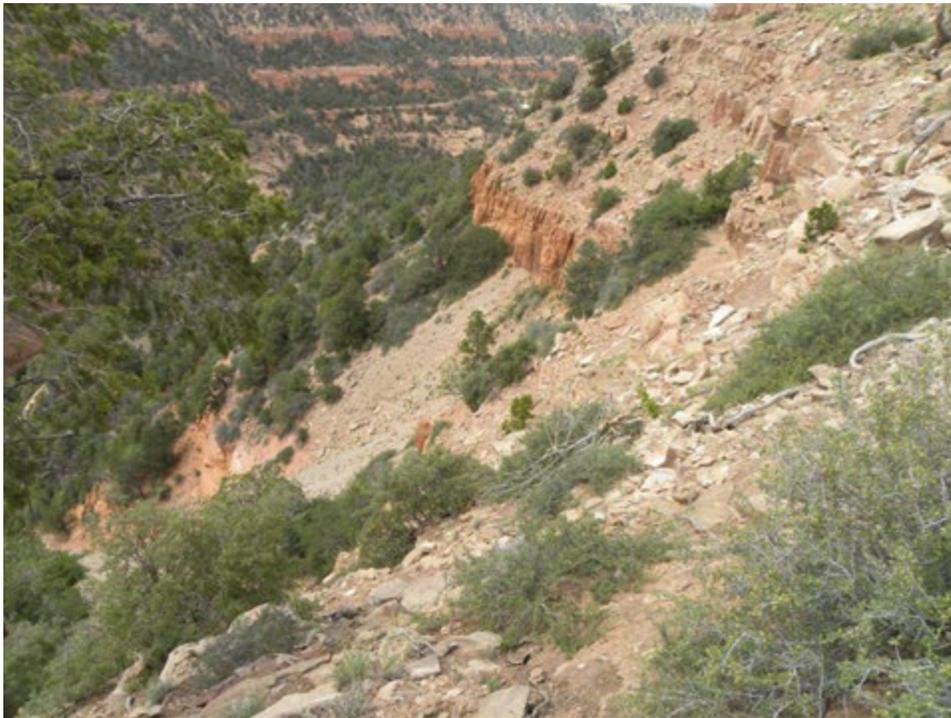
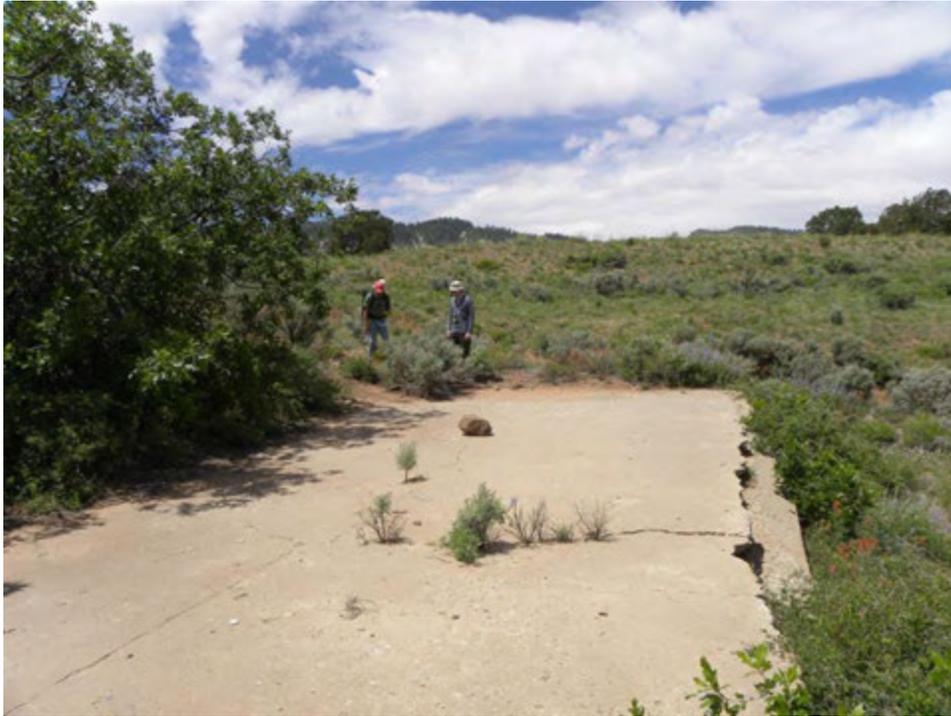
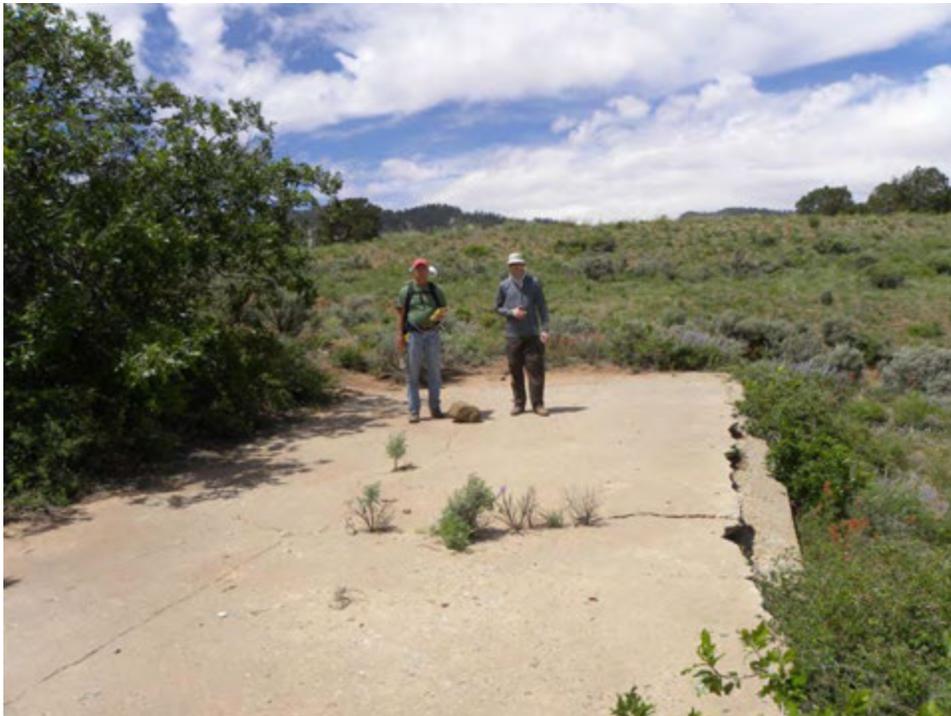
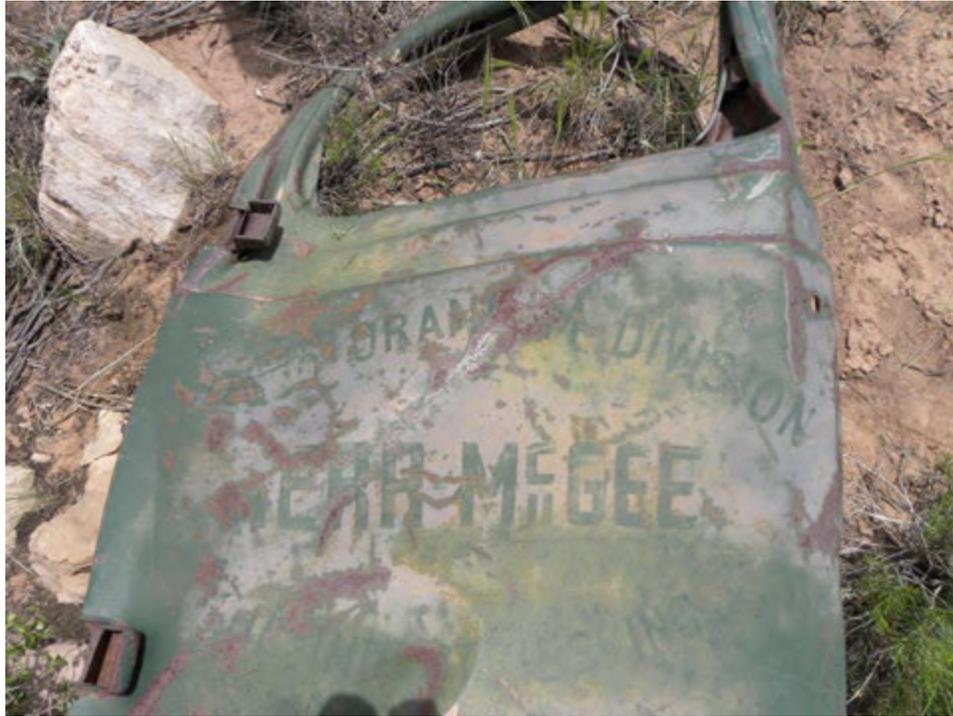
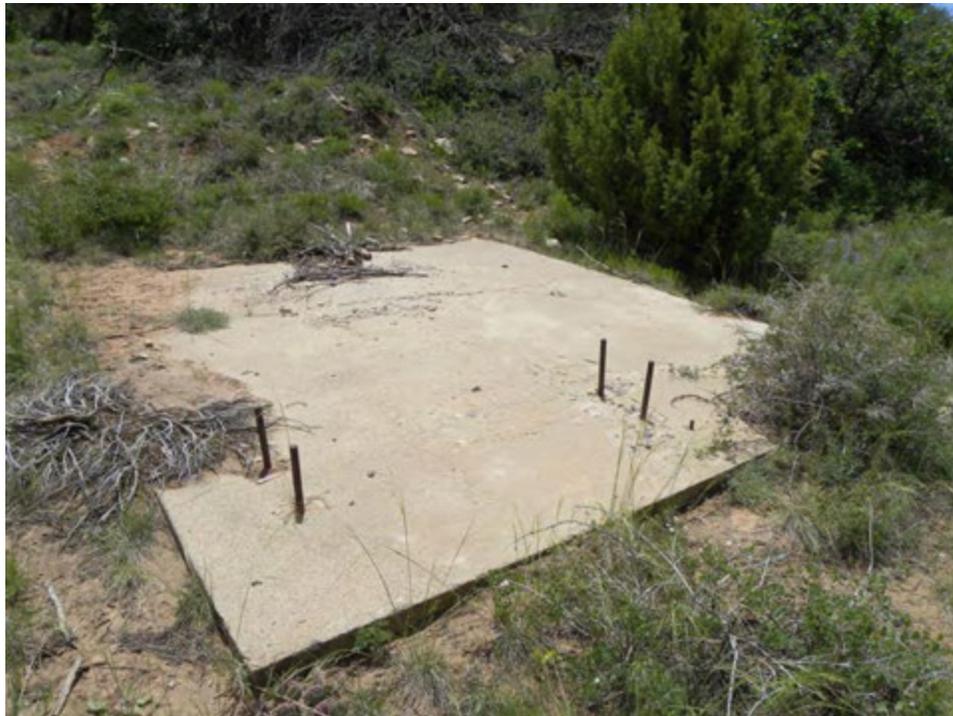
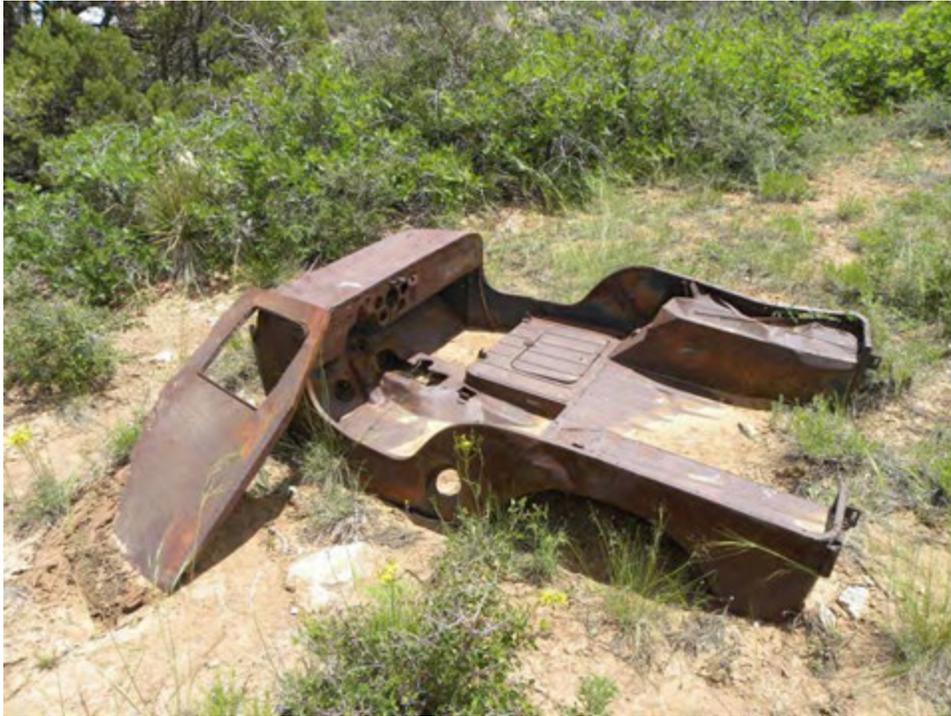
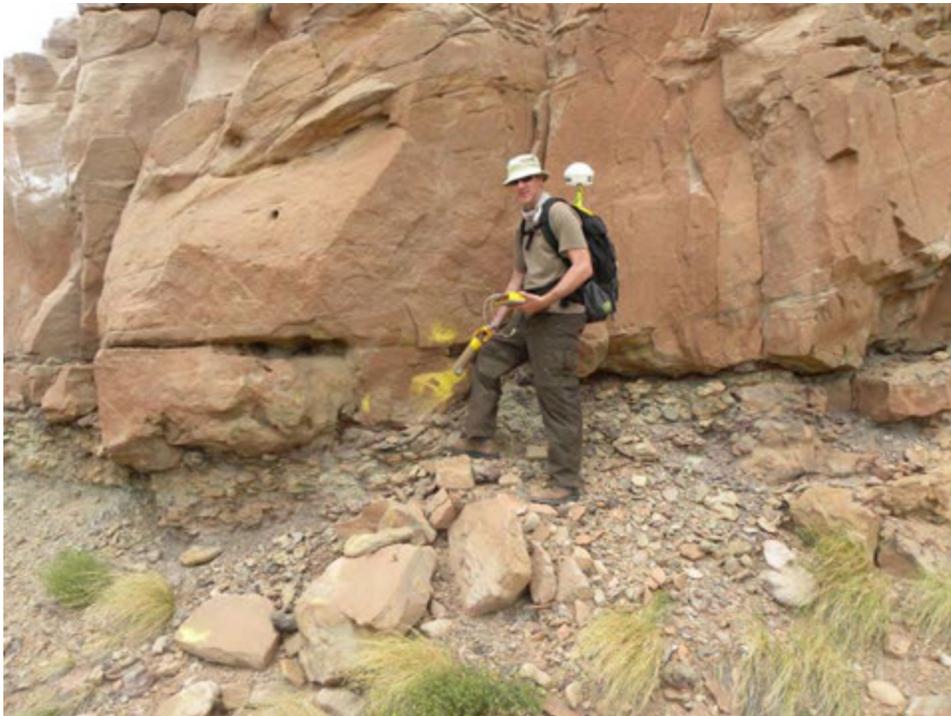
Photo 1. Mesa I, Mine No. 12 (655) site

A total of 7,736 gamma radiation measurements were collected from the mine site, ranging from 14,568 cpm to 999,960 cpm. Measurements collected in the vicinity of the waste debris were found at levels up to approximately 1,000,000 cpm (the maximum gamma radiation level the equipment can detect).

Average background = 15,893 cpm

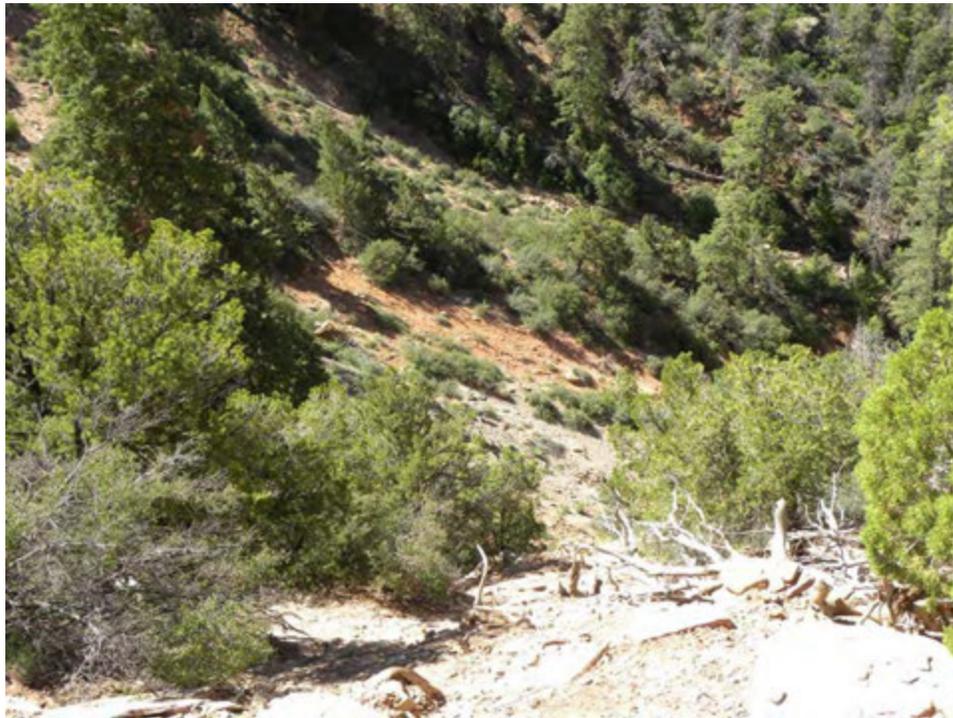
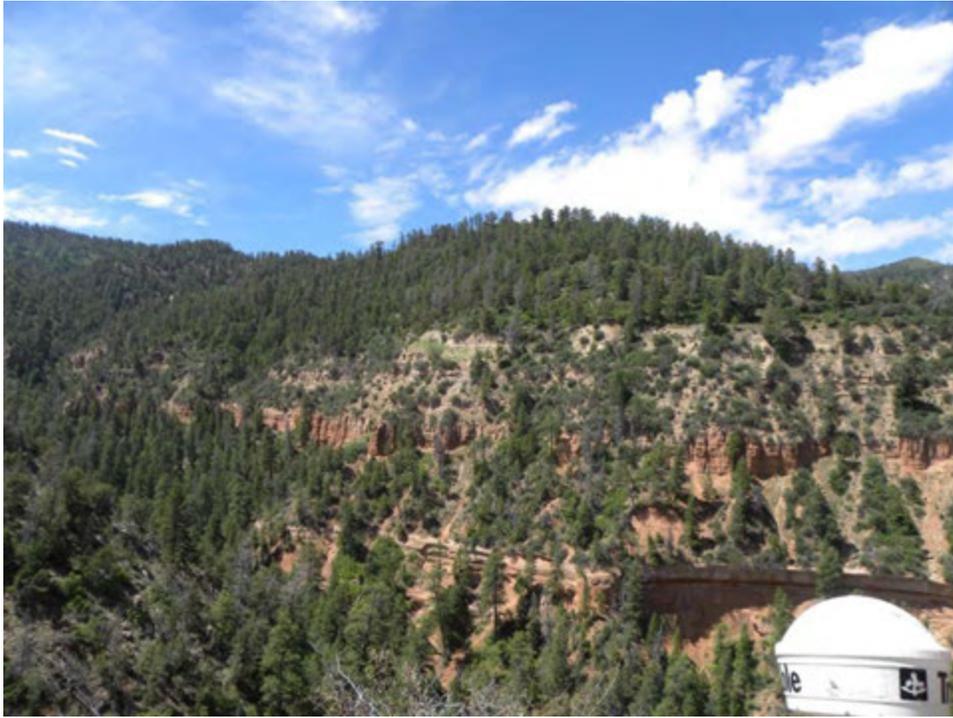
Photo 1. Mesa I, Mine No. 14 (656) site

A total of 5,311 gamma radiation measurements were collected from the mine site, ranging from 11,456 cpm to 999,960 cpm. Measurements collected in the vicinity of the waste debris were found at levels up to approximately 1,000,000 cpm (the maximum gamma radiation level the equipment can detect).

Average background = 12,417 cpm

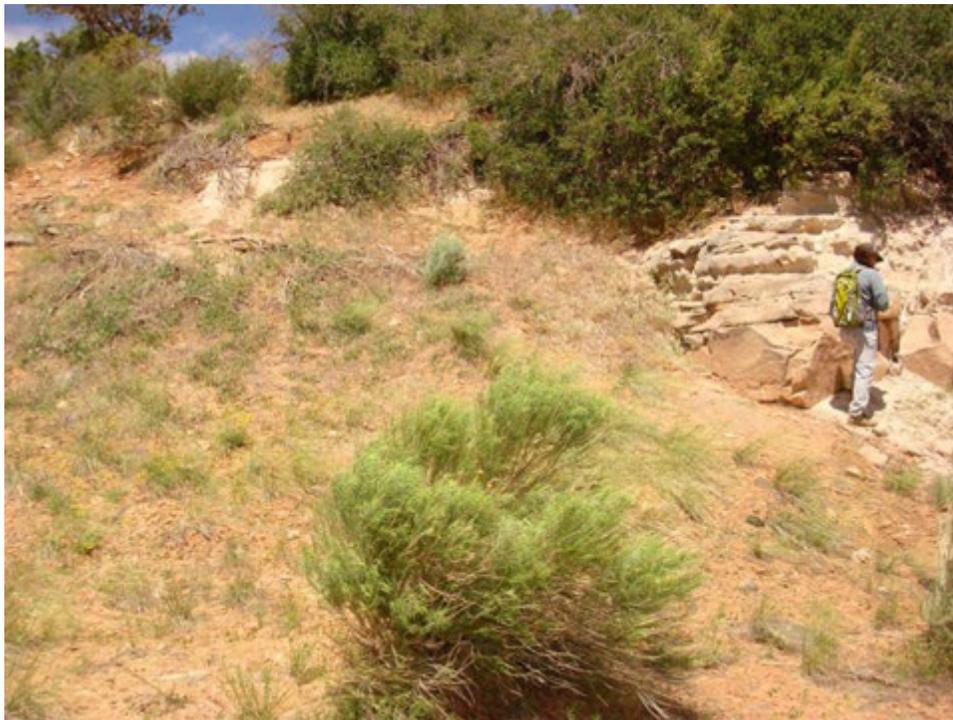
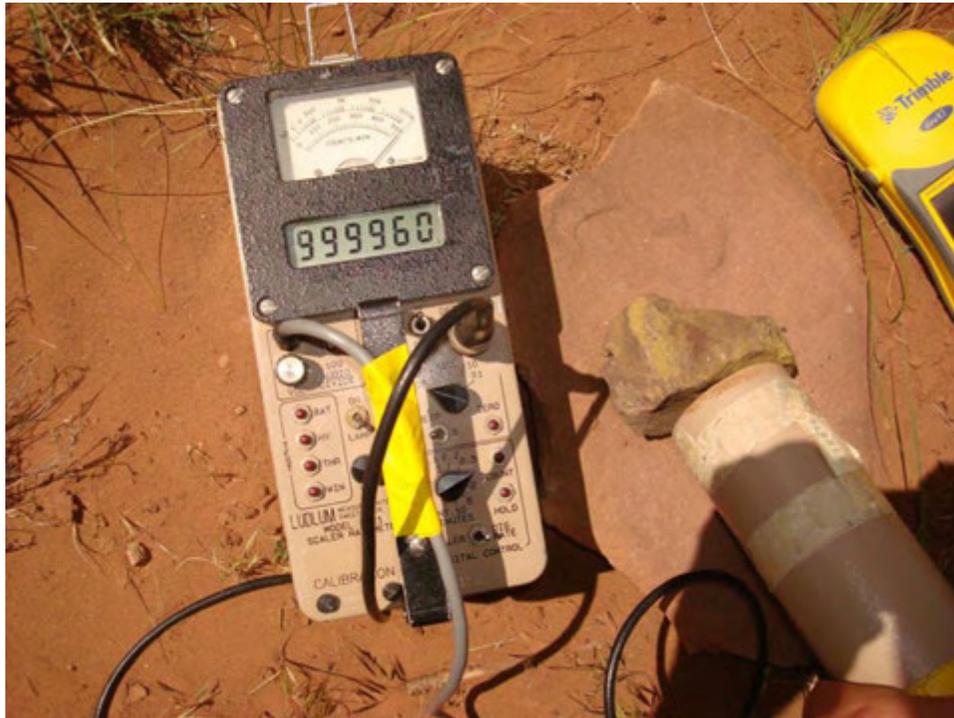
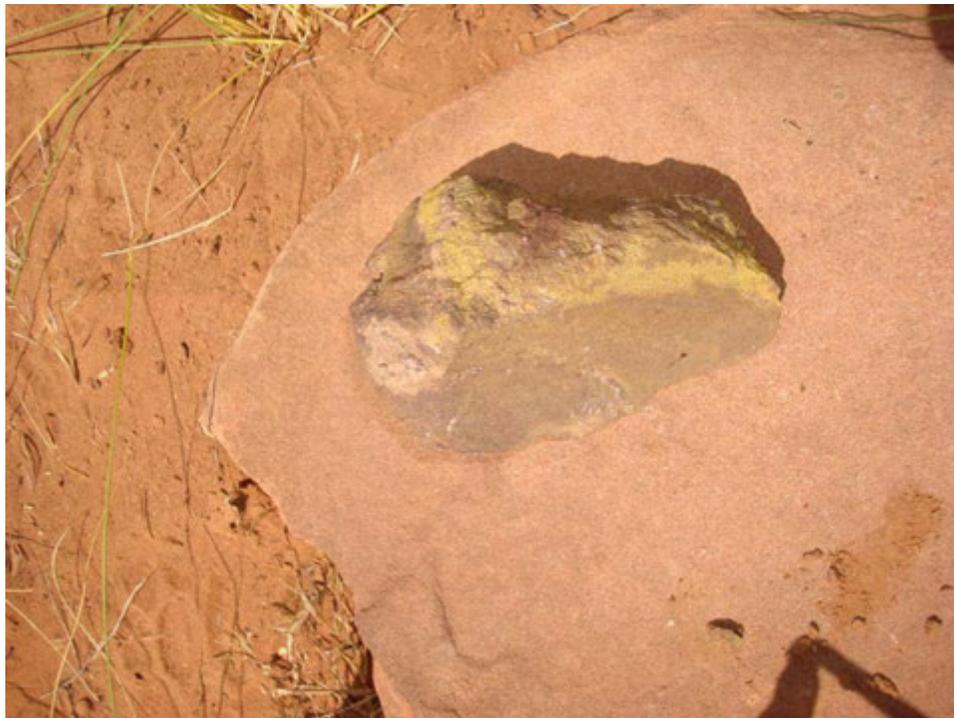
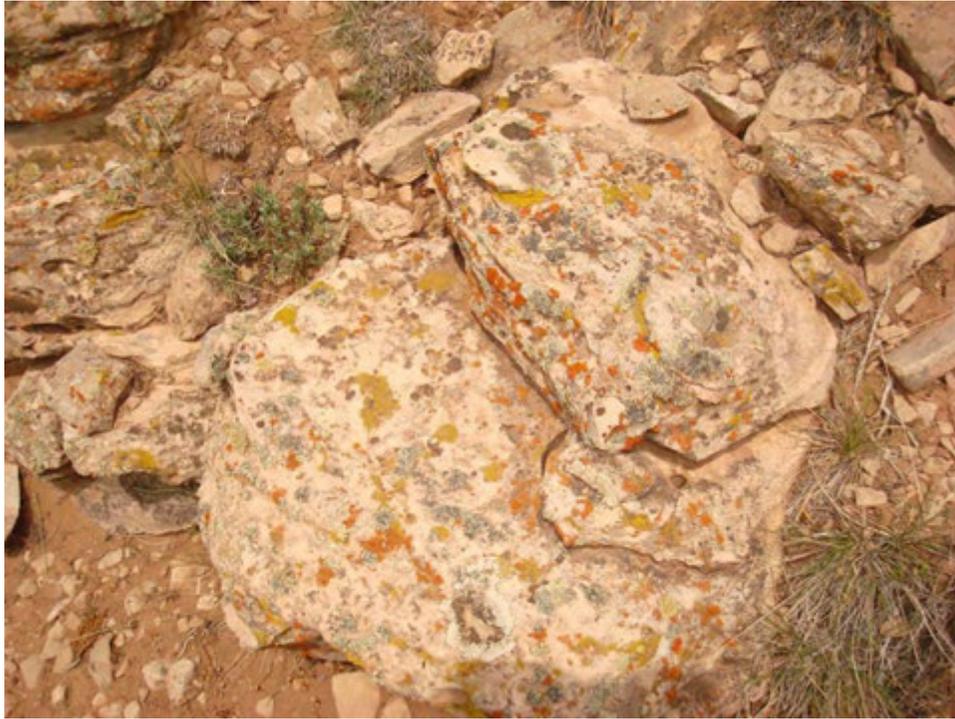
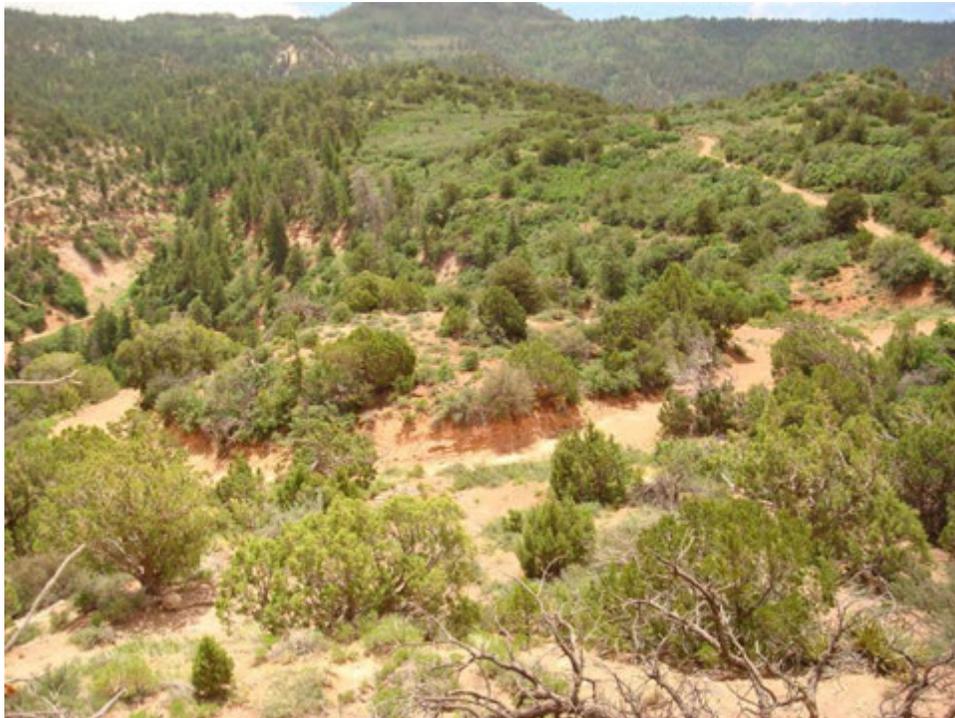
Photo 1. Mesa I, Mine No. 15 (657) site

A total of 611 gamma radiation measurements were collected from the mine site, ranging from 10,470 cpm to 999,960 cpm.

Average background = 12,471 cpm
