2013 HAWAII OCEAN DISPOSAL SITE MONITORING SYNTHESIS REPORT

Prepared by:
Dredging and Sediment Management Team
USEPA Region 9
San Francisco, CA

April 27, 2015

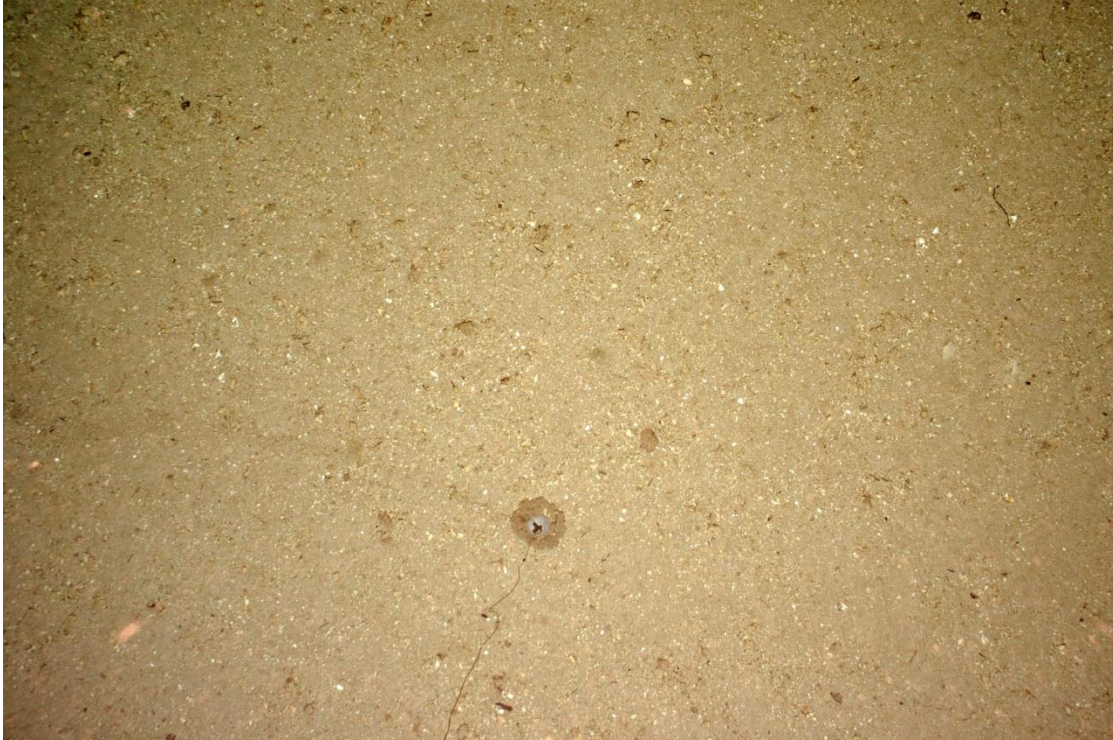
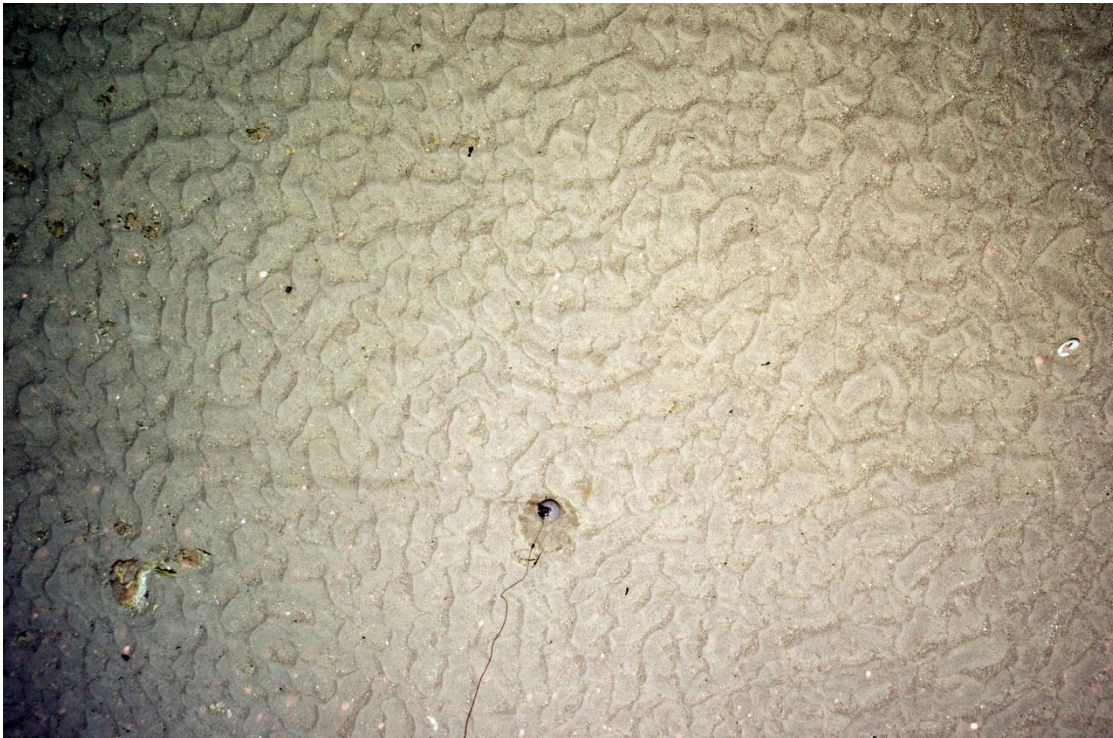
Figure 16. Plan view images of the dredged material deposit compared to the native seafloor at South Oahu. Station C1 on dredged material (top) shows the visual difference in both sediment color and surface texture/features of dredged material compared to the ambient bottom at Station NW6 (bottom). Scale: width of each PV image is approximately 4 m. (Germano & Assoc., 2013)
