TO: David Epps – DuPont CRG
Maryann Nicholson – DuPont CRG
Edward Seger – DuPont CRG
FROM: Sagar Thakali
Gary Long
DATE: January 28, 2014
PROJECT: PLW Ramapo/Pompton
River Investigation
URS JOB NO.: 18986472 FININFO NO.: 507990 cc :
SUBJECT: **Ramapo River and Pompton River Substrate Characterization**
DuPont Pompton Lakes Works
Pompton Lakes, New Jersey

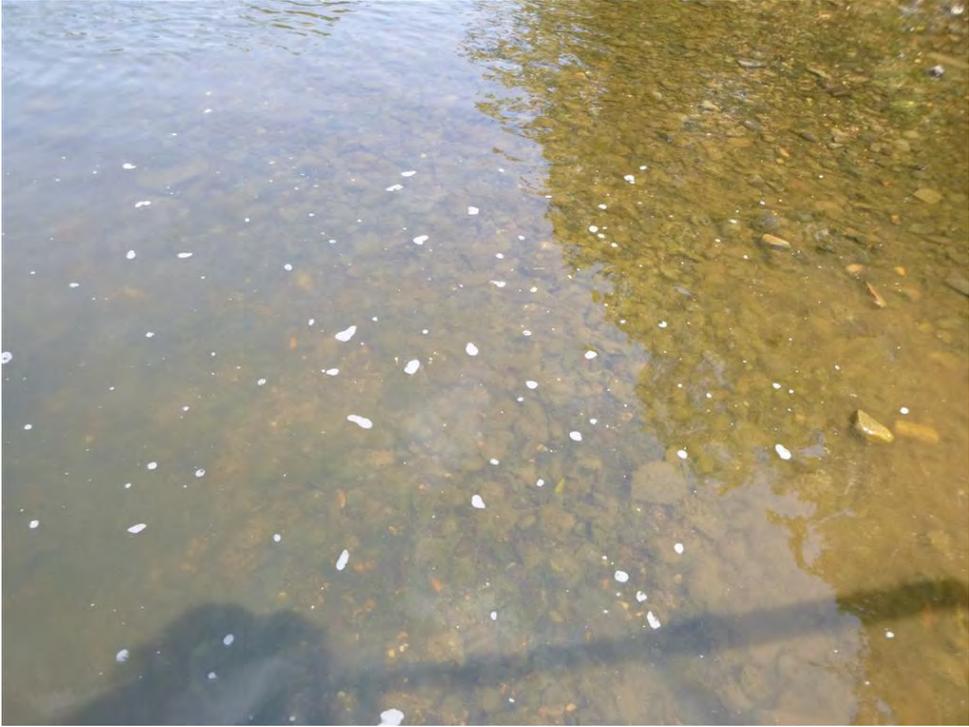
Client Name: DuPont		Site Location: Ramapo River/Pompton River, Morris and Passaic Counties, New Jersey		Project No. 18986472
Photo No. 1	Date: 8/12/13- 8/14/13

Substrate Type Classification: 4 (Pebble)				
Description: Sample Point – 6a Top of cobble bar Classification – 4 ID Type - Visual

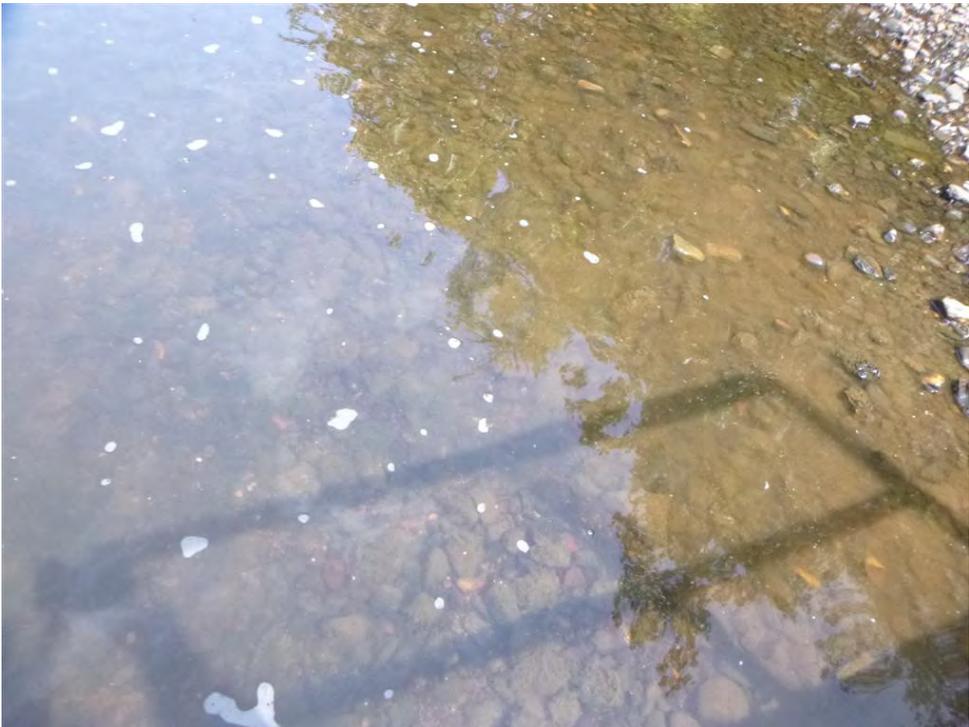
Photo No. 2	Date: 8/12/13- 8/14/13

Substrate Type Classification: 4 (Pebble)				
Description: Sample Point – 6b Top of cobble bar Classification – 4 ID Type - Visual

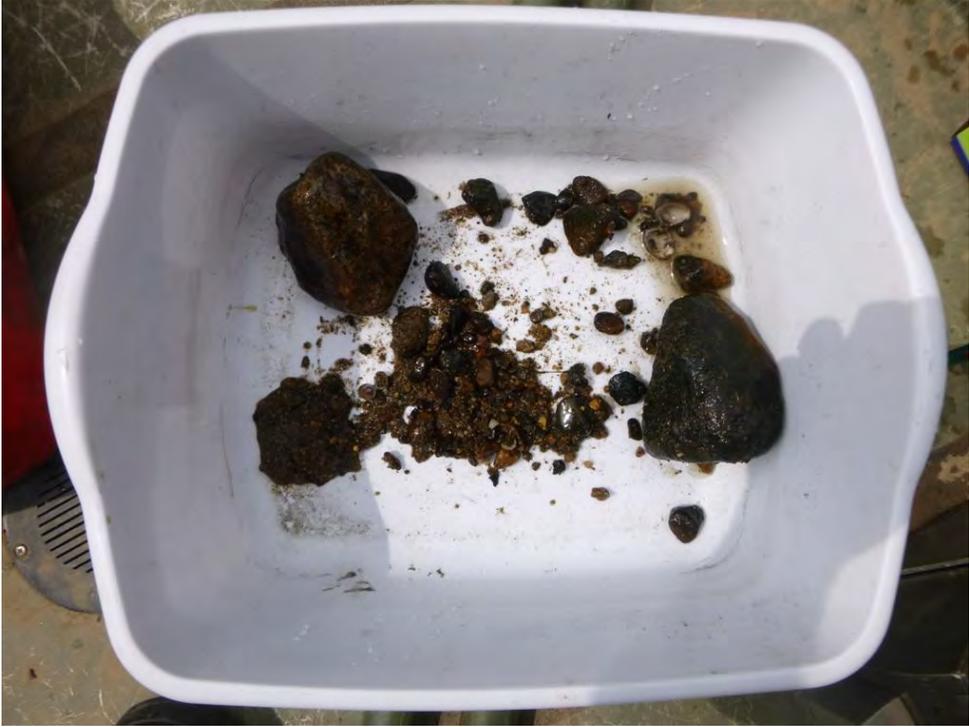
Client Name: DuPont		Site Location: Ramapo River/Pompton River, Morris and Passaic Counties, New Jersey	Project No.: 18986472
Photo No.: 3	Date: 8/12/13- 8/14/13

Substrate Type Classification: 4 (Pebble)			
Description: Sampling Point - 15 Transition to cobble along shoreline. Classification - 4 ID Type - Visual /Ponar

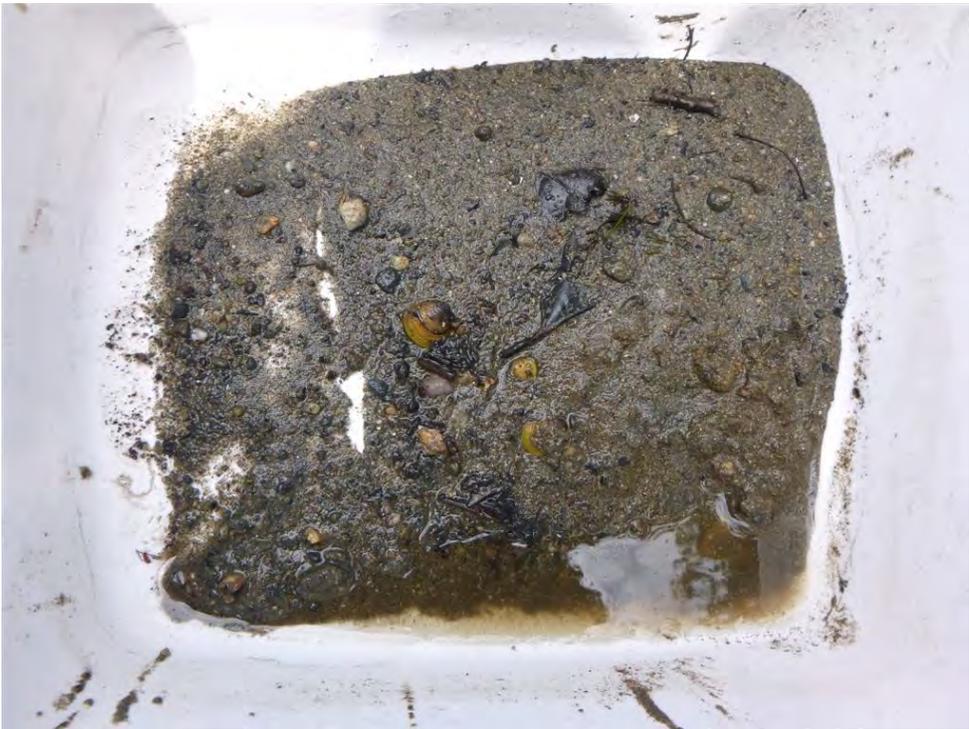
Photo No.: 4	Date: 8/12/13- 8/14/13

Substrate Type Classification: 3 (Coarse Sand/Granule)			
Description: Sampling Point - 19 Classification - 3 ID Type - Visual /Ponar

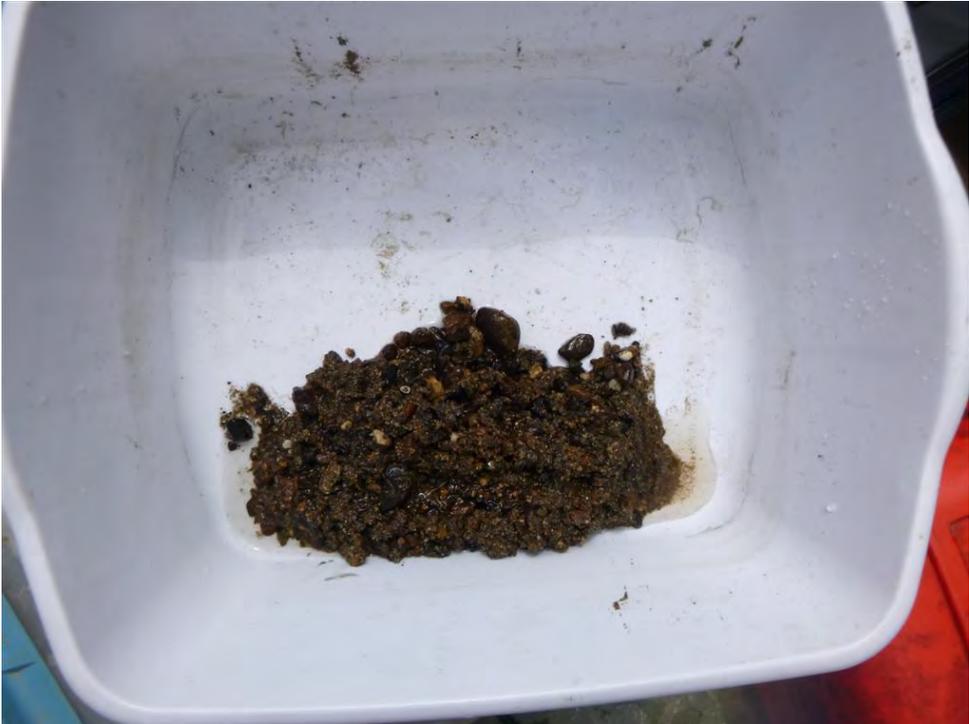
Client Name: DuPont		Site Location: Ramapo River/Pompton River, Morris and Passaic Counties, New Jersey	Project No.: 18986472
Photo No. 5	Date: 8/12/13- 8/14/13

Substrate Type Classification: 3 (Coarse Sand/Granule)			
Description: Sampling Point -29 Classification - 3 ID Type - Visual /Ponar

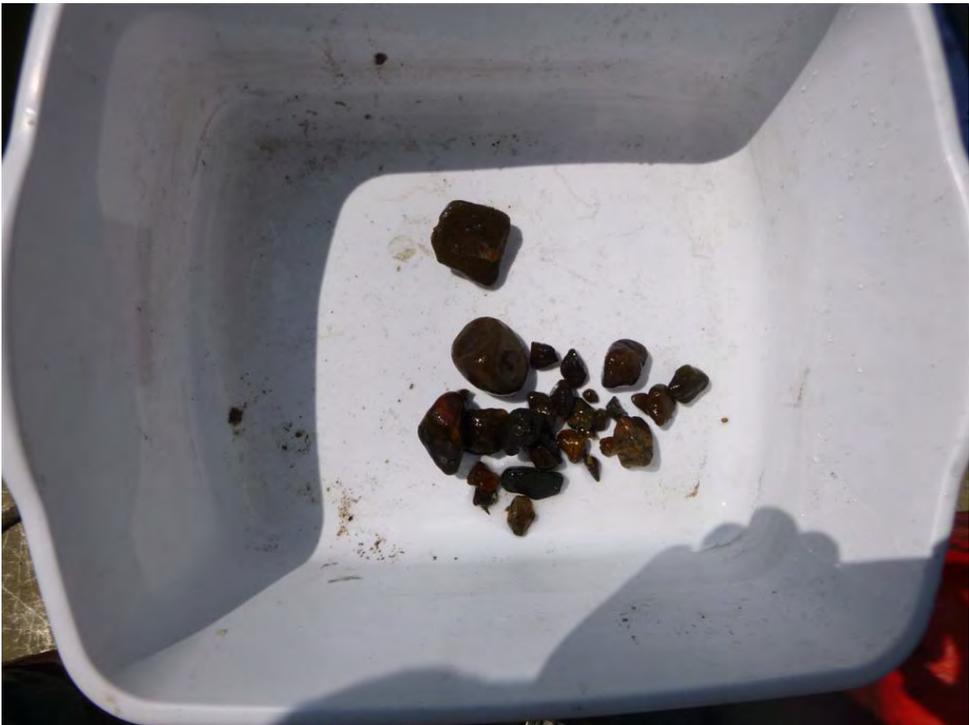
Photo No. 6	Date: 8/12/13- 8/14/13

Substrate Type Classification: 4 (Pebble)			
Description: Sampling Point - 48 Classification - 4 ID Type - Visual/Ponar

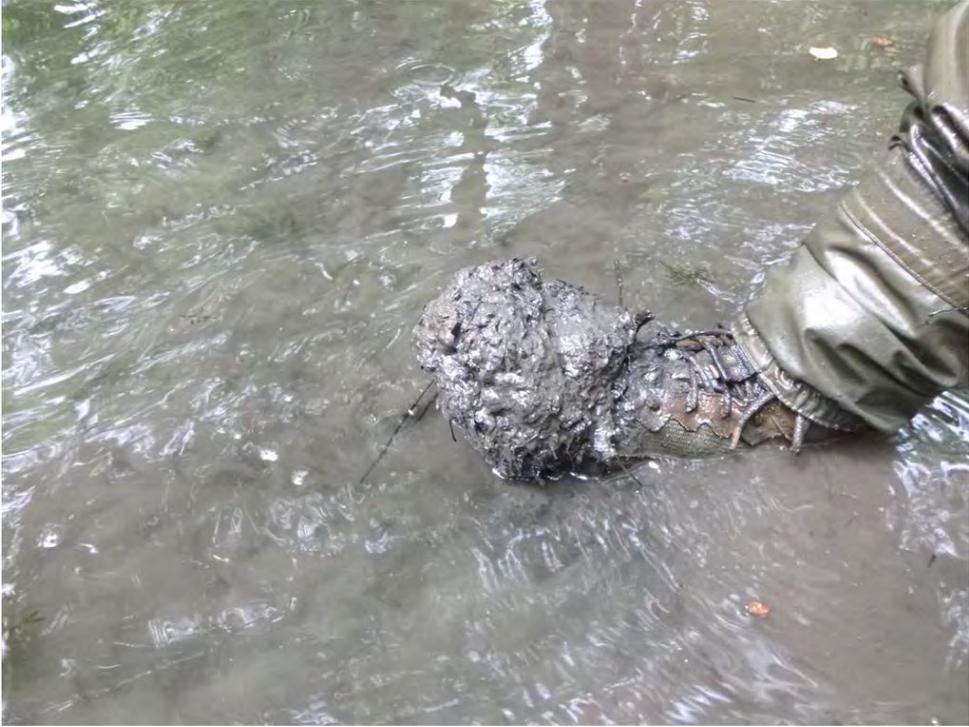
Client Name: DuPont		Site Location: Ramapo River/Pompton River, Morris and Passaic Counties, New Jersey	Project No.: 18986472
Photo No.: 7	Date: 8/12/13-8/14/13

Substrate Type Classification: 1 (Silt/Clay)			
Description: Sampling Point -55 Classification - 1 ID Type - Visual /Probe Silt substrate; sink ~1 foot while wading.

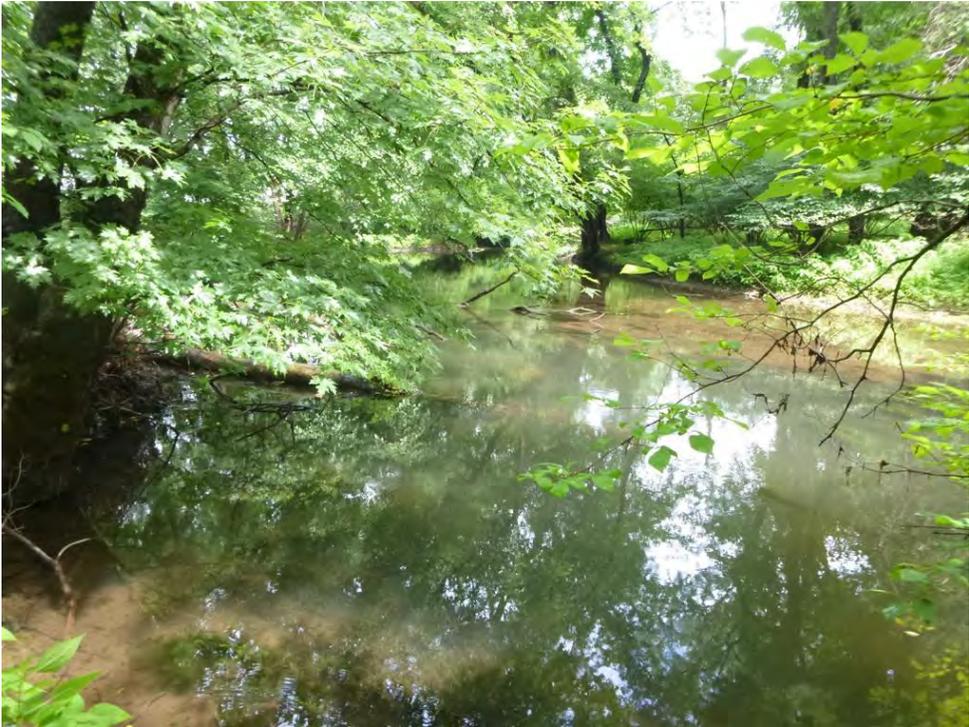
Photo No.: 8	Date: 8/12/13-8/14/13

Substrate Type Classification: 1 (Silt/Clay)		
Description: Sampling Point - 58a Classification - 1 ID Type - Visual/Probe

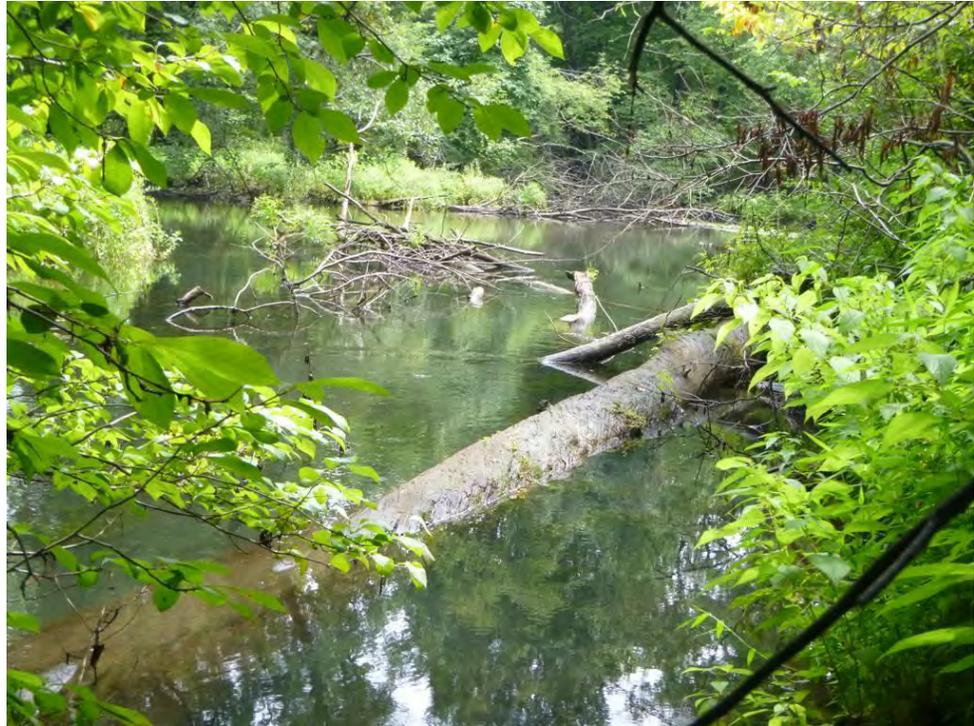
Sampling Point -58b
Classification – 1
ID Type – Visual /Probe

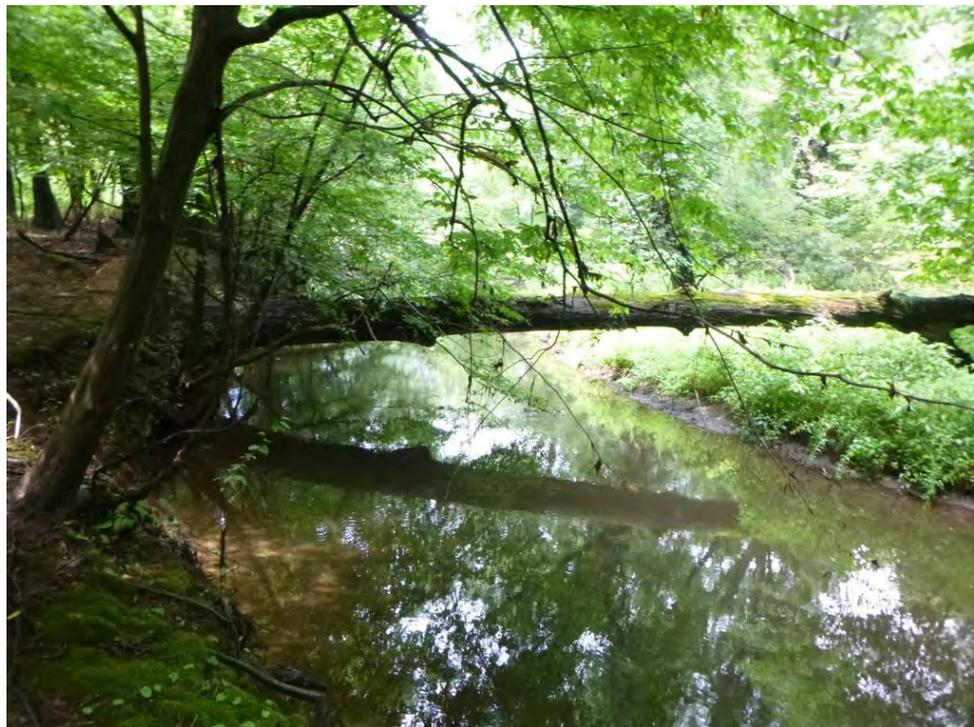
Photo No. 10	Date: 8/12/13- 8/14/13
------------------------	-------------------------------------

Sampling Point – 64a
Classification – 3
ID Type – Visual
Channel contained limited areas of fines.

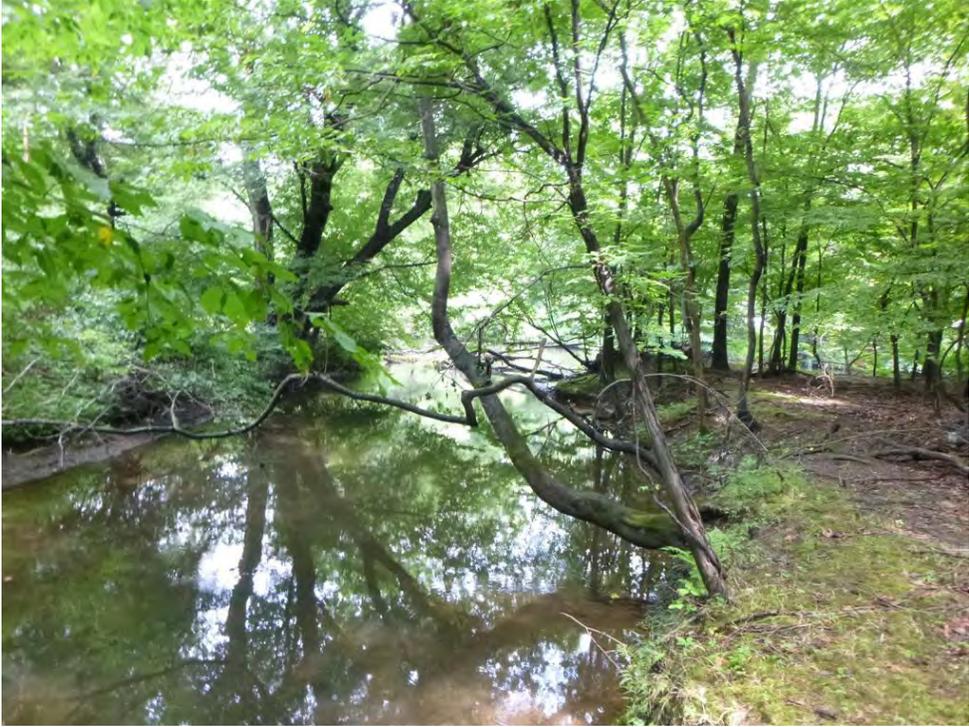
Client Name: DuPont		Site Location: Ramapo River/Pompton River, Morris and Passaic Counties, New Jersey	Project No.: 18986472
Photo No.: 11	Date: 8/12/13- 8/14/13

Substrate Type Classification: 3 (Coarse Sand/Granule)			
Description: Sampling Point -64b Classification - 3 ID Type - Visual Channel contained limited areas of fines.

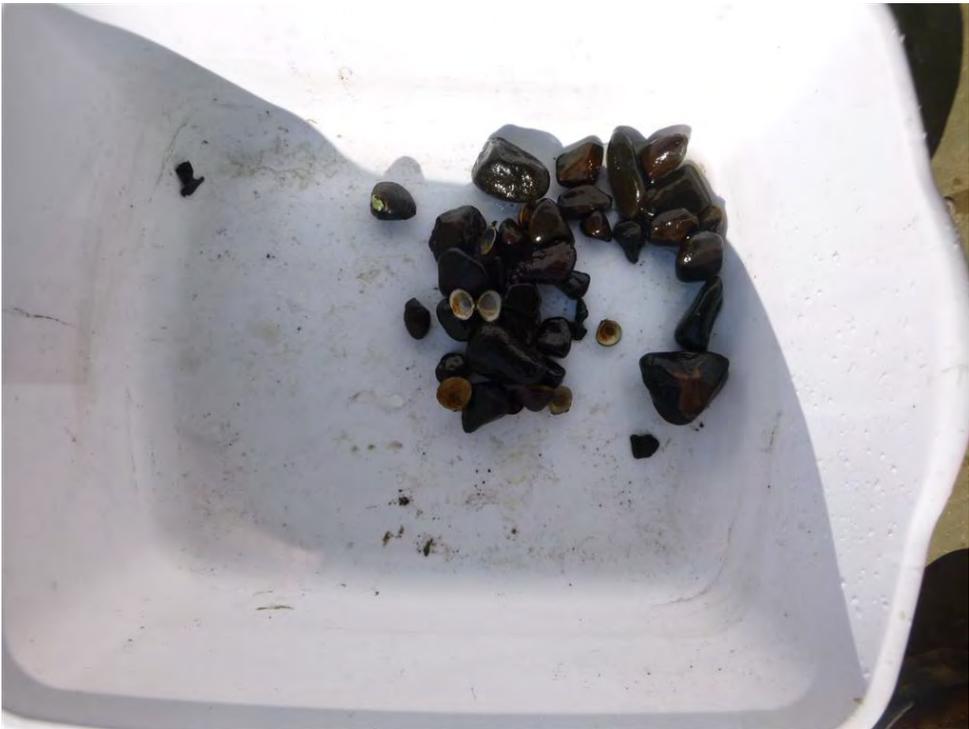
Photo No.: 12	Date: 8/12/13- 8/14/13

Substrate Type Classification: 4 (Pebble)		
Description: Sampling Point - 66 Classification - 4 ID Type - Visual /Ponar

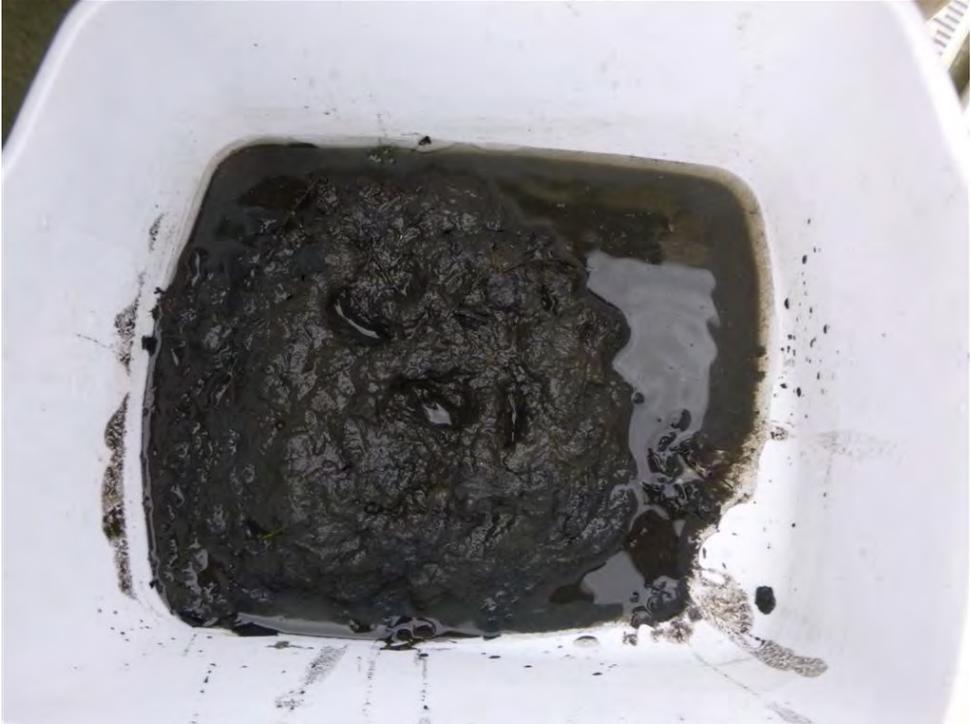
Client Name: DuPont		Site Location: Ramapo River/Pompton River, Morris and Passaic Counties, New Jersey	Project No.: 18986472
Photo No. 13	Date: 8/12/13- 8/14/13

Substrate Type Classification: 1 (Silt/Clay)			
Description: Sampling Point -77 Classification - 1 ID Type - Visual /Ponar

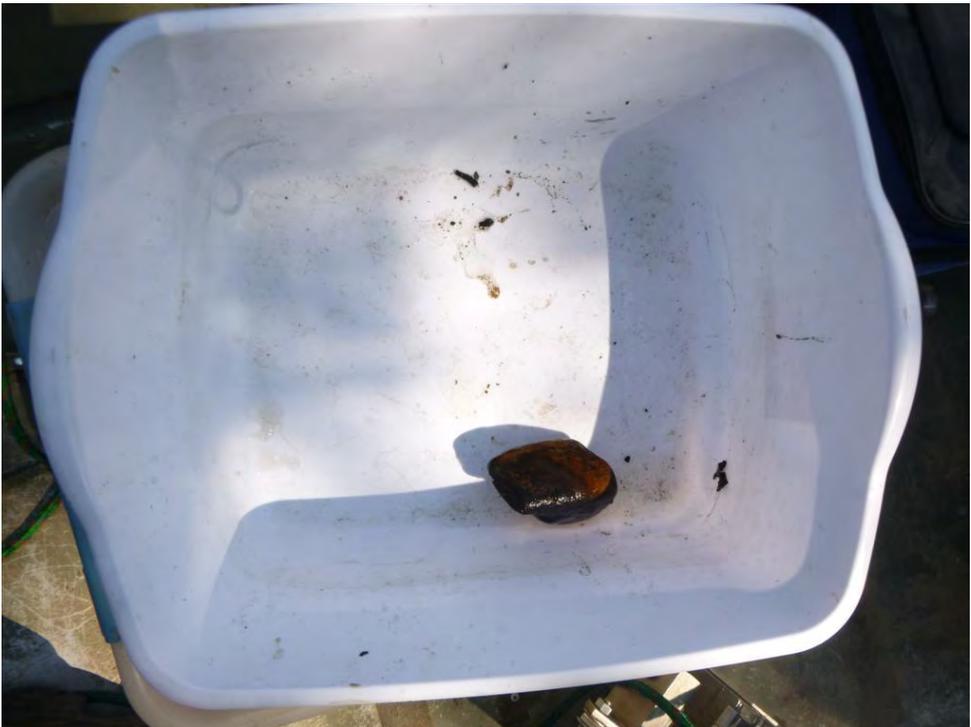
Photo No. 14	Date: 8/12/13- 8/14/13

Substrate Type Classification: 4 (Pebble)			
Description: Sampling Point - 78 Classification - 4 ID Type - Visual /Ponar Limited grab due to coarse material.

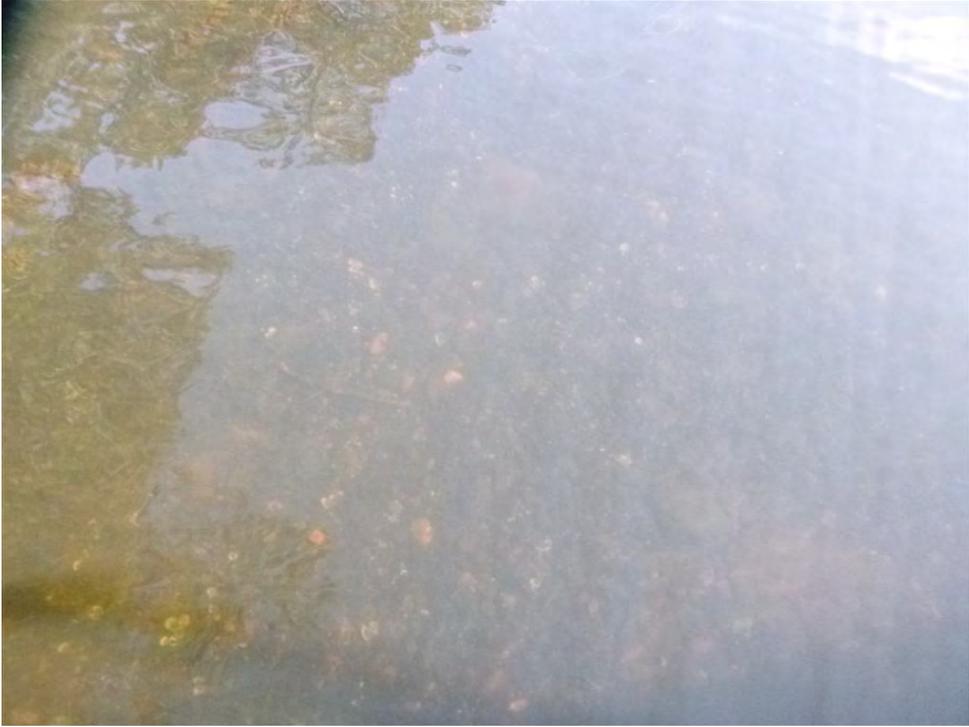
Client Name: DuPont		Site Location: Ramapo River/Pompton River, Morris and Passaic Counties, New Jersey	Project No.: 18986472
Photo No. 15	Date: 8/12/13- 8/14/13

Substrate Type Classification: 4 (Pebble)			
Description: Sampling Point -79 Classification - 4 ID Type - Visual /Probe

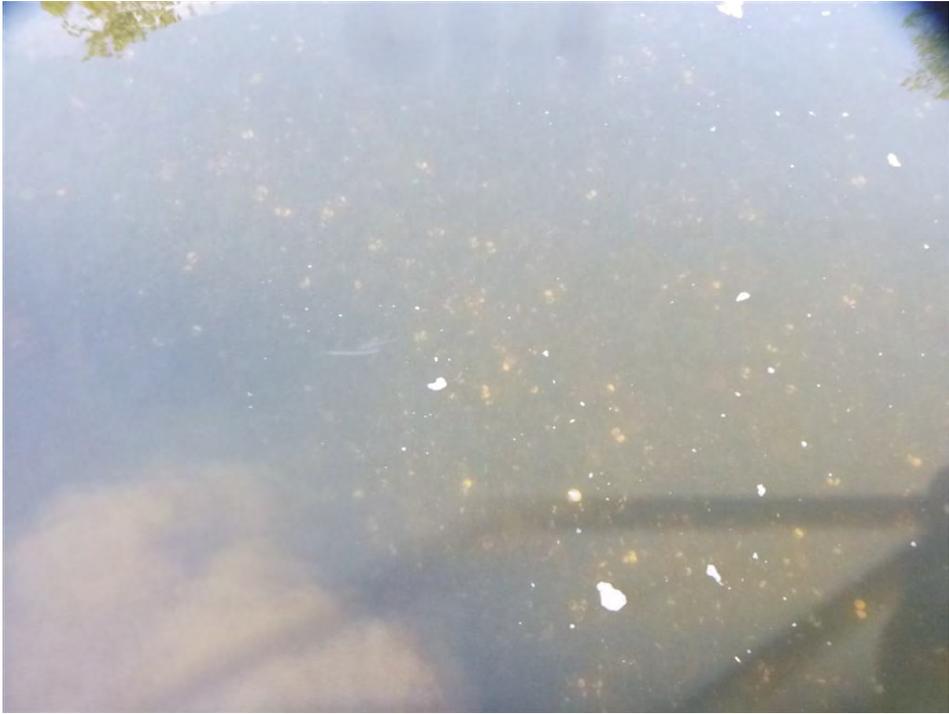
Photo No. 16	Date: 8/12/13- 8/14/13

Substrate Type Classification: 4 (Pebble)			
Description: Sampling Point - 91 Classification - 4 ID Type - Visual /Probe

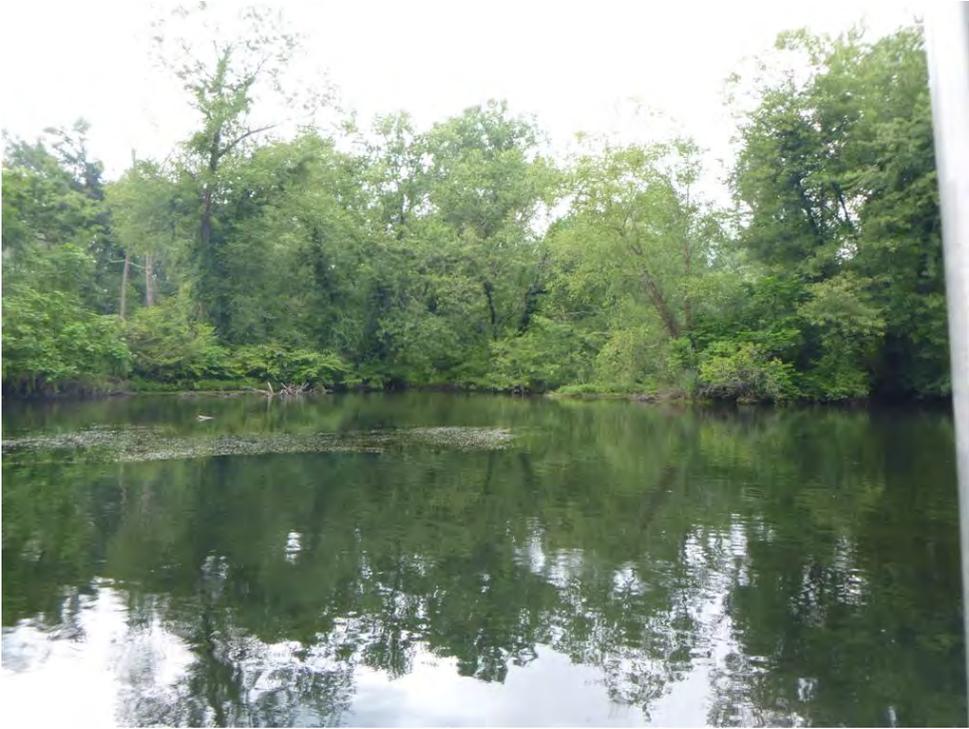
Client Name: DuPont		Site Location: Ramapo River/Pompton River, Morris and Passaic Counties, New Jersey	Project No.: 18986472
Photo No.: 17	Date: 8/12/13- 8/14/13

Substrate Type Classification: 3 (Coarse Sand/Granule)			
Description: Sampling Point -97 Classification - 3 ID Type - Visual /Probe SAV throughout channel

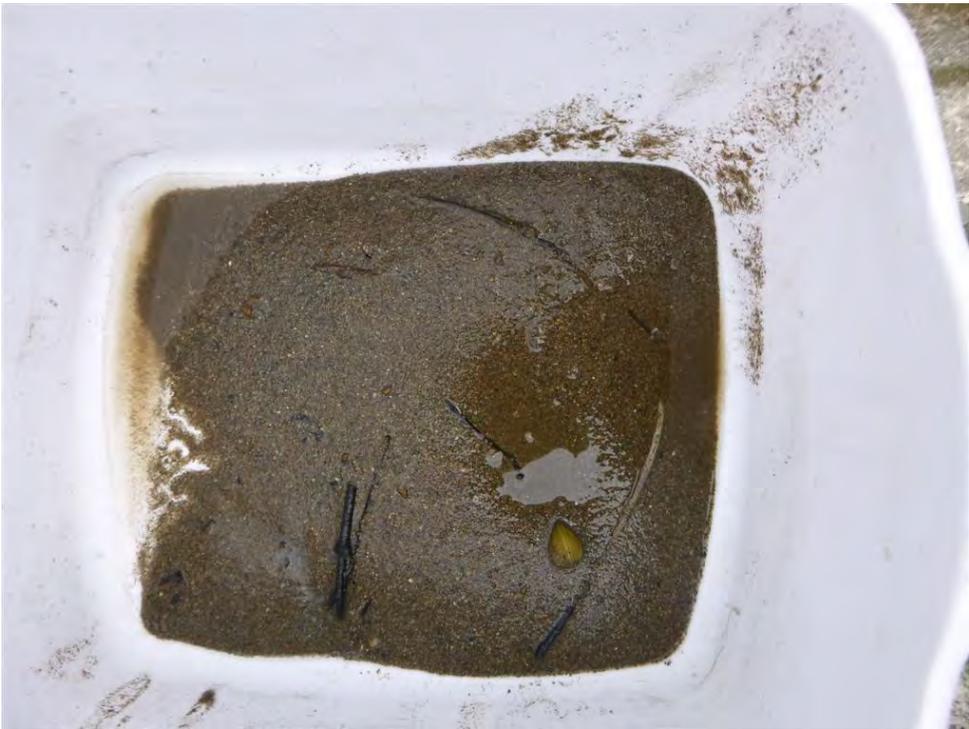
Photo No.: 18	Date: 8/12/13- 8/14/13

Substrate Type Classification: 3 (Coarse Sand/Granule)		
Description: Sampling Point - 99 Classification - 3 ID Type - Visual /Probe

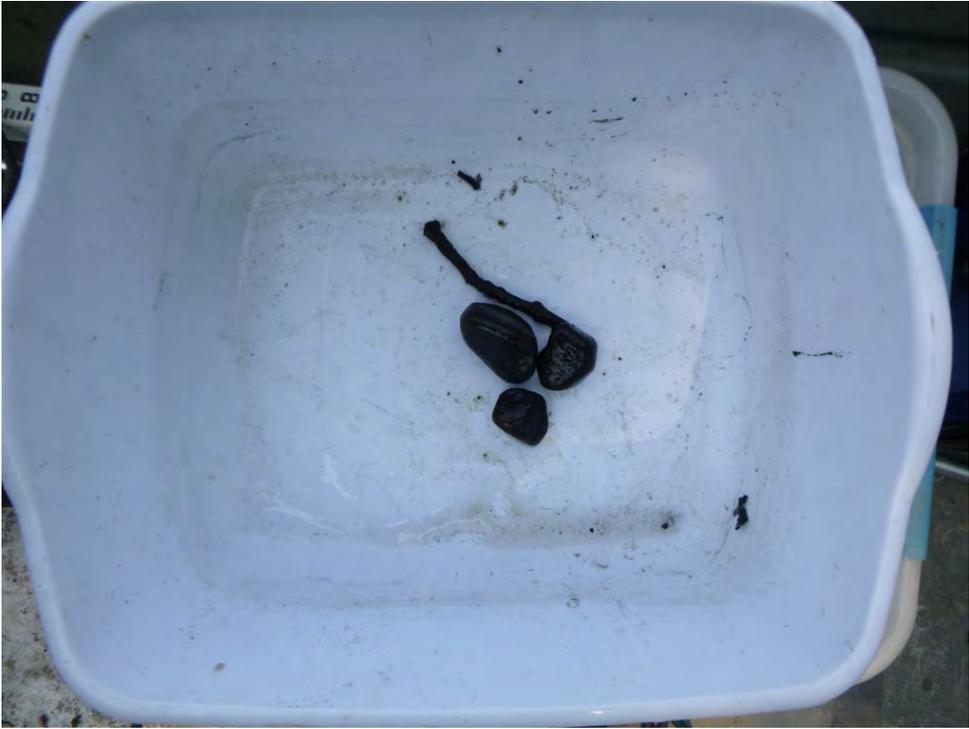
Client Name: DuPont		Site Location: Ramapo River/Pompton River, Morris and Passaic Counties, New Jersey	Project No.: 18986472
Photo No. 19	Date: 8/12/13- 8/14/13

Substrate Type Classification: 4 (Pebble)			
Description: Sampling Point -100 Classification - 4 ID Type - Visual /Ponar Limited grab collected

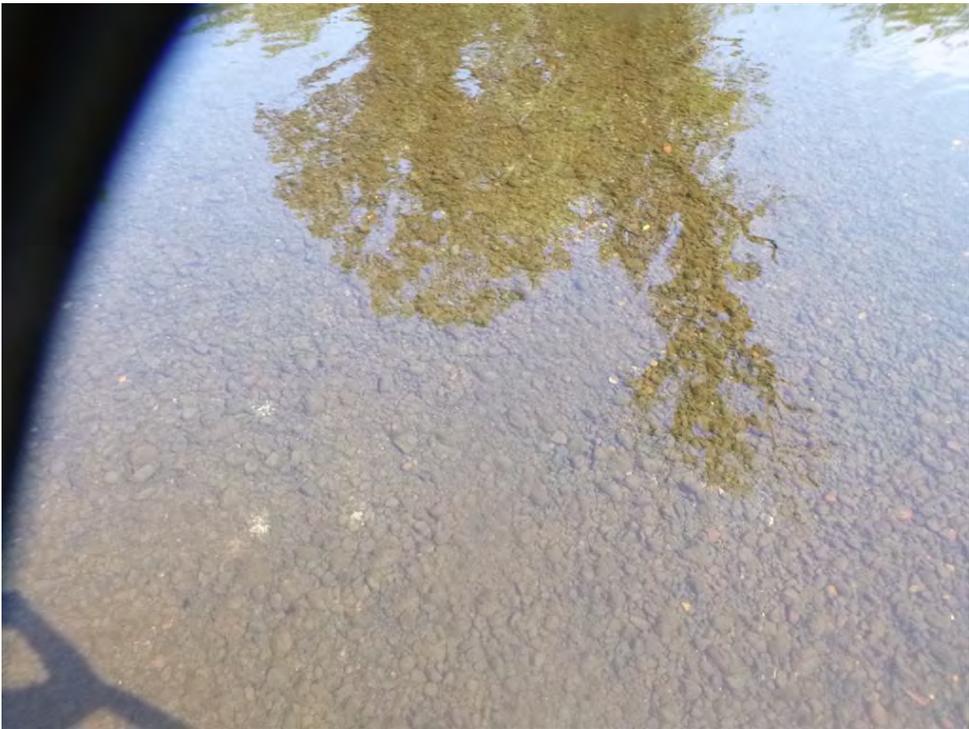
Photo No. 20	Date: 8/12/13- 8/14/13

Substrate Type Classification: 4 (Pebble)		
Description: Sampling Point - 101 Classification - 4 ID Type - Visual /Probe Shallow water

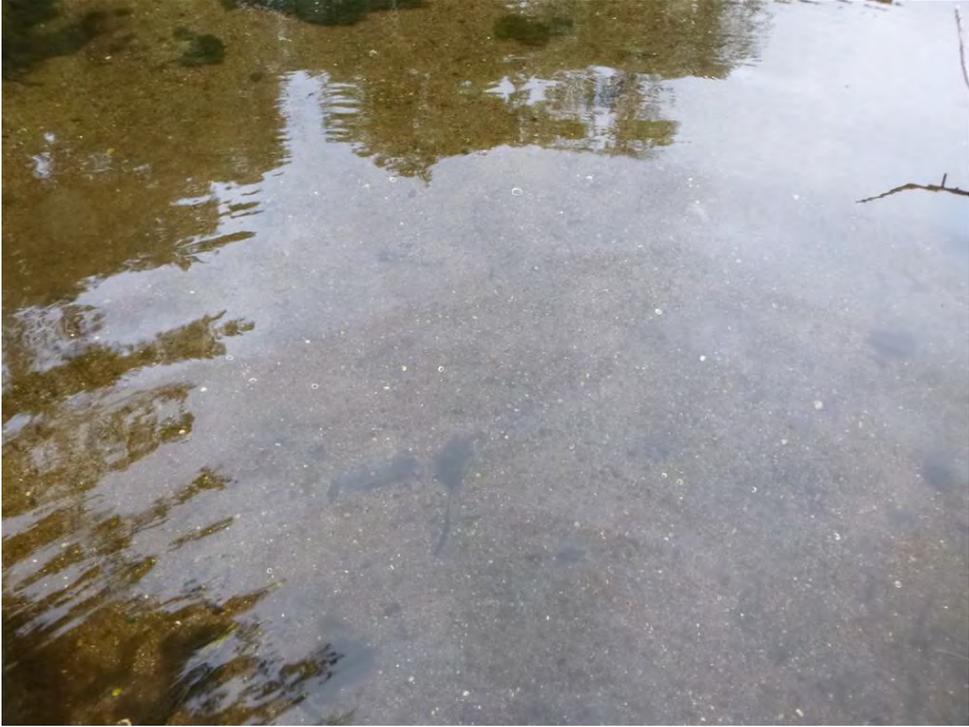
Client Name: DuPont		Site Location: Ramapo River/Pompton River, Morris and Passaic Counties, New Jersey	Project No.: 18986472
Photo No. 21	Date: 8/12/13-8/14/13

Substrate Type Classification: 3 (Coarse Sand/Granule)			
Description: Sampling Point -103 Classification - 3 ID Type - Visual /Ponar

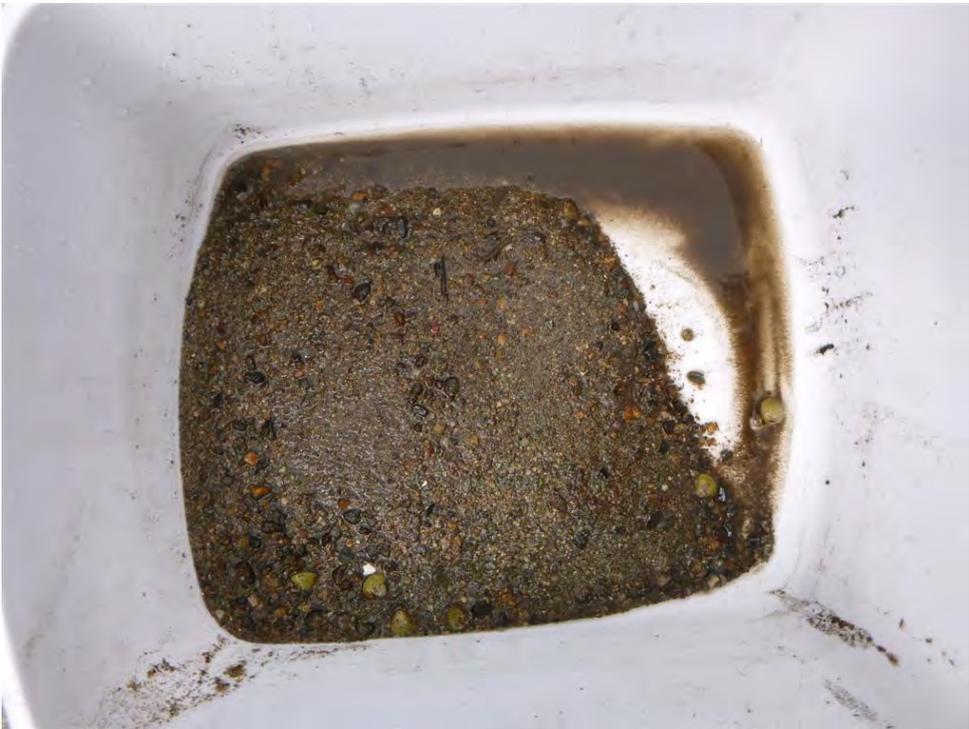
Photo No. 22	Date: 8/12/13-8/14/13

Substrate Type Classification: 3 (Coarse Sand/Granule)		
Description: Sampling Point - 104 Classification - 3 ID Type - Visual /Ponar

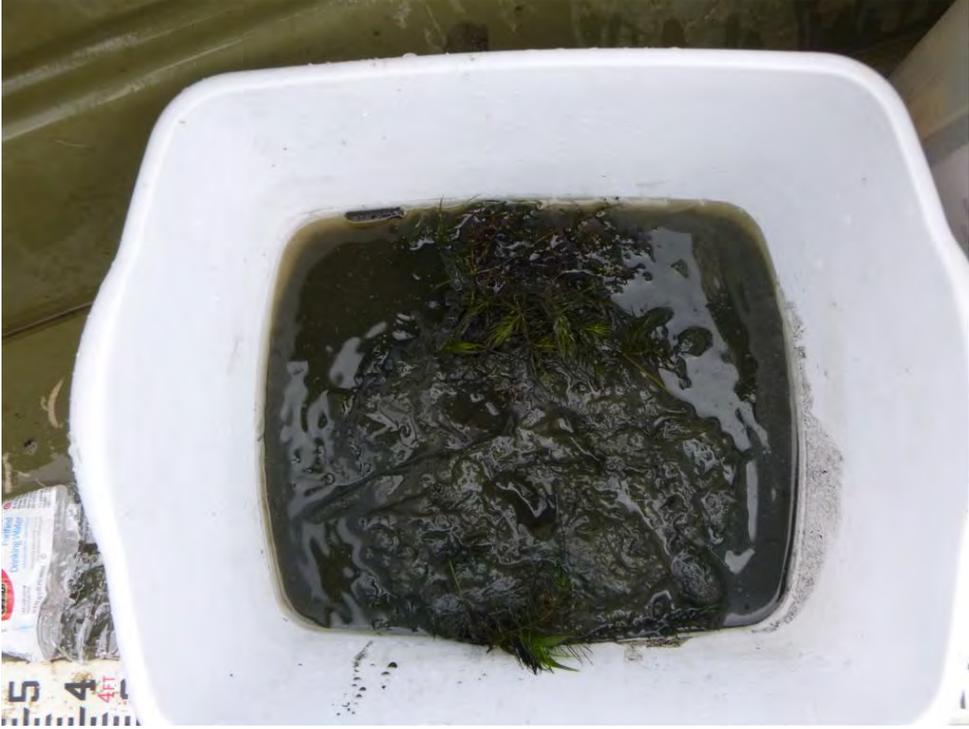
Client Name: DuPont		Site Location: Ramapo River/Pompton River, Morris and Passaic Counties, New Jersey	Project No.: 18986472
Photo No.: 23	Date: 8/12/13-8/14/13

Substrate Type Classification: 1 (Silt/Clay)			
Description: Sampling Point -105 Classification - 1 ID Type - Visual /Probe

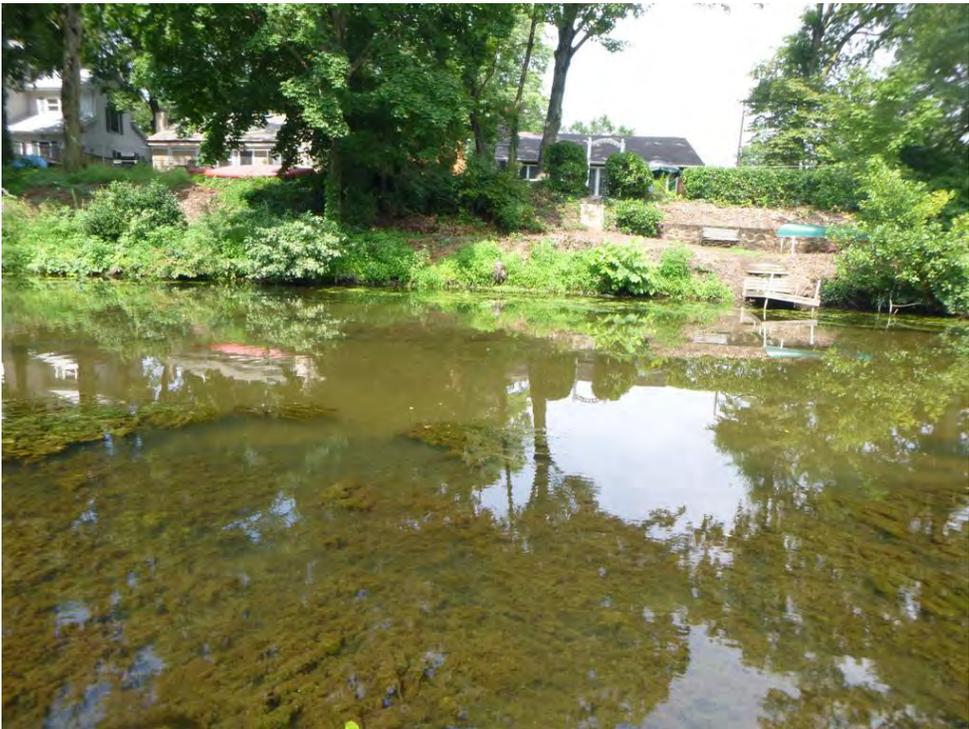
Photo No.: 24	Date: 8/12/13-8/14/13

Substrate Type Classification: 3 (Coarse Sand/Granule)		
Description: Sampling Point - 106 Classification - 3 ID Type - Visual /Probe No photo - heavy veg.

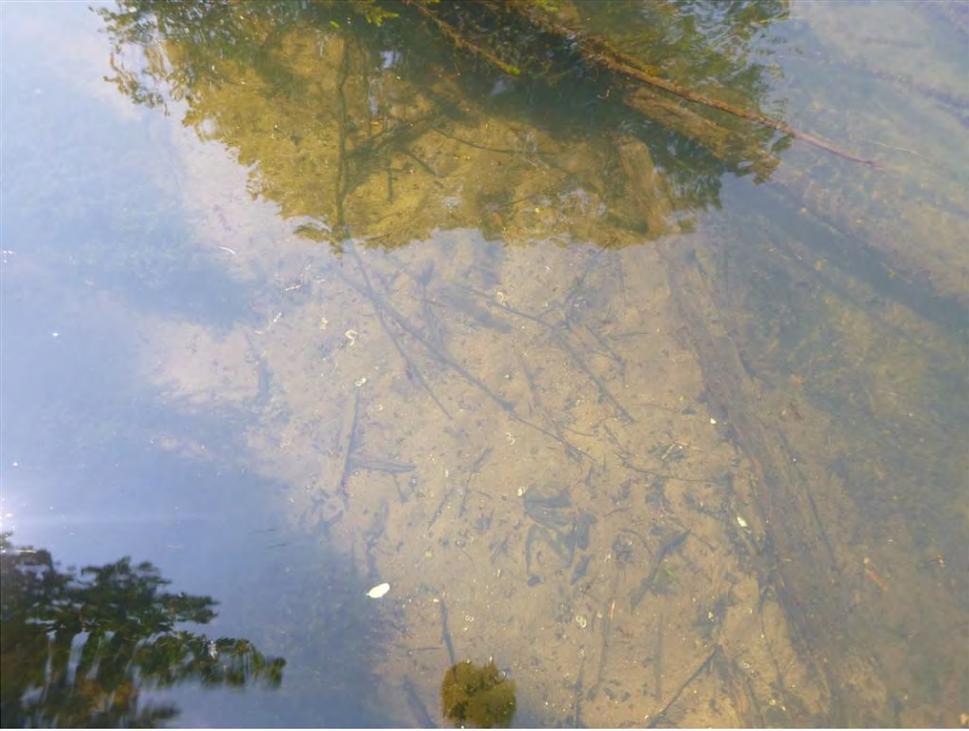
Substrate Type Classification: 3 (Coarse Sand/Granule)			
Description: Sampling Point -109 Classification - 3 ID Type - Visual /Probe

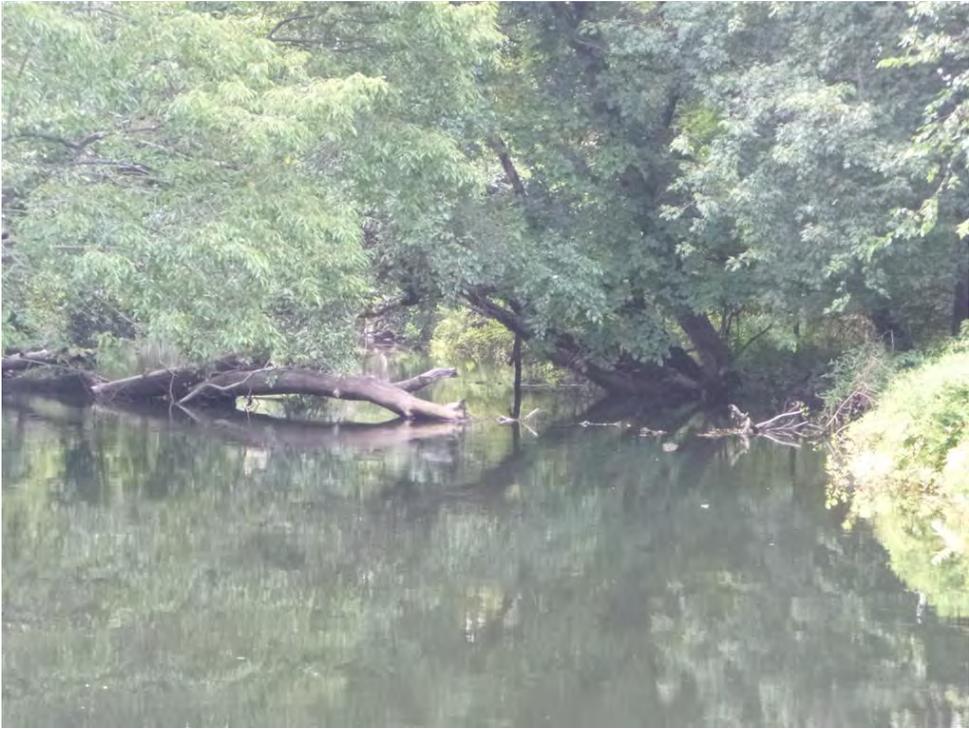
Photo No. 26	Date: 8/12/13- 8/14/13

Substrate Type Classification: 3 (Coarse Sand/Granule)		
Description: Sampling Point - 128 Classification - 3 ID Type - Visual /Probe

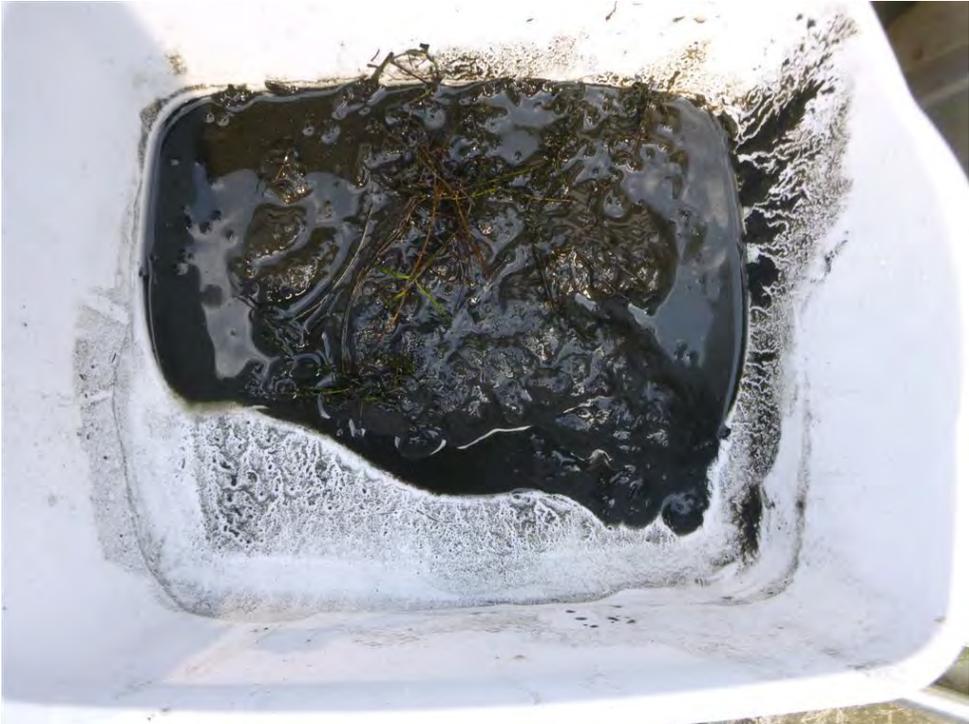
Substrate Type Classification: 1 (Silt/Clay)			
Description: Sampling Point -133 Classification - 1 ID Type - Visual /Ponar

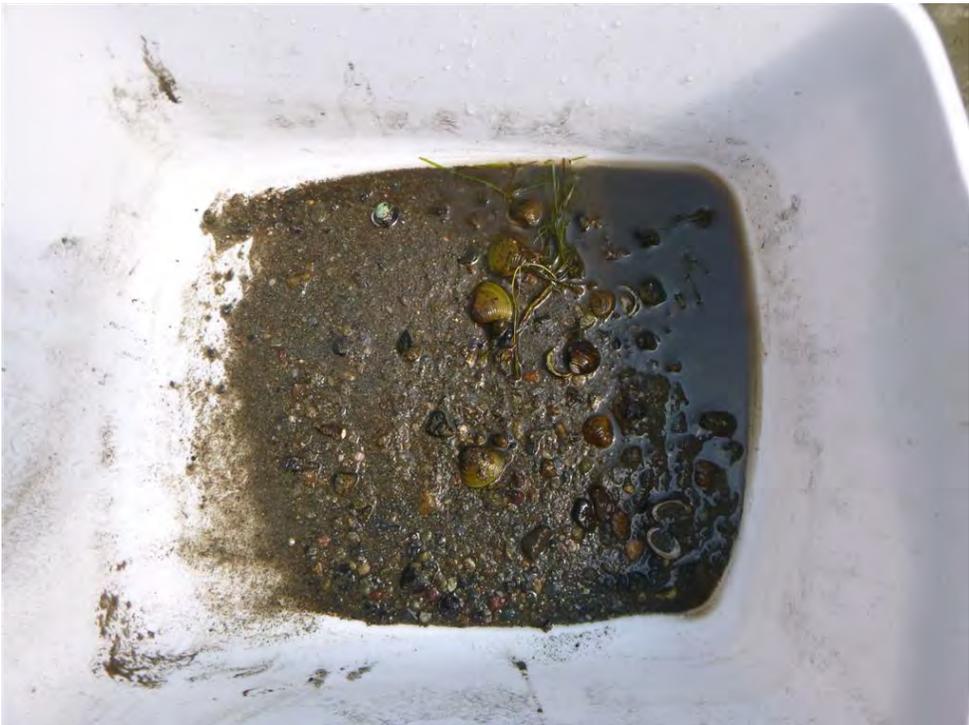
Photo No.: 28	Date: 8/12/13- 8/14/13

Substrate Type Classification: 3 (Coarse Sand/Granule)			
Description: Sampling Point - 134 Classification - 3 ID Type - Visual /Ponar

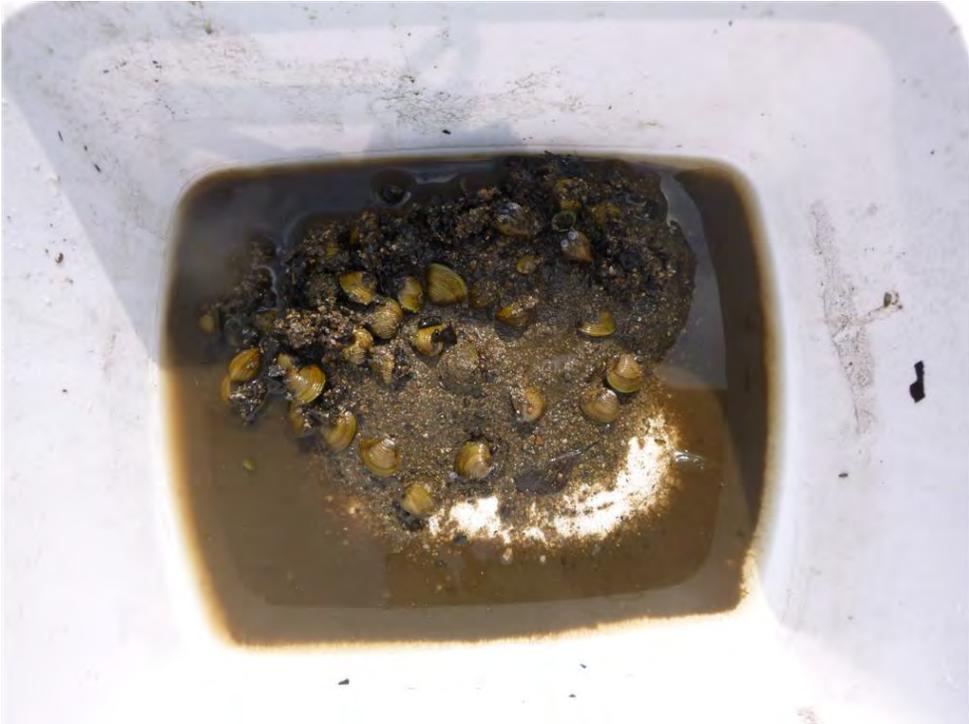
Substrate Type Classification: 3 (Coarse Sand/Granule)			
Description: Sampling Point -144 Classification - 3 ID Type - Visual /Ponar Numerous <i>corbicula</i> .

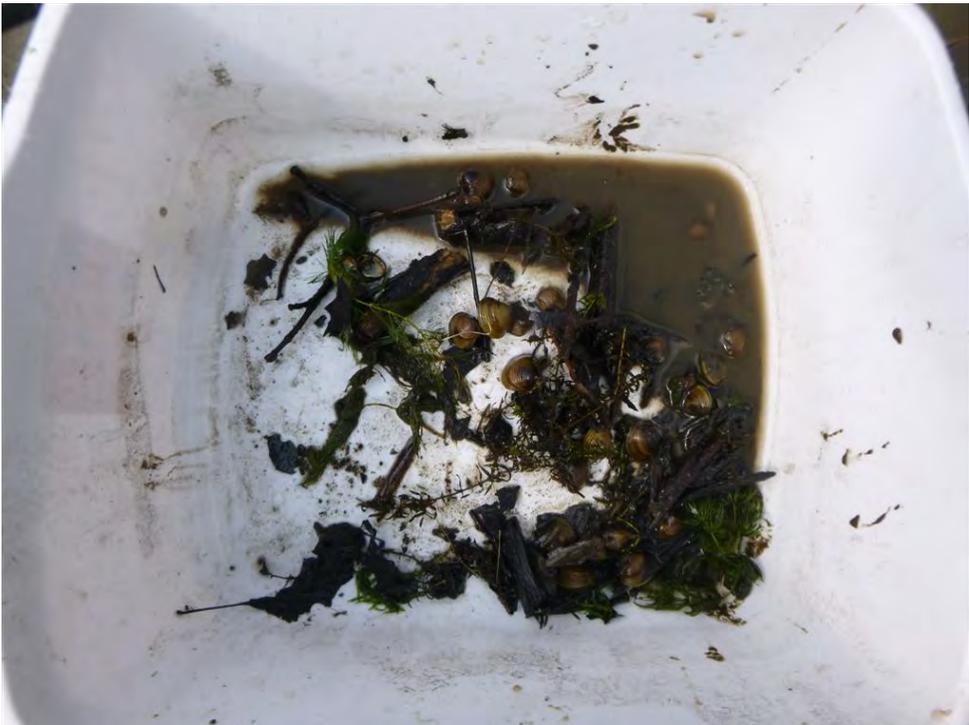
Substrate Type Classification: 3 (Coarse Sand/Granule)			
Description: Sampling Point - 145 Classification - 3 ID Type - Visual /Ponar Woody debris on bottom limited material collected.
