TO: David Epps – DuPont CRG
Maryann Nicholson – DuPont CRG
Edward Seger – DuPont CRG
FROM: Sagar Thakali
Gary Long
DATE: January 28, 2014
PROJECT: PLW Ramapo/Pompton
River Investigation
URS JOB NO.: 18986472 FININFO NO.: 507990 cc :
SUBJECT: **Ramapo River and Pompton River Substrate Characterization**
DuPont Pompton Lakes Works
Pompton Lakes, New Jersey

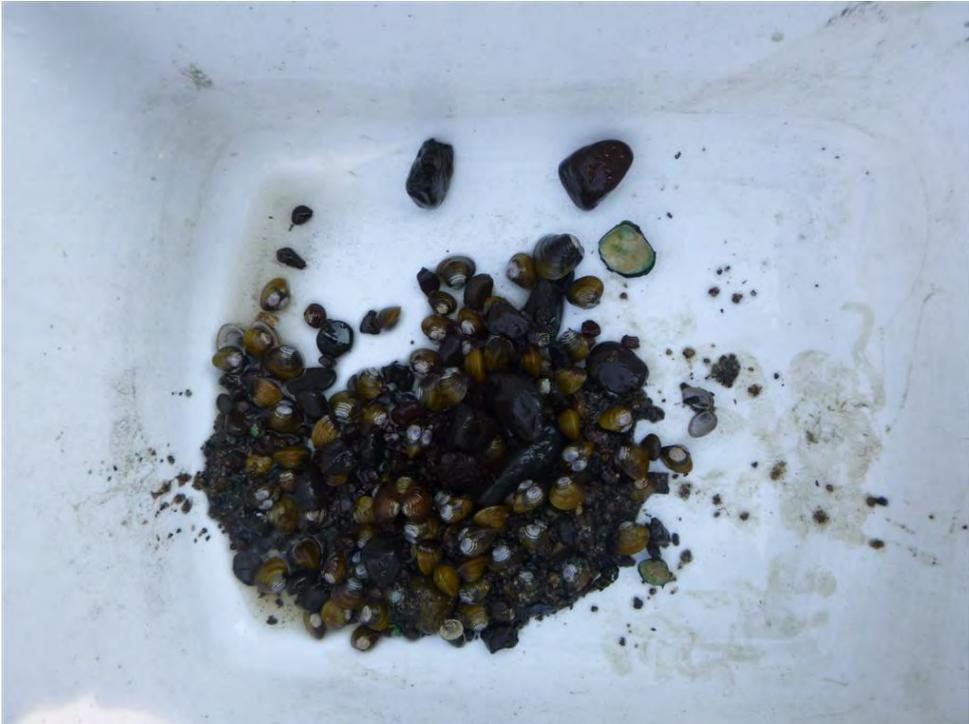
Substrate Type Classification: 3 (Coarse Sand/Granule)			
Description: Sampling Point -156 Classification - 3 ID Type - Visual /Ponar Coarse sand lost from Ponar grab.

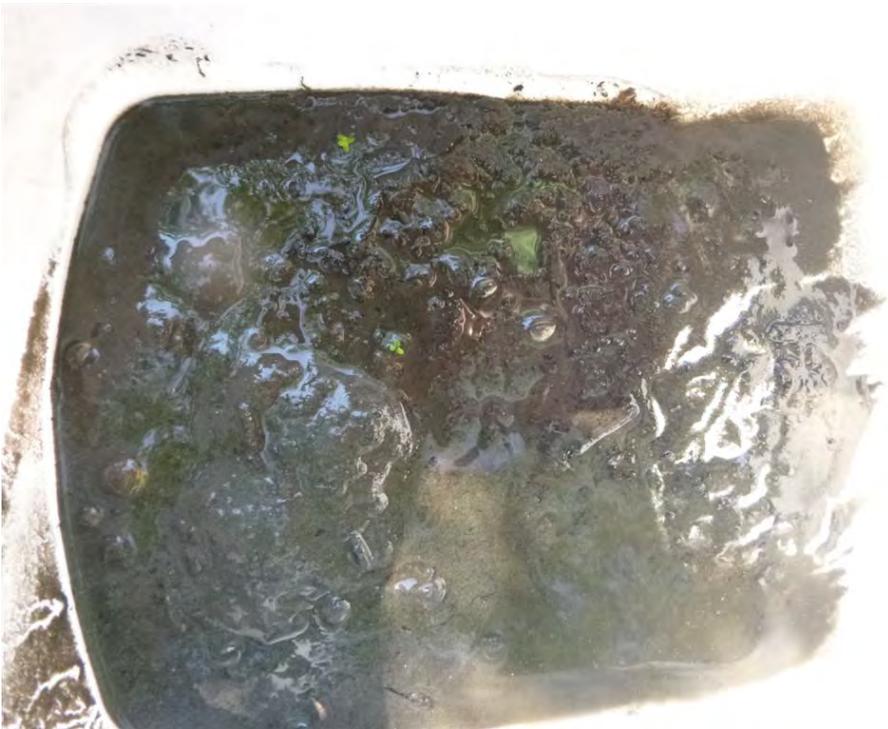
Substrate Type Classification: 1 (Silt/Clay)		
Description: Sampling Point - 157 Classification - 1 ID Type - Visual /Ponar

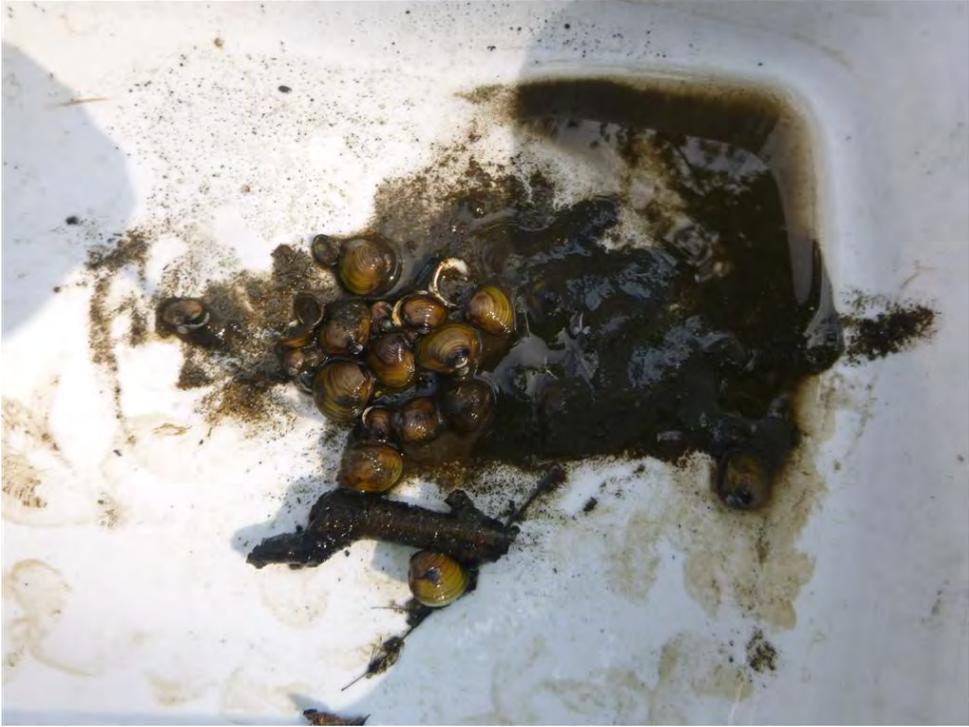
Substrate Type Classification: 1 (Silt/Clay)			
Description: Sampling Point -158 Classification - 1 ID Type - Visual /Ponar

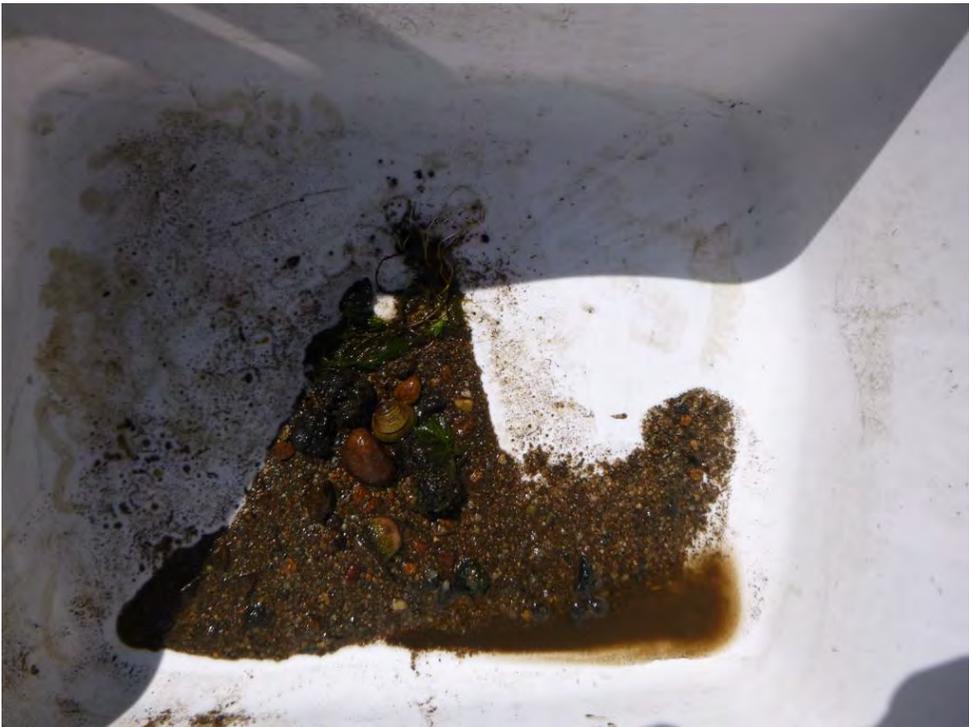
Substrate Type Classification: 3 (Coarse Sand/Granule)			
Description: Sampling Point - 194 Classification - 3 ID Type - Visual /Ponar

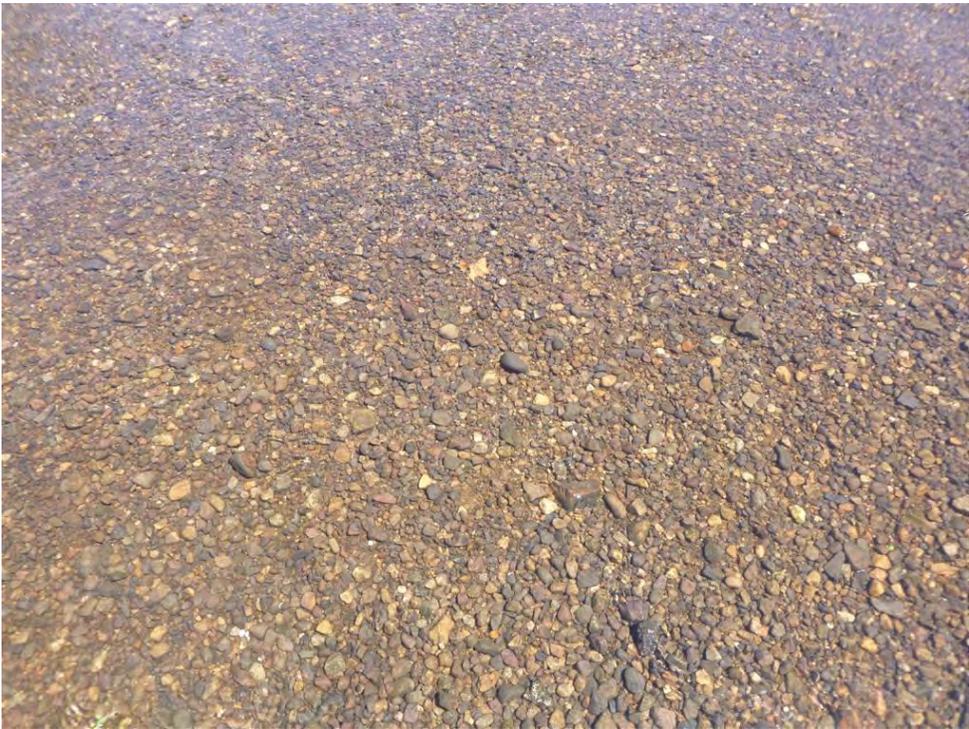
Substrate Type Classification: 4 (Pebble)			
Description: Sampling Point -201 Classification - 4 ID Type - Visual /Probe

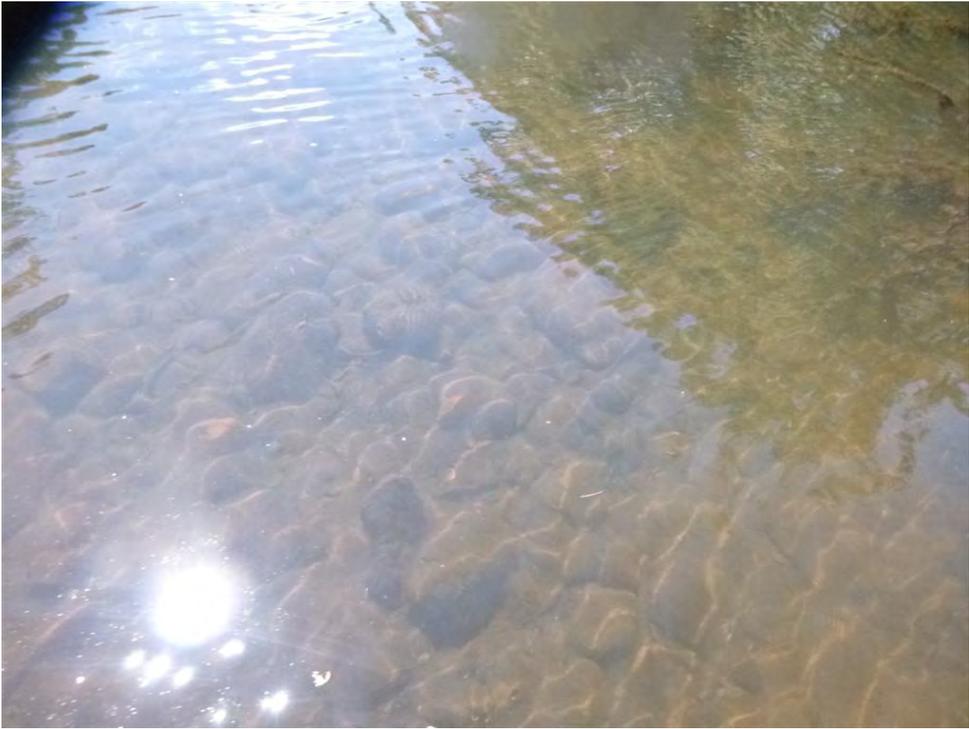
Substrate Type Classification: 5 (Cobble/Boulder)			
Description: Sampling Point - 205a Classification - 5 ID Type - Visual /Probe

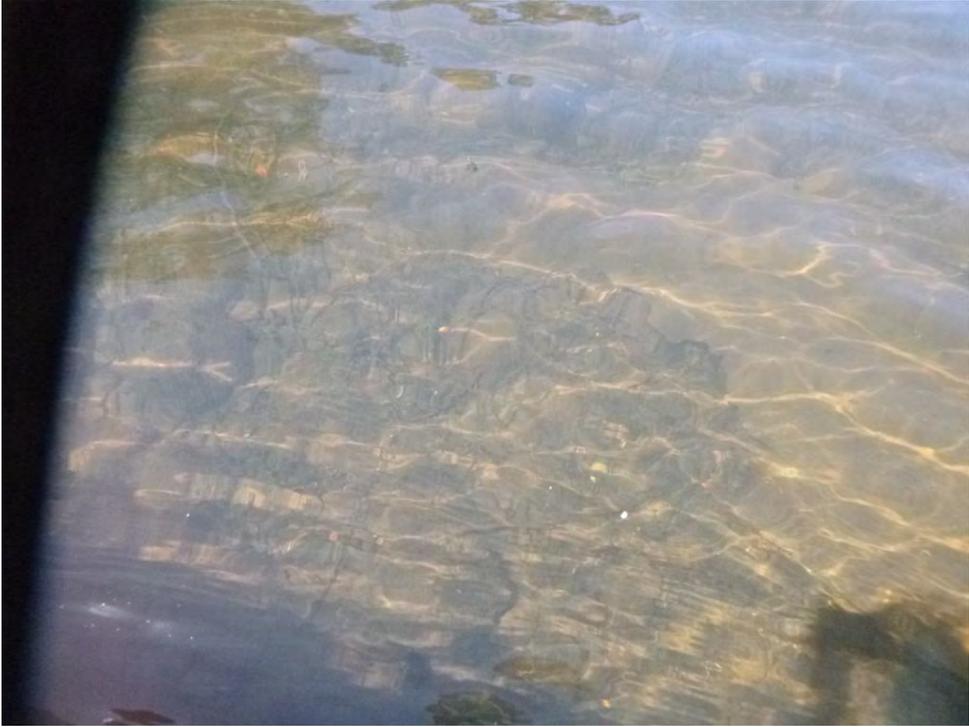
Substrate Type Classification: 5 (Cobble/Boulder)			
Description: Sampling Point -205b Classification - 5 ID Type - Visual /Probe

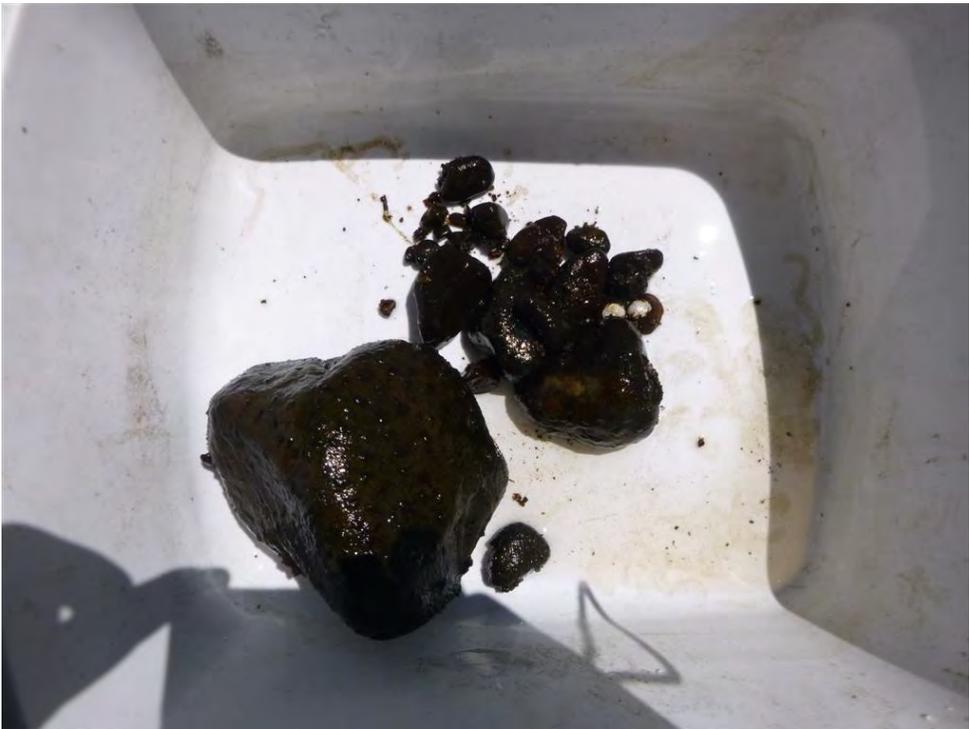
Substrate Type Classification: 5 (Cobble/Boulder)		
Description: Sampling Point - 210 Classification - 5 ID Type - Visual /Probe Collected material with hand.

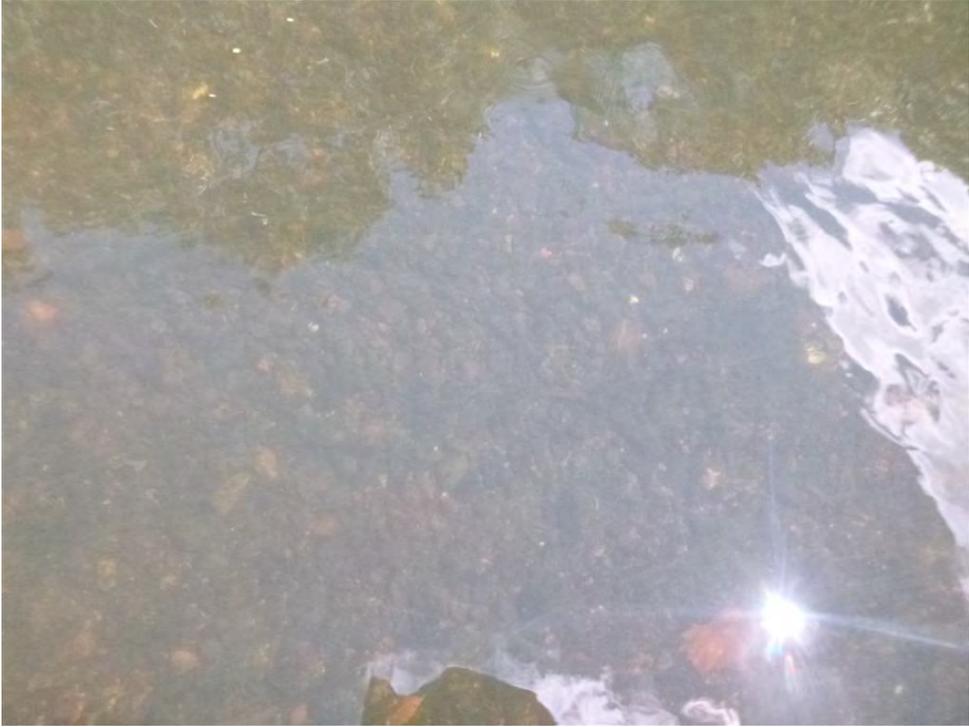
Substrate Type Classification: 4 (Pebble)			
Description: Sampling Point -216a Classification - 4 ID Type - Visual /Ponar

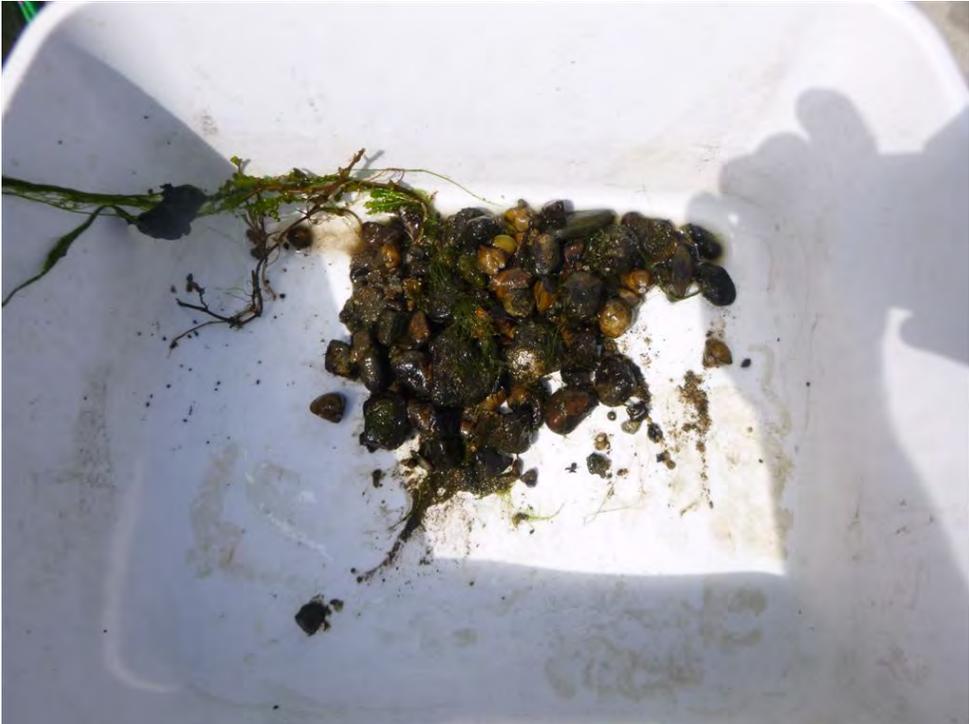
Substrate Type Classification: 4 (Pebble)			
Description: Sampling Point -216c Classification - 4 ID Type - Visual /Ponar

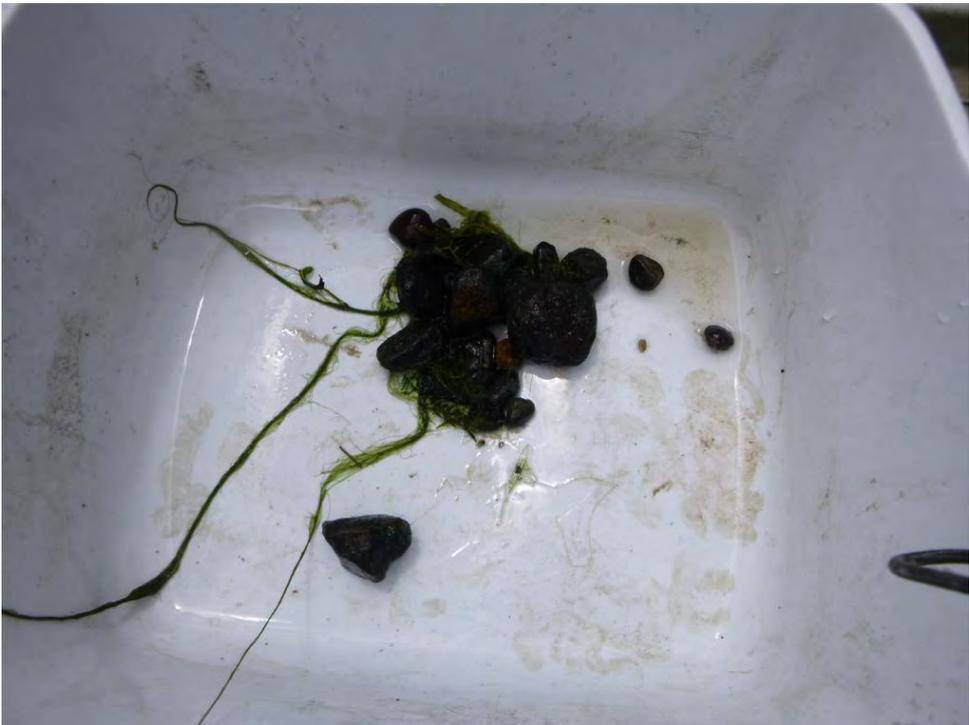
Substrate Type Classification: 4 (Pebble)			
Description: Sampling Point - 221 Classification - 4 ID Type - Visual /Ponar

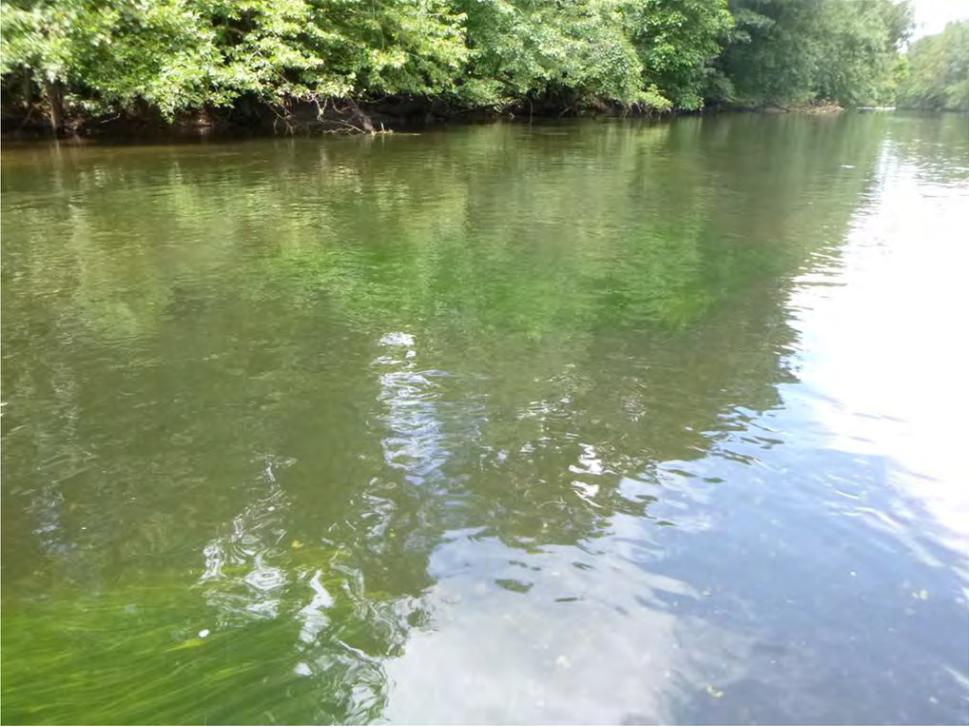
Substrate Type Classification: 4 (Pebble)			
Description: Sampling Point -225 Classification - 4 ID Type - Visual /Probe

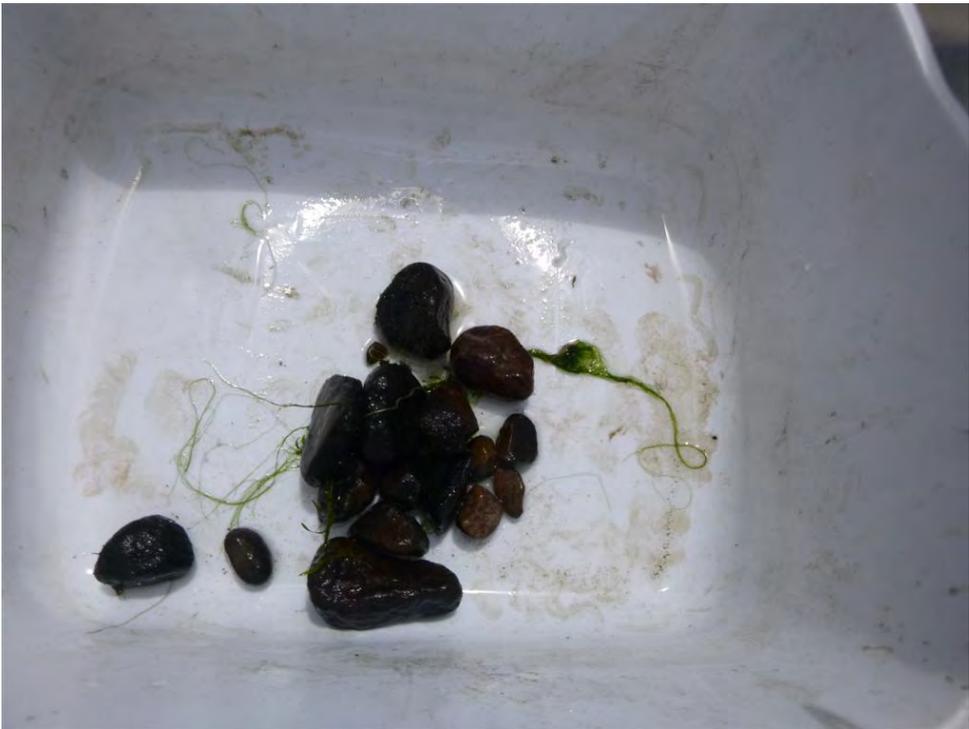
Substrate Type Classification: 4 (Pebble)		
Description: Sampling Point - 227 Classification - 4 ID Type - Visual /Ponar

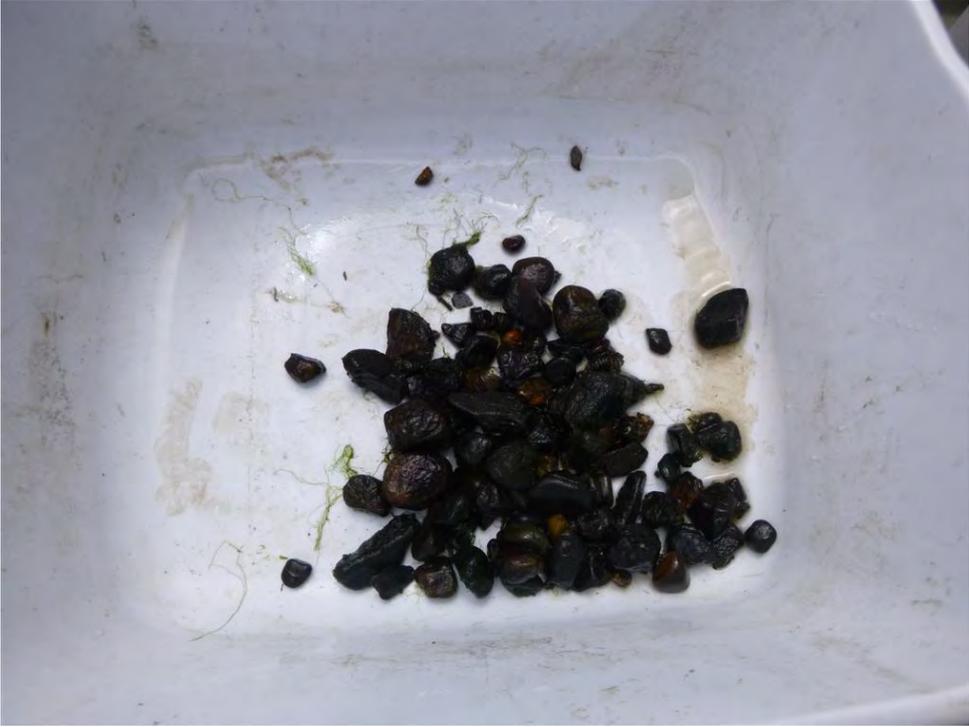
Substrate Type Classification: 4 (Pebble)			
Description: Sampling Point -233 Classification - 4 ID Type - Visual /Ponar
