Rapid Seafloor Reconnaissance and Assessment of Southeast Florida Ocean Dredged Material Disposal Sites Utilizing Sediment Profile Imaging

May 2006 Post-Disposal SPI Mapping at the Miami ODMDS

**Prepared by:
Germano & Associates, Inc.**

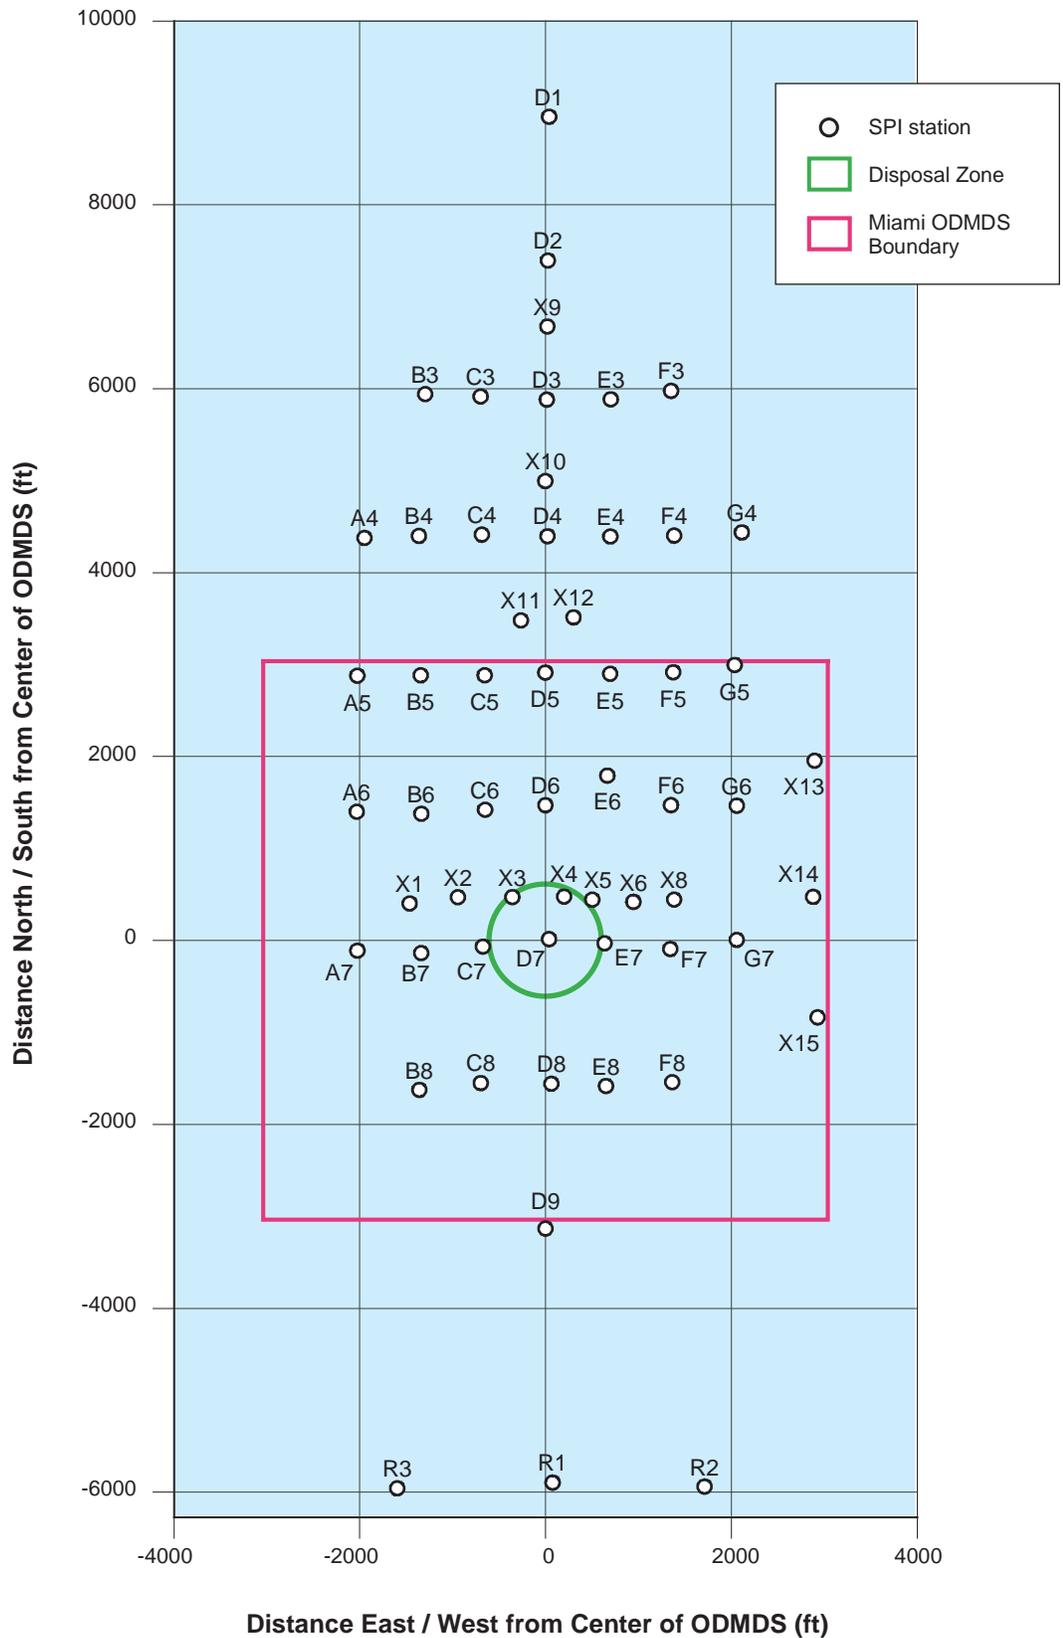
Figure 2-1: SPI sampling locations for the May 2006 survey at the Miami ODMDS.

The sampling involved the collection of sediment-profile images at a total of 58 stations, which can be broken down as follows (see Figure 2-1):

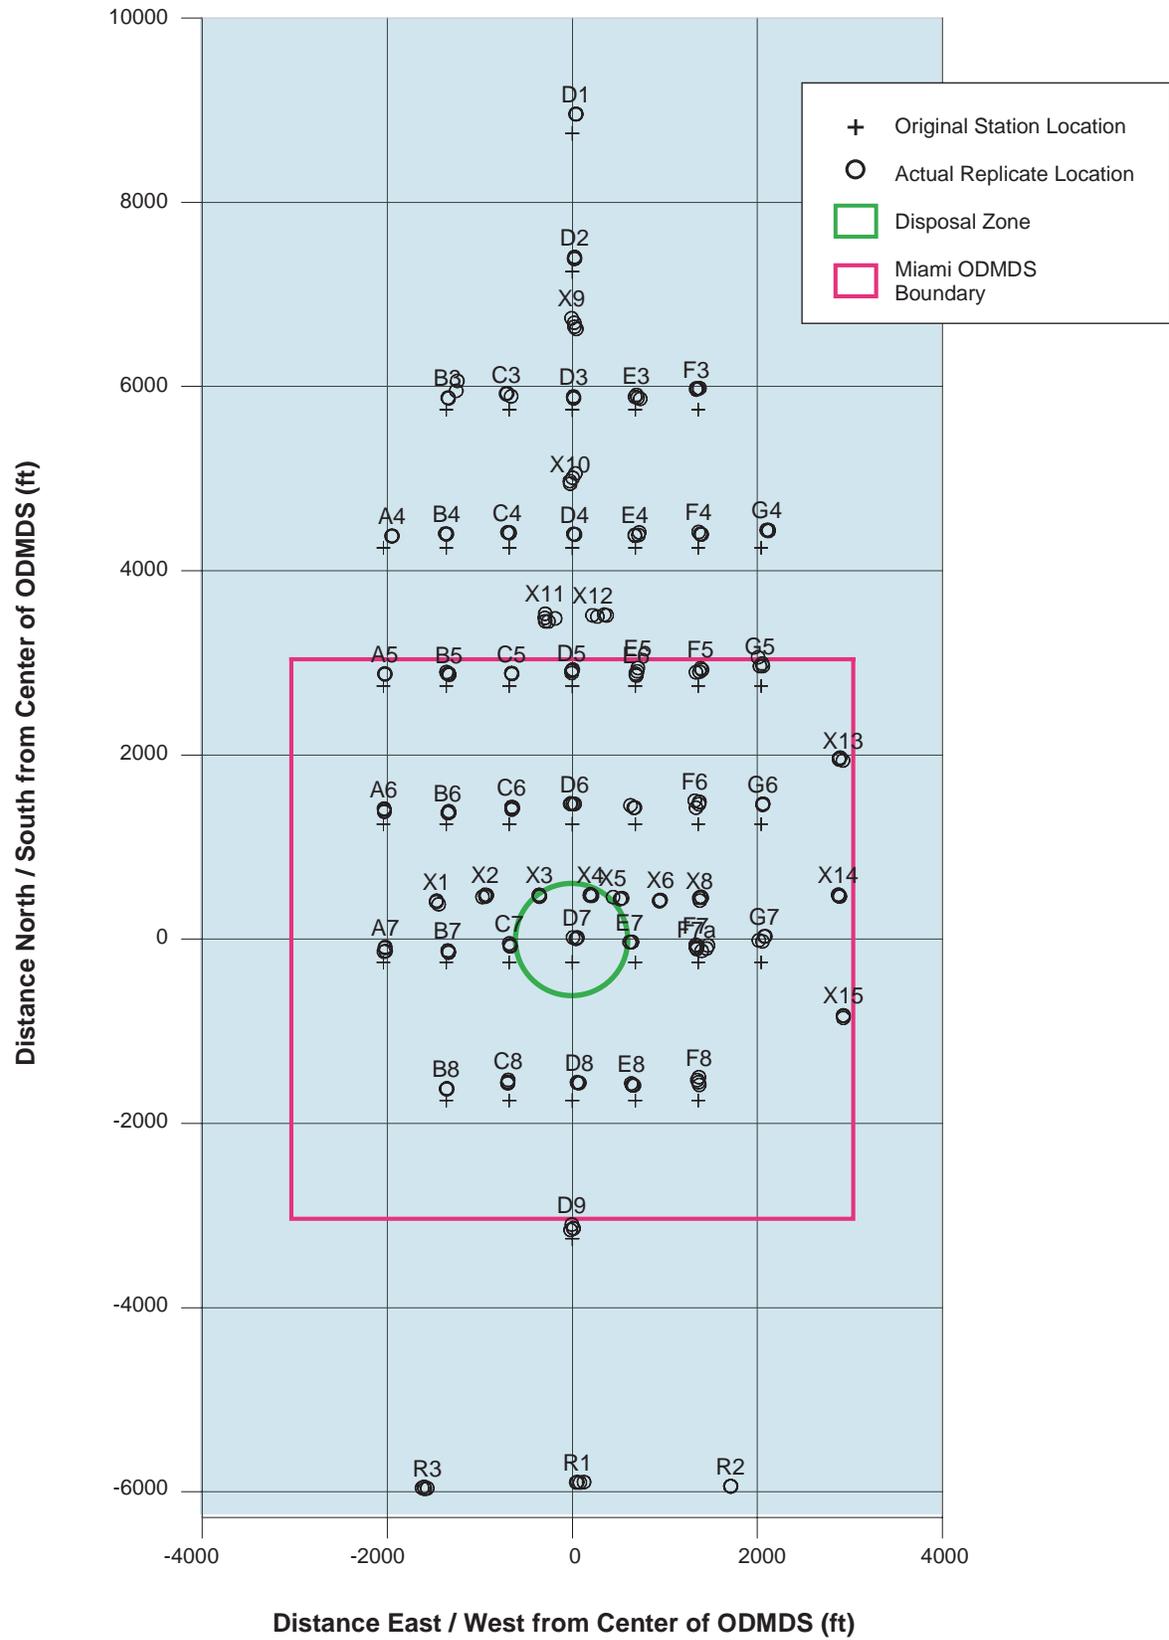
Figure 2-2: Map showing the target sampling location versus the actual location of each replicate camera drop for the May 2006 SPI survey at the Miami ODMDS.

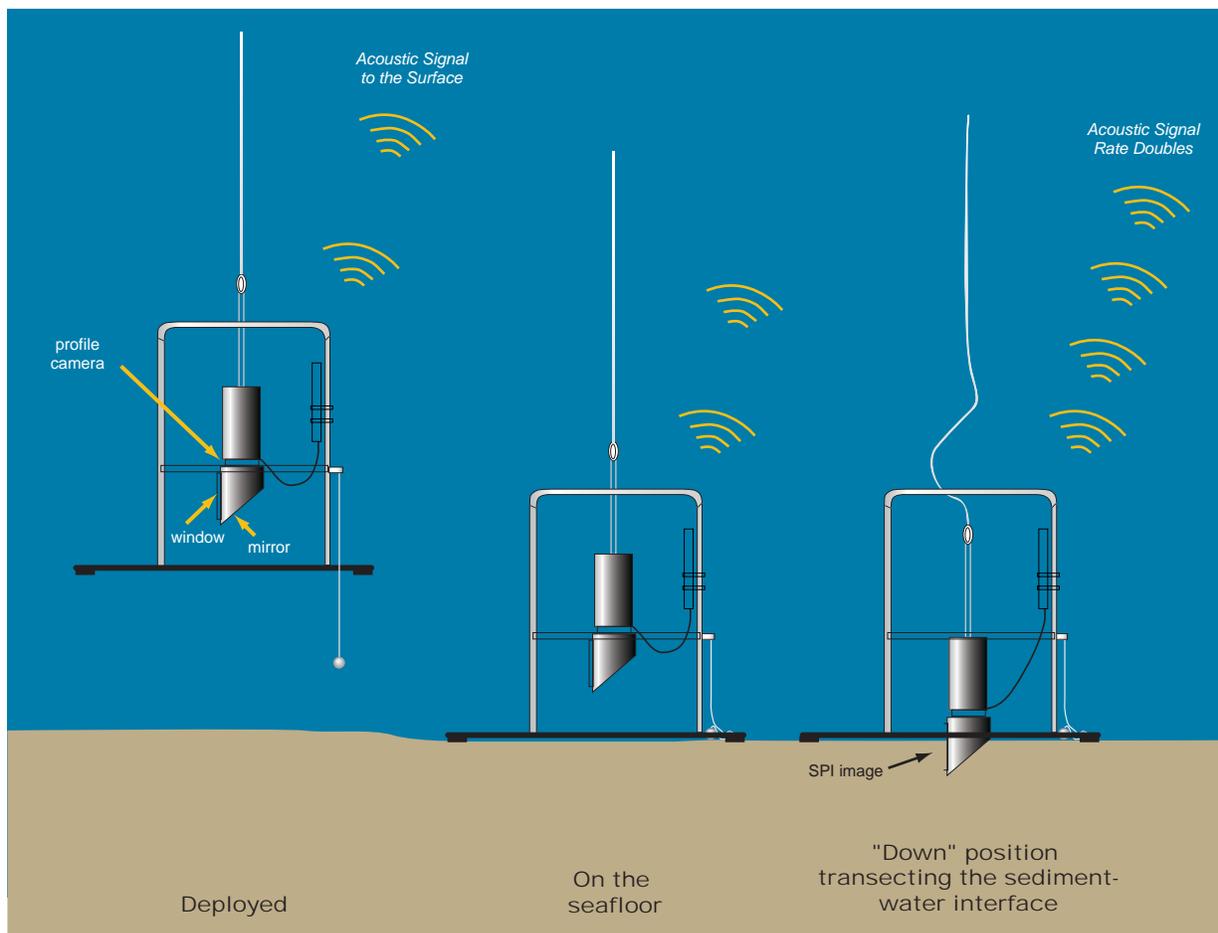
Figure 2-3: Operation of the sediment-profile camera during deployment. The central cradle of the camera is held in the "up" position by tension on the winch wire as it is being lowered to the seafloor (left); once the frame base hits the bottom (center), the prism is then free to penetrate the bottom (right) and take the photograph.

The prism has a strobe mounted inside, near the back of the wedge, to provide illumination for the image. Because the prism is filled with distilled water, the camera always has an optically clear path. The complete assembly, consisting of the watertight camera housing attached to the top of the water-filled prism, is mounted on a moveable carriage within a stainless steel frame. Onboard a survey vessel, this frame is attached to the winch wire and lowered slowly to the seafloor. Tension on the wire keeps the prism in its “up” position. When the frame comes to rest on the seafloor, the winch wire slackens (Figure 2-3) and the camera prism descends into the sediment at a slow, controlled rate that reduces disturbance at the sediment-water interface. As the prism descends and begins to penetrate into the sediment, it trips a trigger that activates a 15-second time-delay circuit. This time delay allows the prism to penetrate fully into the sediment before the image is taken. After the 15-second delay, the internal strobe discharges and the camera’s shutter releases. In this manner, the camera takes a picture of the sediment-water interface and the upper portion of the sediment column that is in direct contact with the prism’s Plexiglas[®] faceplate (i.e., a sediment cross-section or “profile” image). The resulting images give the viewer the same perspective as if looking through the side of an aquarium that is half-filled with sediment.

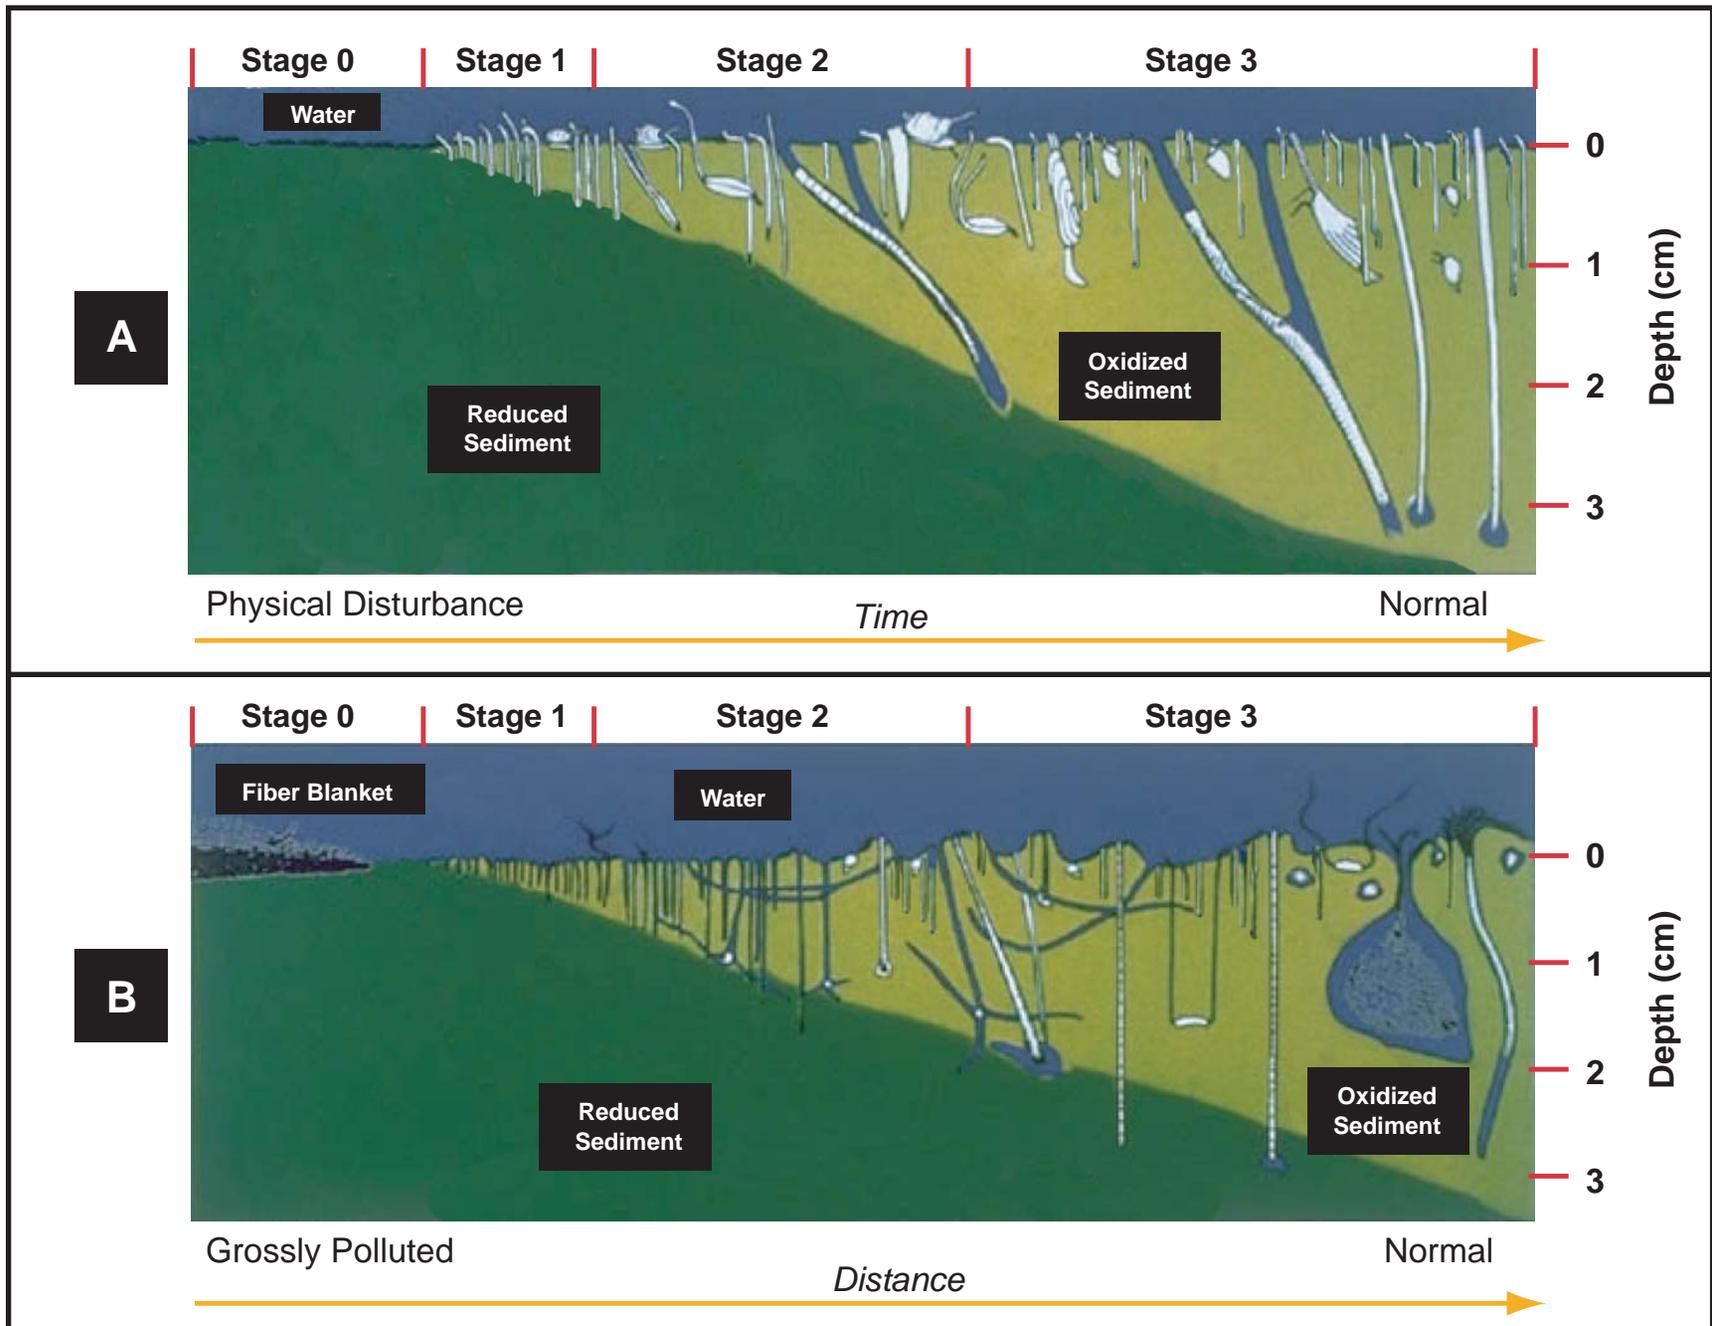
Figure 2-4: Soft-bottom benthic community response to physical disturbance (top panel) or organic enrichment (bottom panel). From Rhoads and Germano, 1982.

Although the successional models depicted in Figure 2-4 are not an ideal fit for an environment like the one at the Miami ODMDS, they nevertheless provided an established conceptual framework within which to evaluate the degree of infaunal activity observed in each image. A successional stage therefore was assigned to each image based on the observation of one or more of the features depicted in the models of

Although the recolonization pattern observed at the Miami ODMDS in the May 2006 SPI survey generally conformed with the conceptual model depicted in Figure 2-4, a key difference relates to organism density. Following disposal of organic-rich dredged material in many nearshore environments, dense mats of Stage 1 tubes are typically observed at the sediment surface within days to weeks. The surface- and near-surface-dwelling Stage 1 and 2 communities observed at the Miami stations within the disposal footprint appeared to have much lower tube densities. Surface tube densities on the surrounding ambient seafloor also appeared to be low. This is attributed to the much lower organic carbon content of both the ambient sediments and the disposed dredged material at the Miami ODMDS.

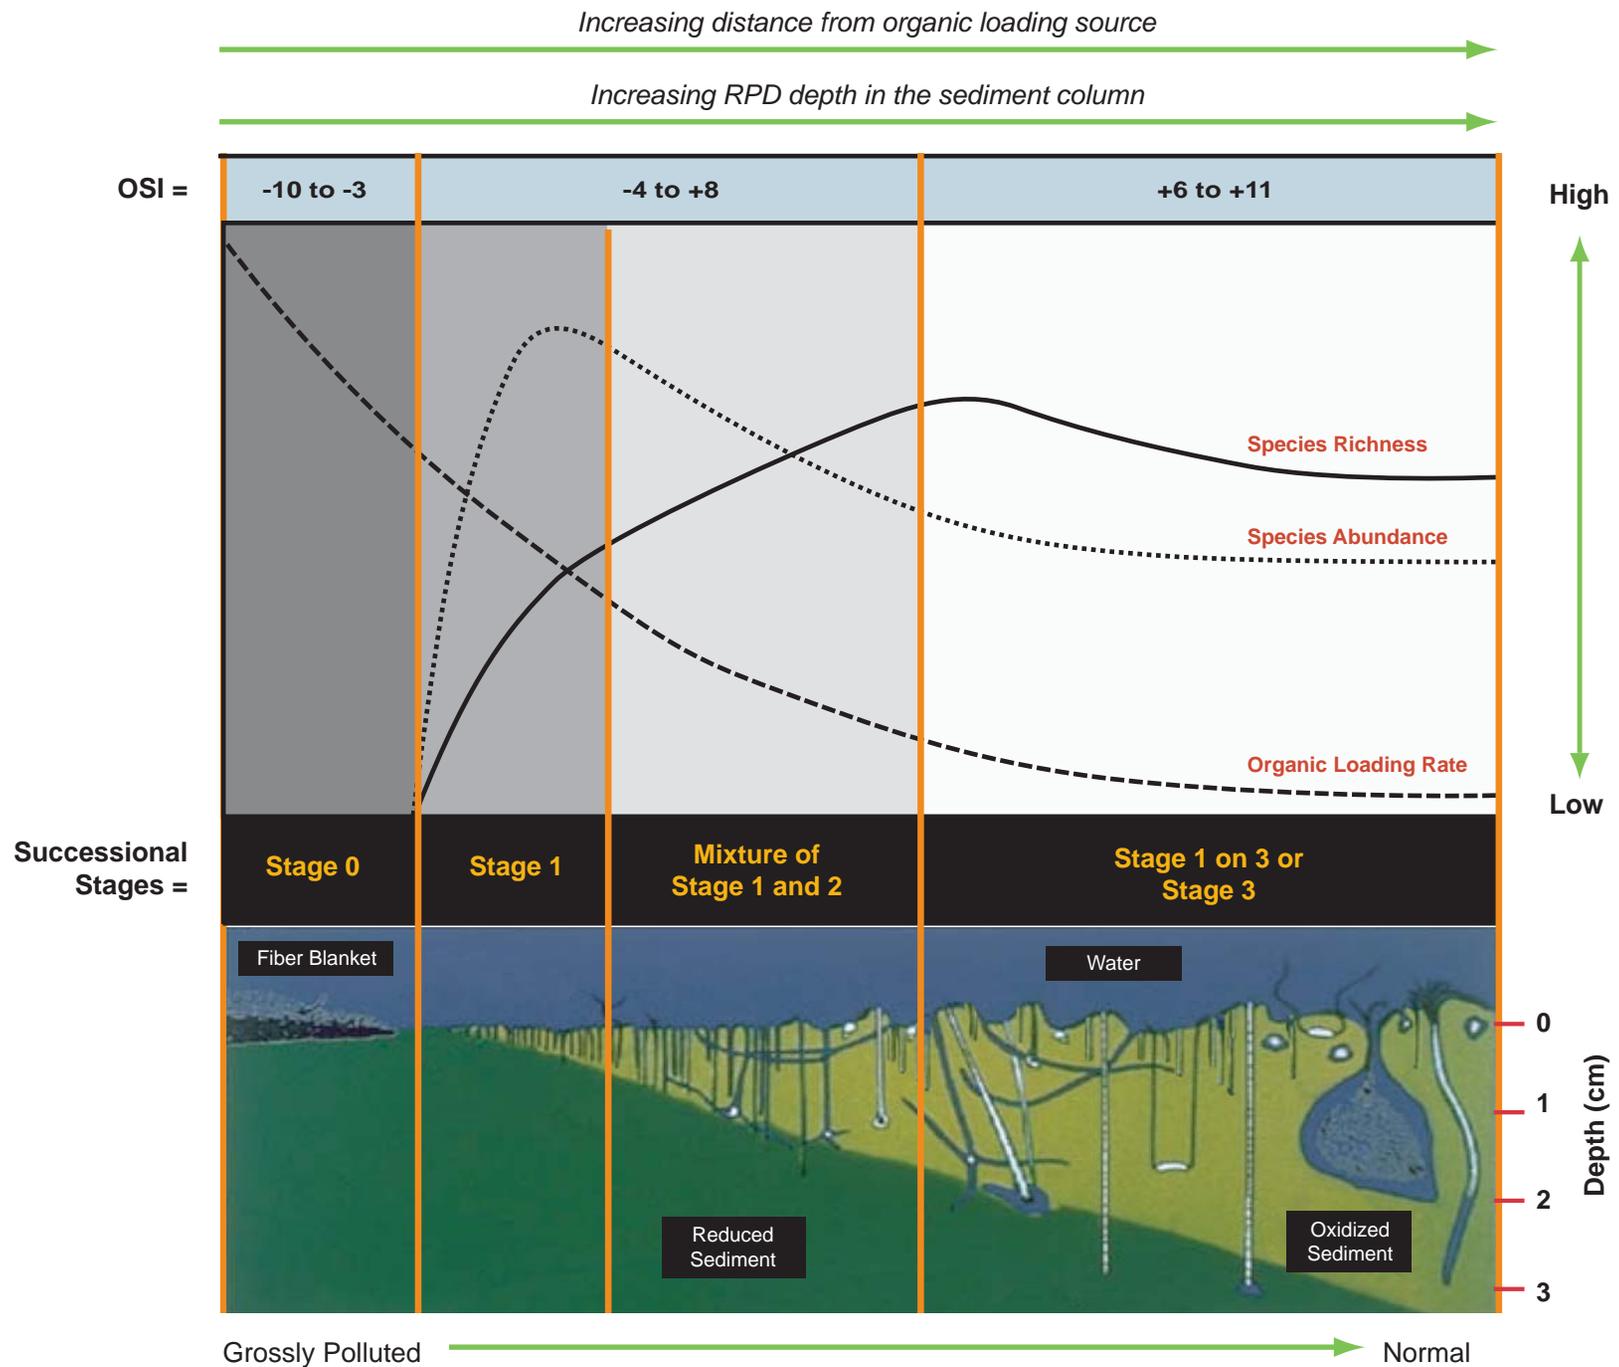
Figure 2-5: Model illustrating the relationships among key SPI parameters and traditional measures of species richness and abundance along an organic enrichment gradient.

Physical measurements made with the SPI system from profile images provide background information about gradients in physical disturbance (caused by dredging, disposal, oil platform cuttings/drilling muds discharge, trawling, or storm resuspension and transport) in the form of maps of sediment grain size, boundary roughness, sediment textural fabrics, and structures. The concentration of organic matter and the sediment oxygen demand (SOD) can be inferred from the optical reflectance of the sediment column and the apparent RPD depth. Organic matter is an important indicator of the relative value of the sediment as a carbon source for both bacteria and infaunal deposit feeders. SOD is an important measure of ecological health; oxygen can be depleted quickly in sediment by the accumulation of organic matter and by bacterial respiration, both of which place an oxygen demand on the porewater and compete with animals for a potentially limited oxygen resource (Figure 2-5; see also Kennish 1986).

The distribution of successional stages in the context of the mapped disturbance gradients is one of the most sensitive indicators of the ecological condition of the seafloor (Rhoads and Germano 1986; Figure 2-5). The presence of Stage 3 equilibrium taxa (mapped from subsurface feeding voids as observed in profile images) can be a good indication of high benthic habitat stability and relative lack of disturbance from natural or anthropogenic factors. A Stage 3 assemblage indicates that the sediment surrounding these organisms has not been disturbed severely in the recent past and that the inventory of bioavailable contaminants is relatively small. These inferences are based on past work, primarily in temperate latitudes, showing that Stage 3 species are relatively intolerant to sediment disturbance, organic enrichment, and sediment contamination. Stage 3 species expend metabolic energy on sediment bioturbation (both particle advection and porewater irrigation) to control sediment properties, including porewater profiles of sulfate, nitrate, and RPD depth in the sedimentary matrix near their burrows or tubes (Aller and Stupakoff 1996; Rice and Rhoads 1989). Bioturbation results in an enhanced rate of decomposition of polymerized organic matter by stimulating microbial decomposition (“microbial gardening”). Stage 3 benthic assemblages are very stable and are also called climax or equilibrium seres.

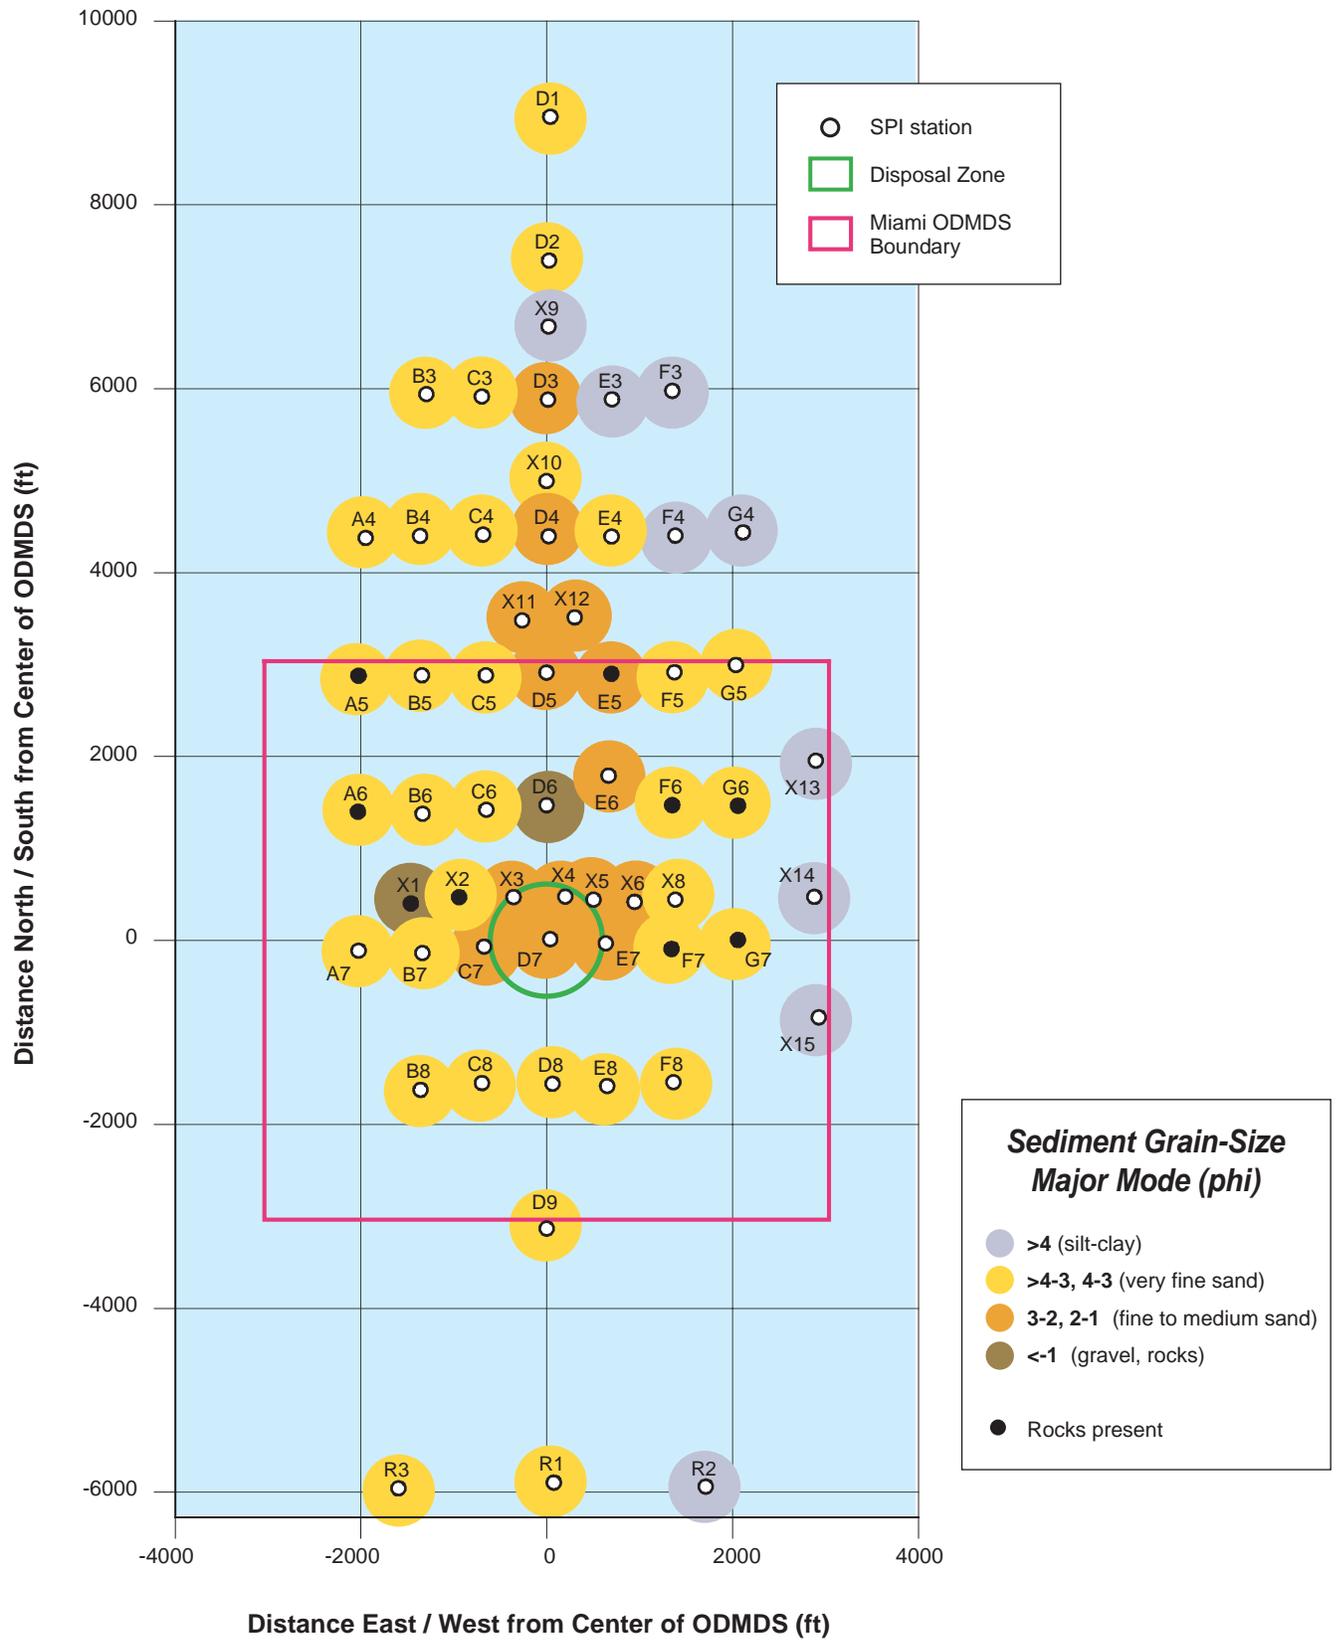
Figure 3-1: Grain size major mode (in phi units) at the Miami ODMDS SPI stations.

Similar to most of the disposal site stations, reference stations R1 and R3 were characterized by silty, very fine sand, while soft silt was found at reference station R2 (Figures 3-1 and 3-2; Table 3-2).

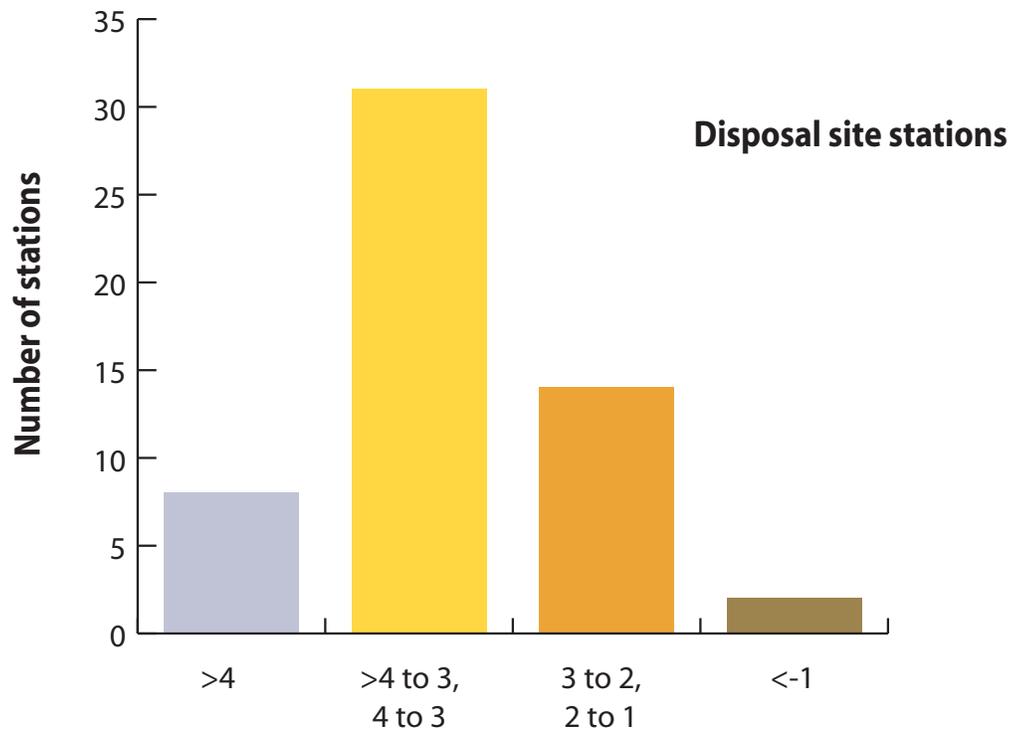
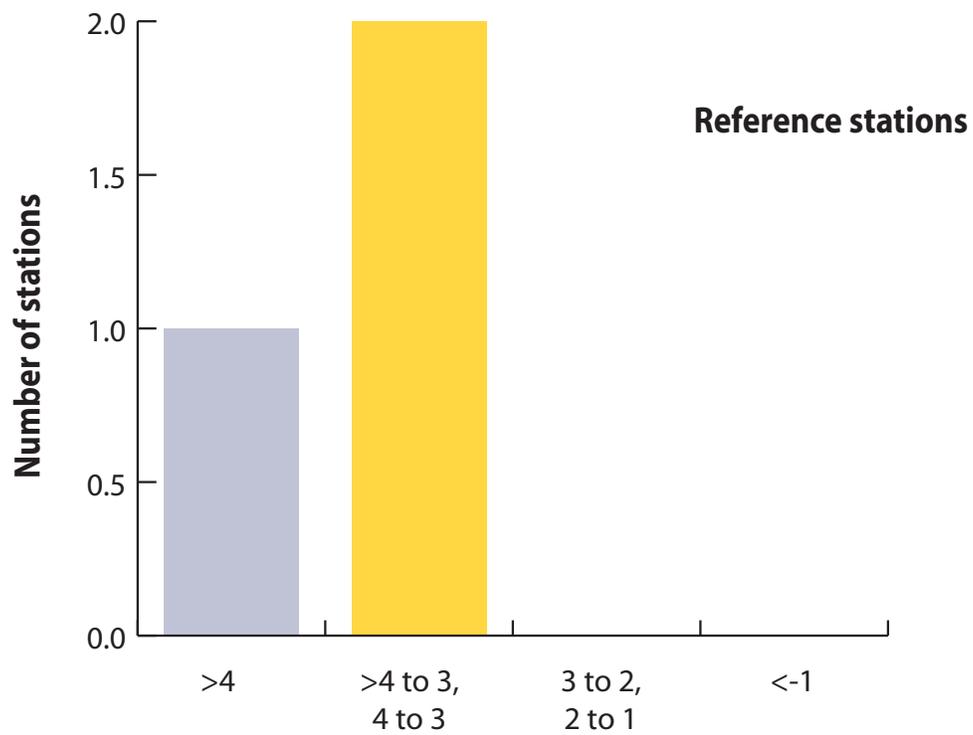
Figure 3-2: Frequency distribution of grain size major modes (in phi units) at the disposal site stations (top) and reference stations (bottom).

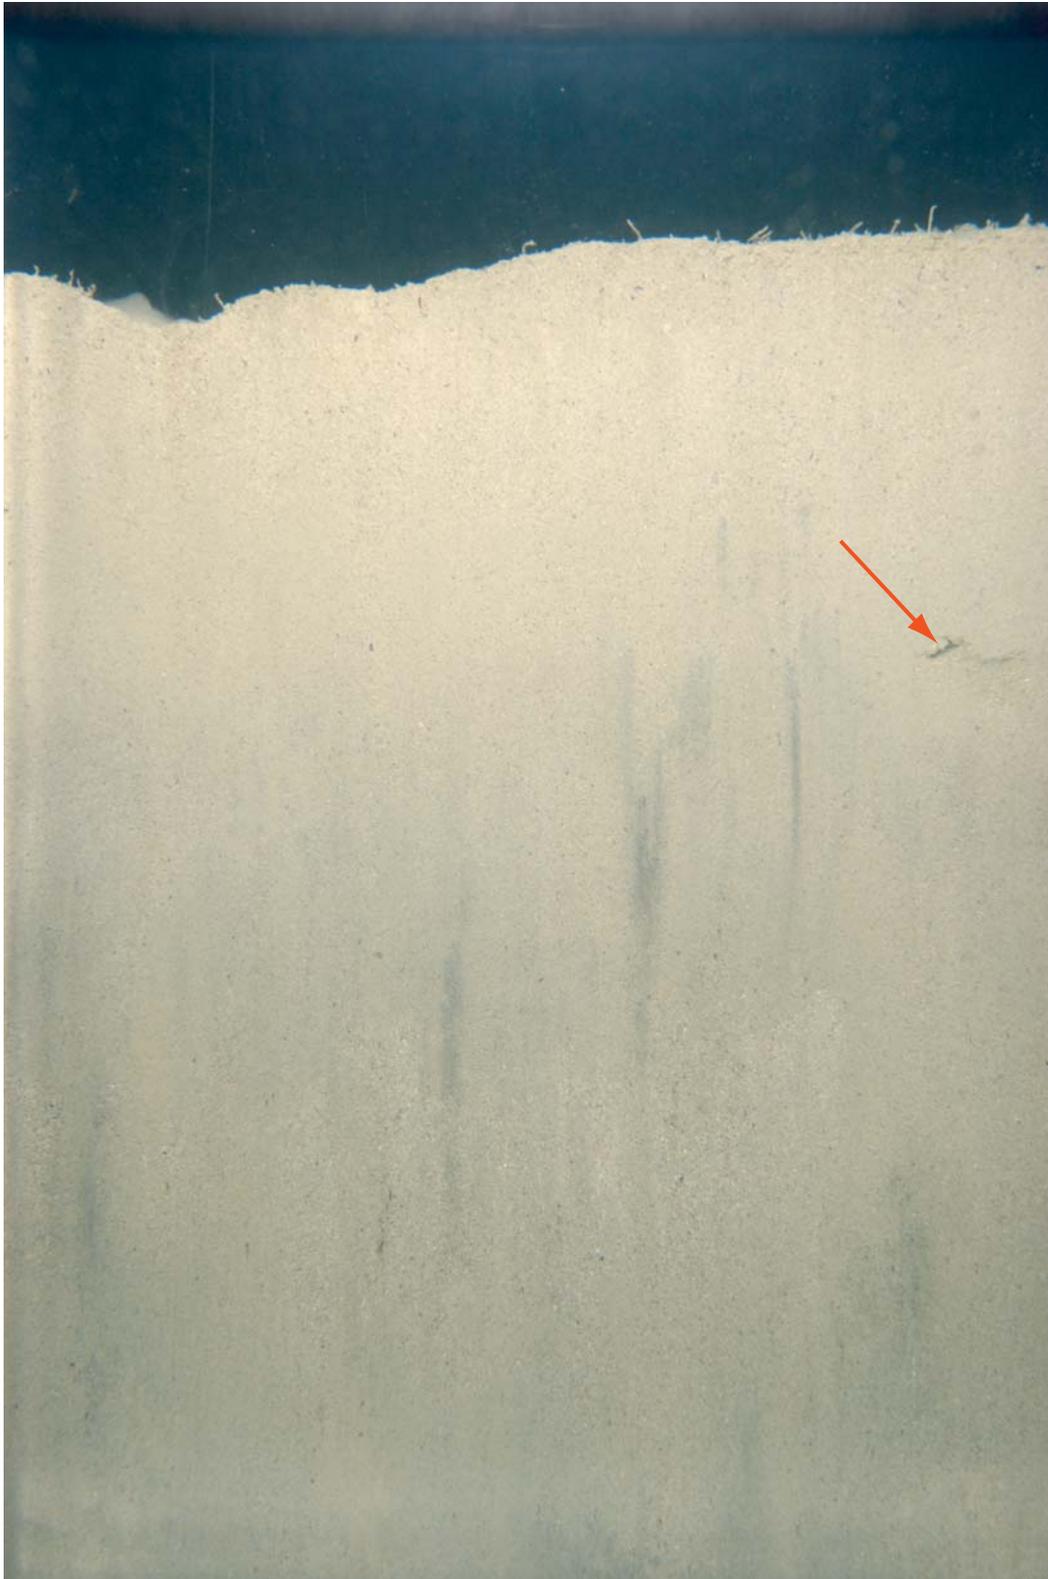
Figure 3-3: SPI image from Station B3 showing typical ambient sediment outside the disposal site consisting of relatively soft, silty, very fine sand (grain size major mode of 4 to 3 phi). Small tubes occur at the sediment surface, and a feeding void is visible at depth (arrow), resulting in a "Stage 1 on 3" successional designation for this image. Scale: actual image width is 14.4 cm.

To the north of the disposal zone, outside the disposal site boundary, discrete layers of dredged material were observed overlying the ambient (i.e., pre-disposal) sediment surface (Figure 3-5). The dredged material comprising these relatively thin, discrete surface layers consisted of fine to very fine sand, while the underlying ambient sediment appeared to have a somewhat finer, more silty texture (Figure 3-8). In general, the dredged material became both finer-grained and occurred in gradually thinner layers moving northward away from the circular disposal zone. Overall, the dredged material in the images (e.g., Figures 3-6 through 3-8) was clearly distinguishable from the ambient surface sediments (e.g., Figure 3-3).

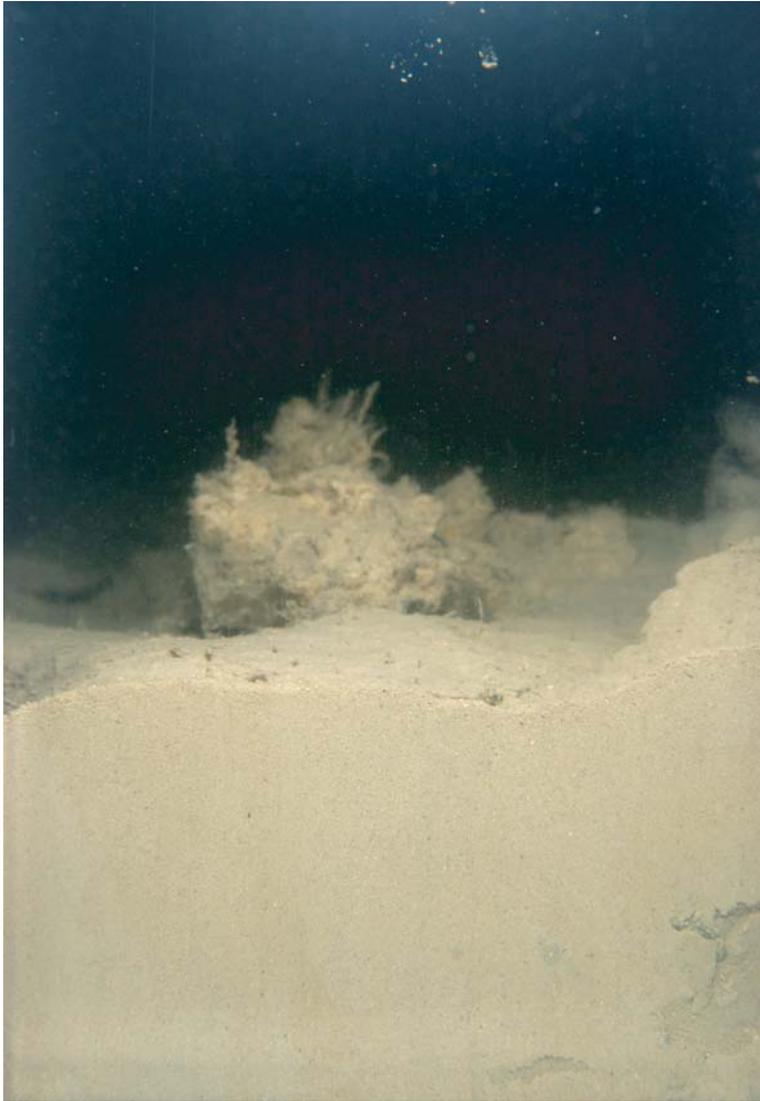
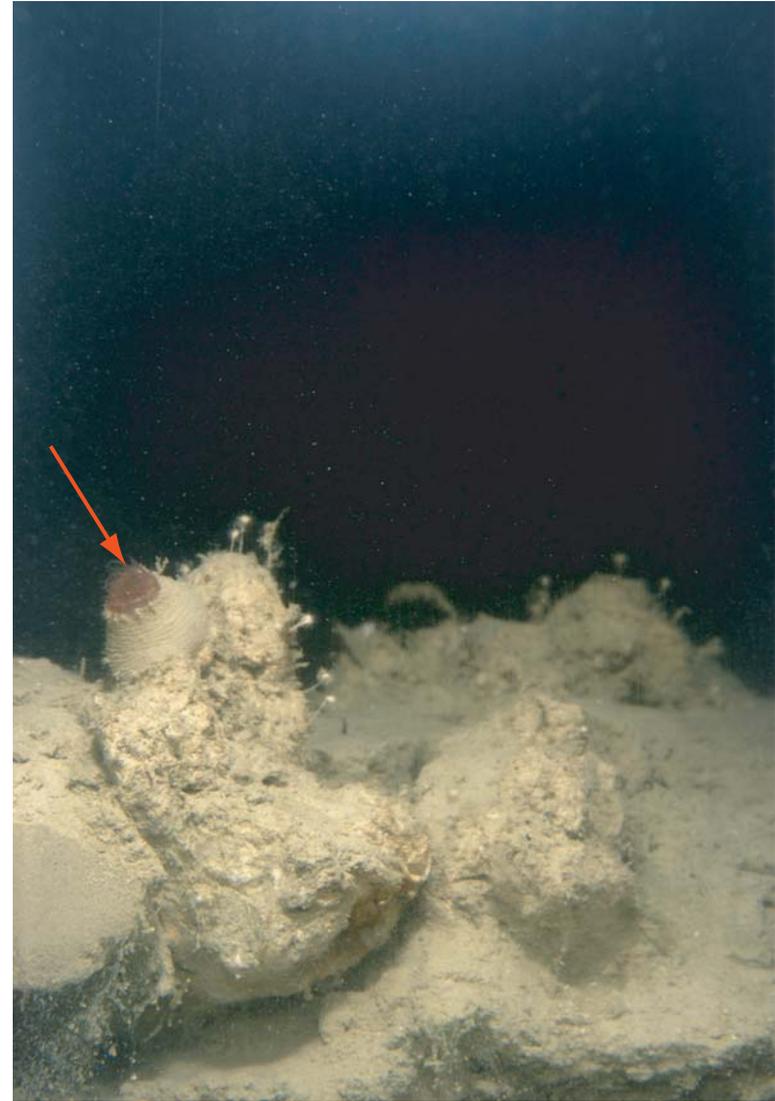
Figure 3-4: SPI images from stations F5 (left) and G6 (right) showing small rocks present at the sediment surface. A grain size major mode of >4 to 3 phi was assigned to the left image due to the silty, very fine sand underlying the rocks, while only the rocks themselves are visible in the right image (grain size major mode of <-1). In both images, the rocks are heavily encrusted with epifauna (the arrow points to a retracted anemone growing on the rock in the right image). Scale: actual image width is 14.4 cm.

In addition to the recent dredged material, rocks also were observed on top of the sand at stations A5, A6, X1 and X2 on the western side of the disposal site and at stations F5, F6, F7, G6 and G7 on the eastern side (mapped with solid black symbols in Figure 3-1). The rocks at these stations were heavily encrusted with epifauna, such as anemones and hydrozoans (Figure 3-4). Given the extent of the biological growth, it is assumed that these rocks had been in place on the seafloor for some time. It is possible that these rocks occur in patchy "rubble" areas resulting from past dredged material disposal activities, prior to the Phase II Deepening Project. If sand was clearly visible beneath the rocks in a given image, that image was assigned a grain size major mode of sand (3 to 2 or 2 to 1 phi). If only the rocks were visible, the image was assigned a grain size major of gravel (<-1 phi) (Figures 3-1 and 3-4).

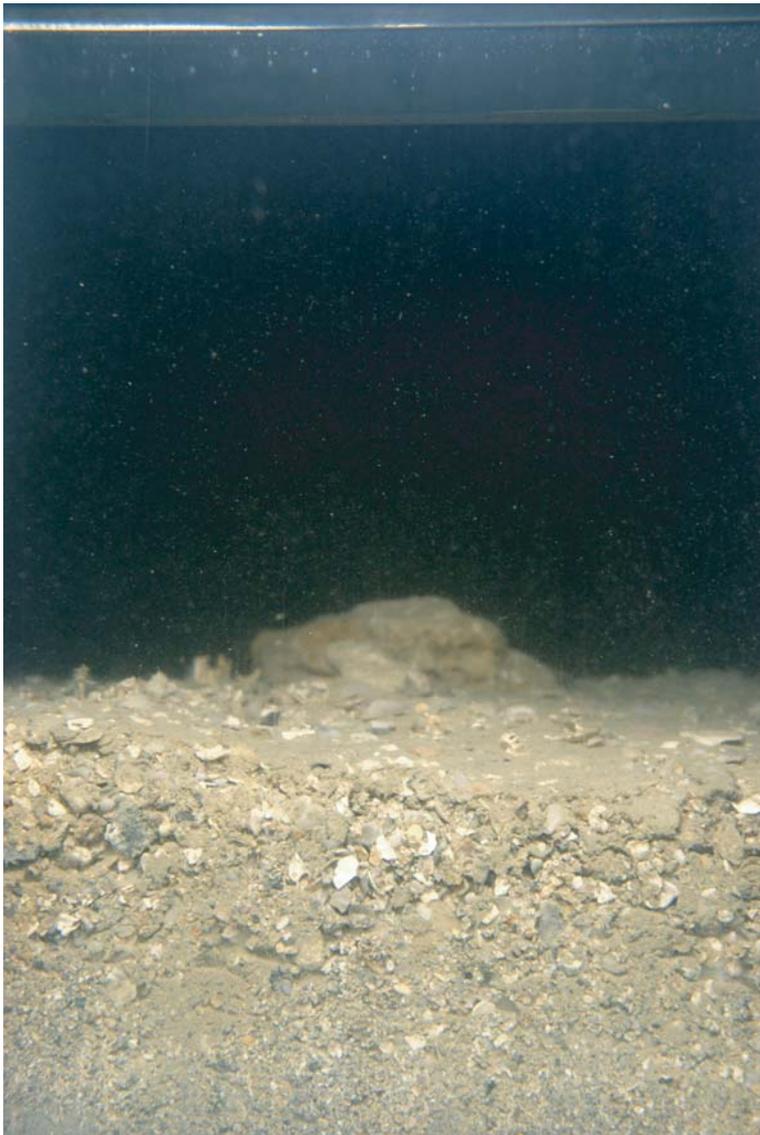
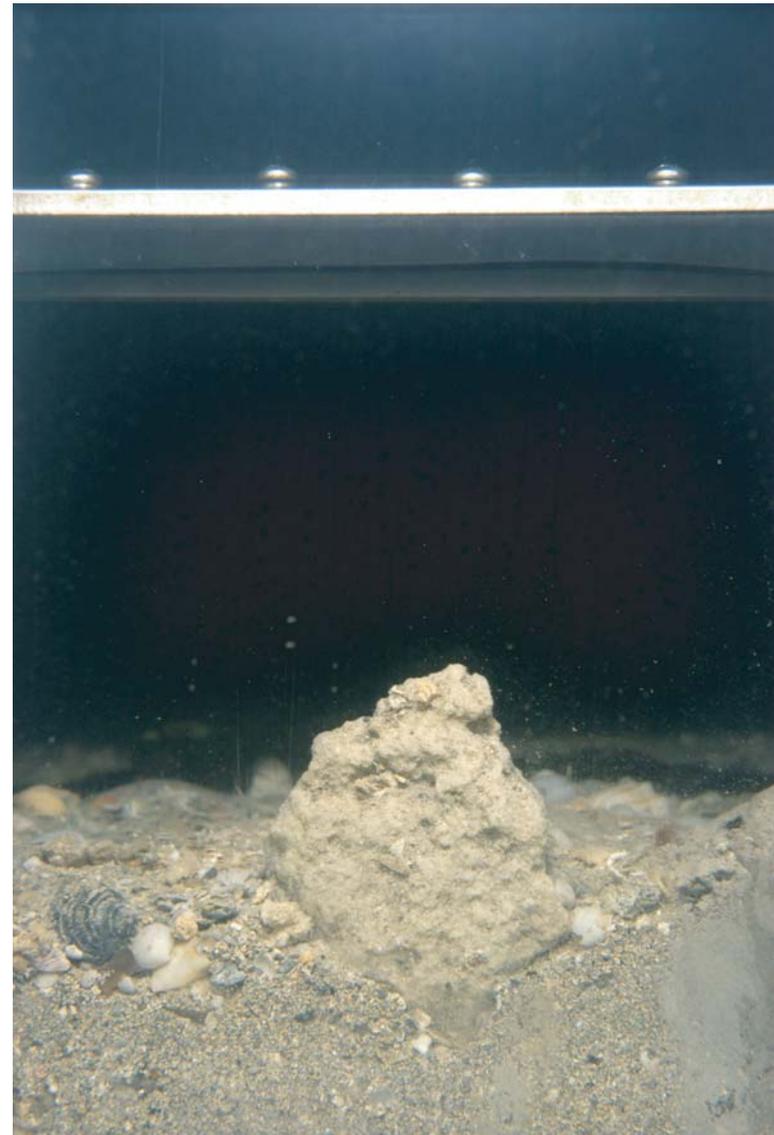
Figure 3-6: SPI images from stations D6 (left) and D7 (right) showing recent dredged material consisting of very coarse sand and gravel. In both images, the dredged material layer extends from the sediment surface to below the camera's imaging depth (i.e., thickness value mapped with a "greater than" sign in Figure 3-5). Scale: actual image width is 14.4 cm.

There were differences among stations in the color and texture of the dredged material. The coarsest dredged material, ranging from coarse sand to various sizes of gravel, occurred at the stations within and near the circular disposal zone (Figure 3-6). At most of these stations, the dredged material extended from the sediment surface to below the camera's imaging depth, resulting in the mapped thickness values being displayed with a "greater than" sign in Figure 3-5. The replicate images from Station E7 serve to illustrate some of the variability observed in the texture of the dredged material (Figure 3-7).

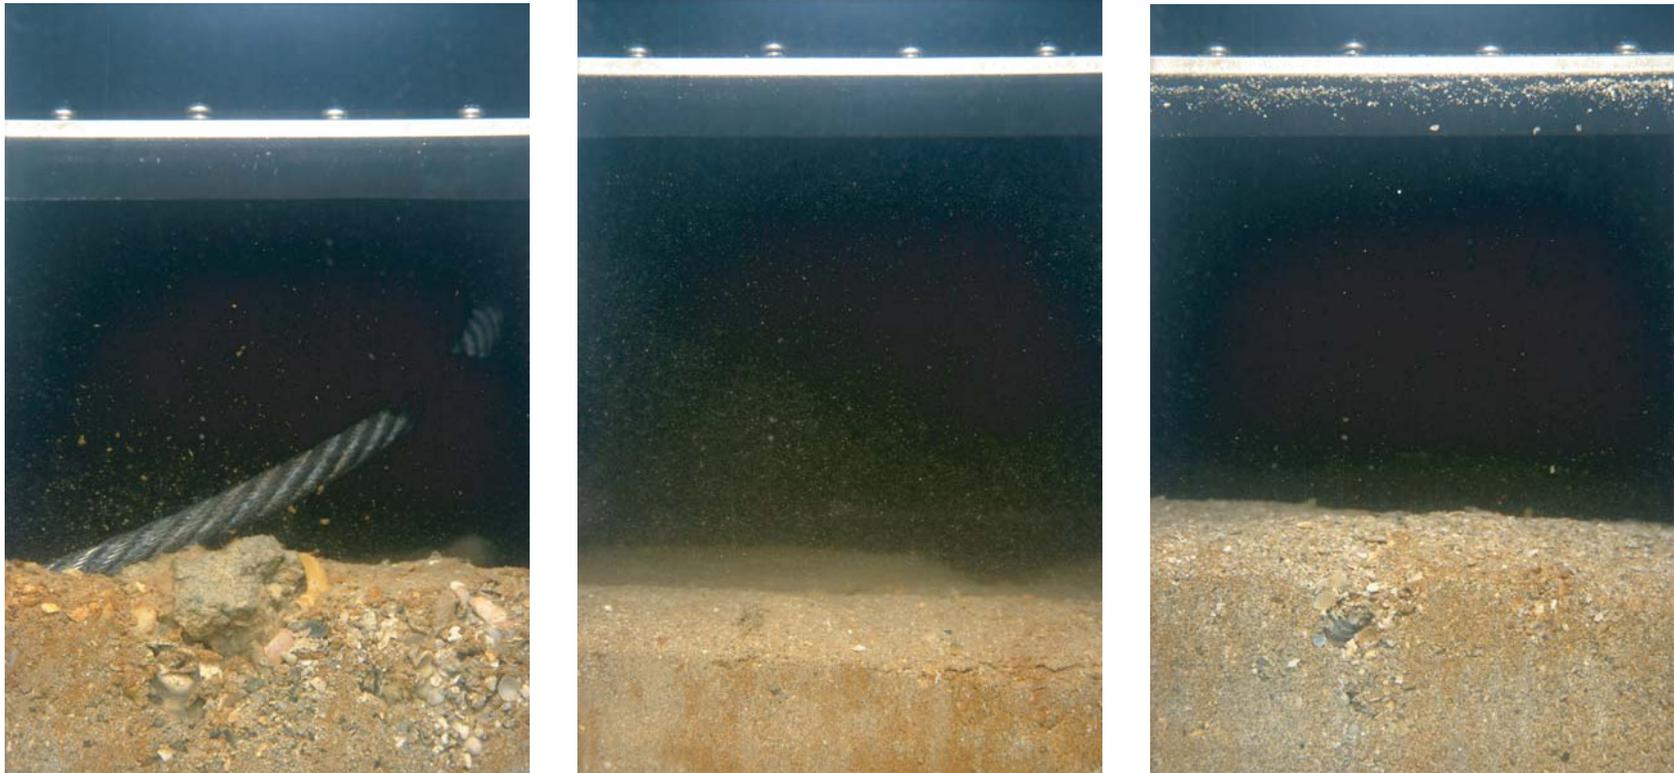
Figure 3-7: Three replicate SPI images from station E7 illustrating within-station variability in the texture of the dredged material, ranging from very coarse sand with gravel and shell fragments (left) to fine sand (middle) to medium sand (right). Note the reddish/rust coloration in all three images. Scale: actual image width is 14.4 cm.
