Rapid Seafloor Reconnaissance and Assessment of Southeast Florida Ocean Dredged Material Disposal Sites Utilizing Sediment Profile Imaging

May 2006 Post-Disposal SPI Mapping at the Miami ODMDS

**Prepared by:
Germano & Associates, Inc.**

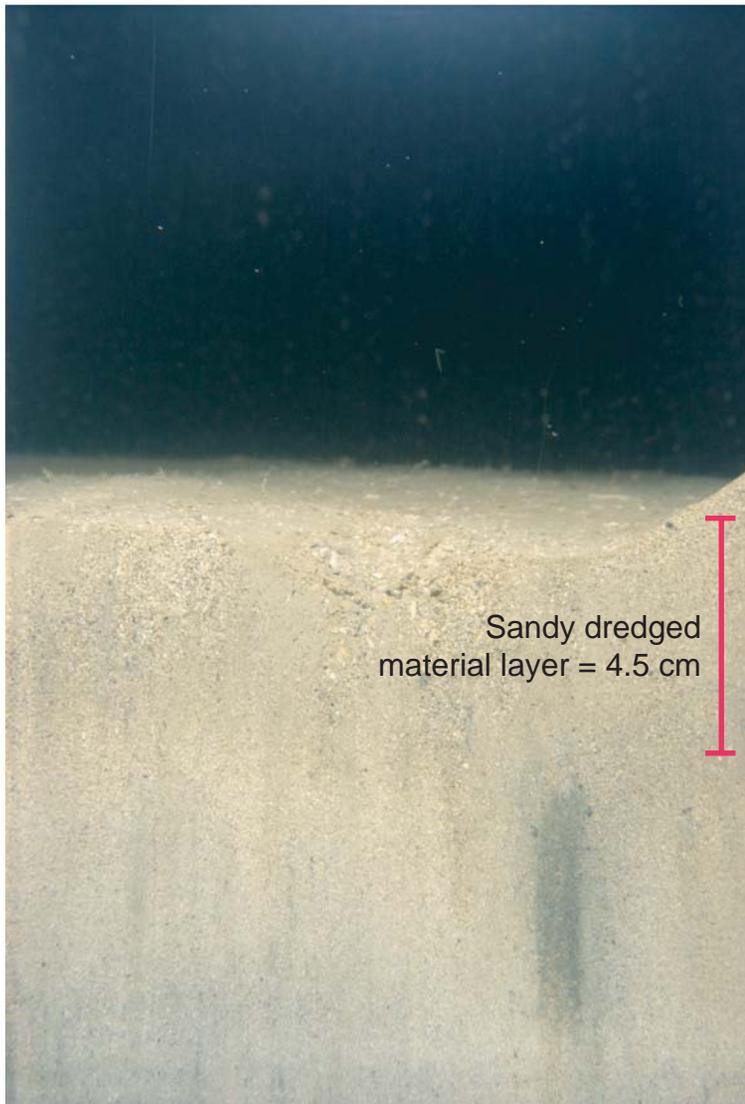
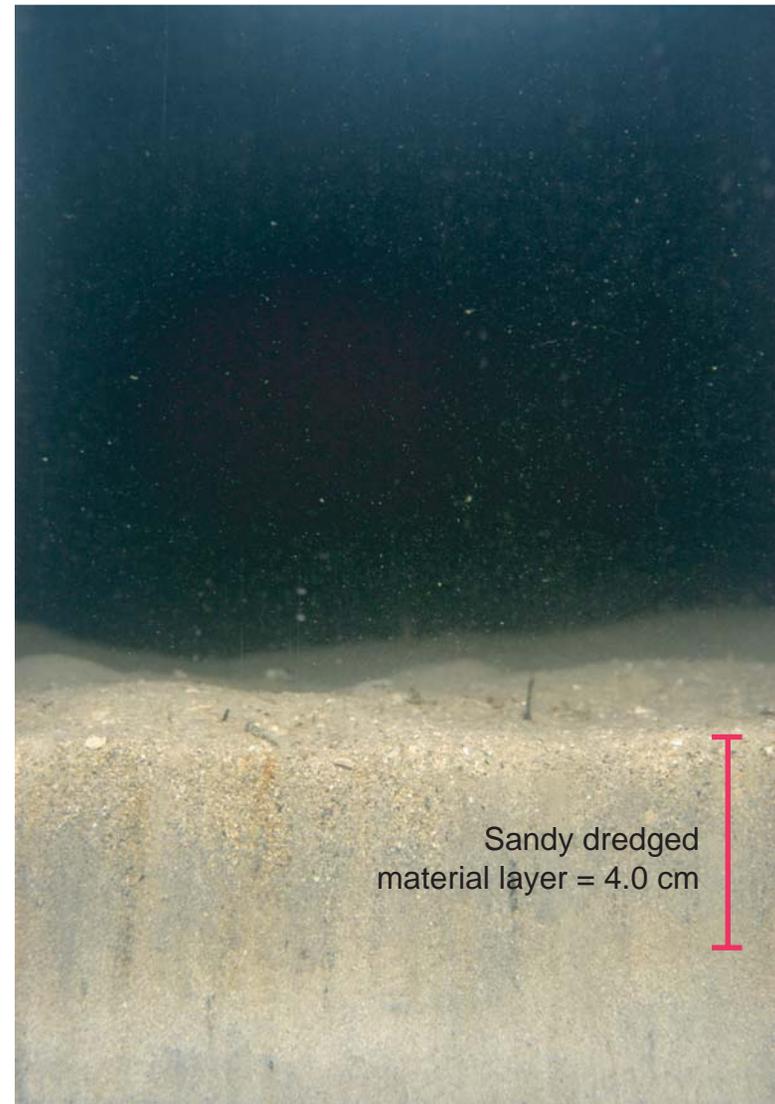
Figure 3-8: SPI images from stations D4 (left) and X11 (right) showing discrete surface layers of dredged material consisting of fine to medium sand overlying ambient sediment at depth. The measured thickness of the surface dredged material layer is 4.5 cm in the left image and 4.0 cm in the right image. Scale: actual image width is 14.4 cm.

To the north of the disposal zone, outside the disposal site boundary, discrete layers of dredged material were observed overlying the ambient (i.e., pre-disposal) sediment surface (Figure 3-5). The dredged material comprising these relatively thin, discrete surface layers consisted of fine to very fine sand, while the underlying ambient sediment appeared to have a somewhat finer, more silty texture (Figure 3-8). In general, the dredged material became both finer-grained and occurred in gradually thinner layers moving northward away from the circular disposal zone. Overall, the dredged material in the images (e.g., Figures 3-6 through 3-8) was clearly distinguishable from the ambient surface sediments (e.g., Figure 3-3).

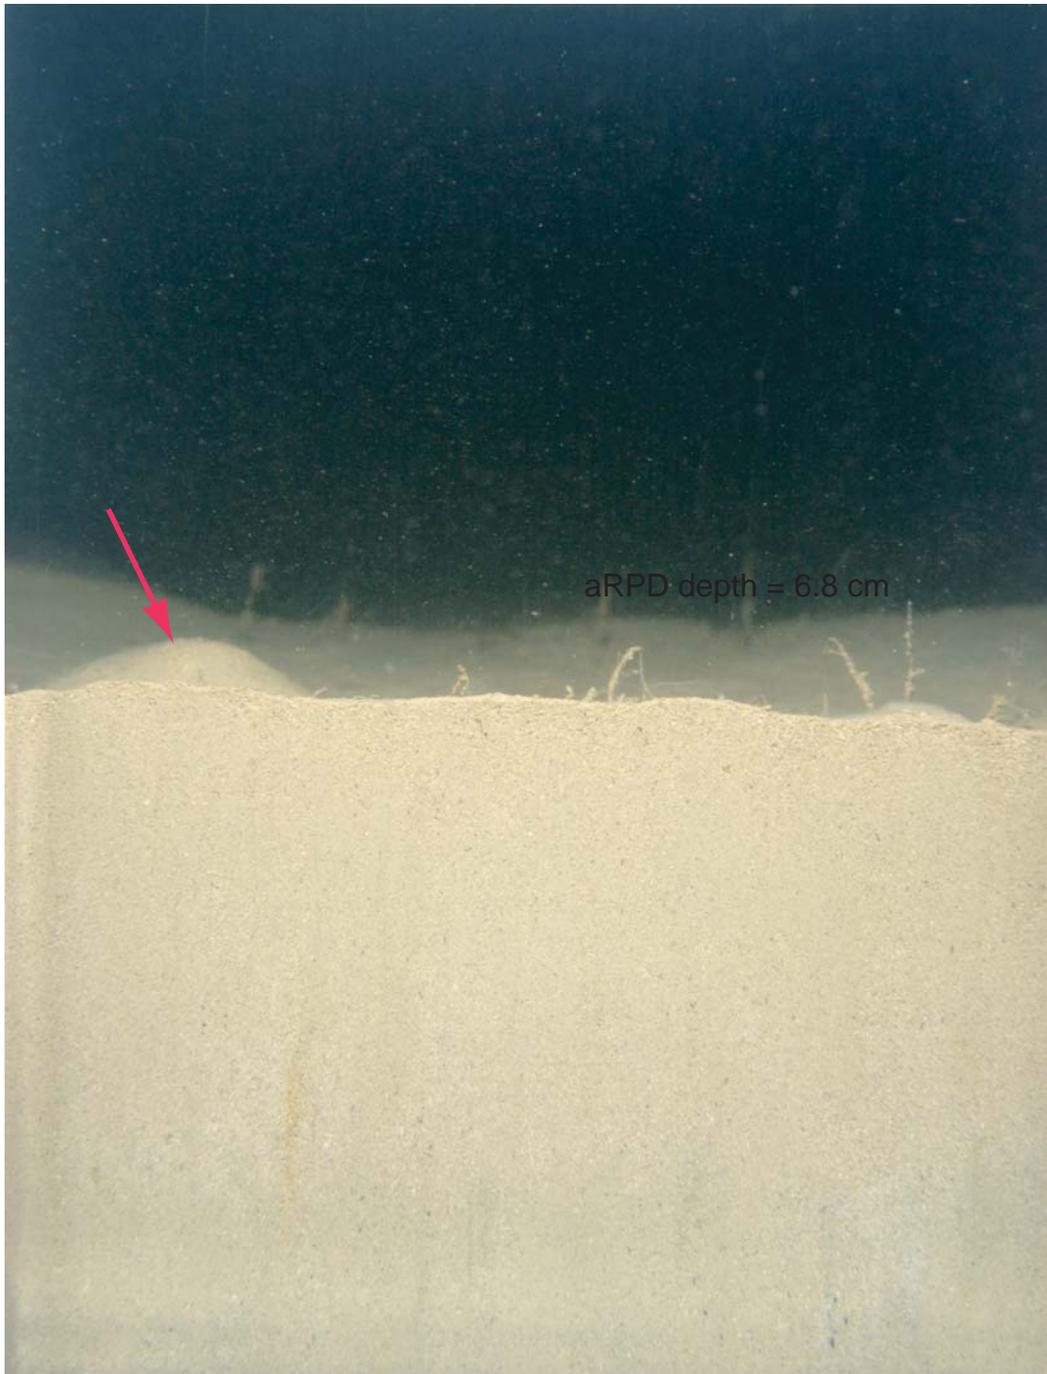
Figure 3-9: In this SPI image from station F8, the small-scale vertical relief across the field-of-view (i.e., "boundary roughness") is due both to sediment accumulation around the upright tubes and to the biogenic mound at left (arrow). This is an example of biogenic boundary roughness. Scale: actual image width is 14.4 cm.

Given the overall absence of consolidated/cohesive muddy sediments at the sampled stations, mud clasts were not observed in any significant numbers in the SPI images from this survey (Tables 3-1 and 3-2). Average small-scale boundary roughness values at the disposal site stations ranged from 0.5 to 4.0 cm, with 46 of the 55 stations (84%) having values of 2.0 cm or less (Table 3-1). The average boundary roughness values at the reference stations likewise were less than 2.0 cm (Table 3-2). In general, these are low values indicating very little small-scale relief across the 14 cm field of view in most of the images, reflecting the largely unconsolidated nature of the surface sediments.

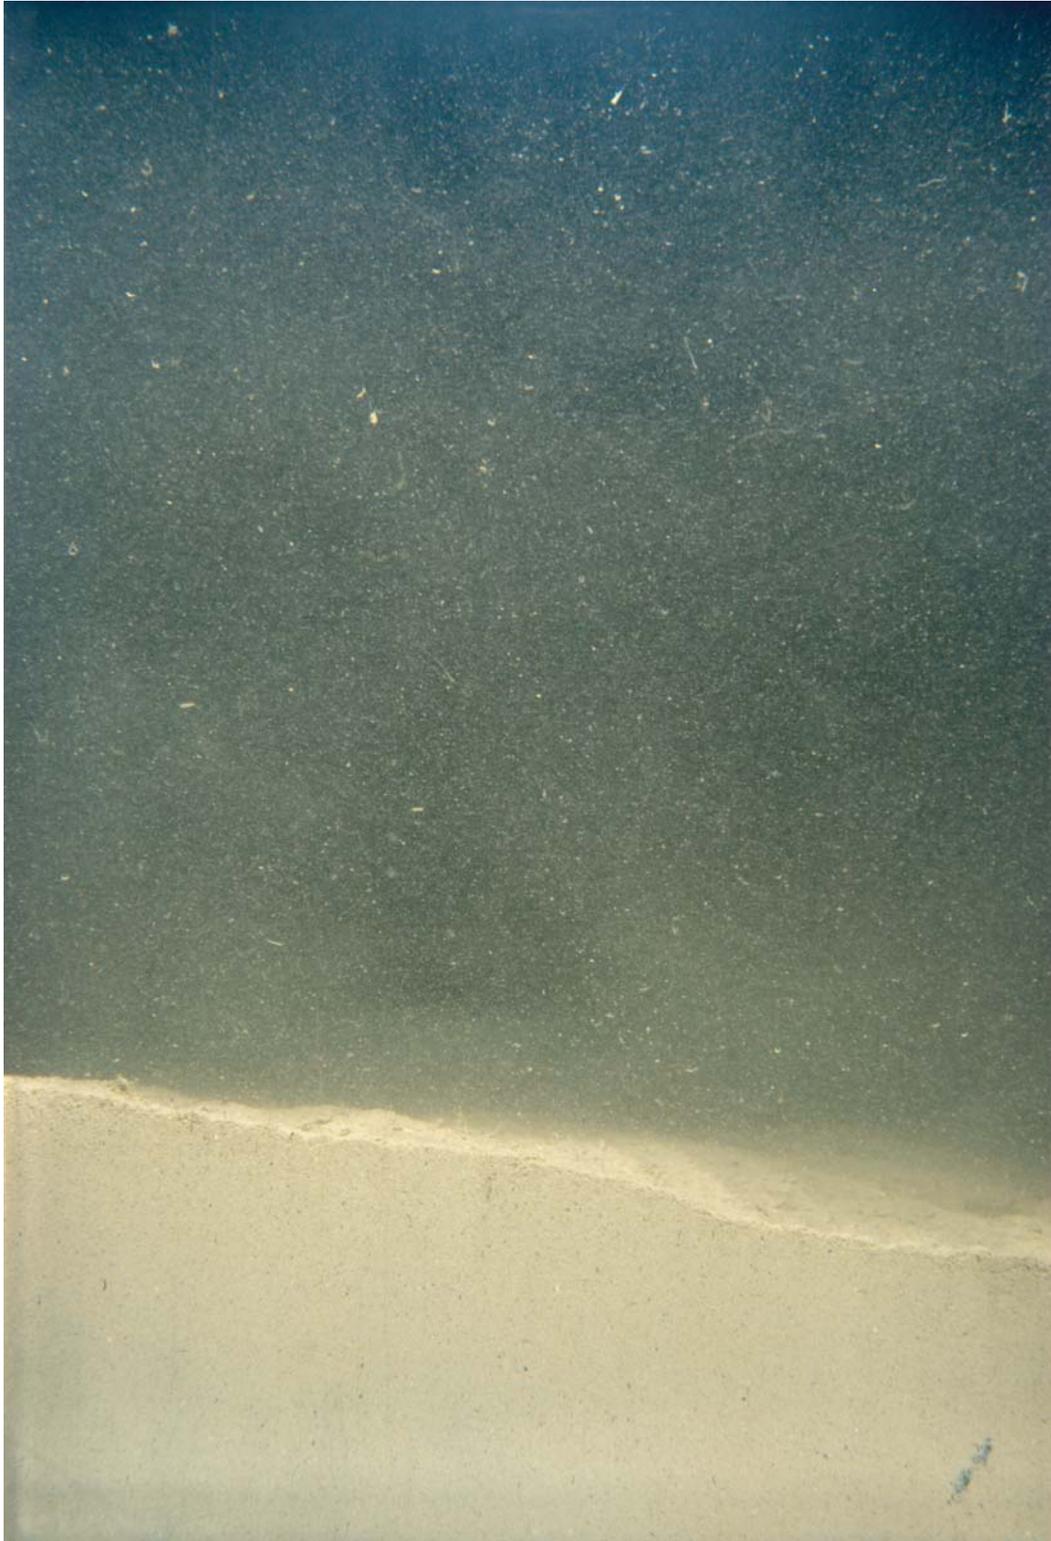
Figure 3-11: SPI image from station A7 showing uniformly light-colored, very silty fine sand. The aRPD depth for this image is considered to be greater than the penetration depth and is expressed as >5.1 cm (i.e., the average vertical distance from the sediment surface to the bottom of the image). Scale: actual image width is 14.4 cm.

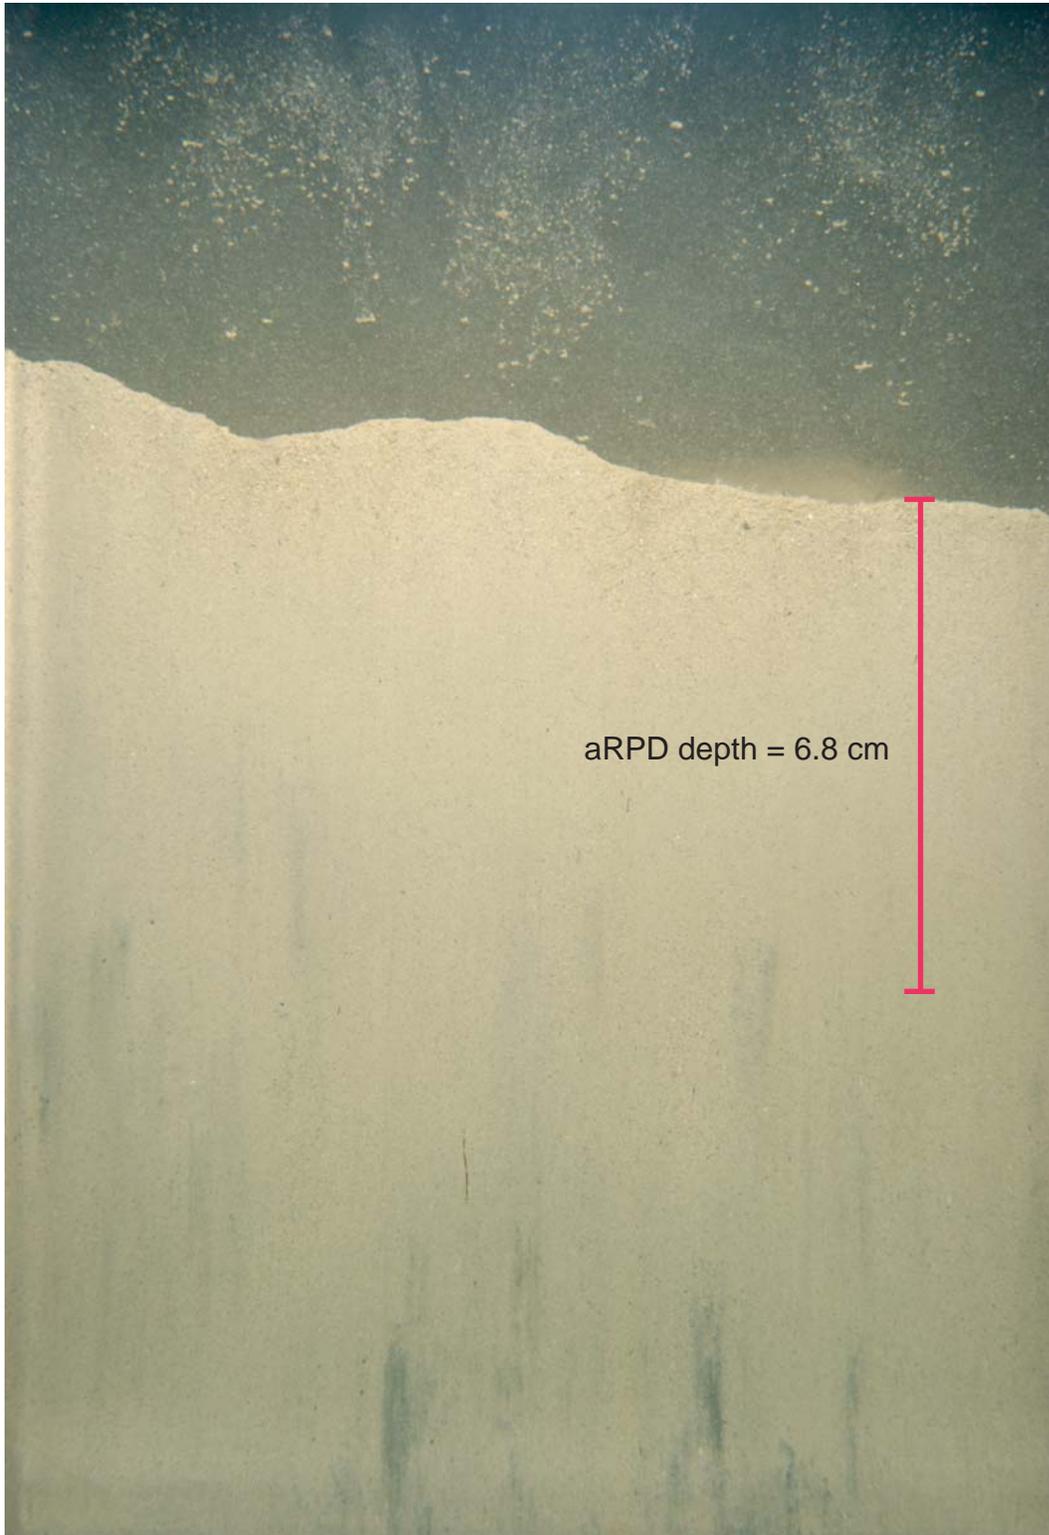
Figure 3-12: SPI image from station F4 showing mostly light-colored silt-clay sediment with intermittent patches of darker sediment at depth. The surface layer of light-colored sediment is fairly thick; the measured aRPD depth for this image is 6.8 cm. Scale: actual image width is 14.4 cm.

Surface sediments at many stations across the surveyed area had uniformly high optical reflectance, with a notable absence of any strong vertical color contrasts that typically denote the transition from a positive to negative redox state with depth in the sediment column (Figure 3-11). At some stations, particularly those with more fine-grained sediment (i.e., higher apparent silt-clay content), there were some patches of darker sediment at depth that probably indicated the transition to more reducing conditions. However, these patches of darker, more reduced sediment typically occurred beneath a relatively thick layer of light-colored (i.e., oxidized) sediment (Figure 3-12).

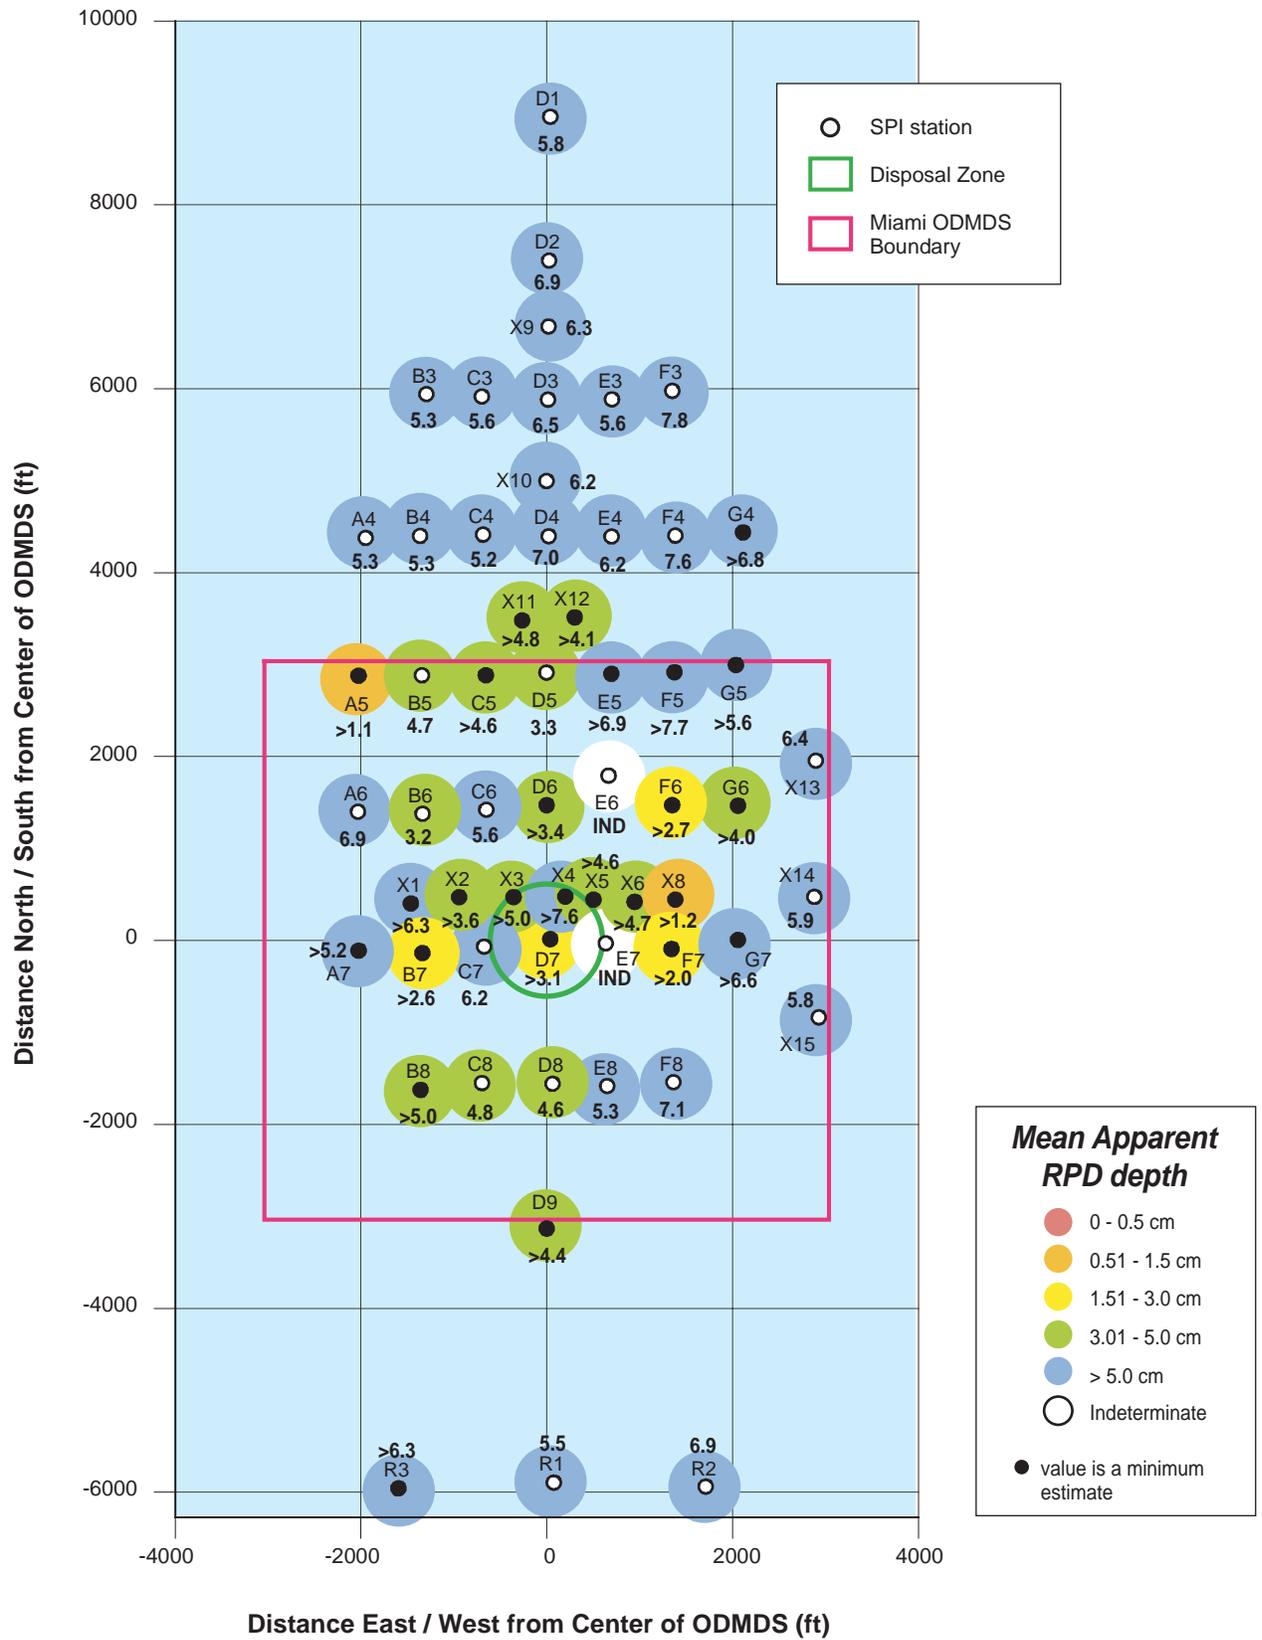
Figure 3-13: Average aRPD depths (cm) at the Miami ODMDS SPI stations.

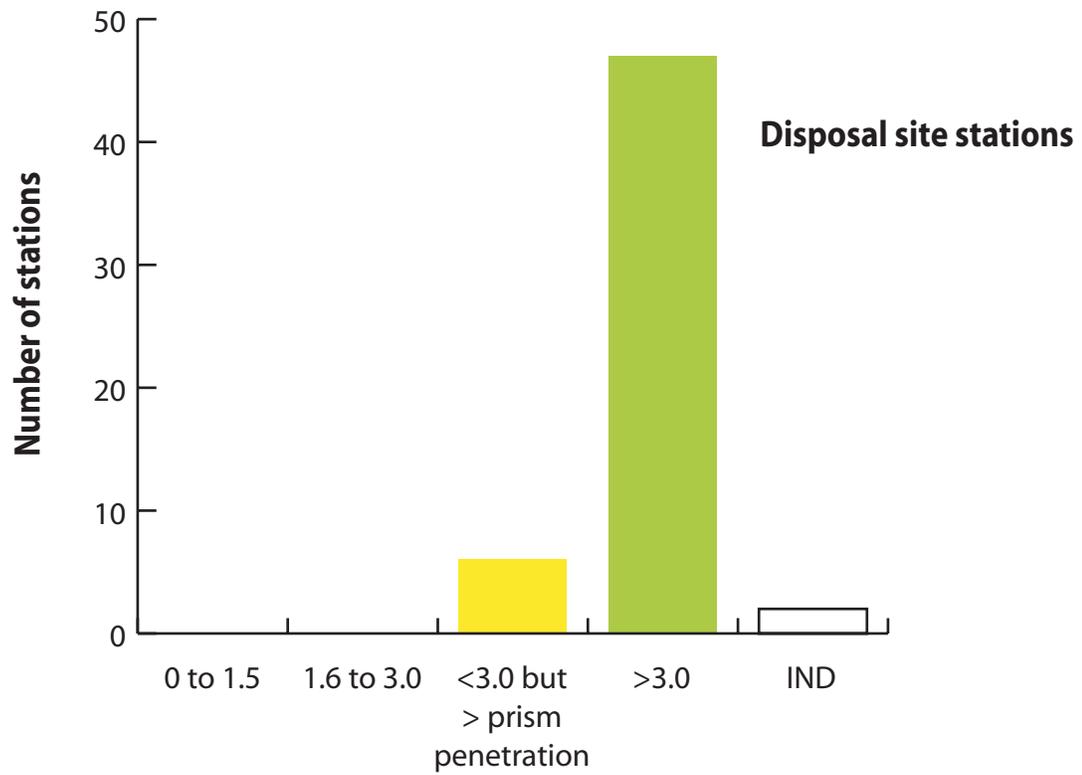
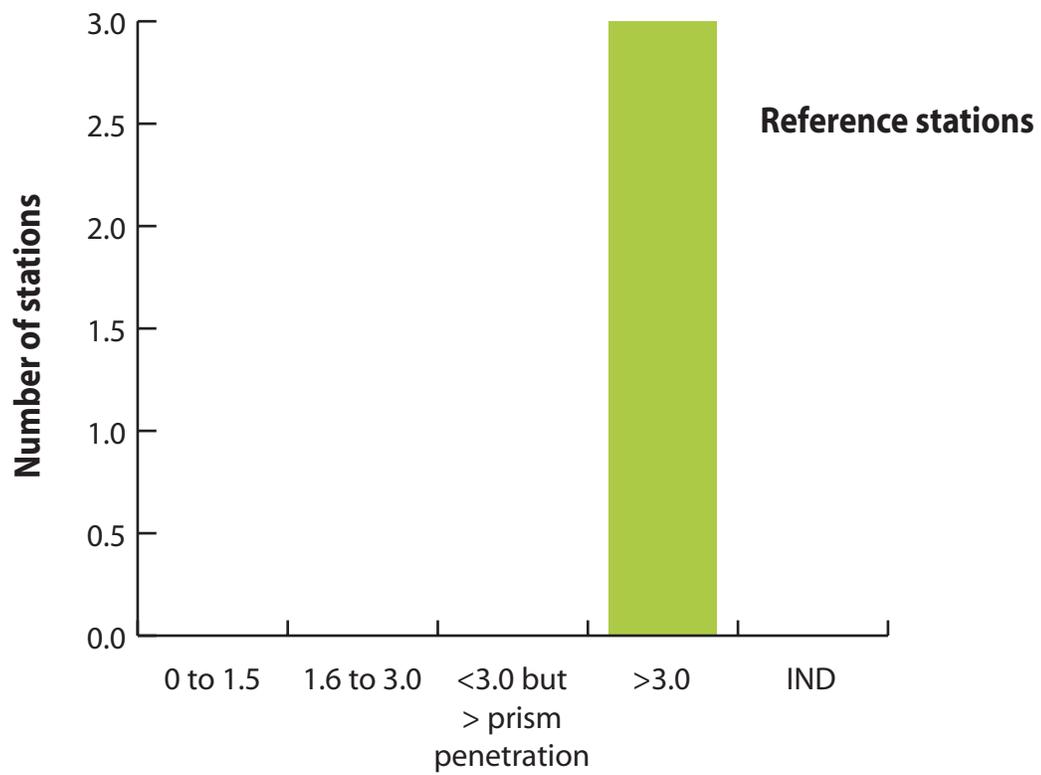
Figure 3-14: Frequency distribution of average RPD depths at the disposal site stations (top) and reference stations (bottom).

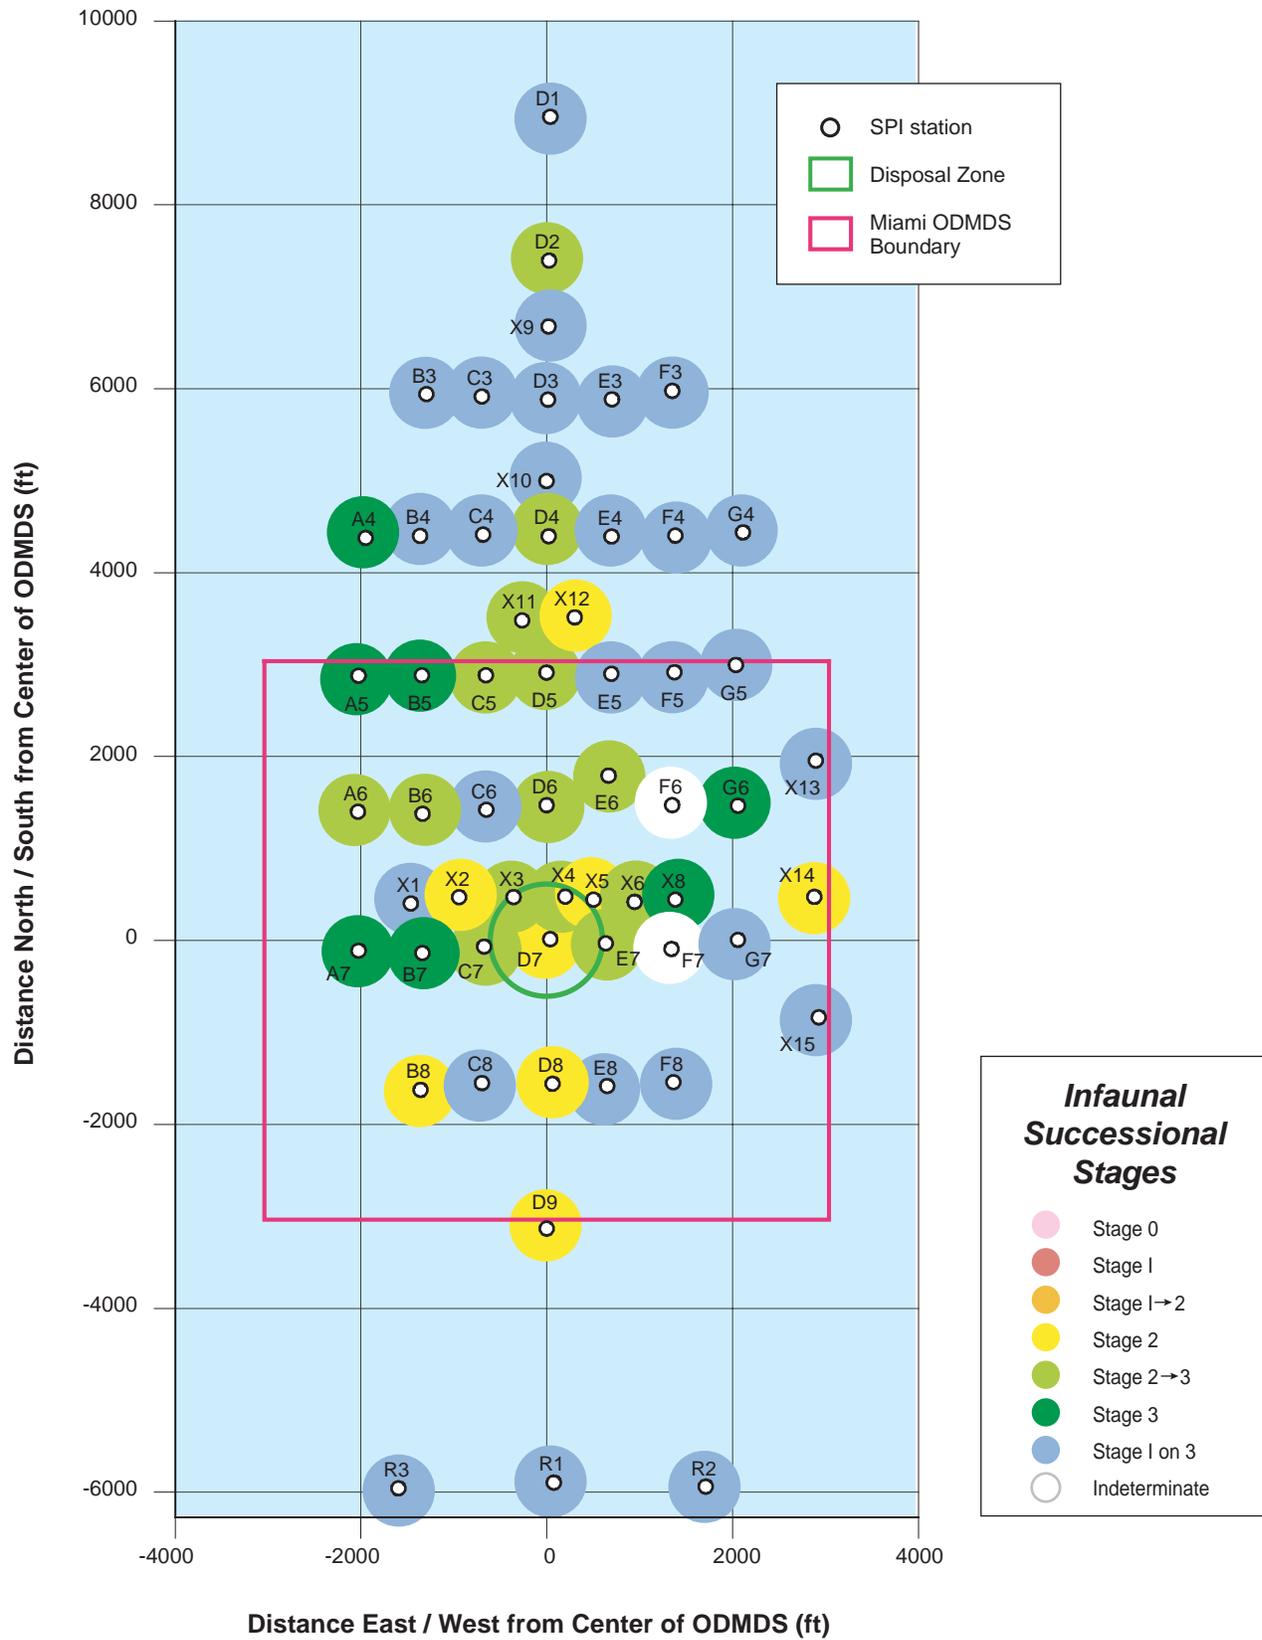
Figure 3-15: Map showing the highest infaunal successional stage observed among the replicate SPI images analyzed at each station in the May 2006 survey.

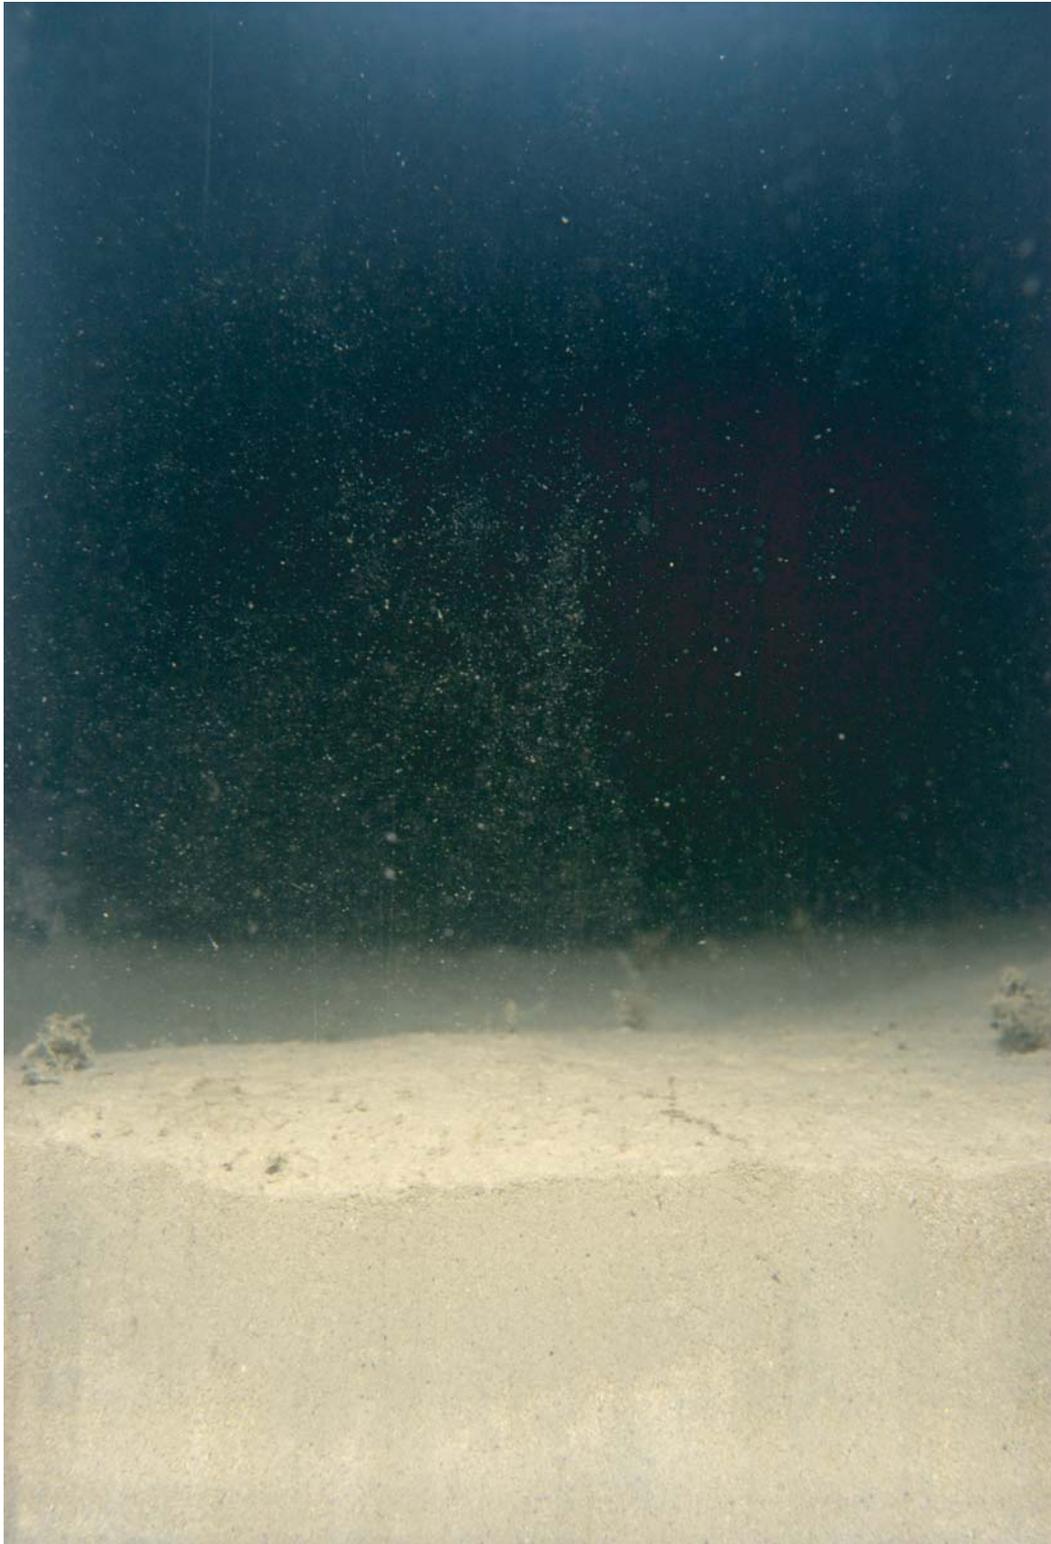
Figure 3-16: SPI image from station D9 illustrating Stage 2, where the visible evidence of biological activity consisted of several different types/sizes of tubes occurring at the sediment surface. Scale: actual image width is 14.4 cm.

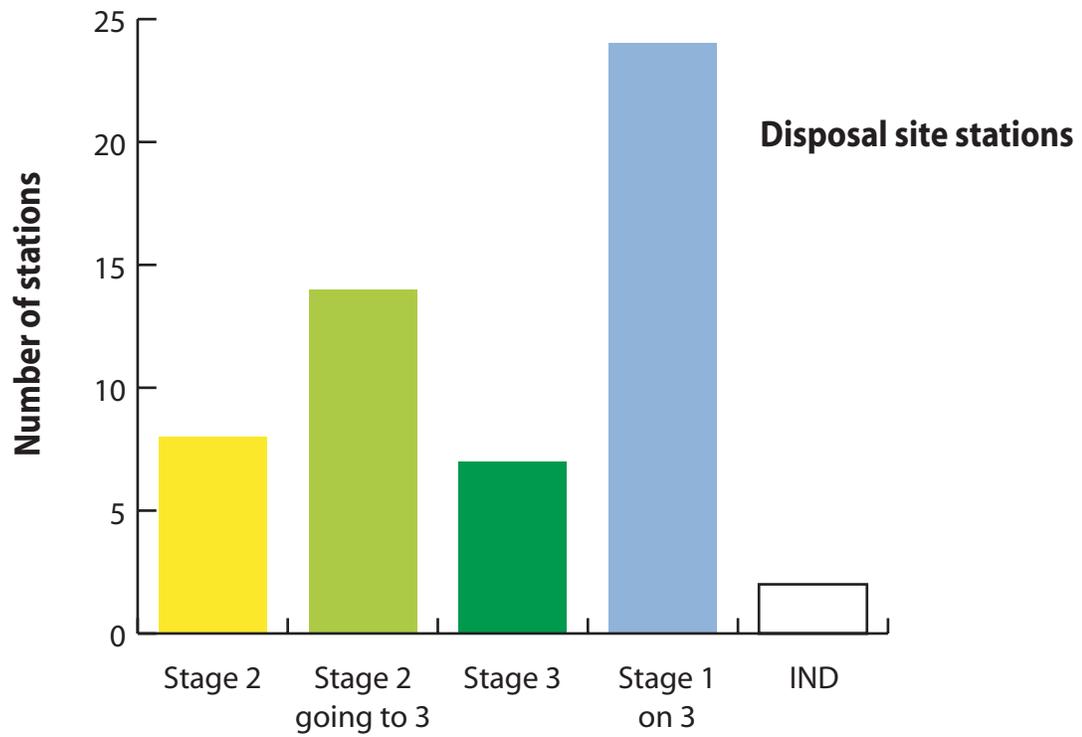
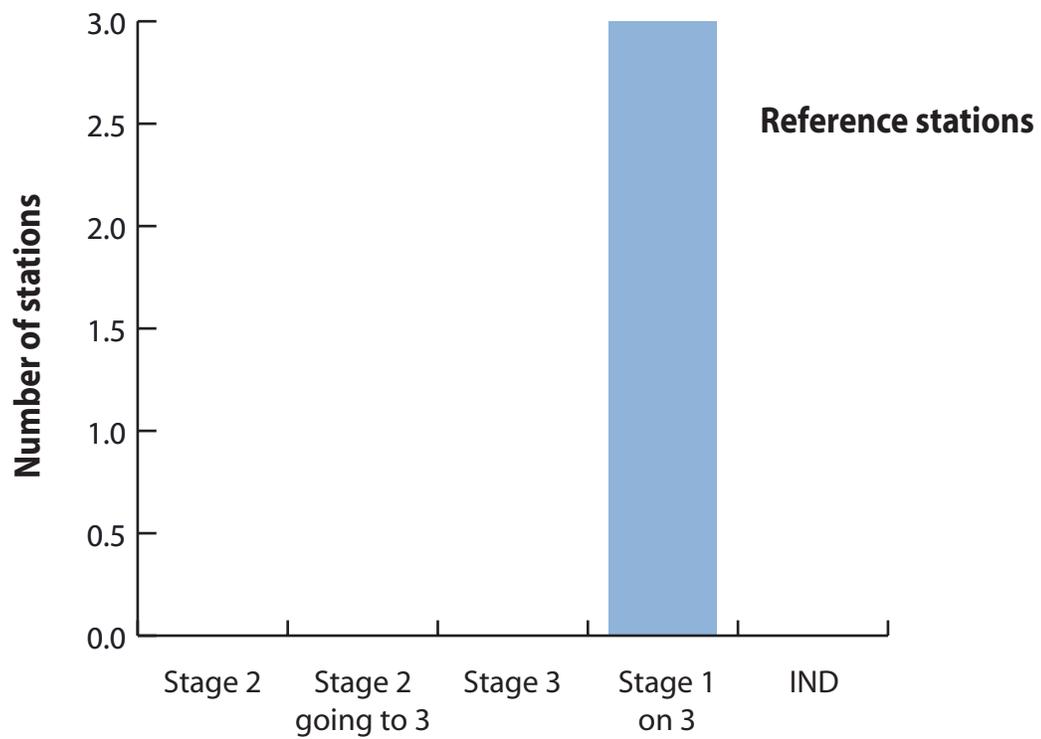
Figure 3-17: Frequency distribution of the highest infaunal successional stage observed at each of the disposal site stations (top) and reference stations (bottom).

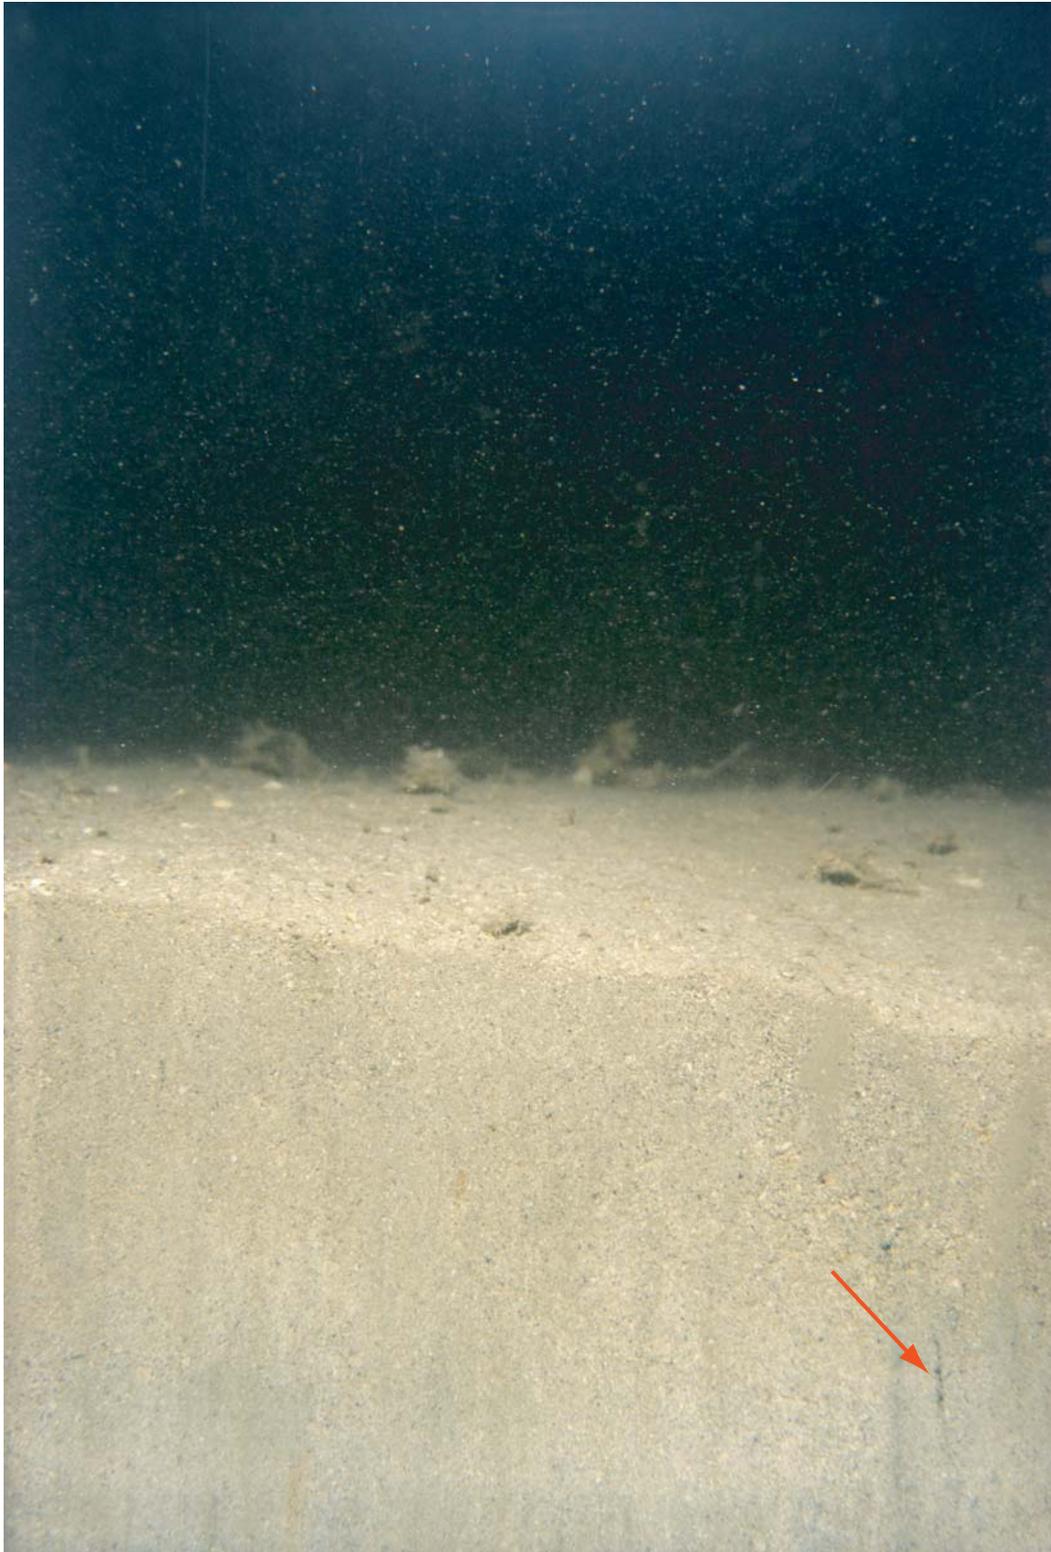
Figure 3-18: SPI image from station C7 illustrating Stage 2 advancing to Stage 3, based on the presence of moderate numbers of different types of tubes at the sediment surface and a small polychaete visible at depth on the lower right (arrow). Scale: actual image width is 14.4 cm.

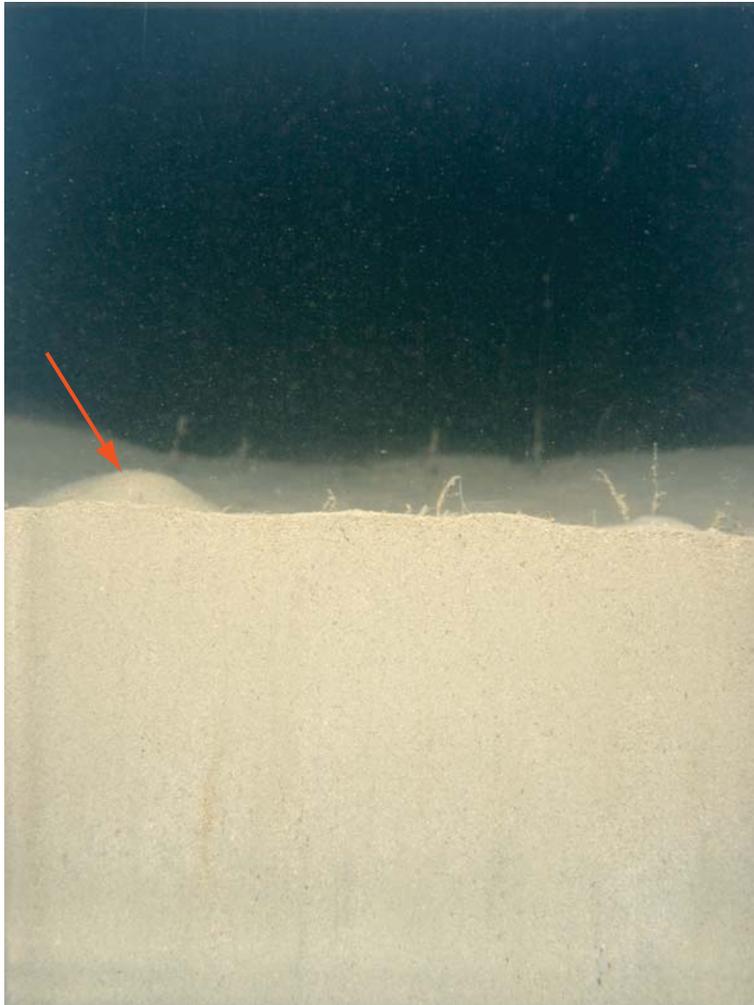
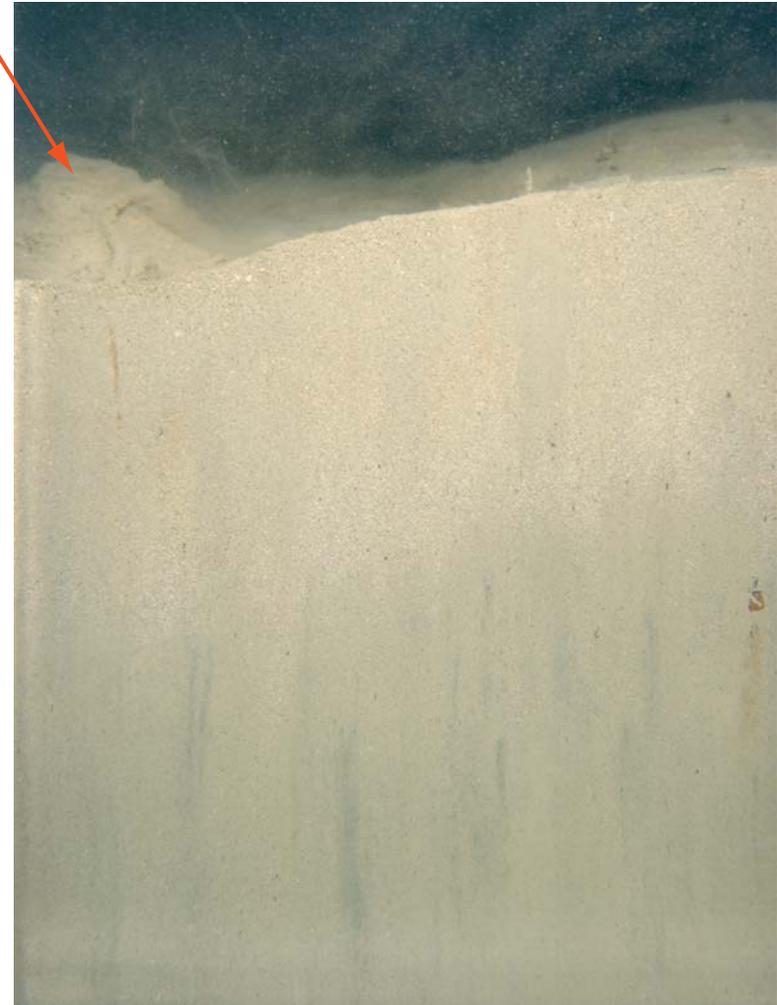
Figure 3-19: SPI images from station F8 (left) and E4 (right) illustrating Stage 1 on 3, based on the observation of low to moderate numbers of small surface tubes, as well as biogenic mounds (arrows) denoting significant bioturbation activity (excavation of subsurface sediment) by deeper-dwelling Stage 3 organisms. Scale: actual image width is 14.4 cm.

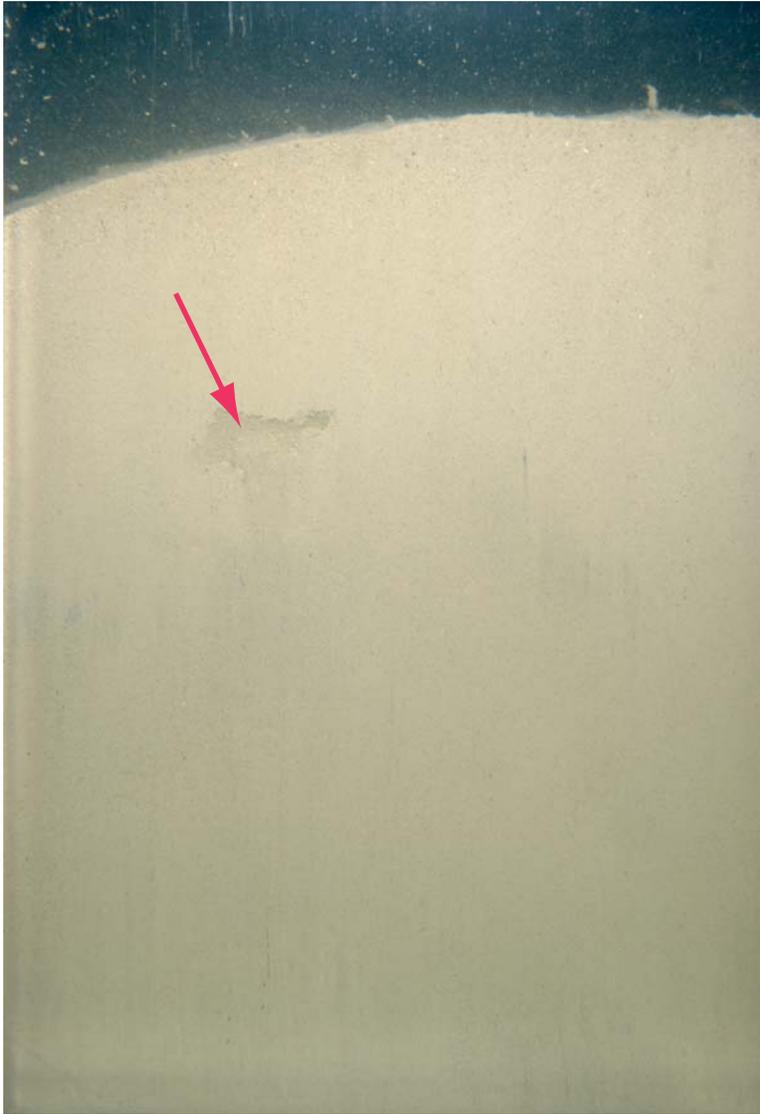
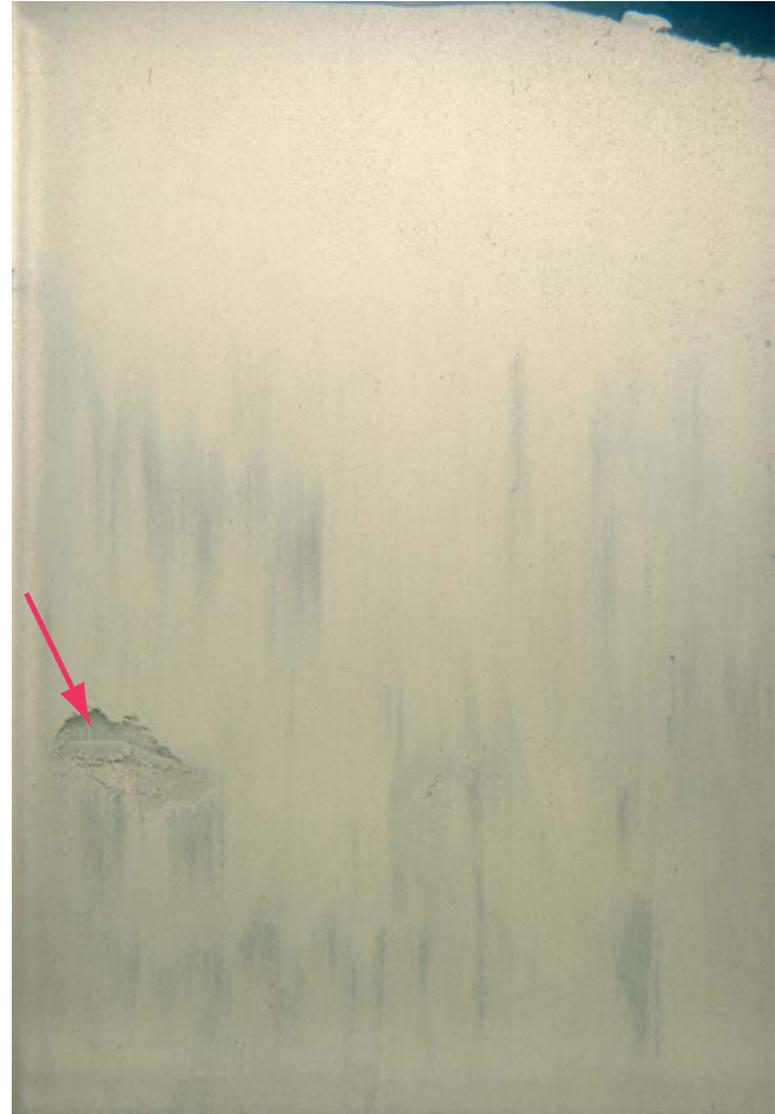
Figure 3-20: SPI images from station F4 (left) and R2 (right) showing Stage 1 surface tubes and active feeding voids at depth (arrows), providing evidence that Stage 3 subsurface deposit-feeders are present in these relatively soft, fine-grained sediments (Stage 1 on 3). Only part of the sediment surface is visible in the right image; the remainder occurs above the viewing window due to over-penetration of the camera prism in soft sediment. Scale: actual image width is 14.4 cm.
