Rapid Seafloor Reconnaissance and Assessment of Southeast Florida Ocean Dredged Material Disposal Sites Utilizing Sediment Profile Imaging

May 2006 Post-Disposal SPI Mapping at the Miami ODMDS

**Prepared by:
Germano & Associates, Inc.**

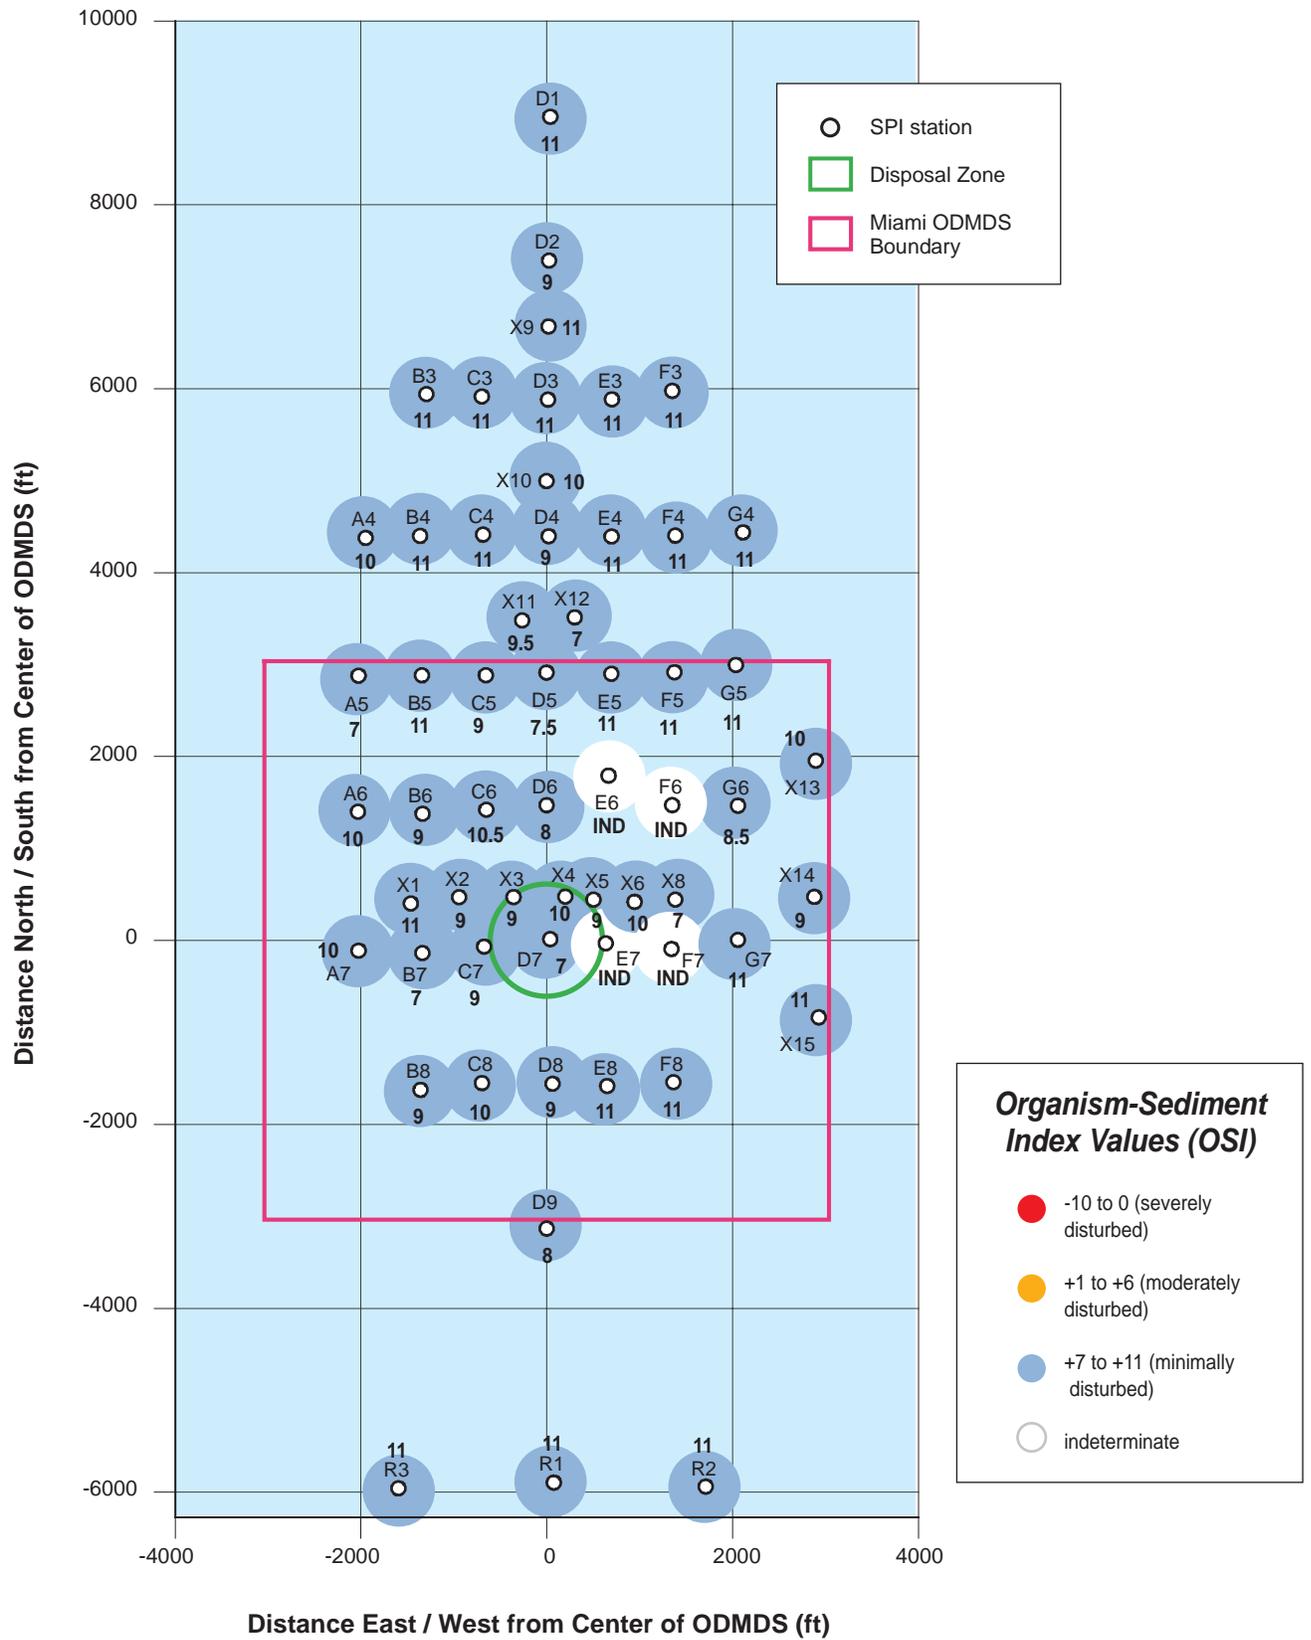
Figure 3-21: Median OSI values at the Miami ODMDS SPI stations.

As described in Section 2.3.9 and illustrated in Figure 2-4, the OSI is a summary metric that provides a way to order, or rank, the stations in terms of the relative degree of benthic habitat disturbance or degradation. For the May 2006 SPI survey at the Miami ODMDS, the median OSI values at all of the disposal site and reference stations were in the range of +7 to +11 (Figures 3-21 and 3-22). Values in this range are considered indicative of little or no appreciable benthic habitat disturbance.

It is notable that the relatively high OSI values were found at stations both within and outside the dredged material footprint. These values reflect a combination of relatively deep RPD depths across all of the surveyed stations in combination with a relatively advanced successional status.

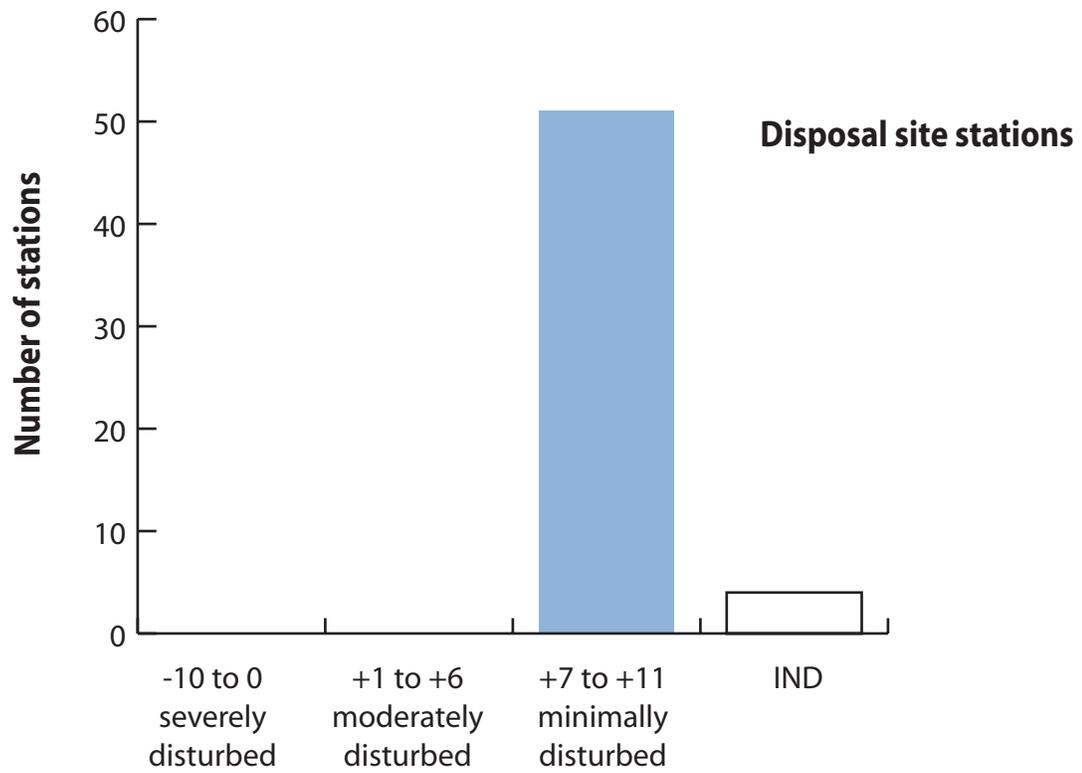
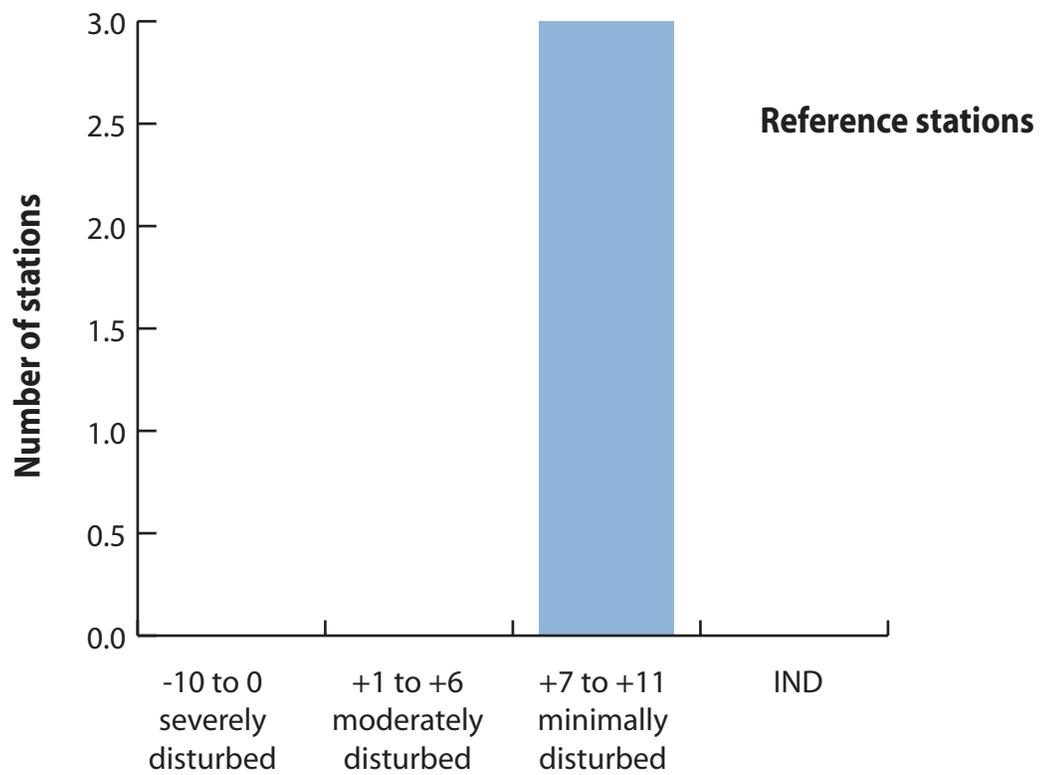
Figure 3-22: Frequency distribution of median OSI values at the disposal site stations (top) and reference stations (bottom).

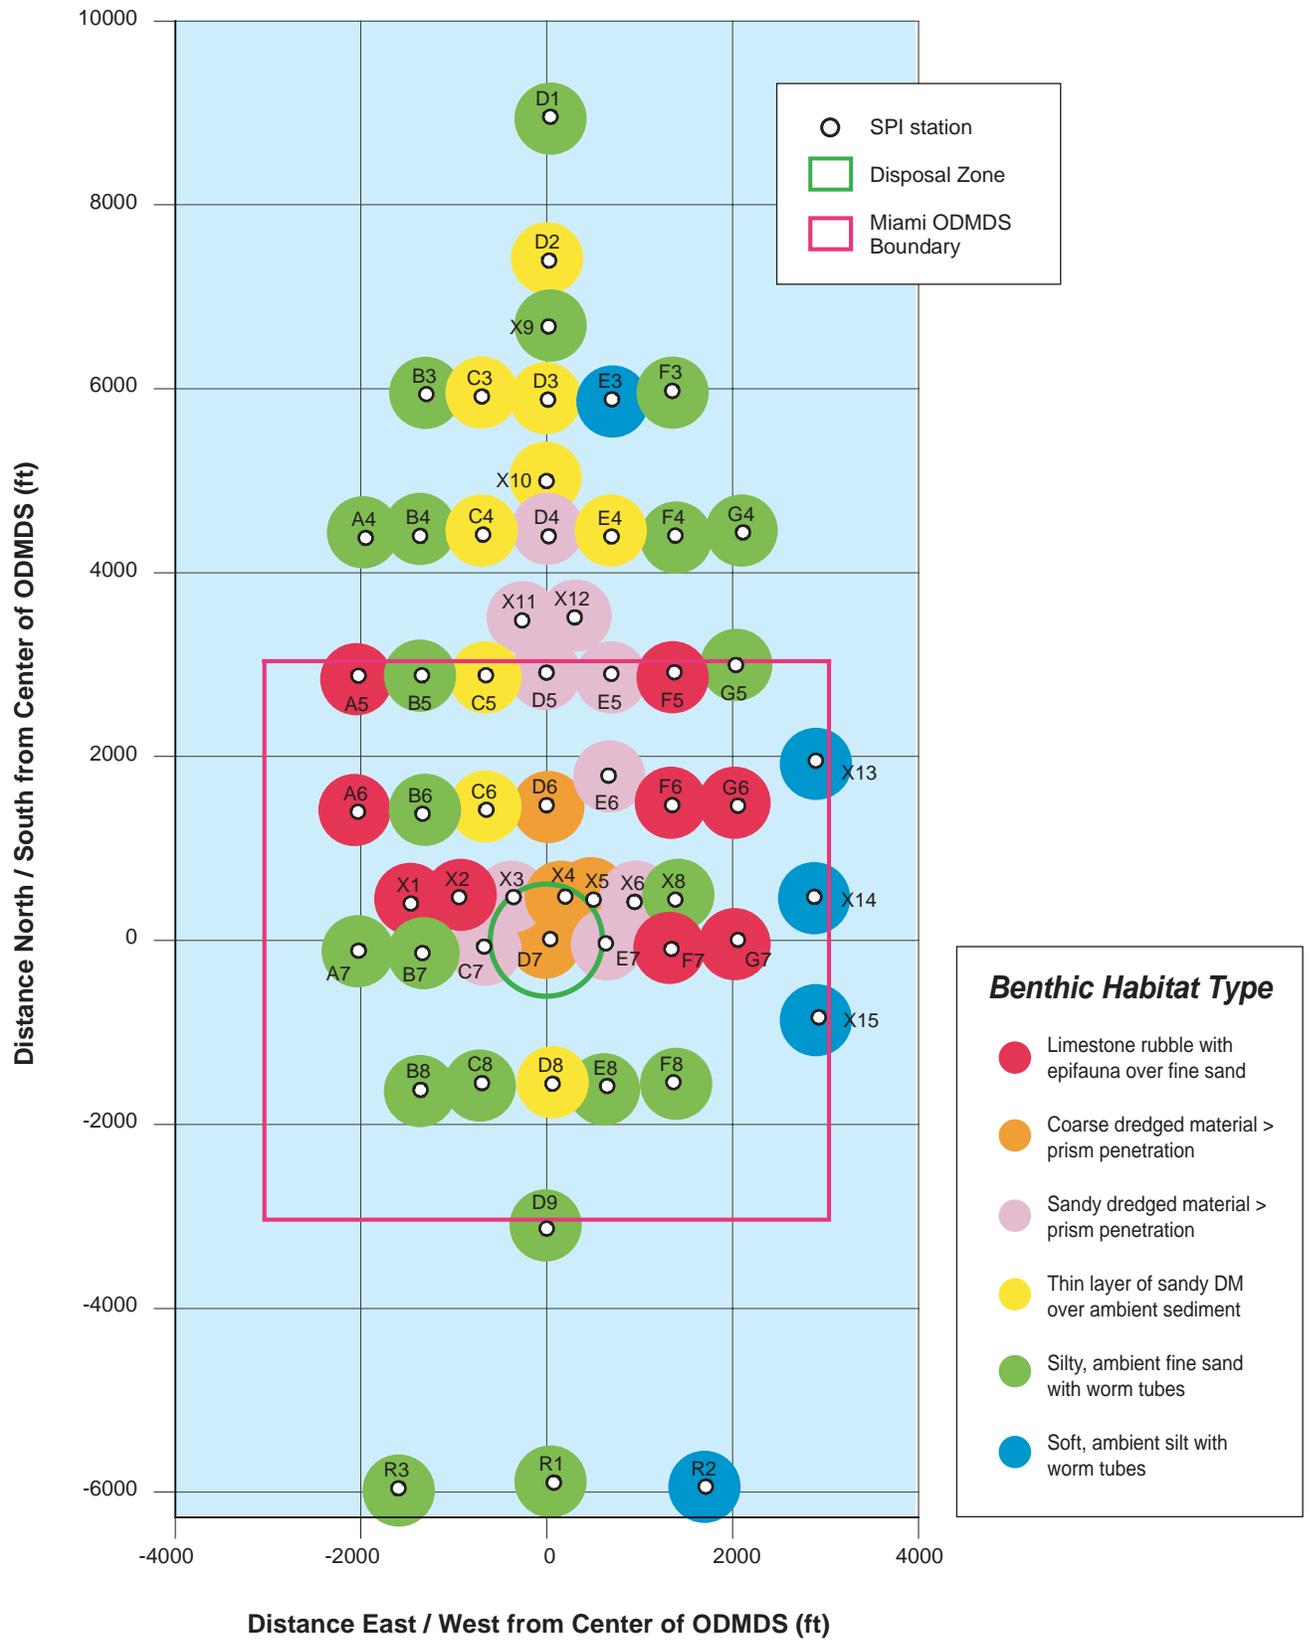
Figure 3-23: Map of benthic habitat types at the Miami ODMDS SPI stations.

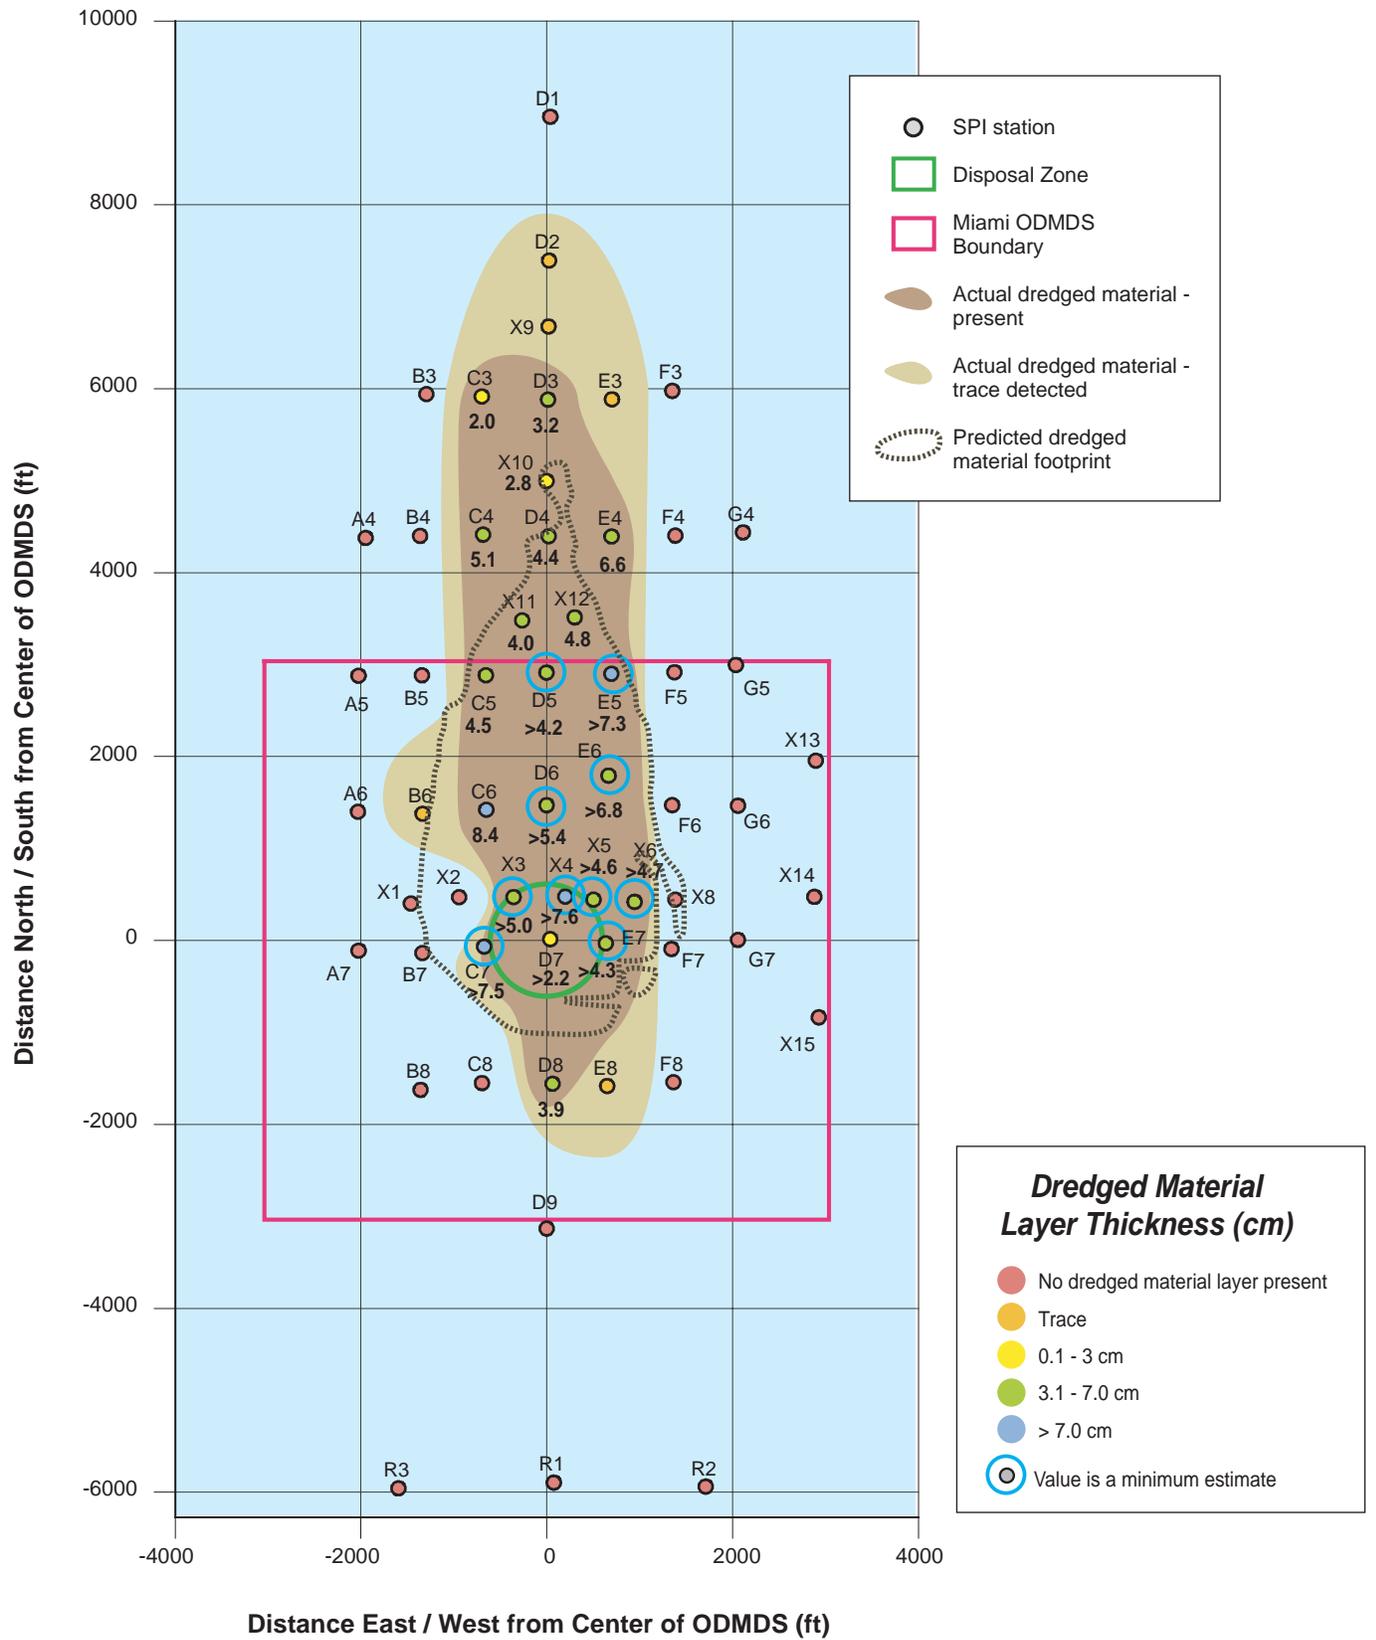
Figure 4-1: Actual distribution of dredged material based on analysis of sediment profile images as compared with modeled results for the Miami Harbor ODMDS.

3. Given the strong northward drift of the dredged material following its release at the Miami ODMDS, it is recommended that the disposal zone be located to the south of its present location. This should help to ensure that more of the resulting seafloor is located within the ODMDS boundaries. However, even moving the disposal point to the southern end of the currently designated site perimeter will not result in dredged material remaining within the site boundary given the conditions at this particular location.
