## Long-Term Stewardship Assessment Report

### BAE Systems Norfolk Ship Repair

EPA ID #: VAD003175072

Report Date: March 13, 2017

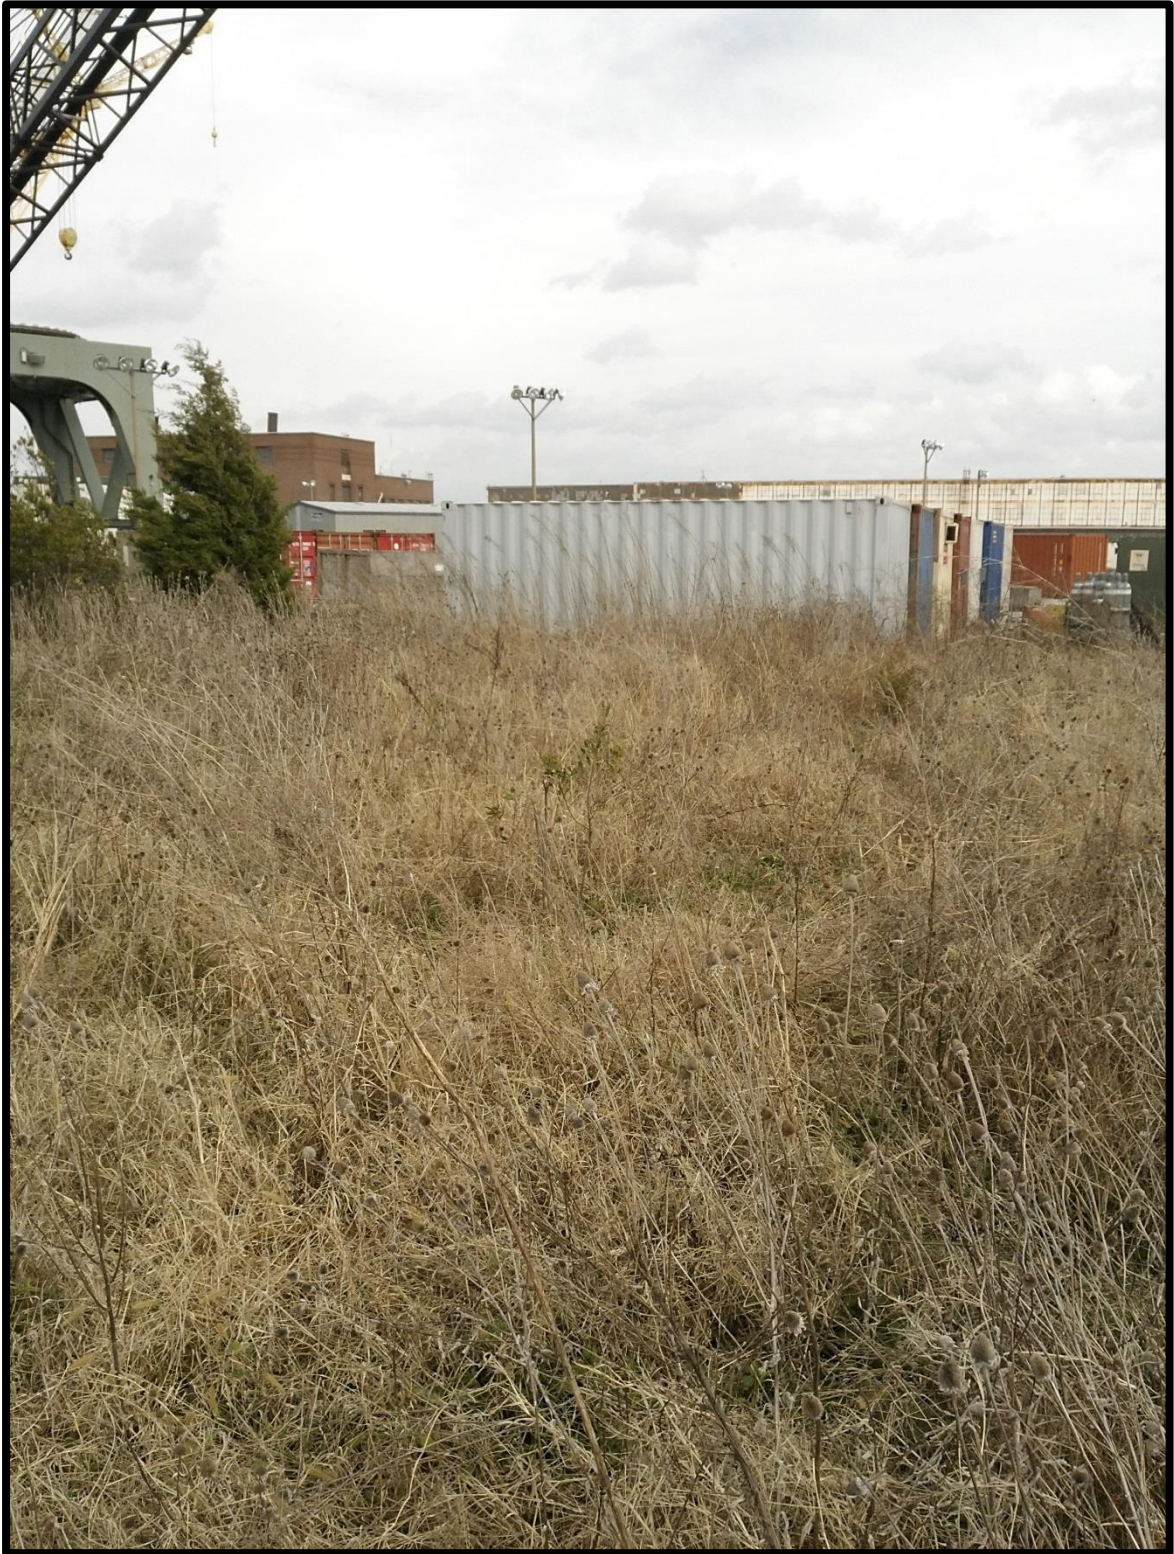
Picture 1: RA-114

Notes: Need to map SMP areas: SWMU-105 → grassy area near office  
bldg. with sidewalk/pavement; RA-114 → unused part  
of the facility, buffer zone between facility and Elizabeth River

**Conclusions and Recommendations:** No EC/IC deficiencies were identified. EPA has determined that the remedy EC/ICs have been and are being implemented. EPA recommends that BAE NSR survey areas RA-114 and SWMU-105 to defined the extent of the Materials Management requirements.

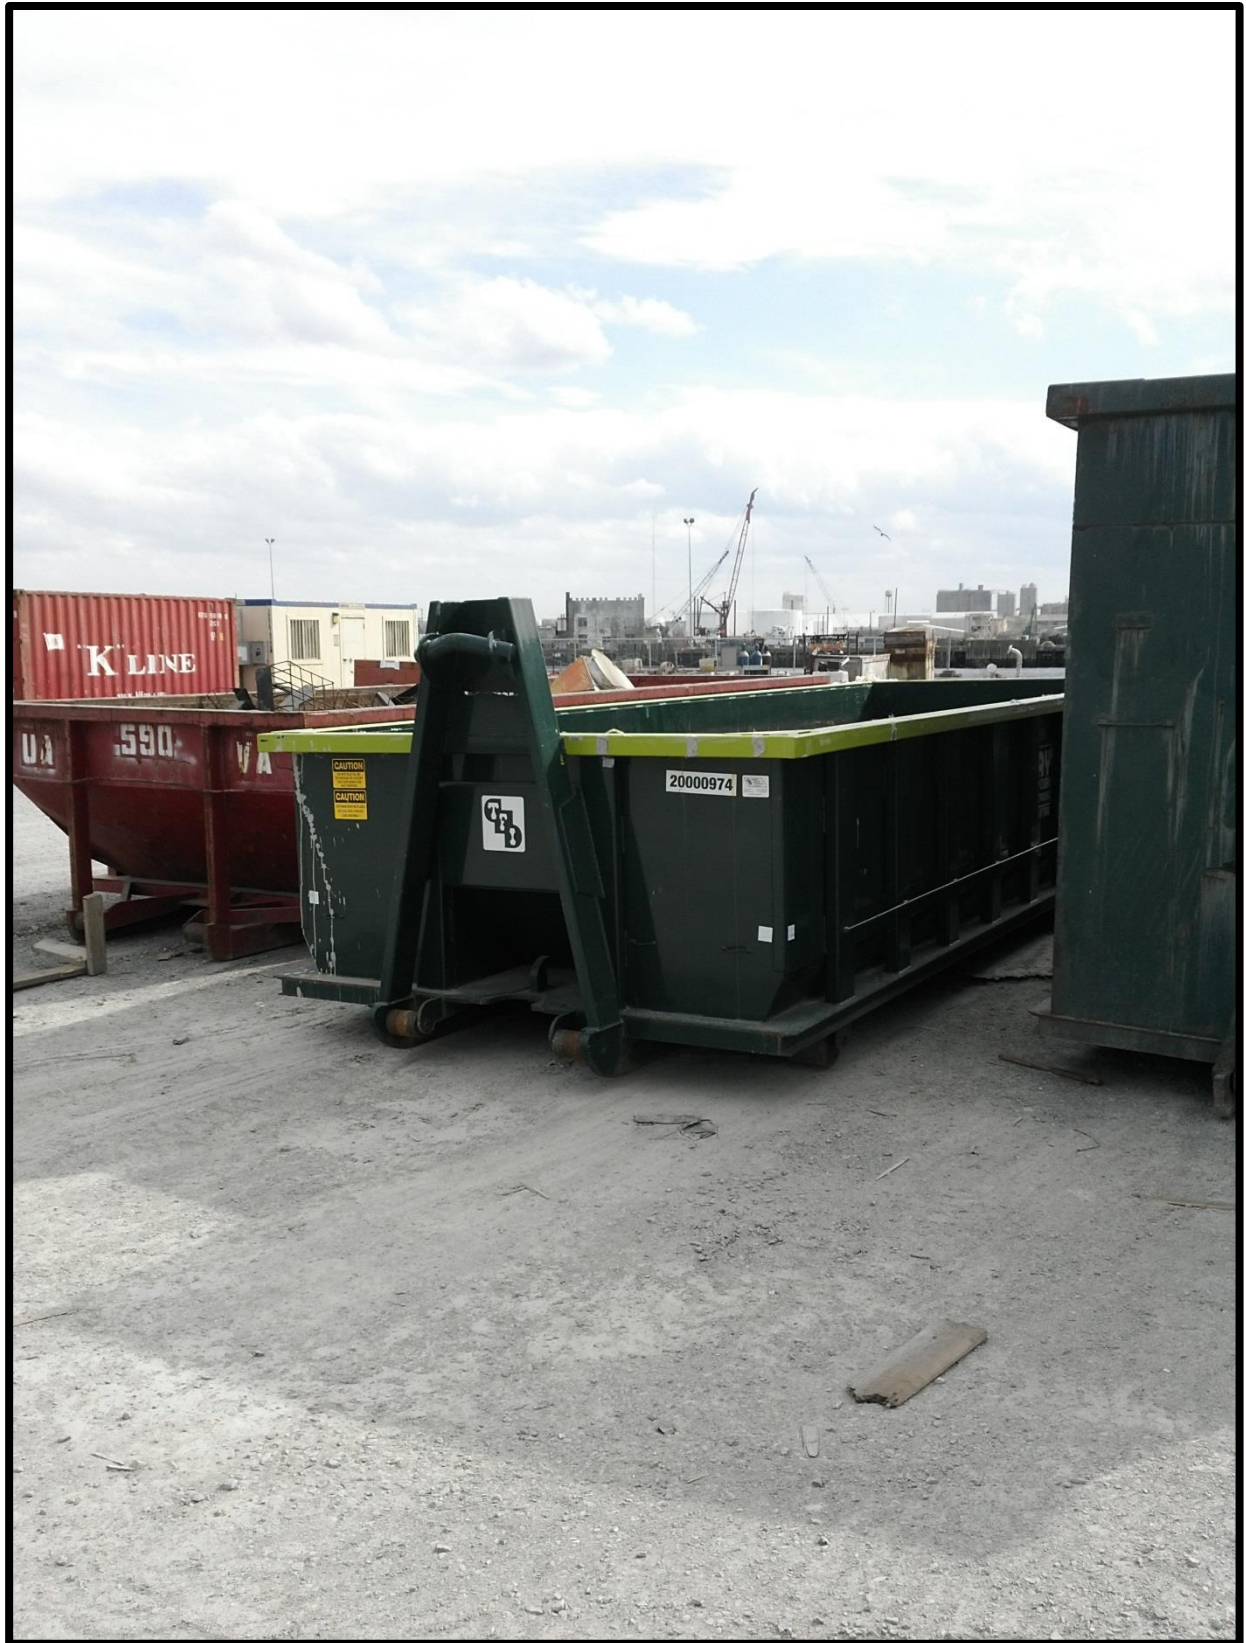
Picture 3: RA-111

**Current Site Status:** In 2009, interim measures were complete after the excavation of PAH impacted soils at RA-111. In 2011, EPA issued the Final Decision and Response to Comments (FDRTC). The final remedy determination is No Further Action with Controls. Controls include a Materials Management Plan and a residential land use restriction. No further action is required for groundwater. The final remedy detailed in the FDRTC is implemented through an Environmental Covenant between USEPA and BAE NSR dated September 28, 2012. The property is currently under continued use as described above.
