ATTACHMENT 25

RADIO MATERIALS CORPORATION

FIGURE — SIMULATED HYDRAULIC CONTAINMENT FOR GROUNDWATER INTERIM CORRECTIVE  
MEASURES

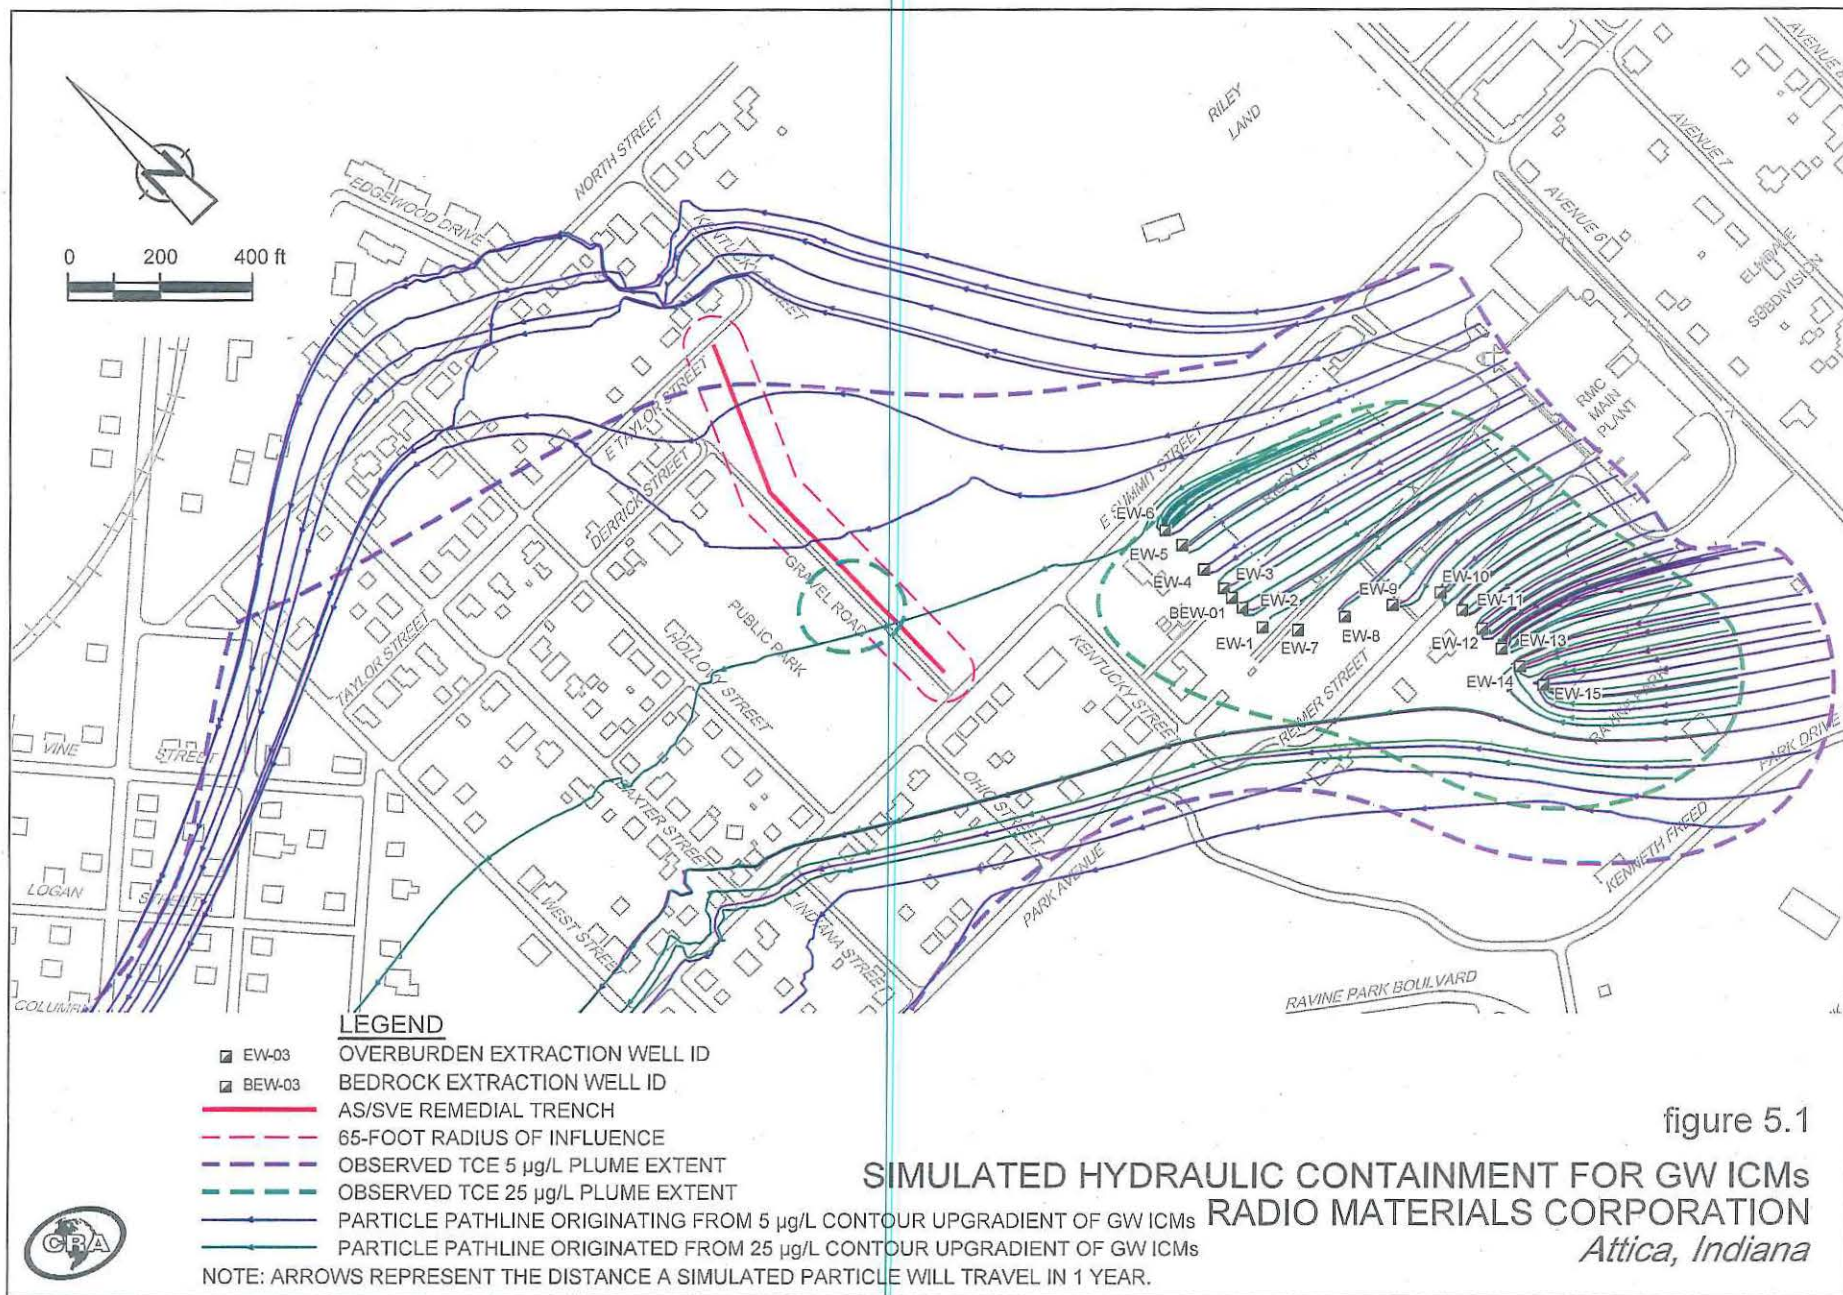
ATTACHMENT 26  
RADIO MATERIALS CORPORATION  
FIGURES – PCE AND TCE CONCENTRATIONS IN OVERBURDEN GROUNDWATER FROM FEBRUARY 2014  
AND NOVEMBER 2014

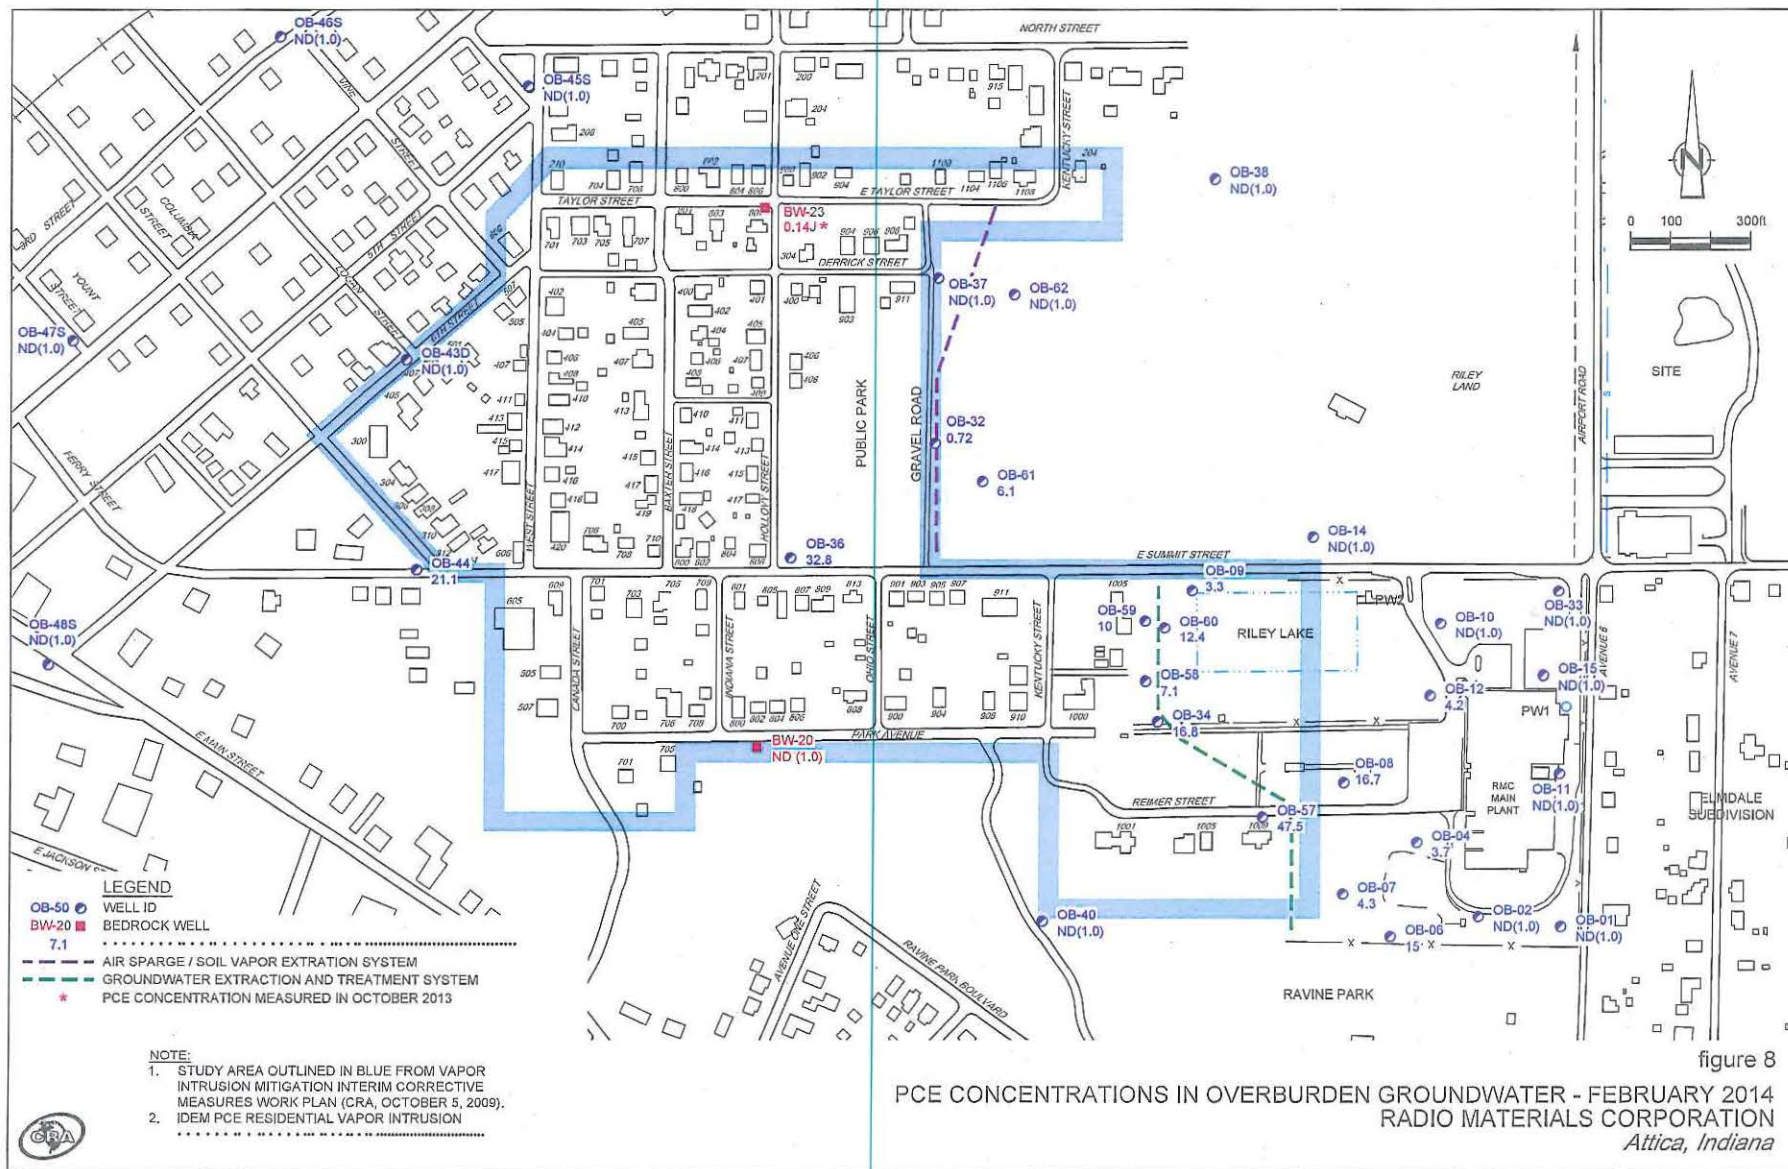
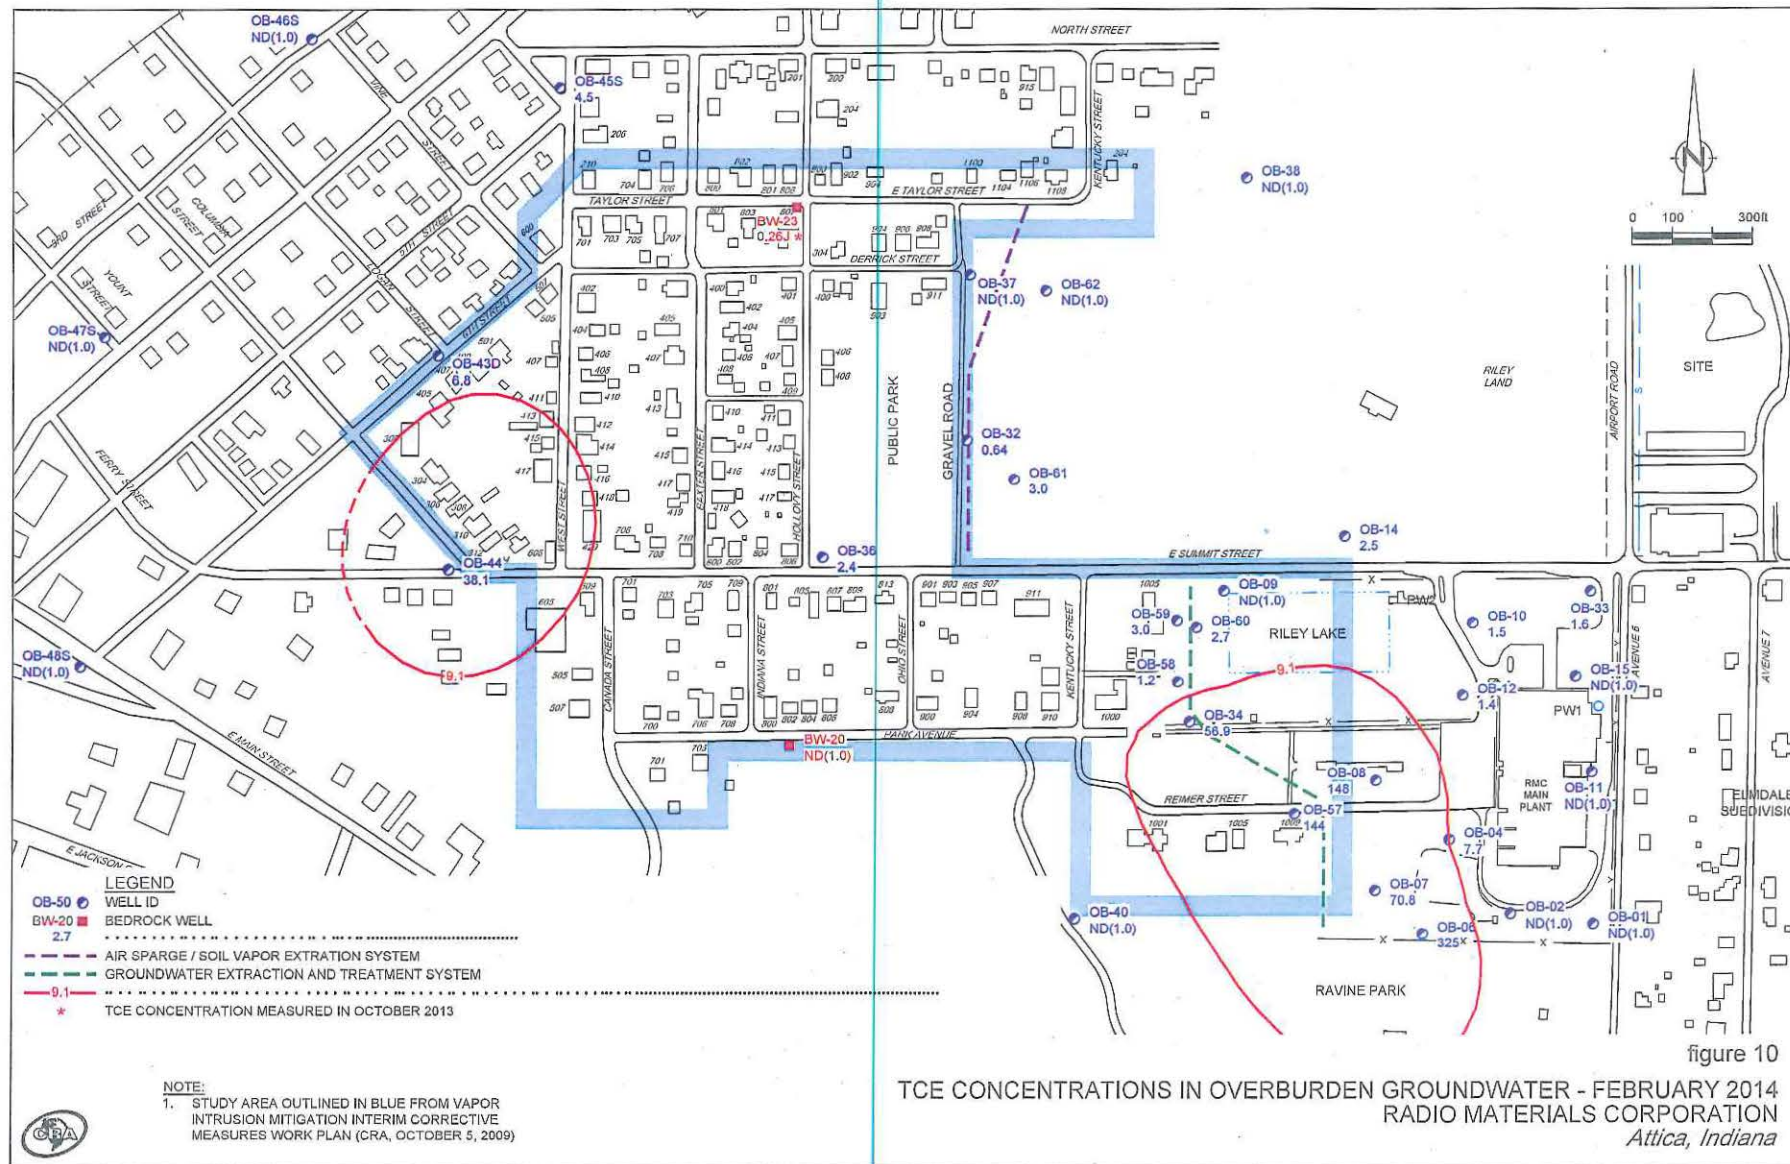
ATTACHMENT 27

FIGURES – SUMMARY OF VOC DETECTIONS ABOVE THE RDCLs IN THE OVERBURDEN AQUIFER  
(SEPTEMBER 2008 – JULY 2009) AND SUMMARY OF 2014 SEMIANNUAL GROUNDWATER ANALYTICAL  
RESULTS FOR SELECTED CVOCS

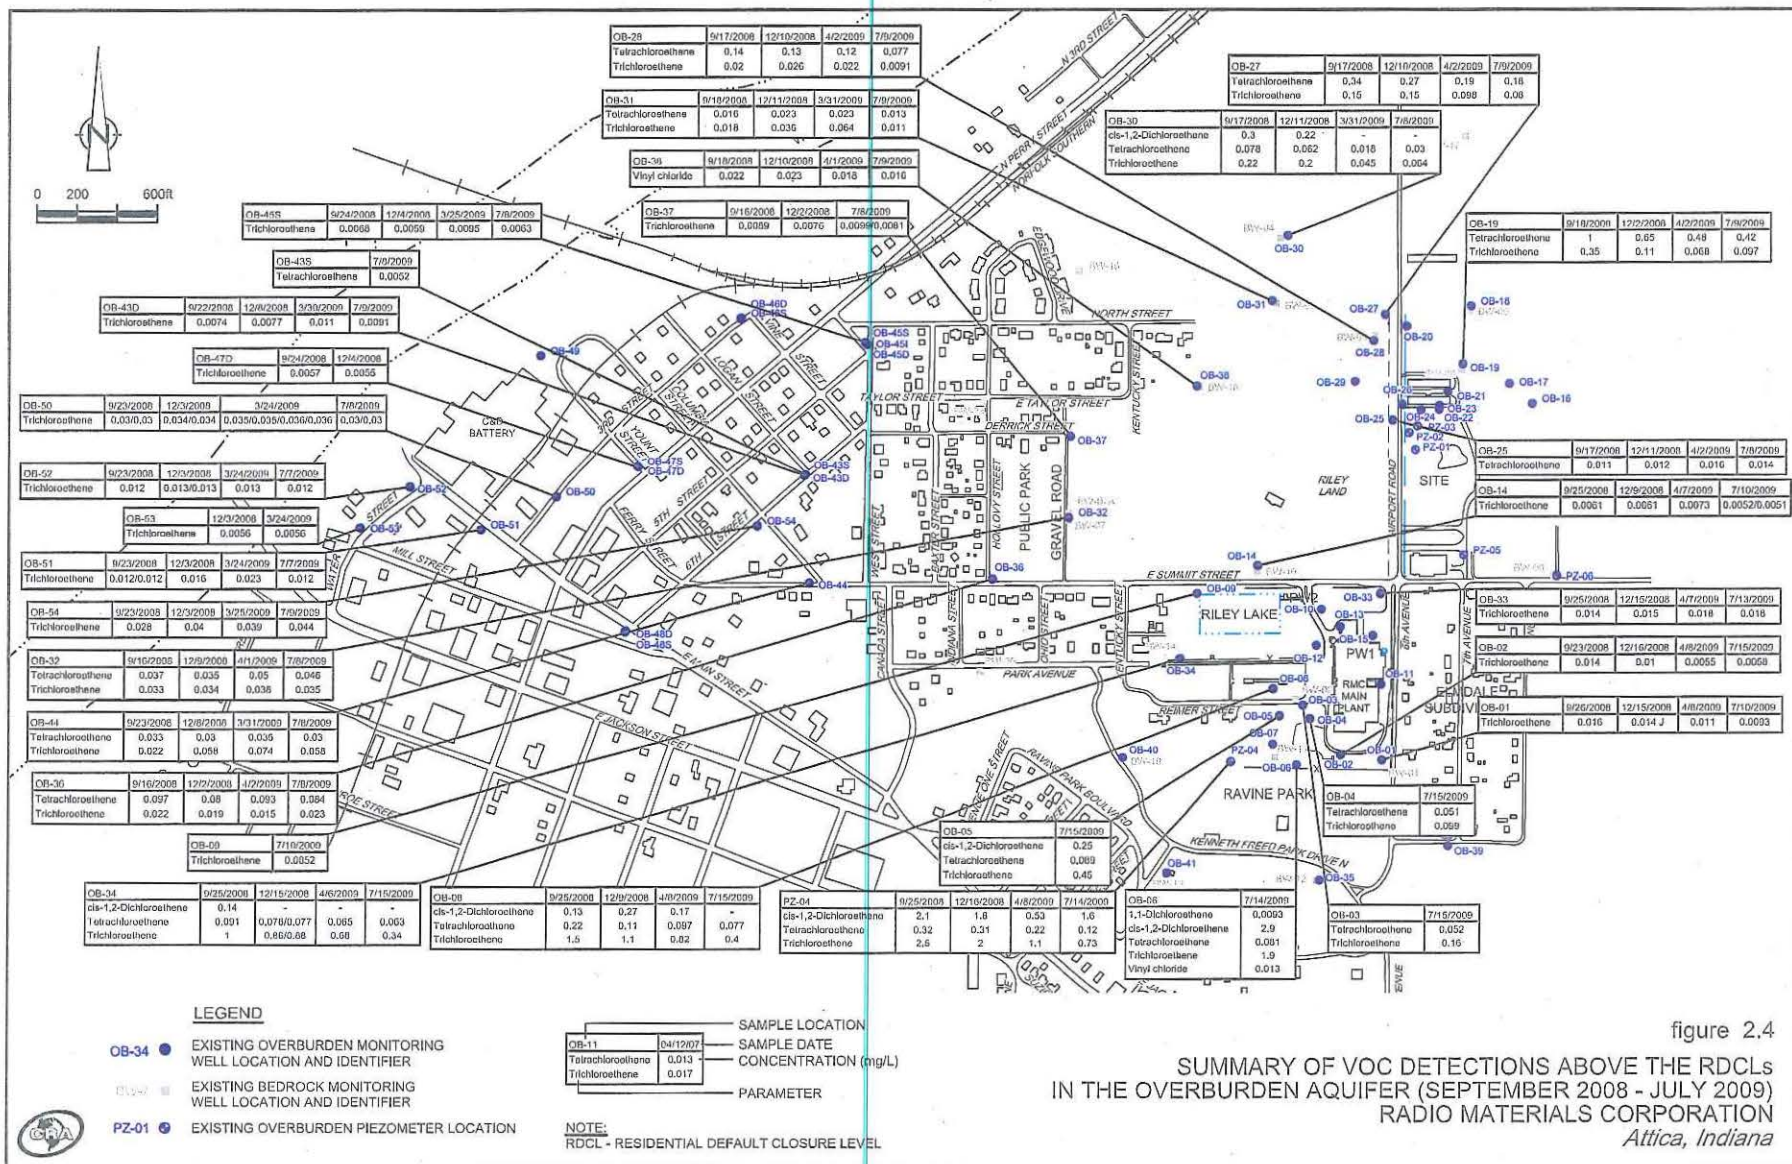
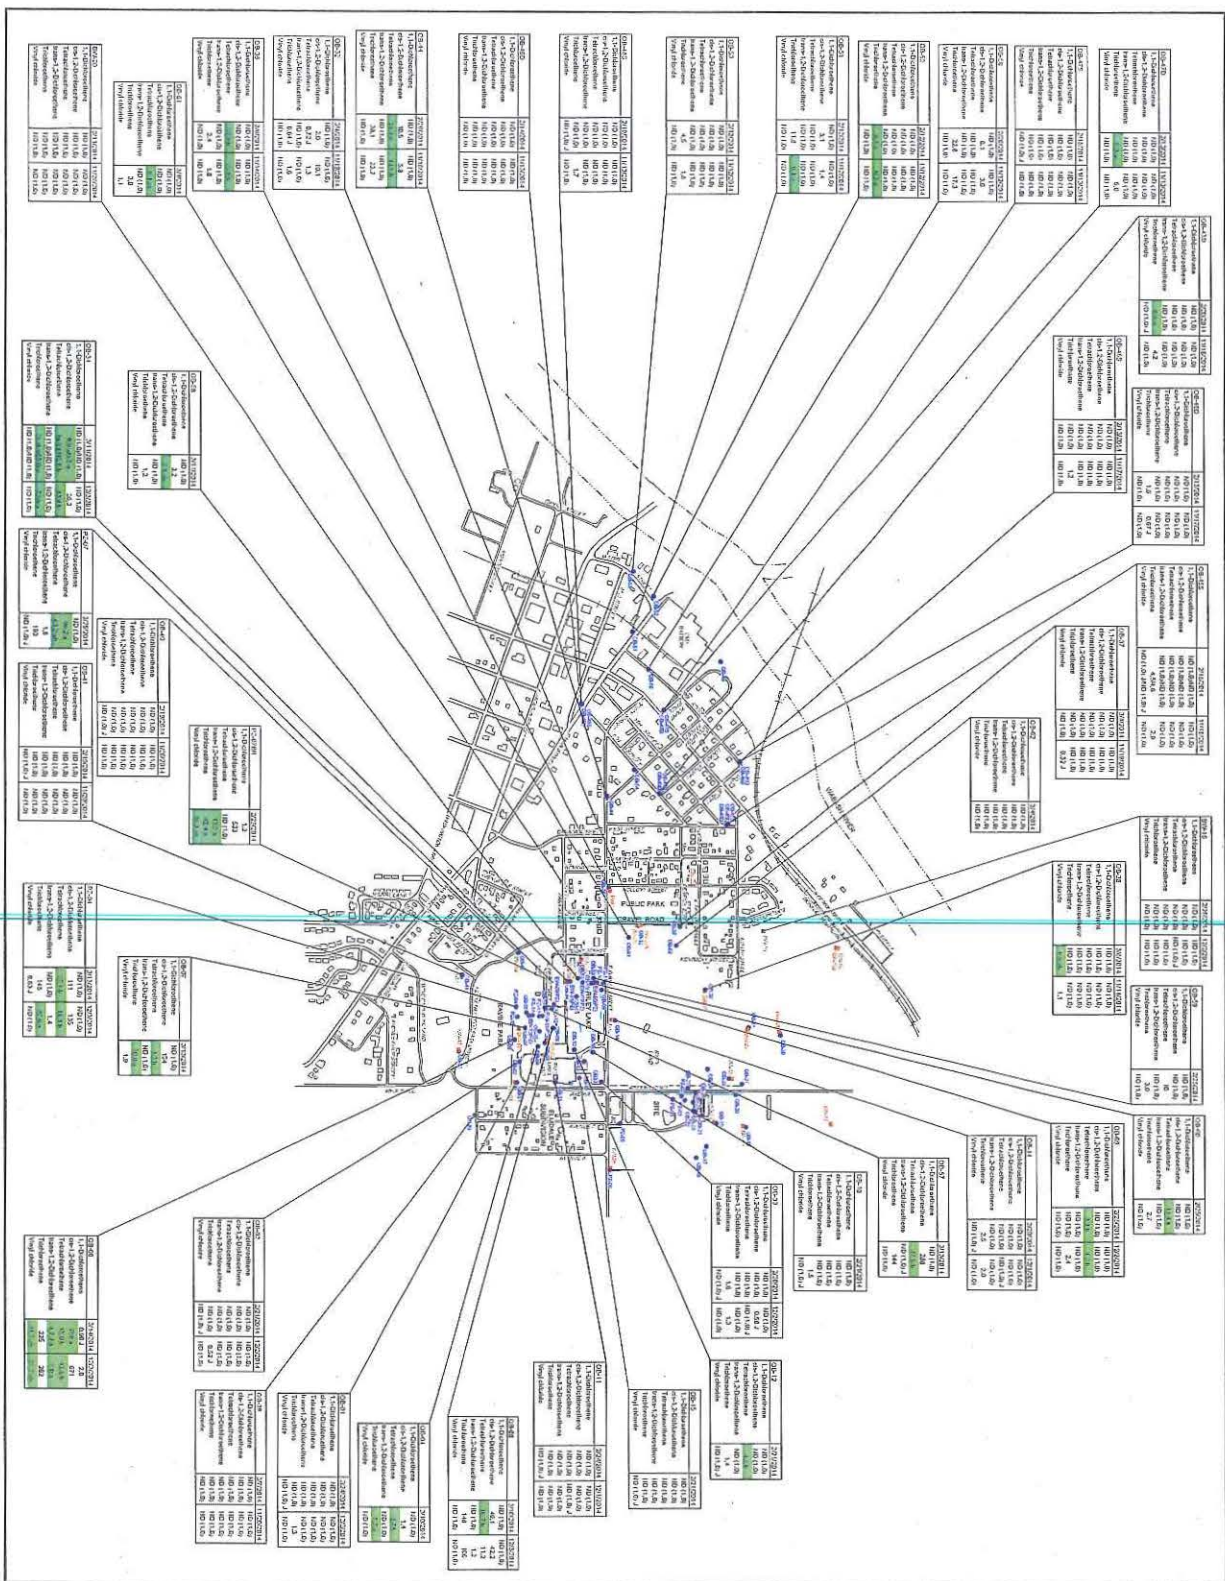
**SUMMARY OF 2014 SEMIANNUAL GROUNDWATER ANALYTICAL RESULTS FOR SELECTED CUDOS**
