Navajo Abandoned Uranium Mine Site Screen Report

Delter AUM Site

Navajo AUM Eastern Region

May 2009

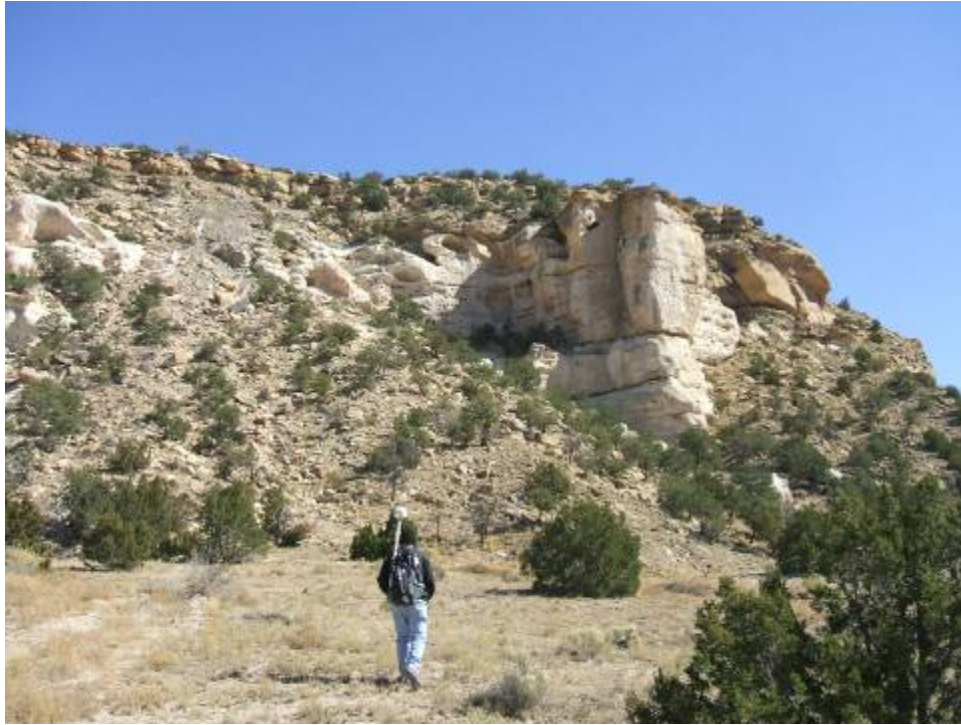
Photo 1. Delter mine site hill side, towards the east

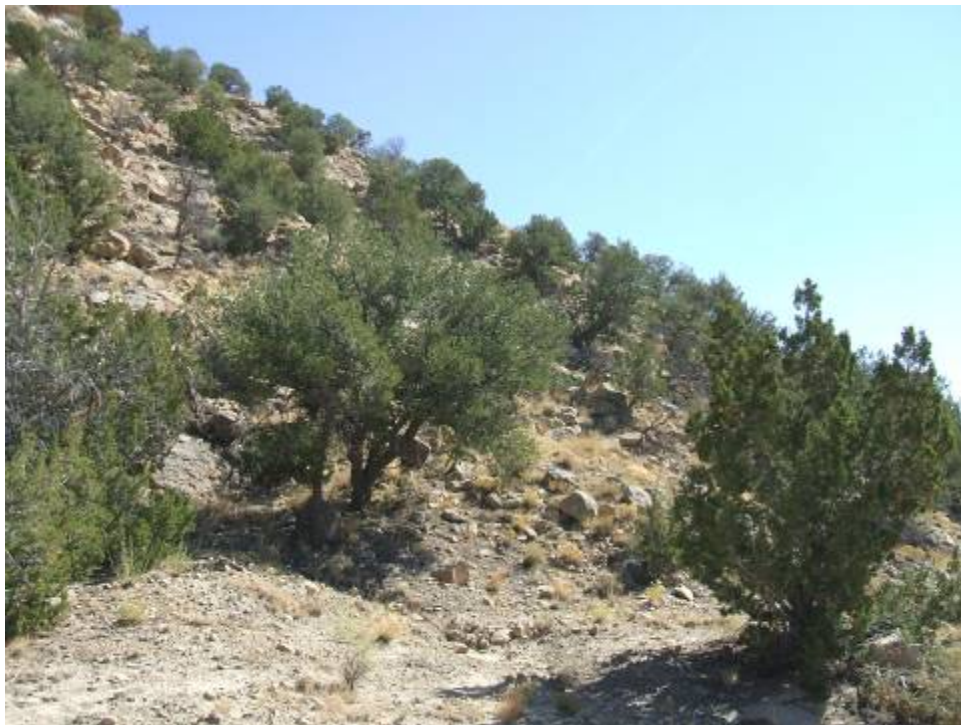
Photo 2. Delter mine site hill side, towards the southeast

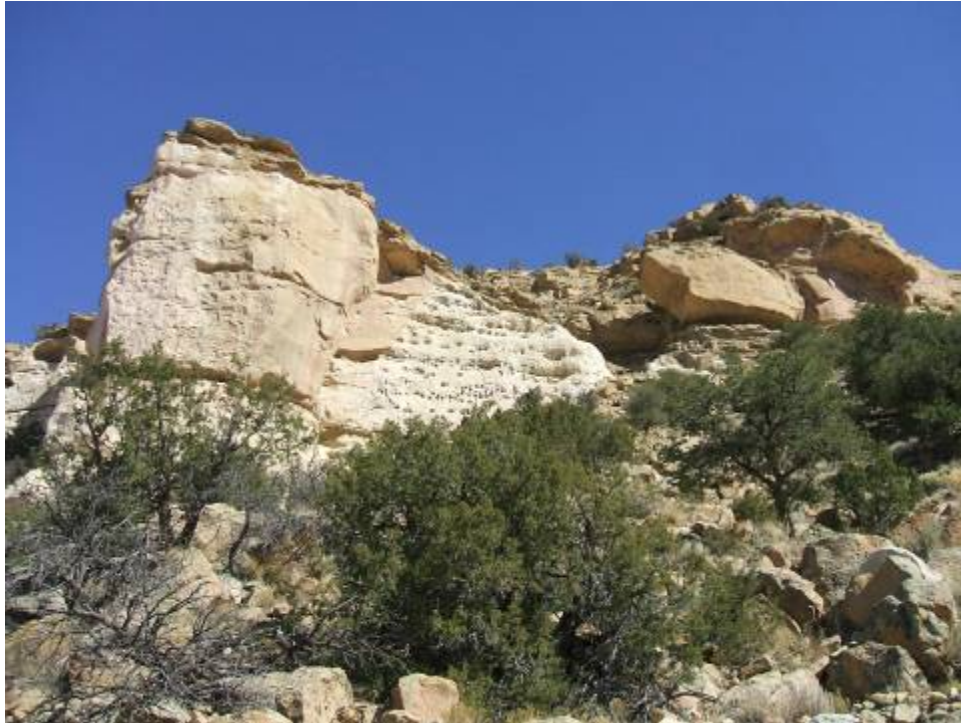
Reclamation status of the mine site is currently unknown. No visible signs of reclamation were observed. No waste piles, adits, or other mine features were observed during the site visit, the site was located along a cliff / landslide area..

Photo 3. Delter mine site cliff face, towards the east

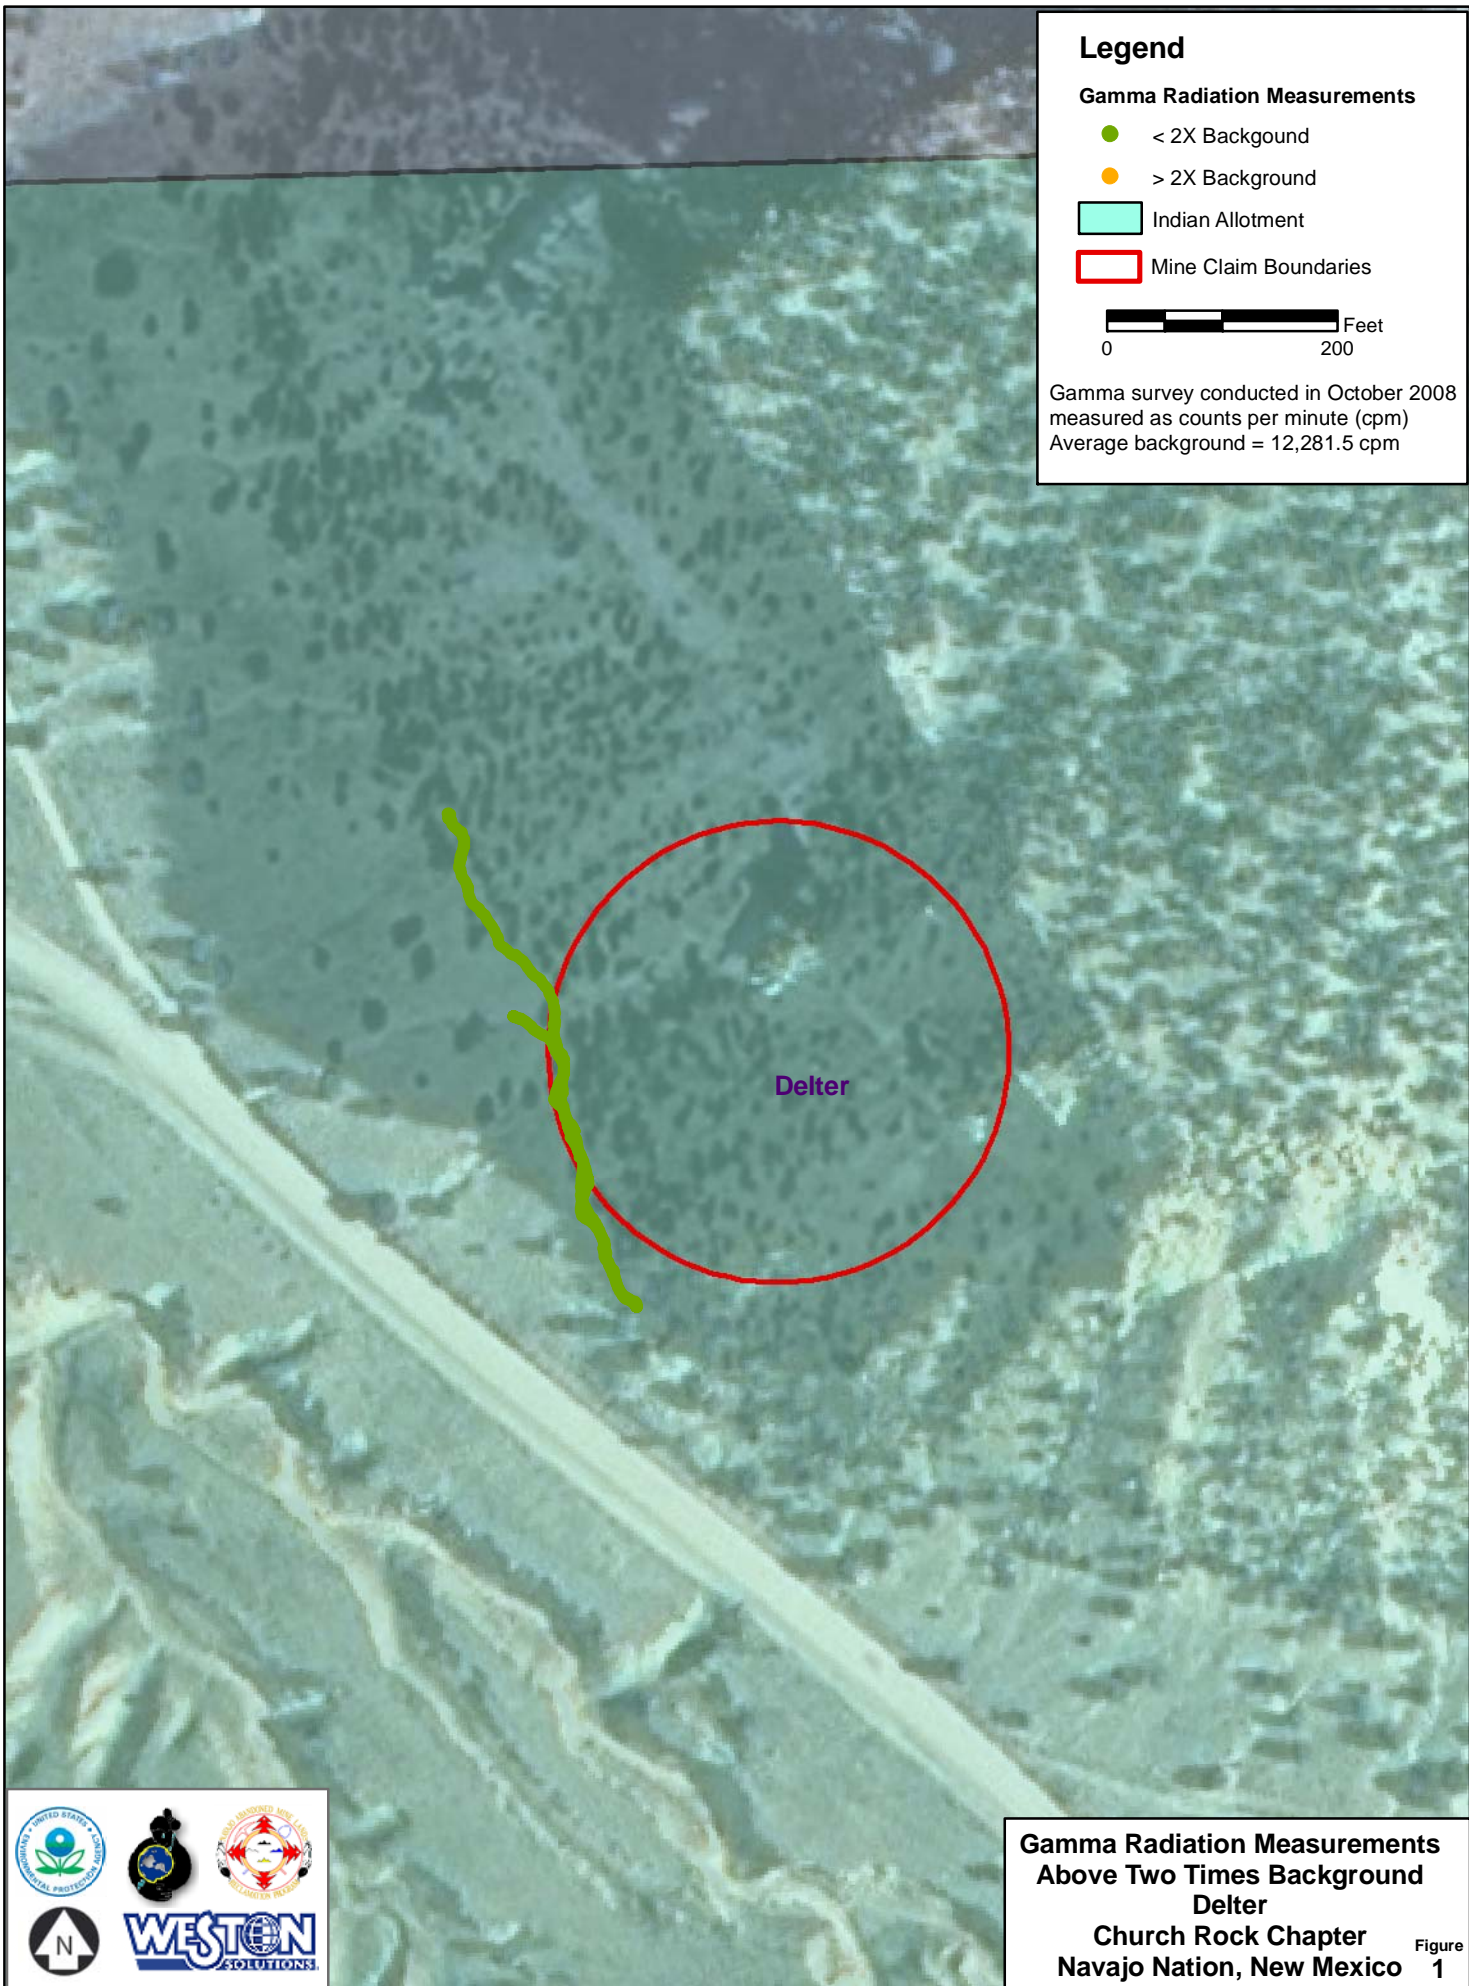
A total of 514 gamma radiation measurements were collected from mine sites, ranging from 9,706 cpm to 56,632 cpm. The measurements are represented in Figures 1 and 2.
