Navajo Abandoned Uranium Mine

Site Screen Report

Mesa IV, West Mine AUM Site

March 2010

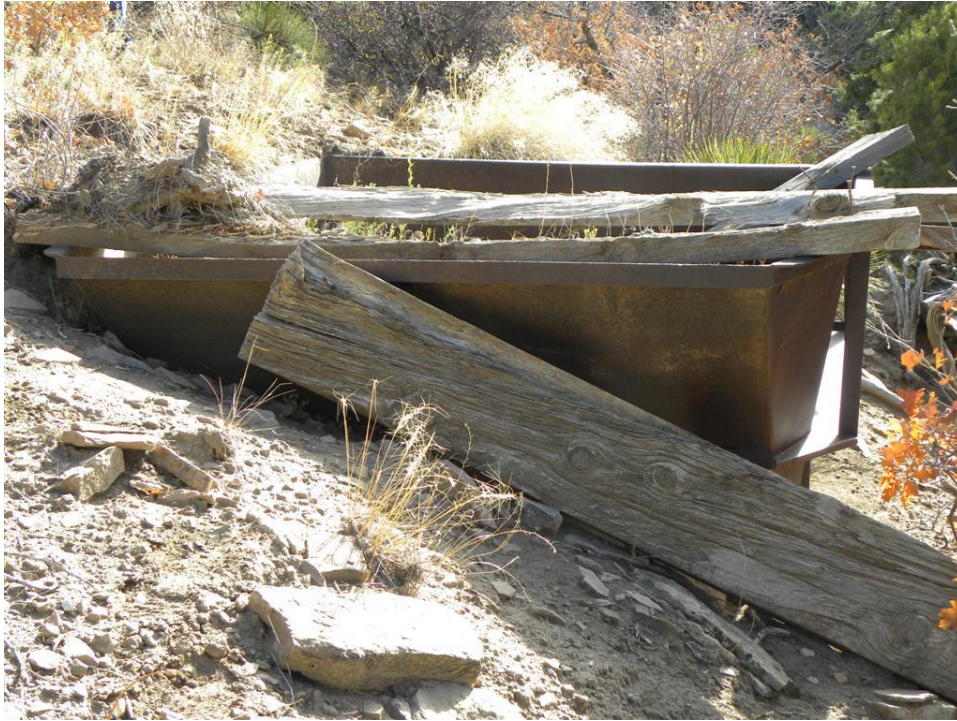
Photo 1. Metal container

A large metal container was found at the site
