Navajo Abandoned Uranium Mine

Site Screen Report

Mine Name: Charles Huskon No. 19

August 2011

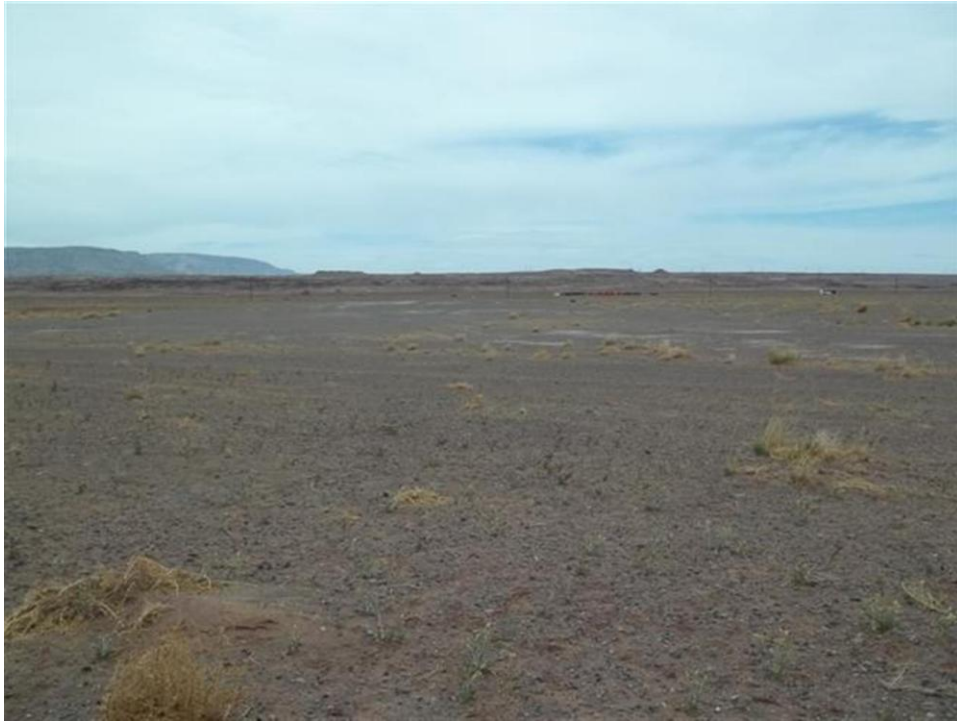
Photo 1: Mine Site #120

Excavation area in center of site

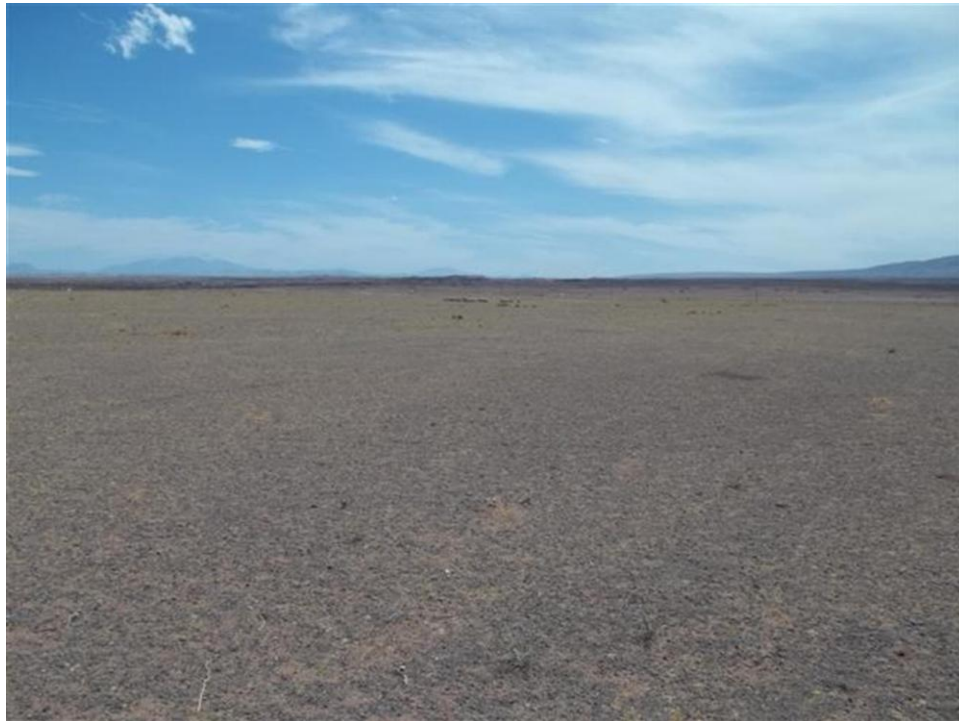
Photo 8: Mine Site #229

2 reclamation caps: Cap 1 - 100' x 80' x 2.5', red-brown soil with small gravel and berm along SE corner; Cap 2 - 75'dia x 1.5'h, red-brown soil with small gravel

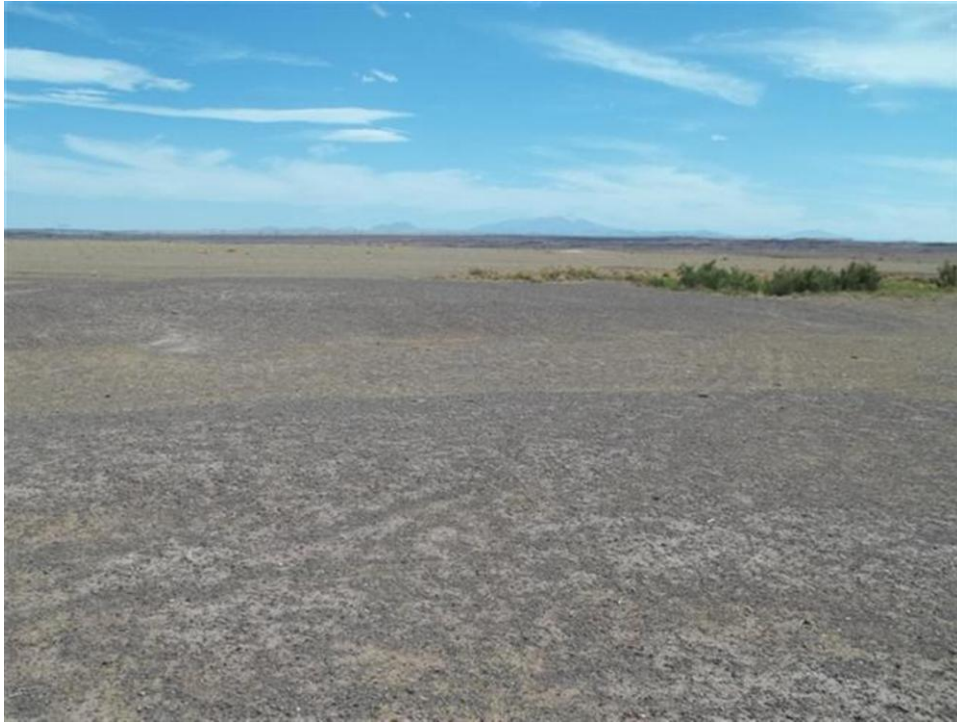
Photo 9: Mine Site #229; Reclamation area and spring/pond

0 to 0.25 miles: Small livestock pond on site #229
