# Navajo Abandoned Uranium Mine

## Site Screen Report

**Mine Name: Max Johnson No. 1**  
**Mine ID: 125**

**August 2011**

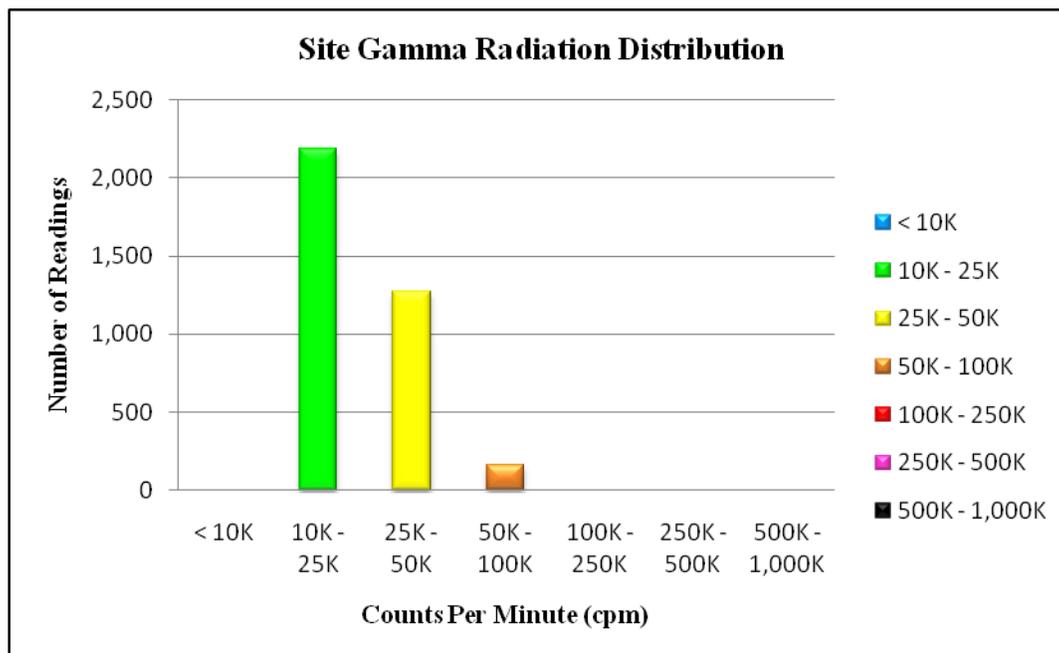
**Distribution Chart and Statistics:**

<b>Site Gamma Radiation Statistics</b>	
Number of Readings	3,627
Minimum (cpm)	13,717
Maximum (cpm)	74,406
Mean (cpm)	26,226
Median (cpm)	23,004
Standard Deviation	10,377

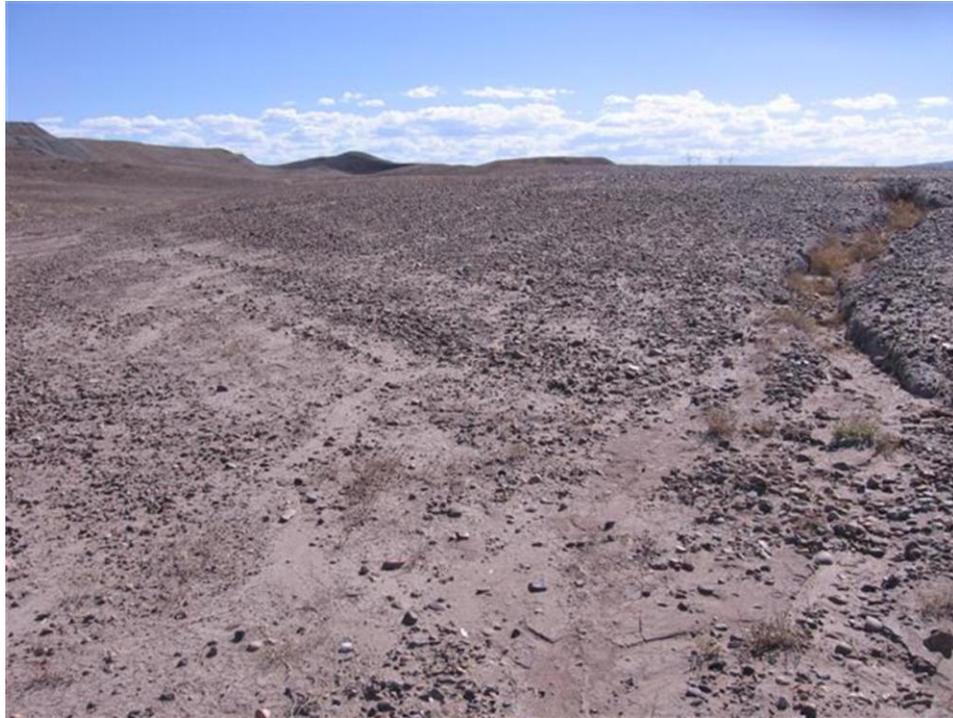
**Photo 2:** Mine Site #125; Reclamation area

Reclamation cap 1 (125ReclCap1): 550'x350'x6' oval, red-gray fine soil with rocks on top.

Reclamation cap 2 (125ReclCap2): 200'x600' rectangle, red-gray fine soil, mining debris (oil cans, wooden stakes, screws)

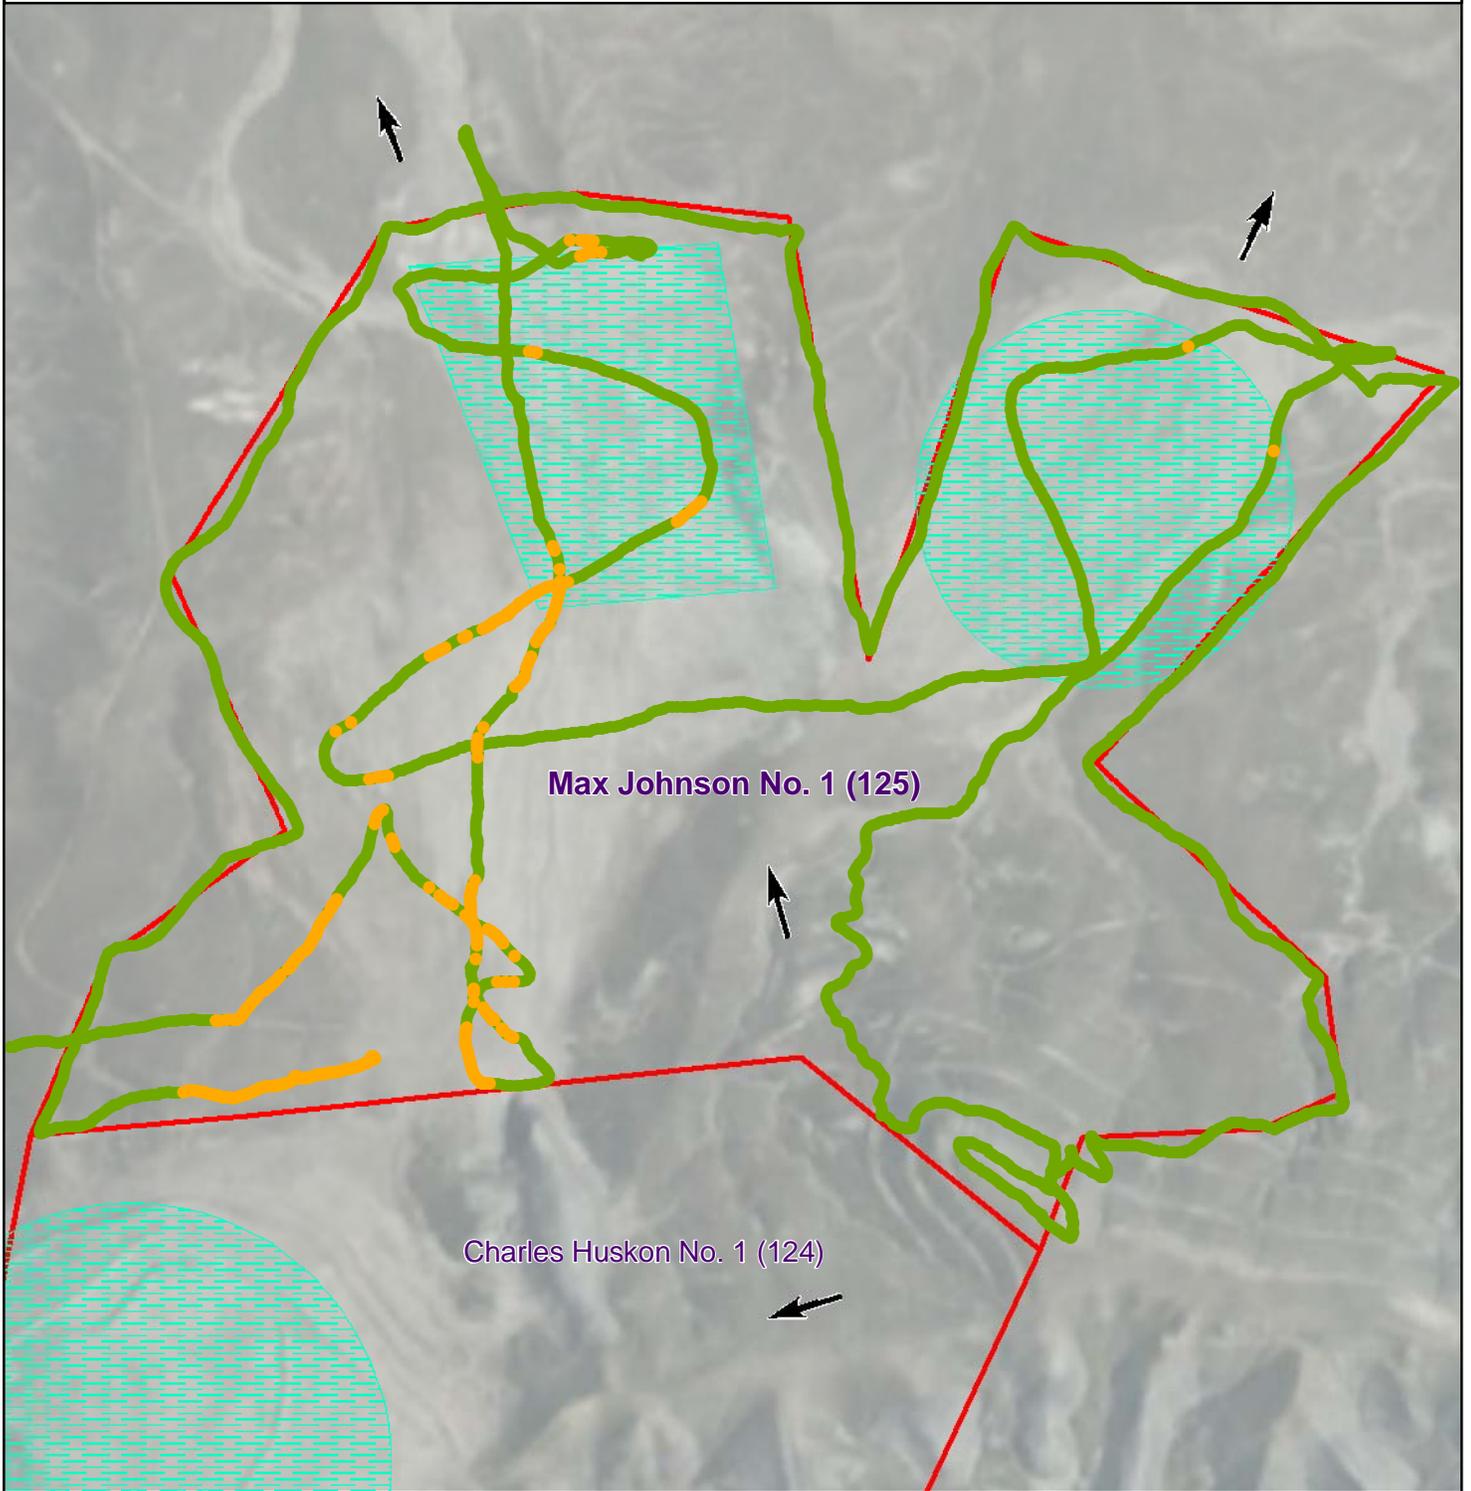
**Figure 1 - Gamma Radiation Measurements, Above Two Times Background  
 Max Johnson No. 1 (125)  
 Coalmine Mesa Chapter, Navajo Nation**

A total of 3,627 gamma radiation measurements were collected from the mine site, ranging from 13,717 cpm to 74,406 cpm. Measurements collected in the vicinity of the reclamation area were found at a maximum level of approximately 75,000 cpm. The measurements are represented in Figures 1 and 2.

- < 2X Background
- > 2X Background

Average background 17,549 cpm

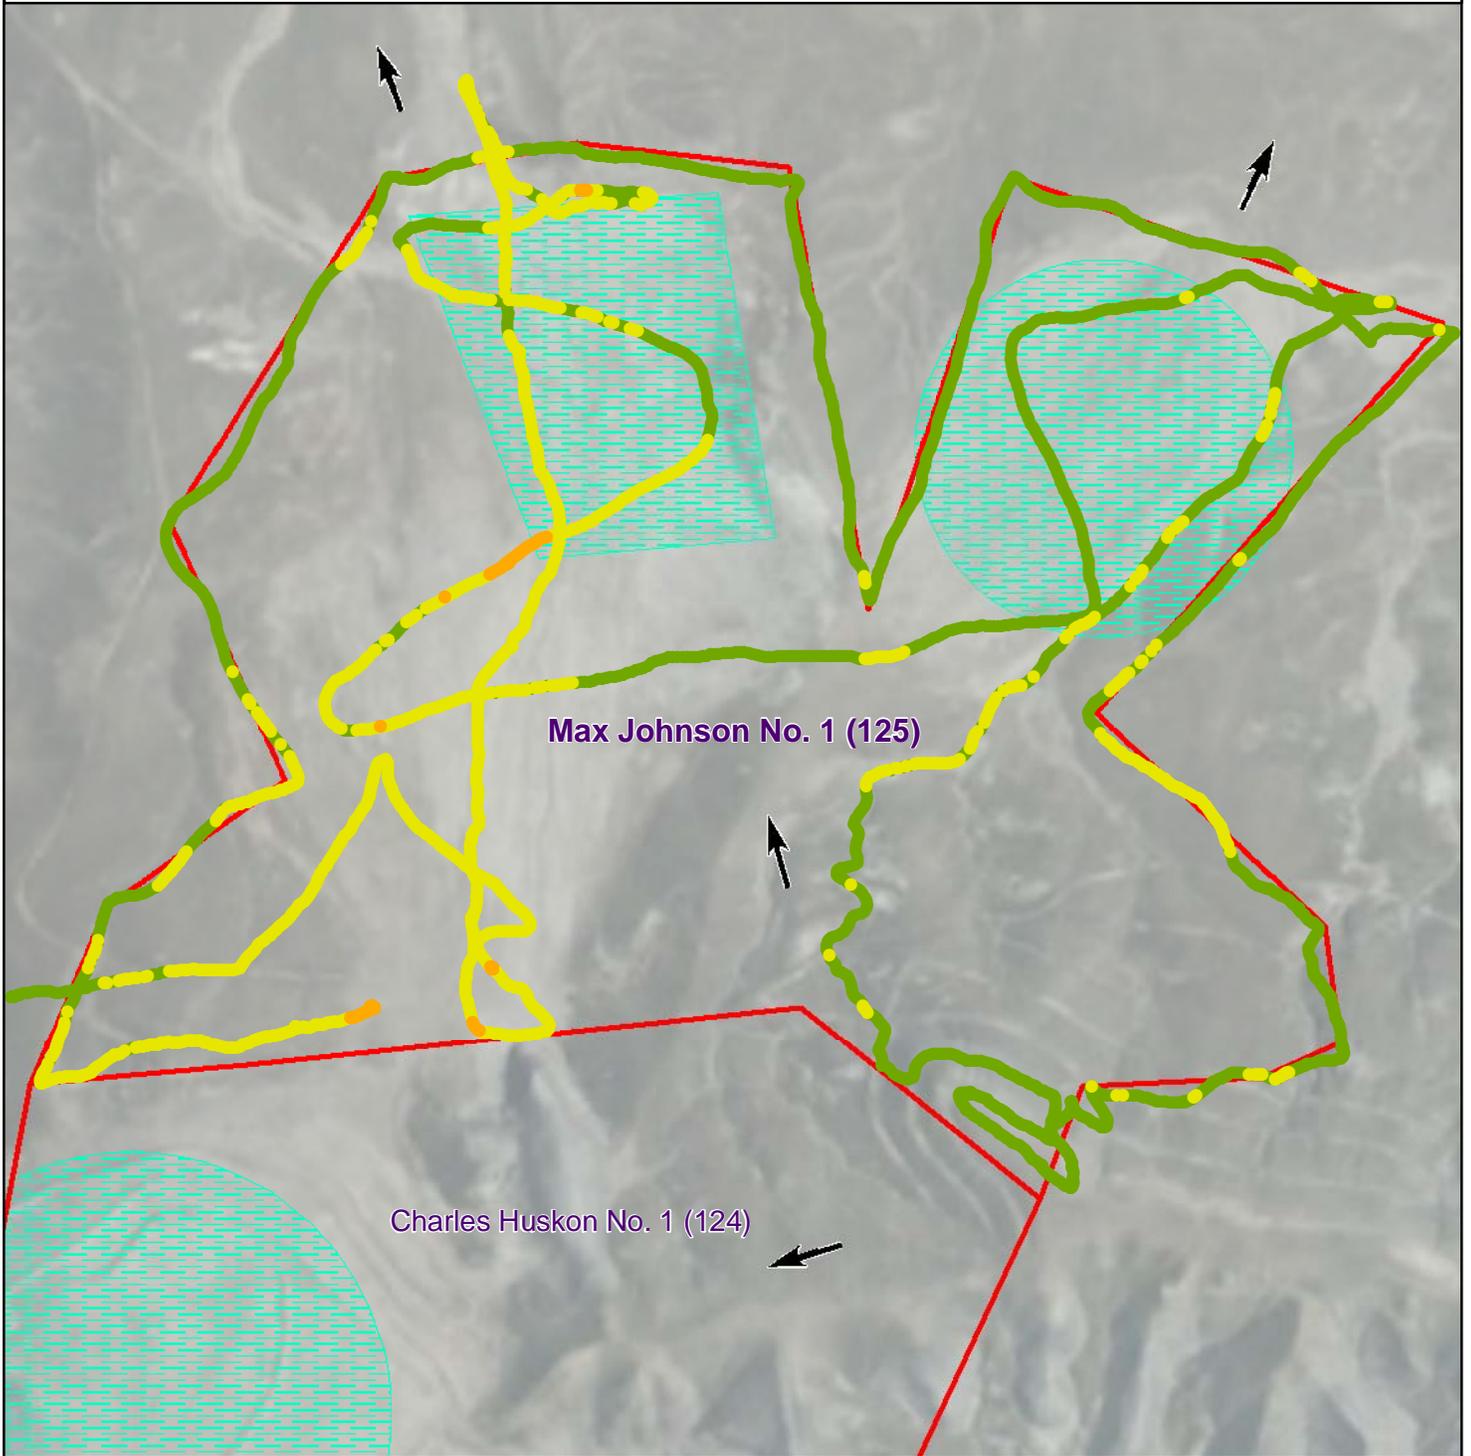
**Figure 2 - Gamma Radiation Measurements**  
**Max Johnson No. 1 (125)**  
**Coalmine Mesa Chapter, Navajo Nation**

- 0 - 10,000 cpm
- 10,000 - 25,000 cpm
- 25,000 - 50,000 cpm
- 50,000 - 100,000 cpm
- 100,000 - 250,000 cpm
- 250,000 - 500,000 cpm
- 500,000 - 1,000,000 cpm

Measured as counts per minute (cpm) Average background 17,549 cpm
