Navajo Abandoned Uranium Mine

Site Screen Report

Mine Name: Max Johnson No. 9
Mine ID: 130

August 2011

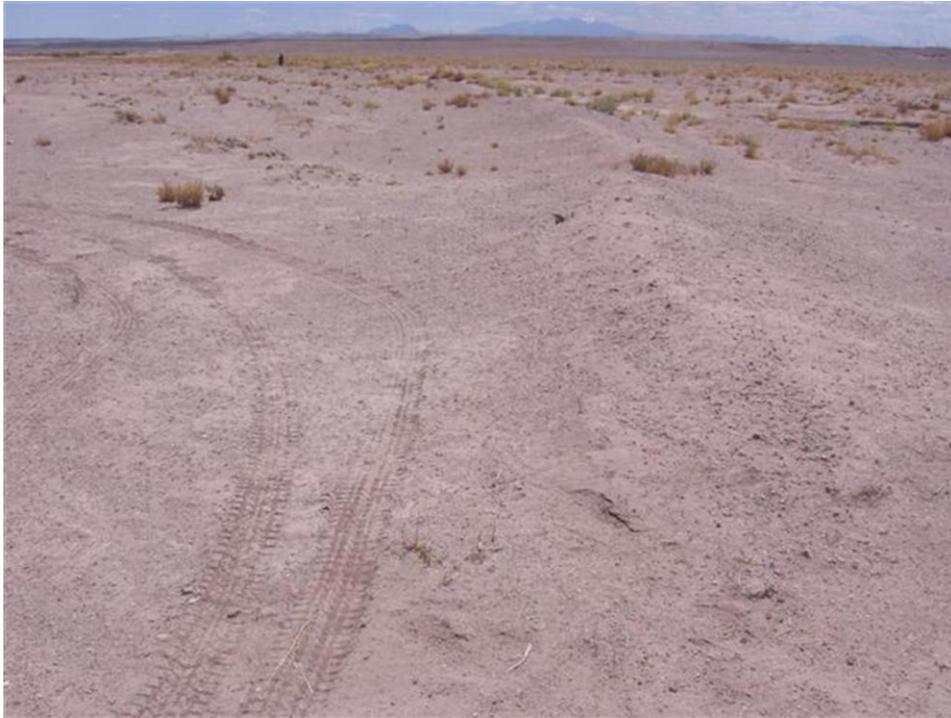
Photo 2: Mine Site #130; Berm

Reclamation cap and berms
