Navajo Abandoned Uranium Mine

Site Screen Report

Juan Horse No. 3 AUM Site

January 2011

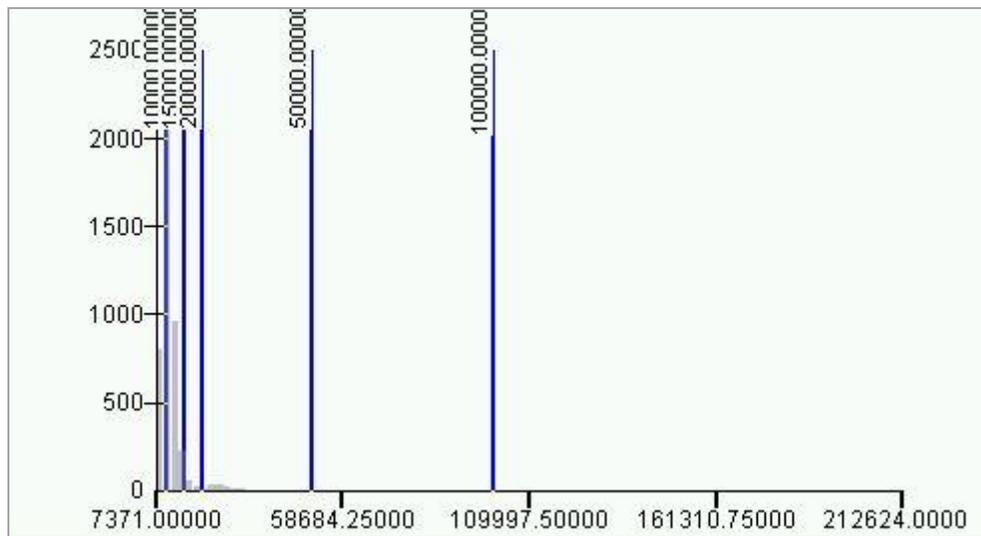
The following chart and statistics were generated by ESRI ArcGIS 9.3.1, and show the general distribution of the site gamma radiation measurements. The horizontal X axis represents the gamma radiation reading levels in cpm (lowest levels to the left). The vertical Y axis represents the frequency of each gamma radiation level.

Count:	4696
Minimum:	7371.00000
Maximum:	212624.00000
Sum:	58112939.00000
Mean:	12374.98701
Median:	10635.00000
Standard Deviation:	12271.65629

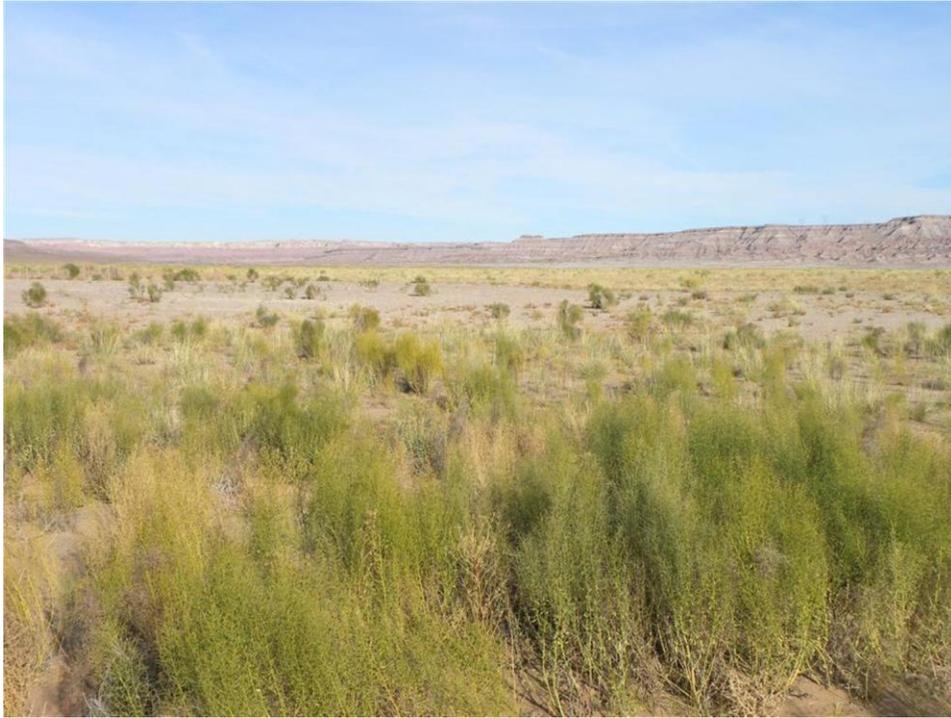
Photo 1. Juan Horse No. 3 mine site

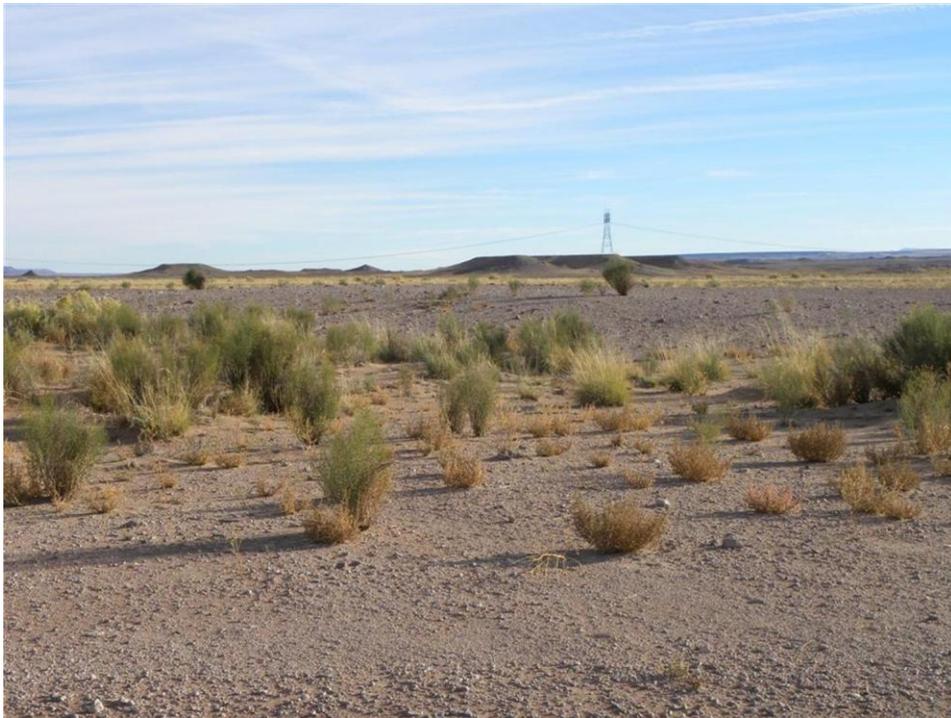
Reclamation cap in the center of the site, approximately 200' x 100'

Photo 2. Juan Horse No. 3 mine site, reclamation cap

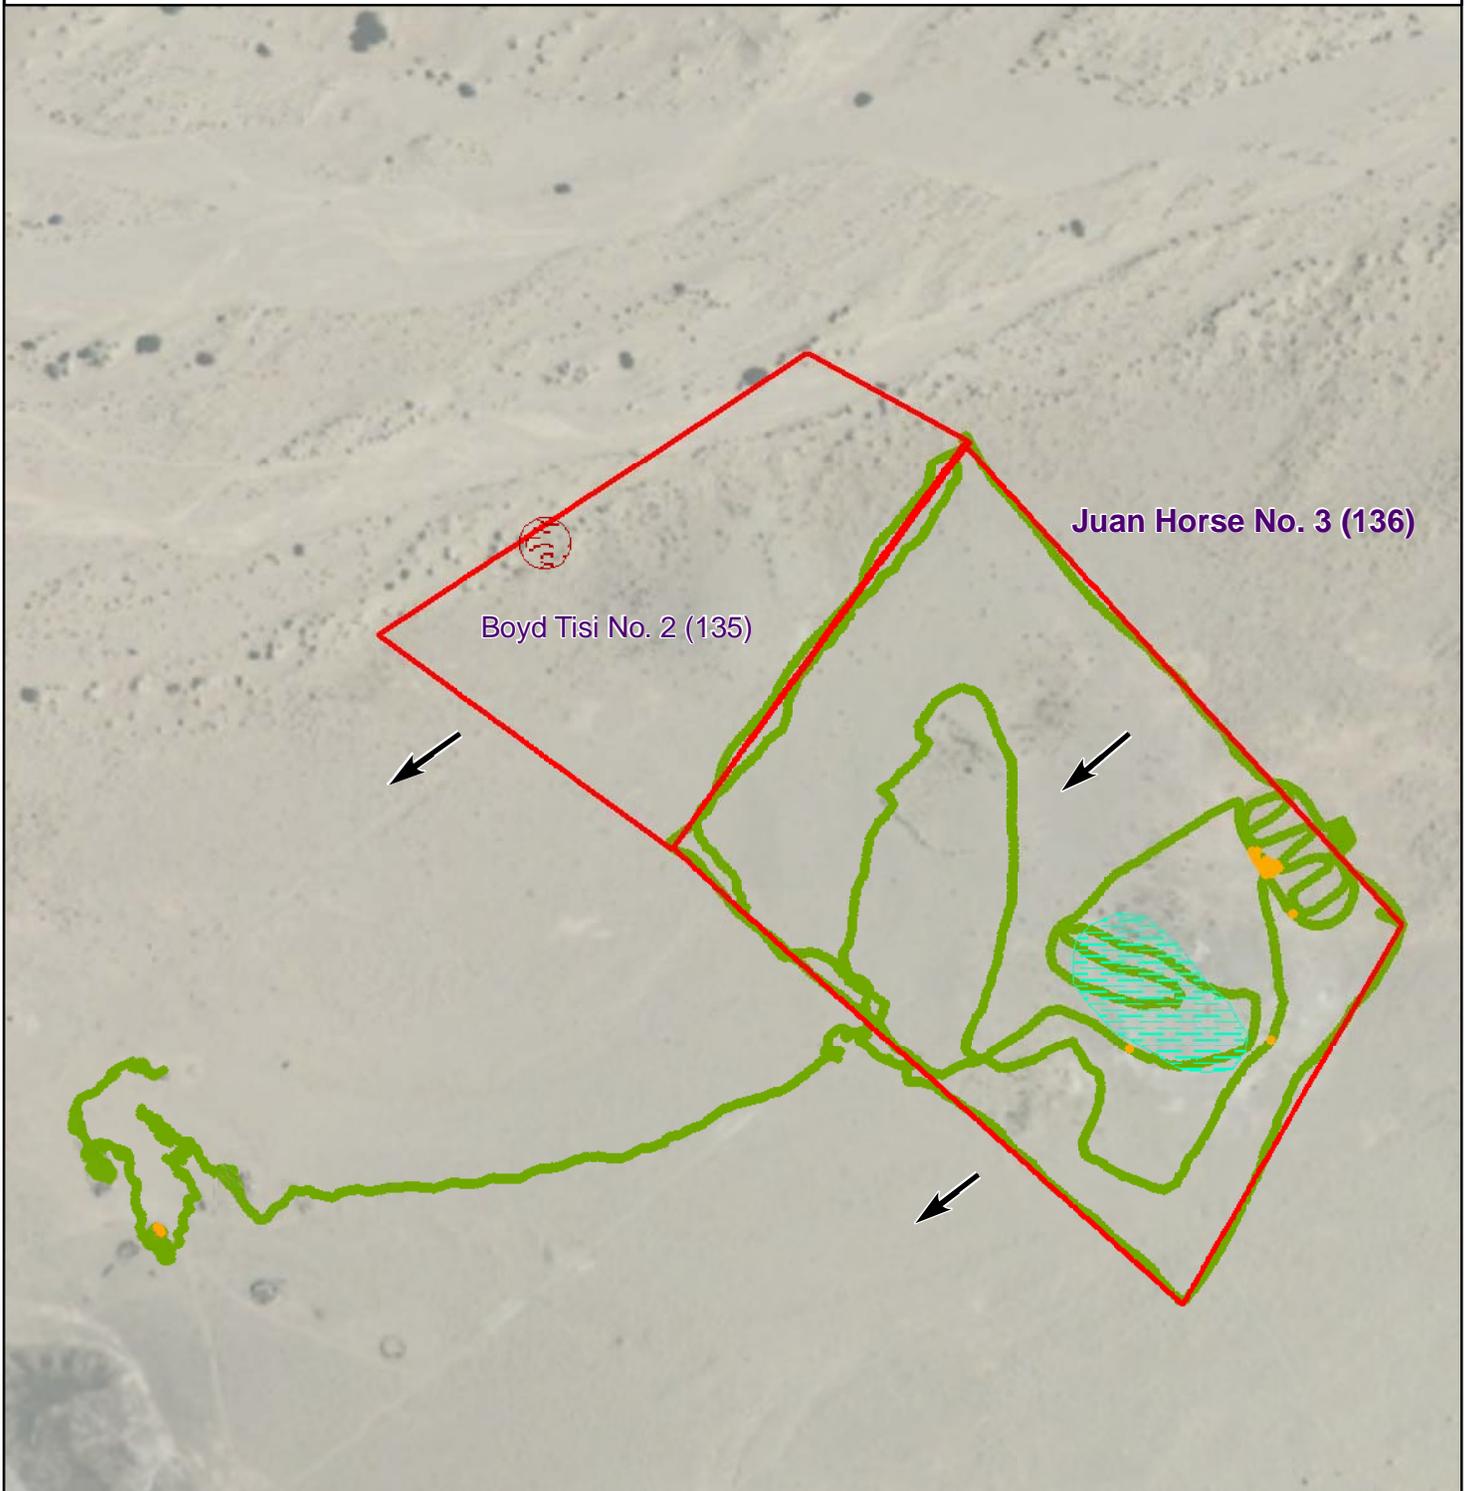
A total of 4,696 gamma radiation measurements were collected from the mine site, ranging from 7,371 cpm to 212,624 cpm. A petrified log near the structures 0.15 mi west of the site was found at over 200,000 cpm. The measurements are represented in Figures 1 and 2.

**Figure 1 - Gamma Radiation Measurements, Above Two Times Background
 Juan Horse No. 3 (136)
 Coalmine Mesa Chapter, Navajo Nation**

**Gamma survey conducted 11/2010
 Measured as counts per minute (cpm)**

Average background 11,523 cpm

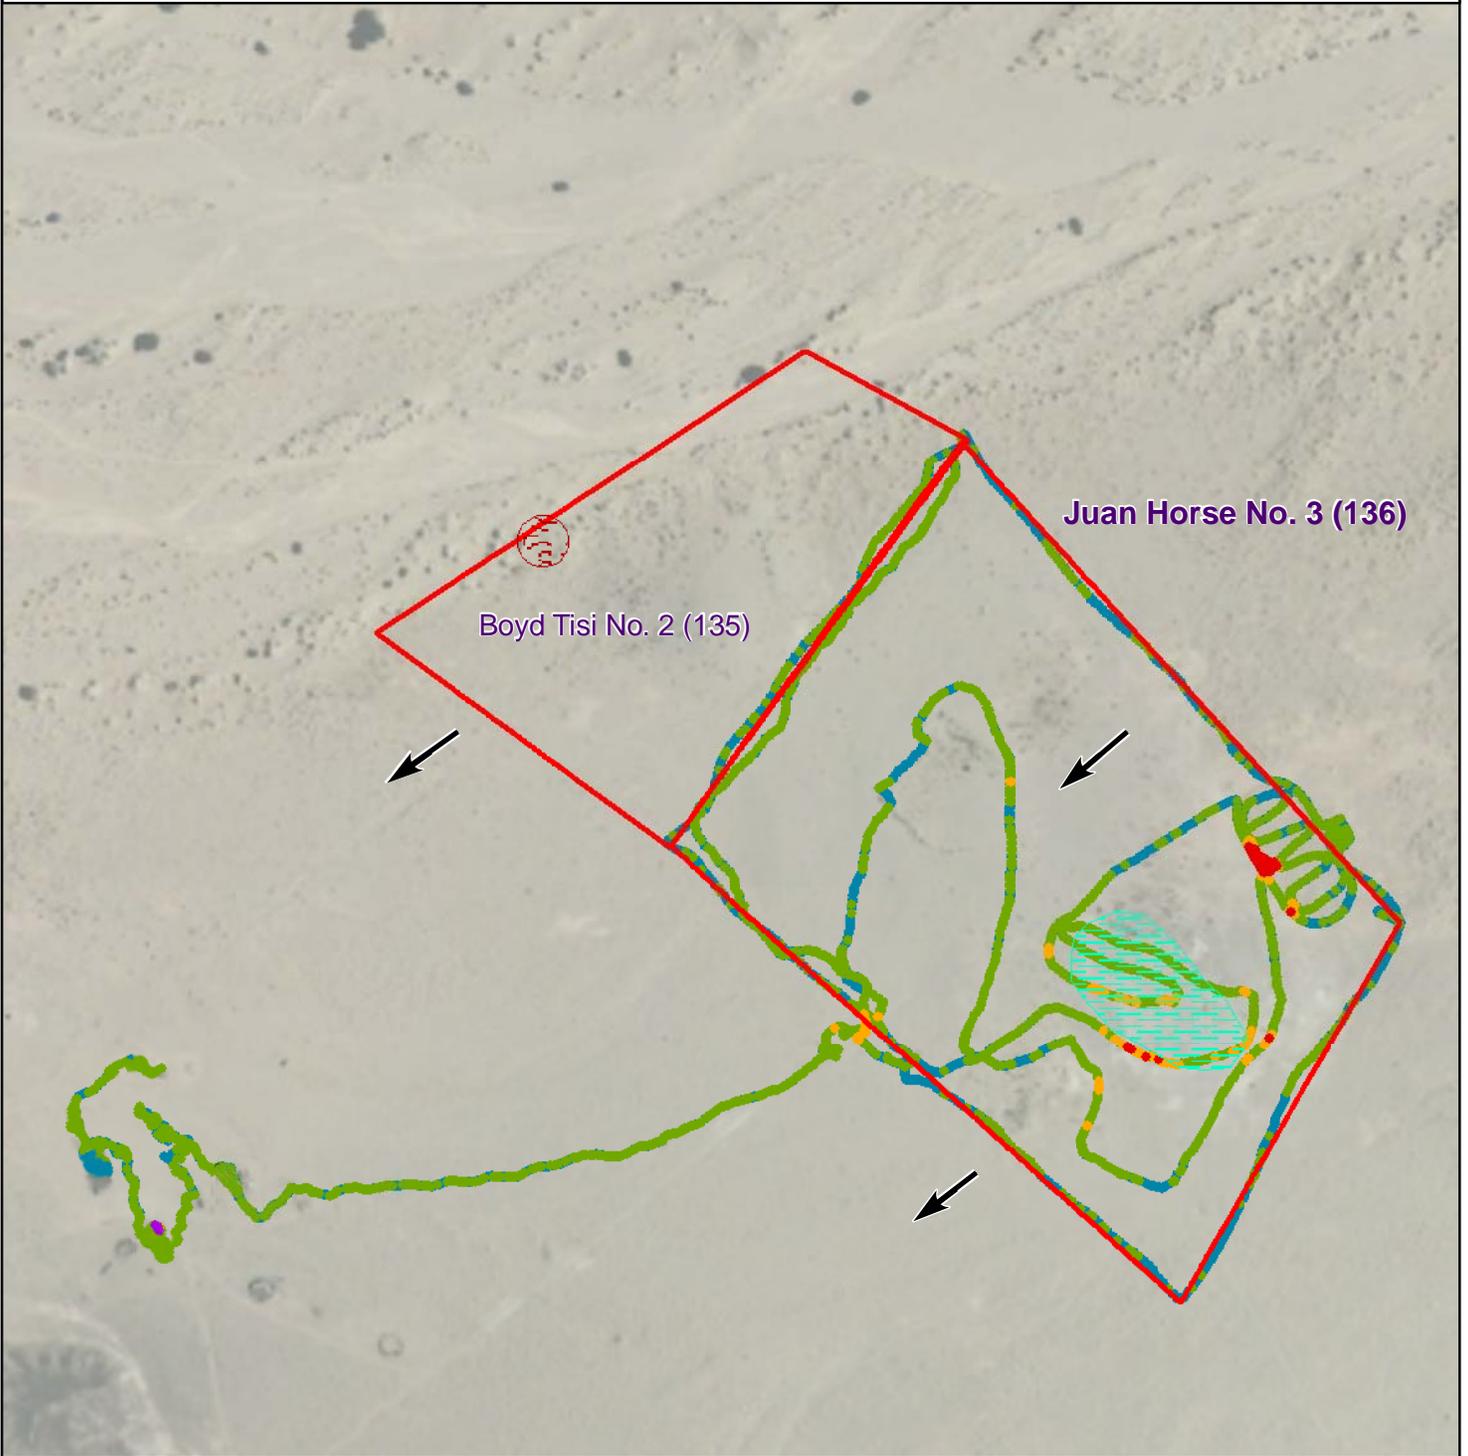
**Figure 2 - Gamma Radiation Measurements
 Juan Horse No. 3 (136)
 Coalmine Mesa Chapter, Navajo Nation**

Average background 11,523 cpm

Gamma survey conducted 11/2010
 Measured as counts per minute (cpm)
