# Navajo Abandoned Uranium Mine

## Site Screen Report

### Jackpot No. 5 AUM Site

**January 2011**

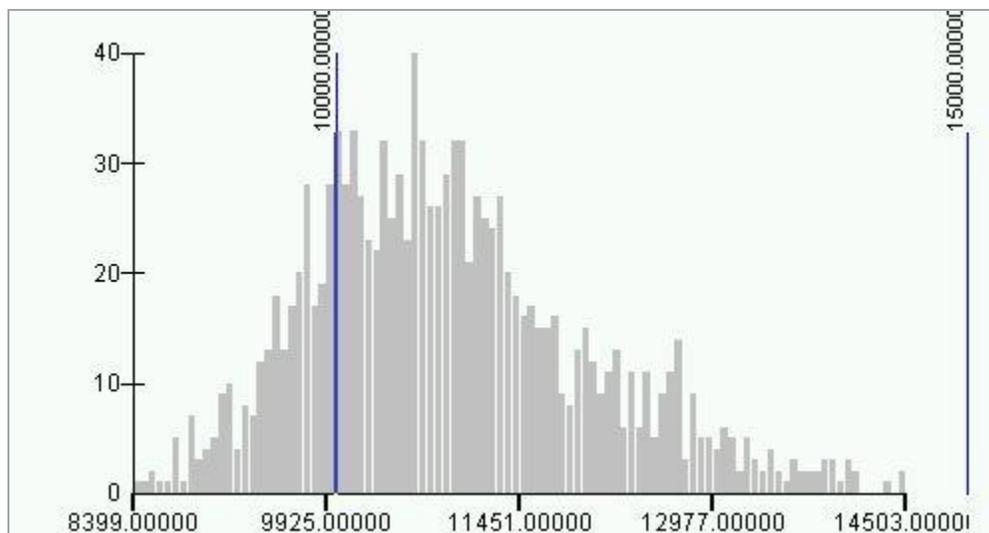
The following chart and statistics were generated by ESRI ArcGIS 9.3.1, and show the general distribution of the site gamma radiation measurements. The horizontal X axis represents the gamma radiation reading levels in cpm (lowest levels to the left). The vertical Y axis represents the frequency of each gamma radiation level.

Count:	1230
Minimum:	8399.00000
Maximum:	14503.00000
Sum:	13390807.00000
Mean:	10886.83496
Median:	10754.50000
Standard Deviation:	1097.54136

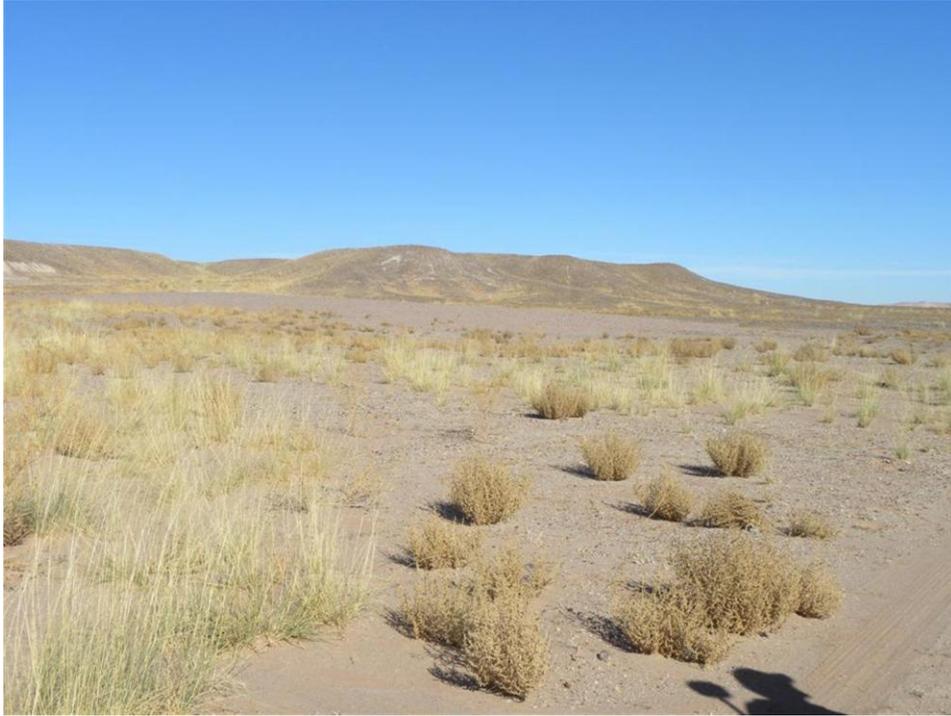
Photo 1. Jackpot No. 5 mine site

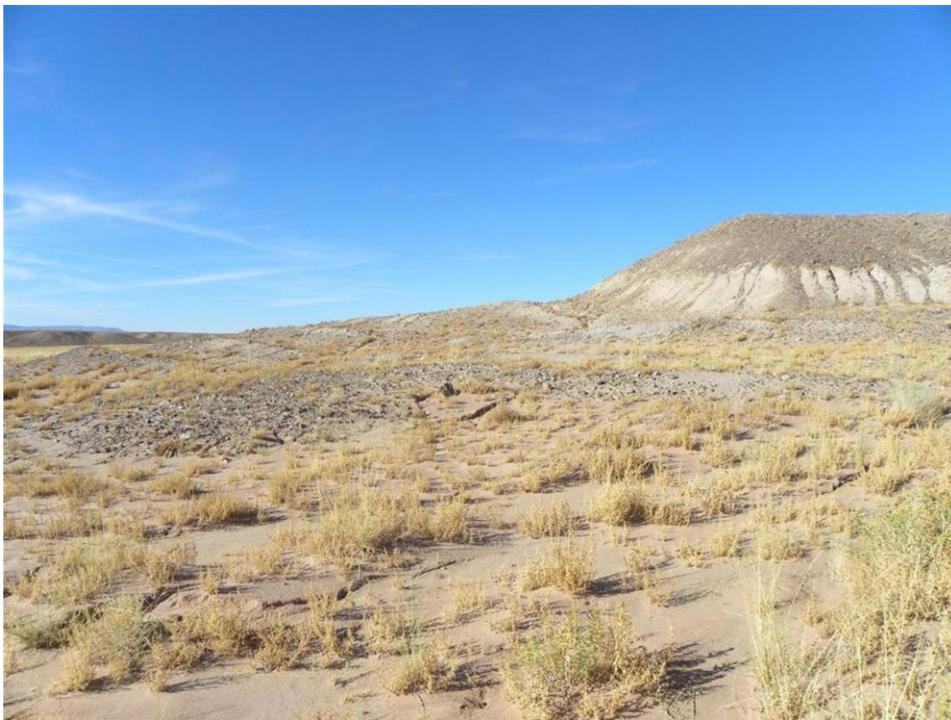
Large reclamation cap beneath what appeared to be old workings, grey granular material, 450' x 200'

Photo 2. Jackpot No. 5 mine site, reclamation cap area

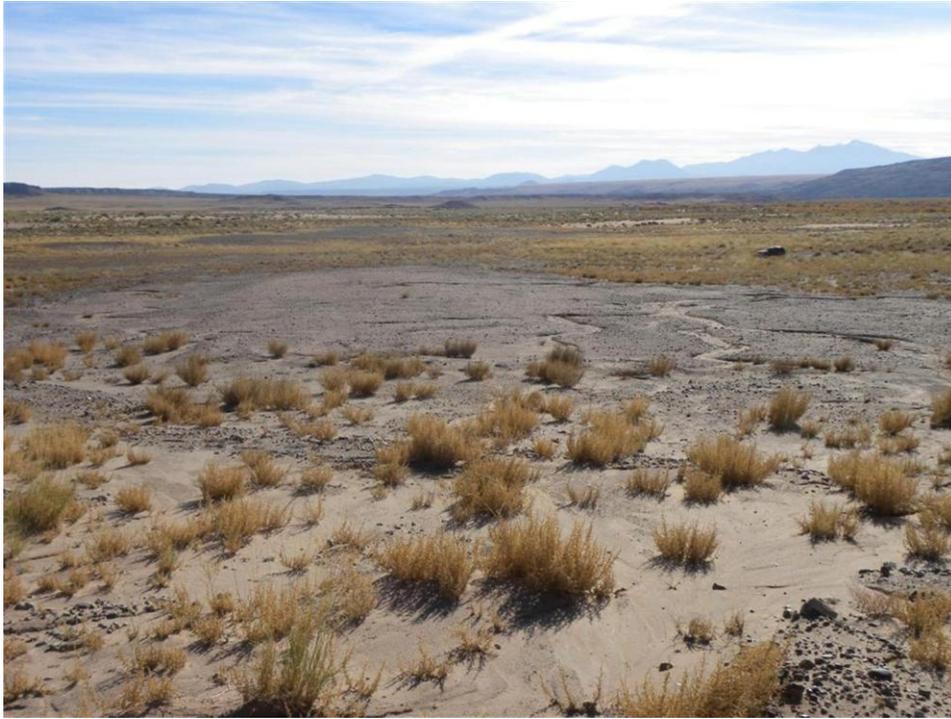
Photo 3. Jackpot No. 5 mine site, discolored soil immediately N of the site

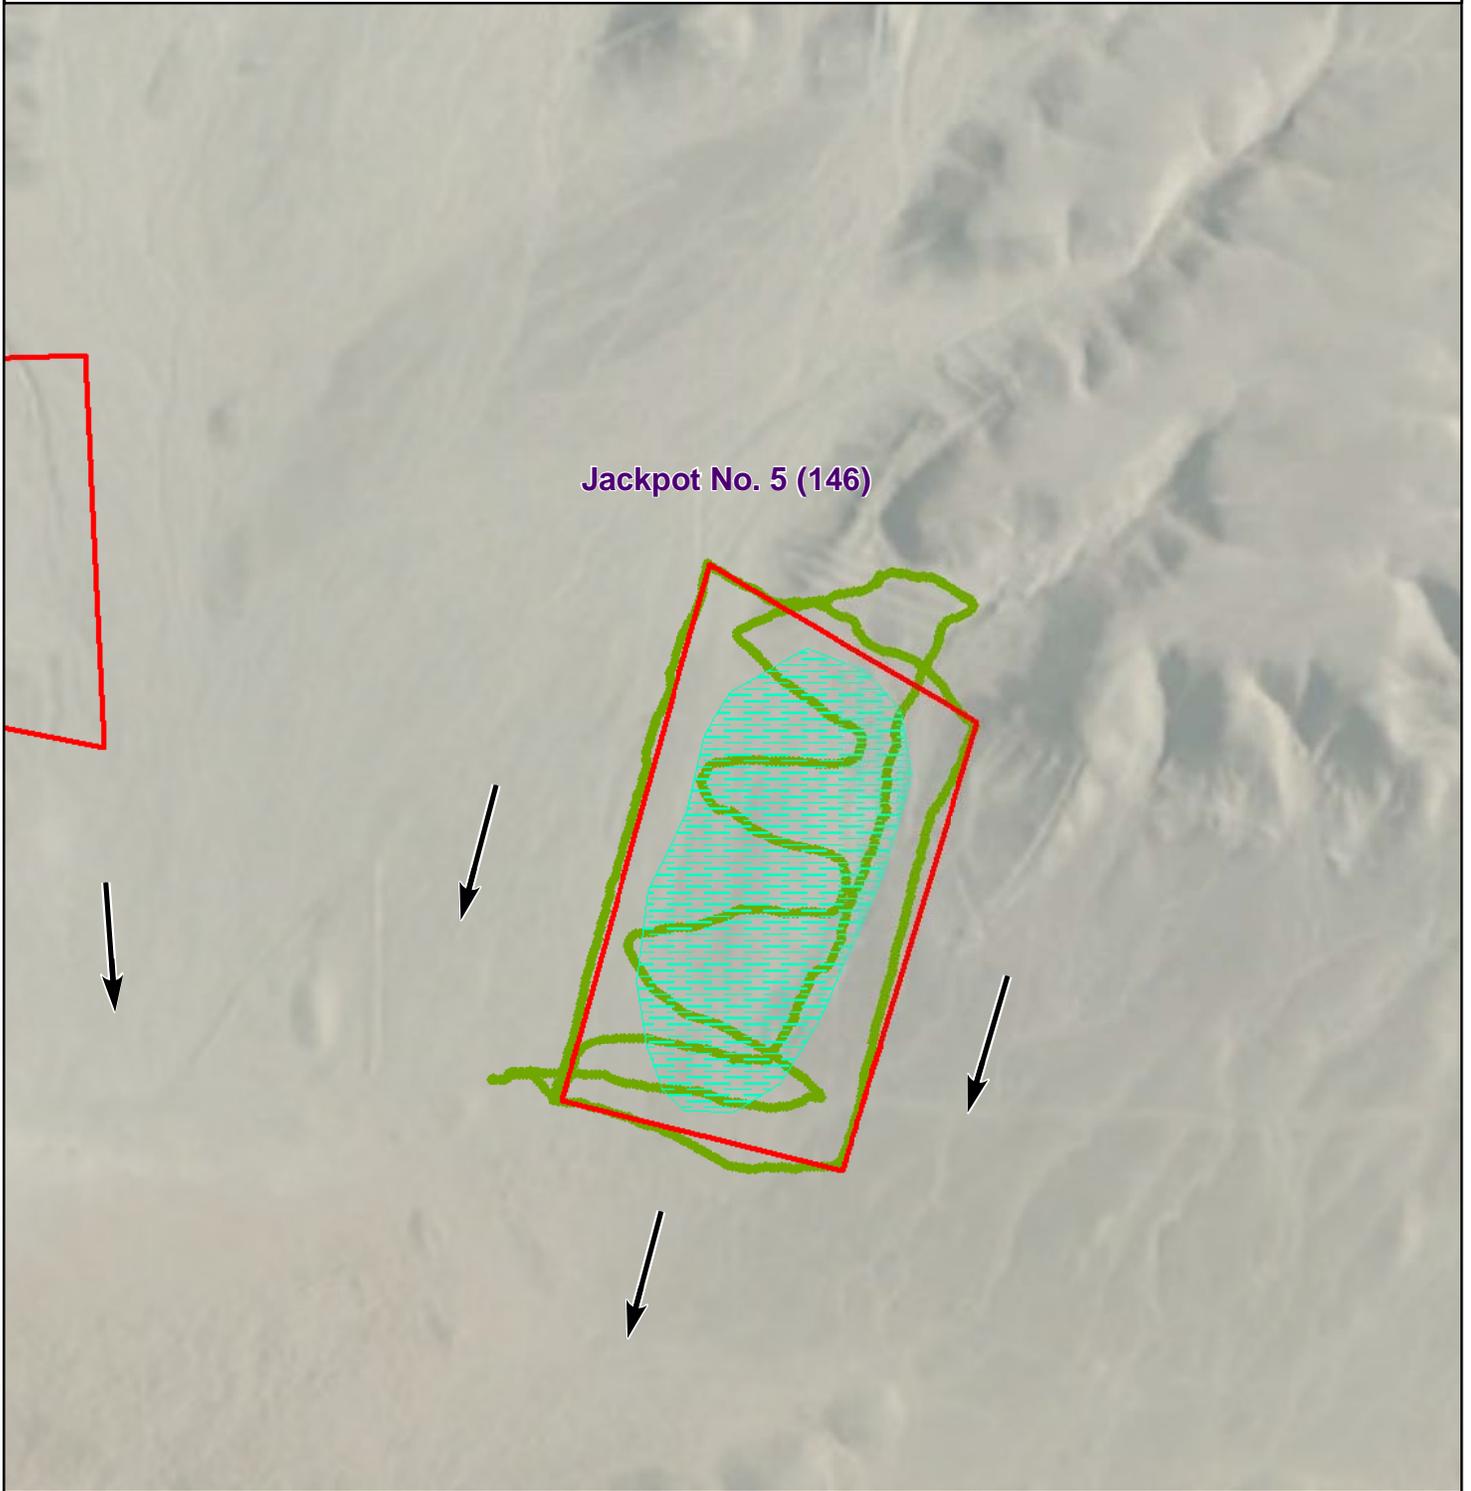
A total of 1,230 gamma radiation measurements were collected from the mine site, ranging from 8,399 cpm to 14,503 cpm. The measurements collected at the reclamation cap were found at a maximum level of approximately 15,000 cpm. The measurements are represented in Figures 1 and 2.

**Figure 1 - Gamma Radiation Measurements, Above Two Times Background  
Jackpot No. 5 (146)  
Coalmine Mesa Chapter, Navajo Nation**

Gamma survey conducted 11/2010  
Measured as counts per minute (cpm)

Average background 9,980 cpm

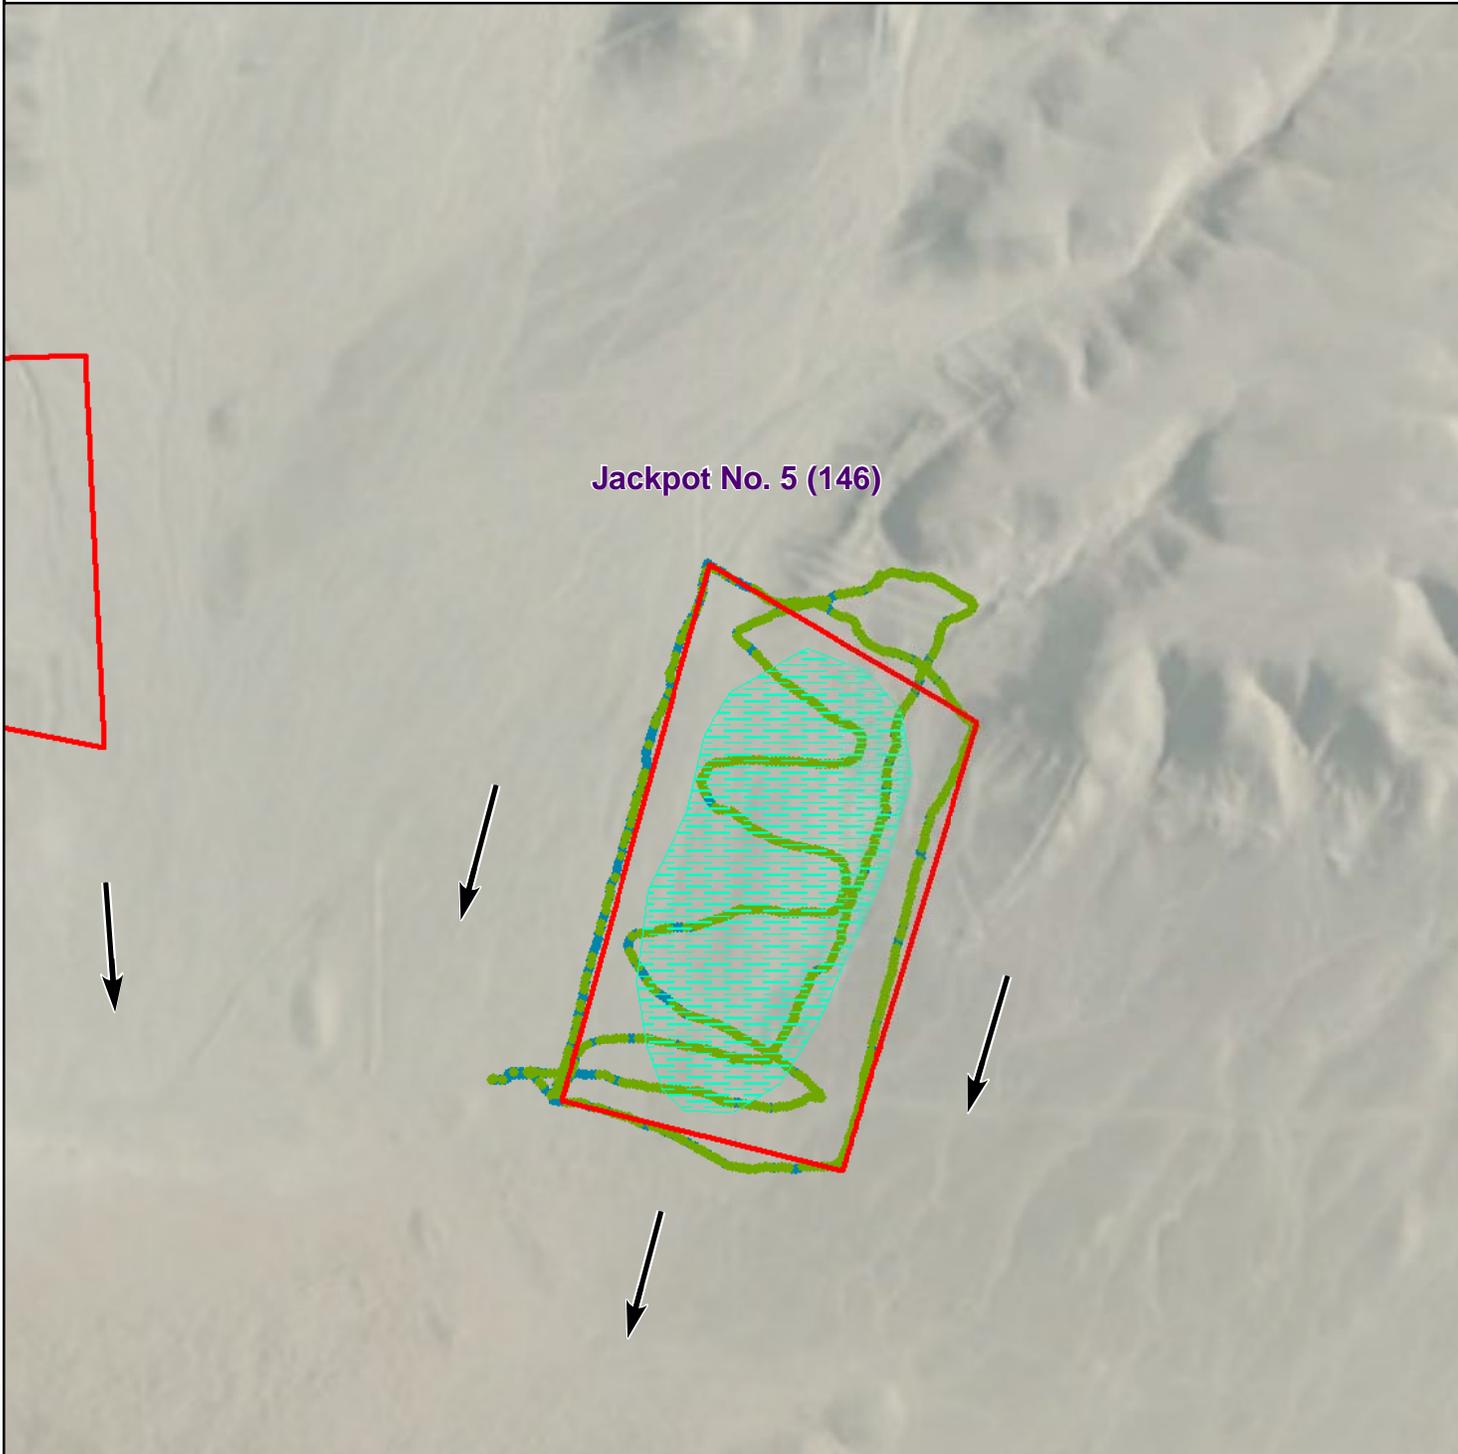
**Figure 2 - Gamma Radiation Measurements  
Jackpot No. 5 (146)  
Coalmine Mesa Chapter, Navajo Nation**

**Gamma survey conducted 11/2010  
Measured as counts per minute (cpm)**

**Average background 9,980 cpm**
